**Health Monitoring of  
Superstructures of  
New Zealand Road Bridges:**

**Waitangi Washout Bridge,  
Hawke's Bay**

**Transfund New Zealand Research Report No.171**

R.P. Andersen, W.S. Roberts, R.J. Heywood & T.J. Heldt  
Infratech Systems & Services Pty Ltd,  
Brisbane, Australia

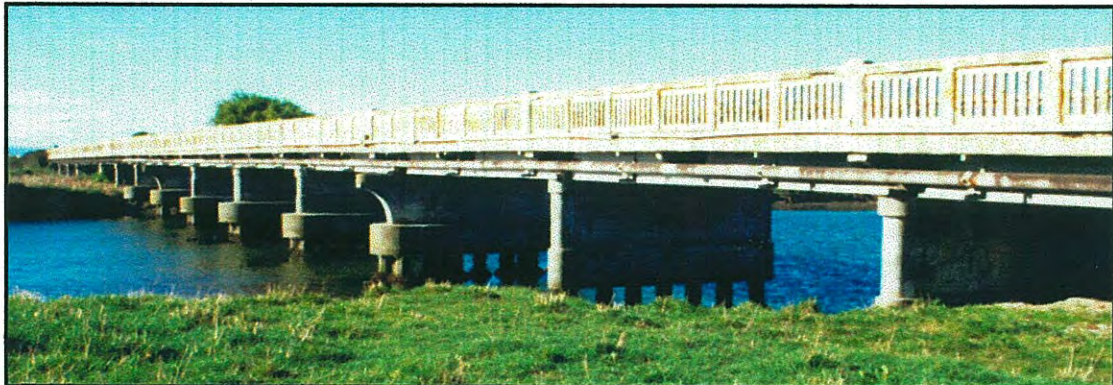
Figure 3.1 Waitangi Washout Bridge, in Hawke's Bay, North Island, New Zealand.

The Waitangi Washout Bridge, located on State Highway (SH) 2, crosses the Tutaekuri River between Napier and Hastings, Hawke's Bay Region, North Island. The structure consists of twenty simply supported spans, each with three reinforced concrete girders supporting a reinforced concrete deck. The concrete deck has integral kerbs and concrete guardrails. The typical span length is 12.2 m. Construction of the 244 m-long bridge was completed in 1935. The bridge is illustrated in Figure 3.1, and Figure 3.2 shows the soffit of the superstructure of a typical span.

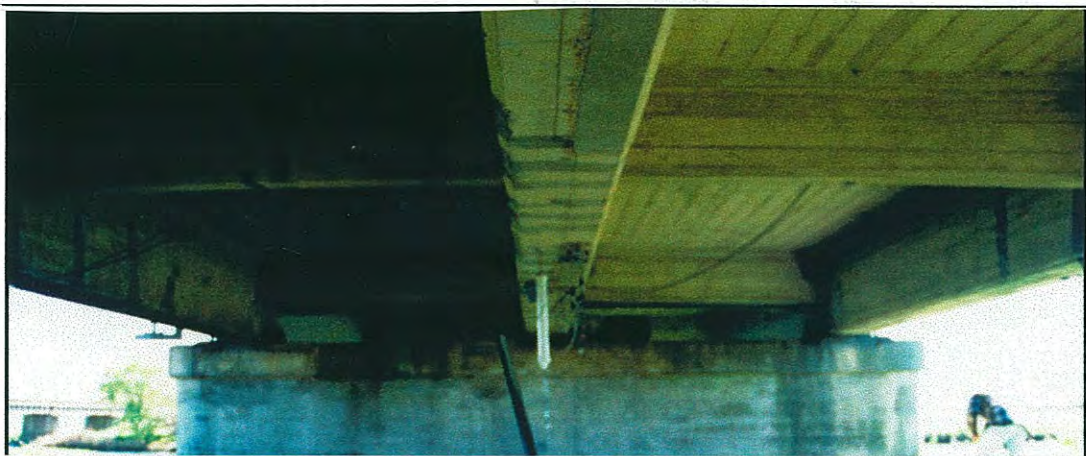
Figure 3.2 Typical superstructure soffit.

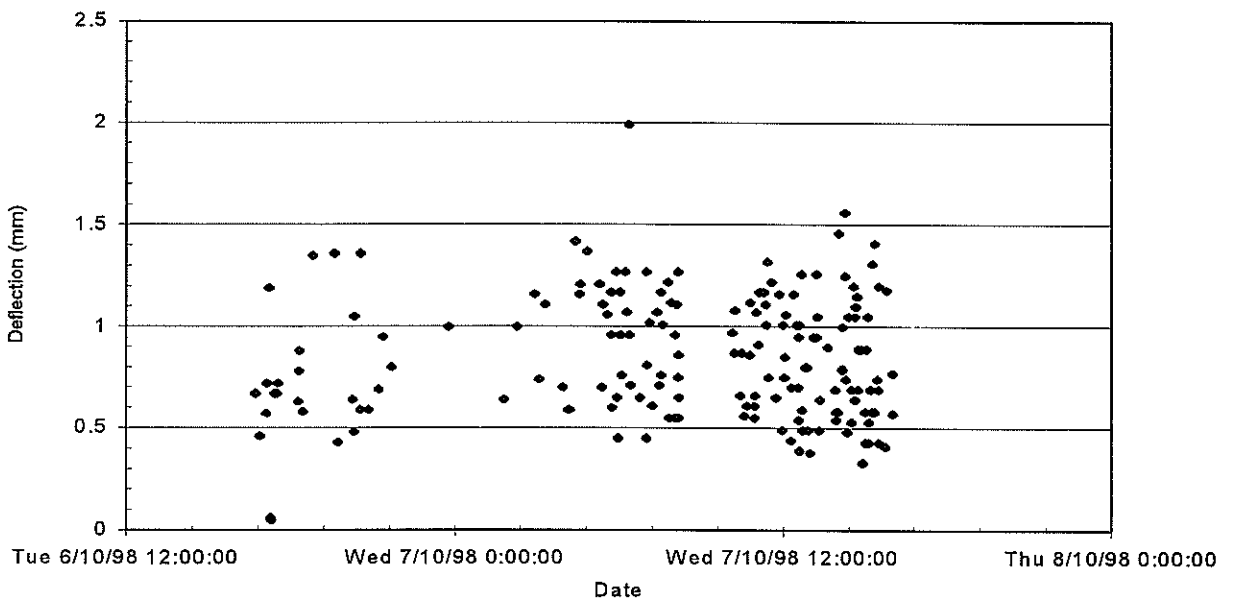
**Figure 4.9** Scatter diagram for deflection transducer D(2) for the entire monitoring period.

A waveform for the deflection response of Girder 2 for the heaviest vehicle recorded is illustrated in Figure 4.8, and the scatter diagram for this transducer is presented in Figure 4.9.

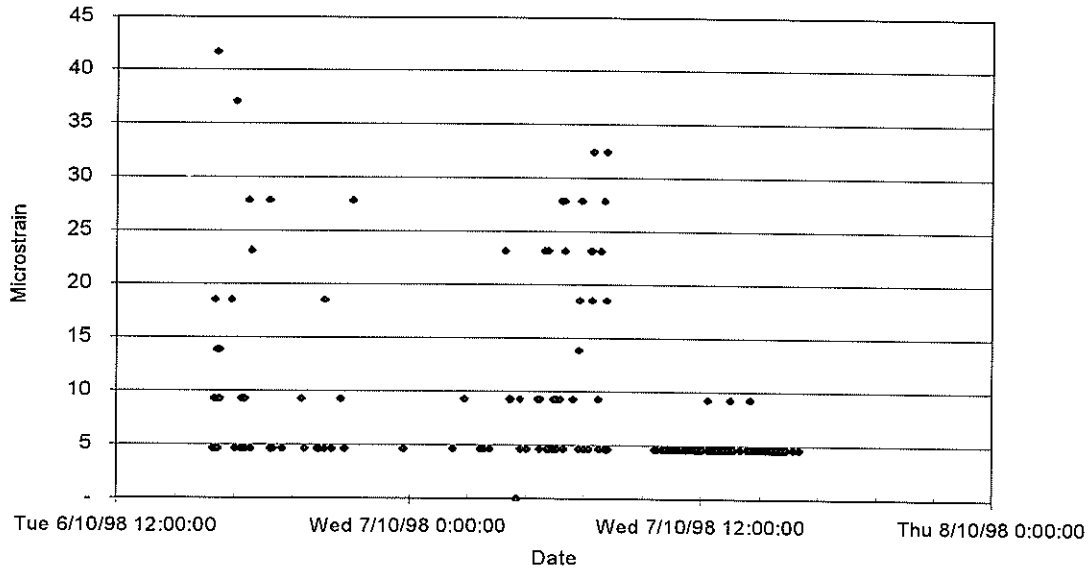
Figure 4.11 Scatter diagram for deck transducer S(Slab).

The scatter diagram for the deck transducer is presented in Figure 4.11. The deck and girder configuration of this bridge means that the normal traffic does not apply wheel loads to the critical location to induce the maximum strains in the deck. Increasing the monitoring period may increase the possibility of a wheel load being positioned at the critical location.

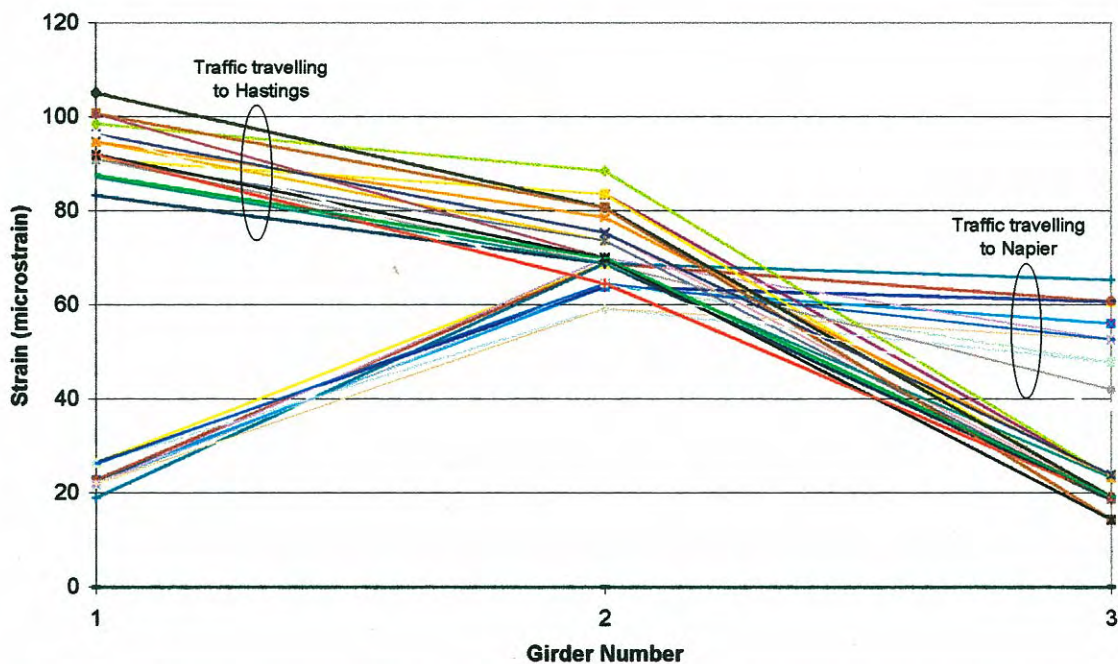
Figure 4.17 Distribution of strain for known vehicle testing for all girders, at different speeds.

The maximum strains for each transducer recorded from the known vehicle are presented in Table 4.2. These results indicate that the maximum responses of the transducers on Girder 1 are up to 50% larger than of the transducers installed on Girder 3. The structure is symmetrical and the load of the known vehicle on the structure was consistent in each direction of travel. Therefore the indication is that there is a difference in condition or structural behaviour between Girders 1 and 3, or that the condition of the road profile is increasing the load effect on the structure. This difference in Girders 1 and 3 is also confirmed by their significantly different strain distributions shown in Figure 4.17.

The distribution of strain into each of the girders from the known vehicle data is presented in Figure 4.17. The distribution presented is consistent with the data collected from health monitoring the ambient heavy vehicle traffic. The distribution shows that most of the strain was distributed into Girders 1 and 2 for the vehicles travelling to Hastings. This was almost identical for the vehicles travelling towards Napier, when most of the strain was distributed into Girders 2 and 3.

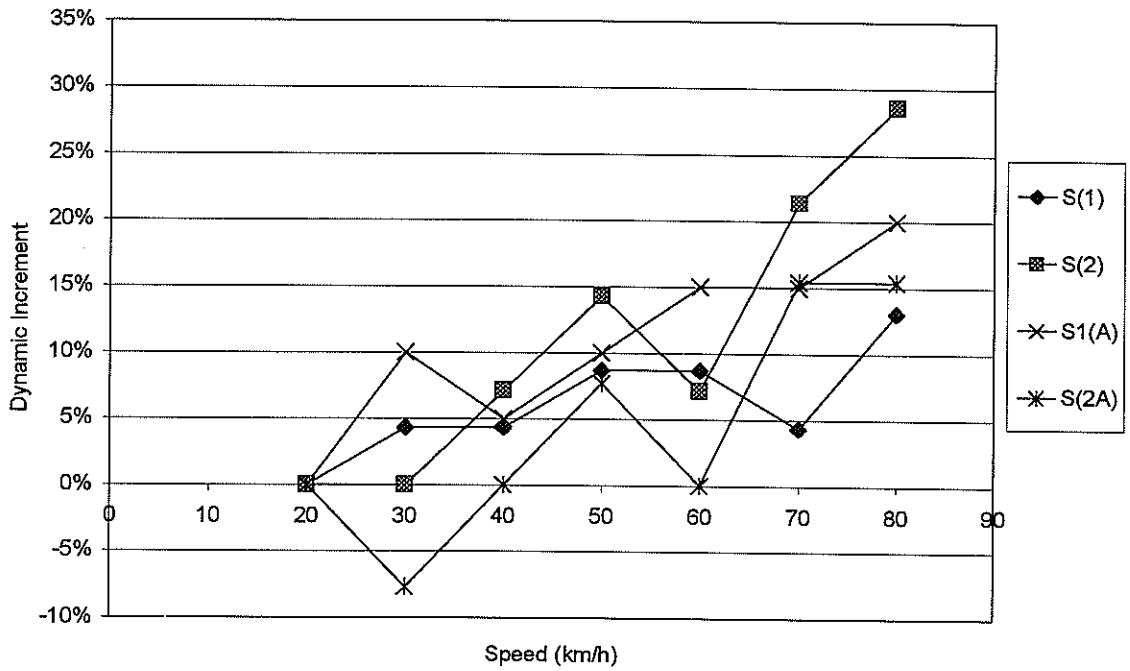
Figure 4.18 Dynamic increment plot for known vehicle travelling to Hastings.

Only the transducers most effected by the passage of the vehicle are presented in these Figures 4.18 and 4.19. The maximum value of dynamic increment recorded was around 30%, which corresponds to the value recommended by the Bridge Manual for this span.

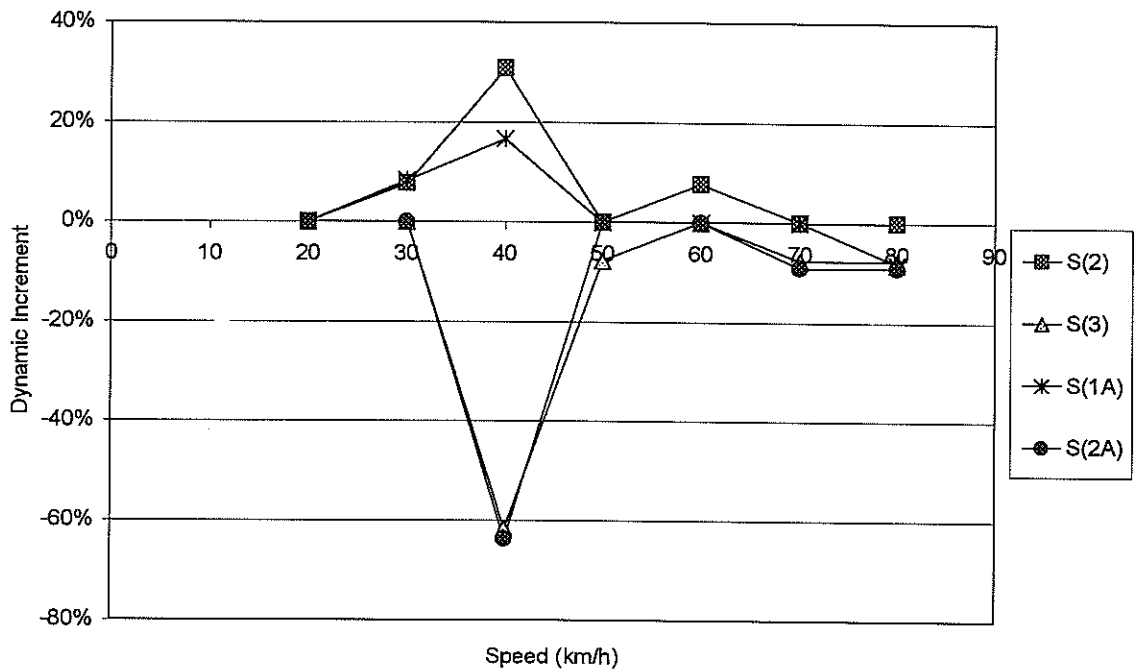
Figure 4.19 Dynamic increment plot for known vehicle travelling to Napier.

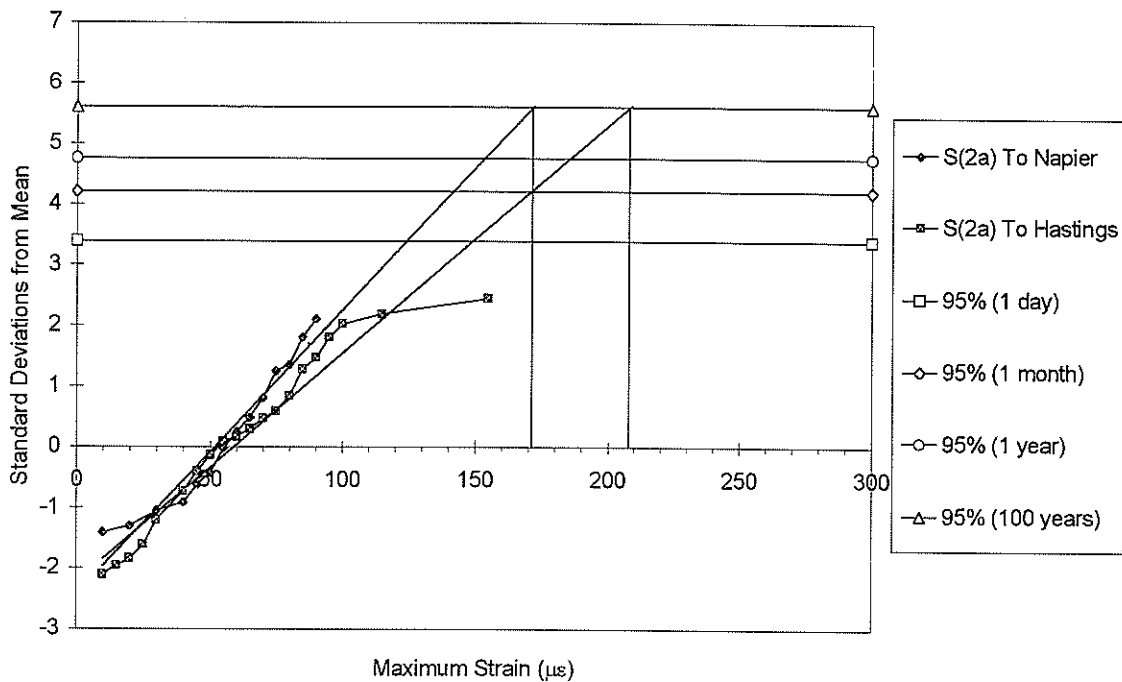
Figure 5.1 Inverse normal distributions used to determine the effect caused by multiple presence, using the approach consistent with the Bridge Manual.

In this report the multiple presence effects have been determined using the approach that is consistent with the Bridge Manual. The distributions for the vehicles travelling to Hastings and to Napier are plotted in Figure 5.1 for the centre girder which is the critical component for multiple presence events. Both distributions have been extrapolated to the ultimate event corresponding to 95% in 100 years. The ultimate response for the vehicles travelling to Hastings is 210  $\mu\epsilon$ , and for the vehicles travelling to Napier the ultimate response is 170  $\mu\epsilon$ . Adding these events gives an ultimate multiple presence event with a magnitude of 380  $\mu\epsilon$ .

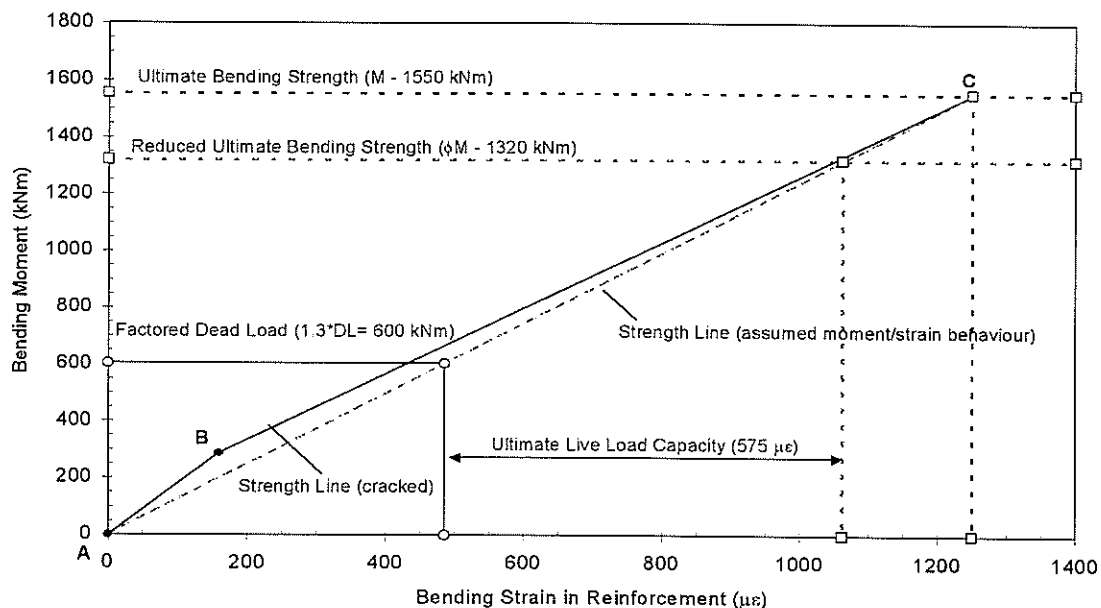
**Figure 5.2** Moment versus strain relationship and summary of Fitness for Purpose for the Waitangi Washout Bridge.

Figure 5.2 illustrates a theoretical moment versus strain curve for a typical girder of the Waitangi Washout Bridge. The graph presents the method used by Infratech to obtain a relationship between bending moment and strain for determining the Fitness for Purpose Evaluation for this bridge.

Line AB on Figure 5.2 represents the linear elastic behaviour of the concrete girder. Point B represents the point at which the concrete cracks, at which point the moment strain relationship begins to follow Line BC. This represents the behaviour of the concrete girder in the cracked state.

Because the girders on this bridge are already cracked under service loads, the actual relationship between moment and strain for these girders is expected to be similar to line AC.
