**Health Monitoring of
Superstructures of
New Zealand Road Bridges:
Tuakopai Bridge, Bay of Plenty**

Transfund New Zealand Research Report No.174

R.P. Andersen, W.S. Roberts, R.J. Heywood & T.J. Heldt
Infratech Systems & Services Pty Ltd,
Brisbane, Australia

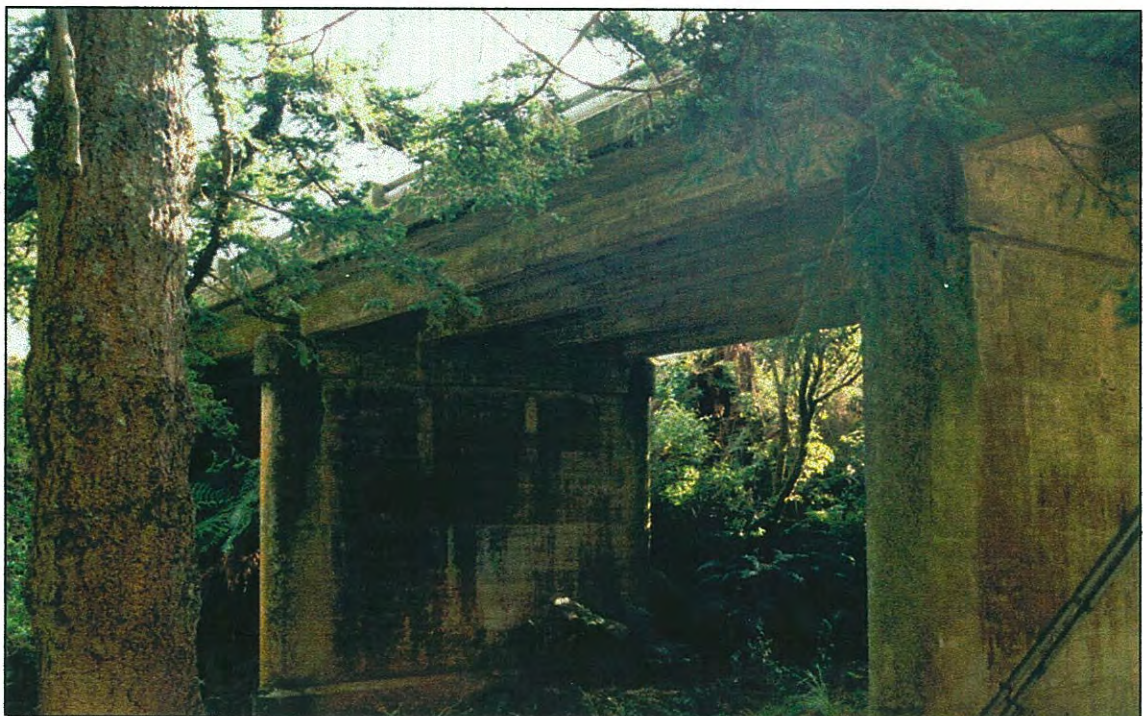
Figure 3.1 Tuakopai Bridge on SH 29, in Bay of Plenty region.

The Tuakopai Bridge (RP 29-24/14.85) is located on State Highway (SH) 29, which is a heavily trafficked route leading from the Waikato Region to the Port of Tauranga, Bay of Plenty Region. The bridge (Figure 3.1) consists of three reinforced concrete beam and slab spans, 12.19 m in length. Each span has four girders at 2 m centres, that essentially are simply supported on reinforced concrete piers. However the detail at the abutments may provide some moment capacity at member ends. The detail over the pier and abutments is illustrated in Figure 3.2. The bridge was constructed in 1938 and the original drawings for the bridge show a concrete guardrail. However this was removed and has been replaced with a standard metal guardrail. The deck slab is nominally 200 mm thick.

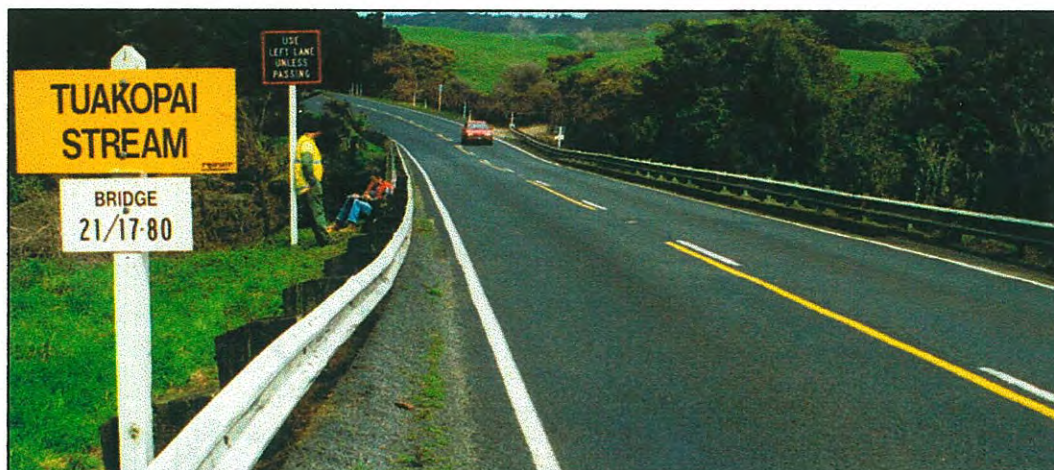
Figure 3.3 Road over the bridge (note the metal guardrail that replaces the original guardrail).

The bridge is located on an open highway section of two-lane road with a carriageway width of 7.32 m. The road over the bridge is illustrated in Figure 3.3.

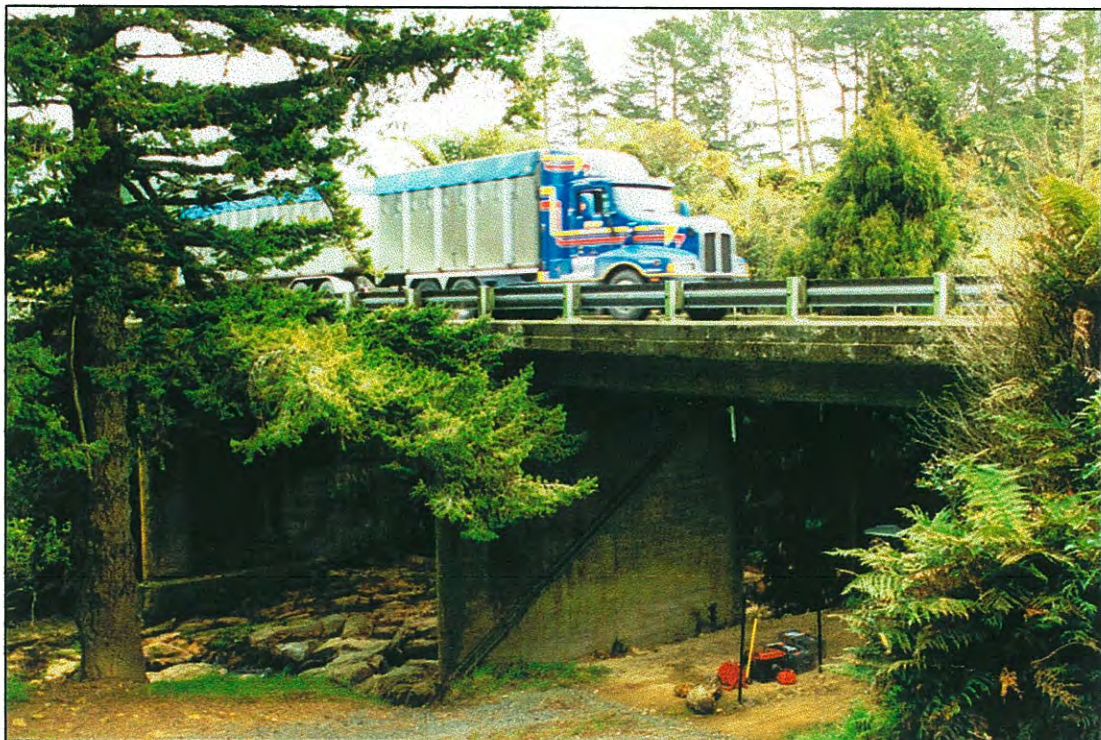
Figure 4.3 Axle mass and configuration of the known vehicle.

In order to provide a control for all the data gathered during the entire monitoring period, the behaviour of the bridge in response to a known load (i.e. a heavy vehicle of known mass and dimension) was measured. This component of the Health Monitoring programme was conducted on Friday 2 October, 1998, using a known heavy vehicle, supplied by TD Haulage Ltd, Tauranga (shown on the bridge in Figure 4.2). It was a seven-axled heavy vehicle of known mass (gross 44.8 tonnes) and dimensions. The axle weights and configuration are illustrated in Figure 4.3.

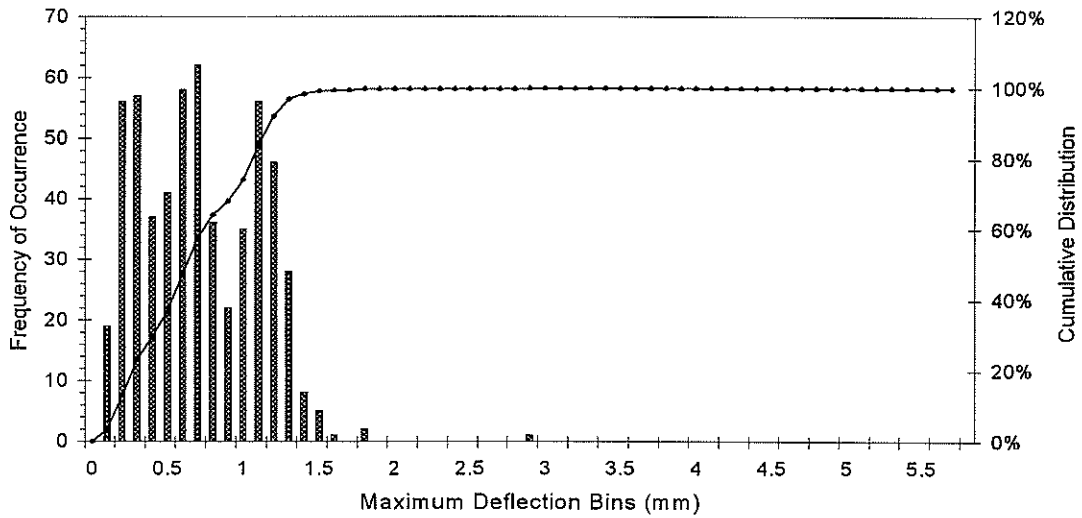
Figure 4.8 Histogram and cumulative distribution function for transducer D(1-4).

The data from the scatter diagrams can also be plotted on a histogram that incorporates a cumulative distribution. An example of the histogram from the scatter diagram is presented for transducer D(4-1) in Figure 4.8. The histogram illustrates two separate sections or populations of data. This is characteristic of traffic travelling in opposite directions on different sides of the bridge, or of different populations of vehicles. By separating the data into directions, the data relevant to each transducer can be plotted and a more accurate indication of the traffic can be determined.

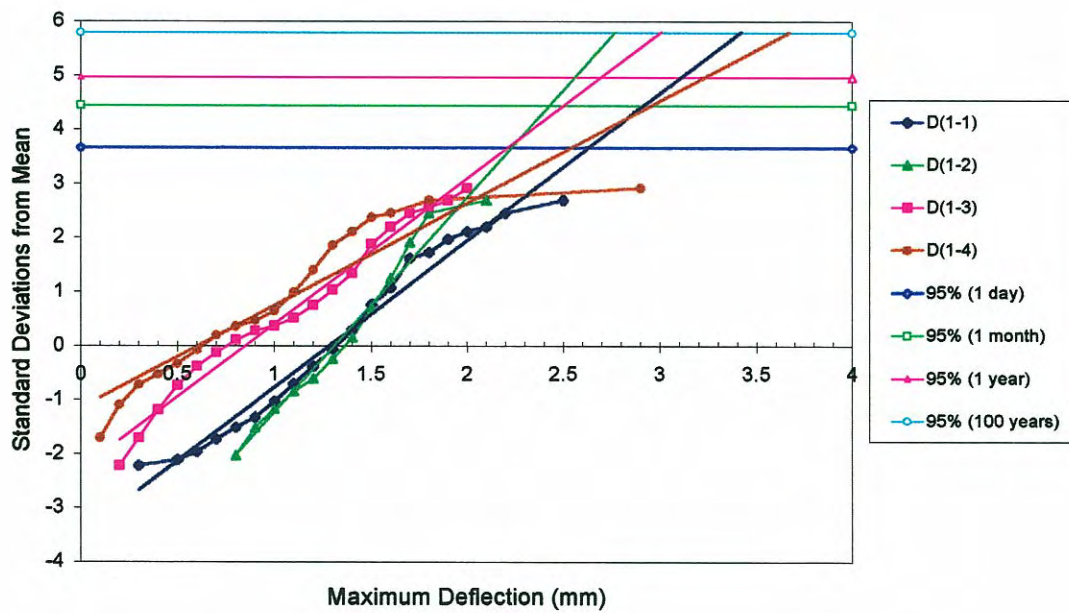
Figure 4.10 Inverse normal plot for deflection transducers.

Figure 4.10 shows the inverse normal plots for all the deflection transducers. These plots have been influenced by a few isolated events which caused higher than typical deflections. These events are also evident on the scatter plot in Figure 4.7.

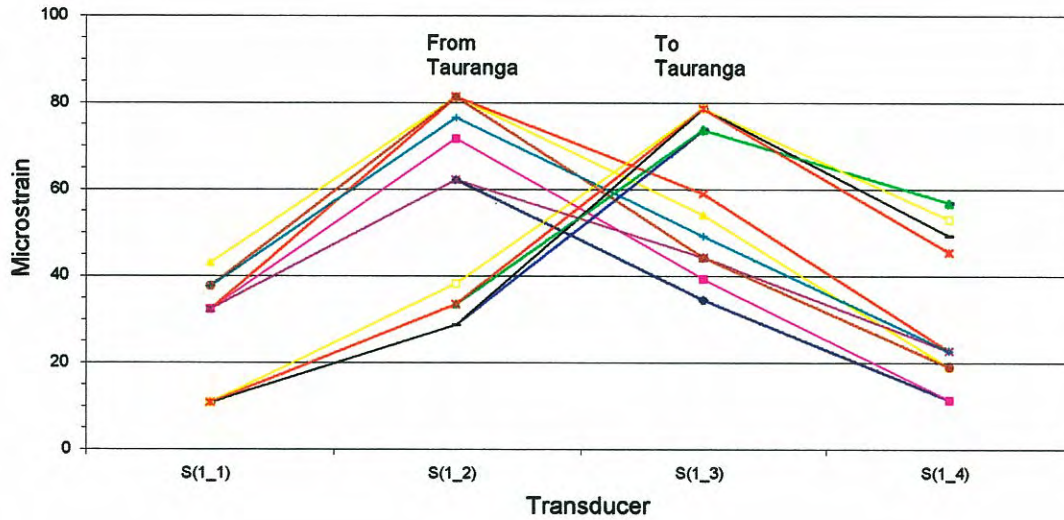
Figure 4.11 Distribution of strain for known vehicle (directions to and from Tauranga as indicated).

The distribution of strain across the four girders is presented in Figure 4.11 and the distribution of deflection is shown in Figure 4.12. These distributions are based on the results with the known vehicle driving at a range of speeds in the normal lane position. The strain and deflection distributions show differences, and typically there is more deflection compared with strain in the outer girders. This is particularly the case for Girder 1.

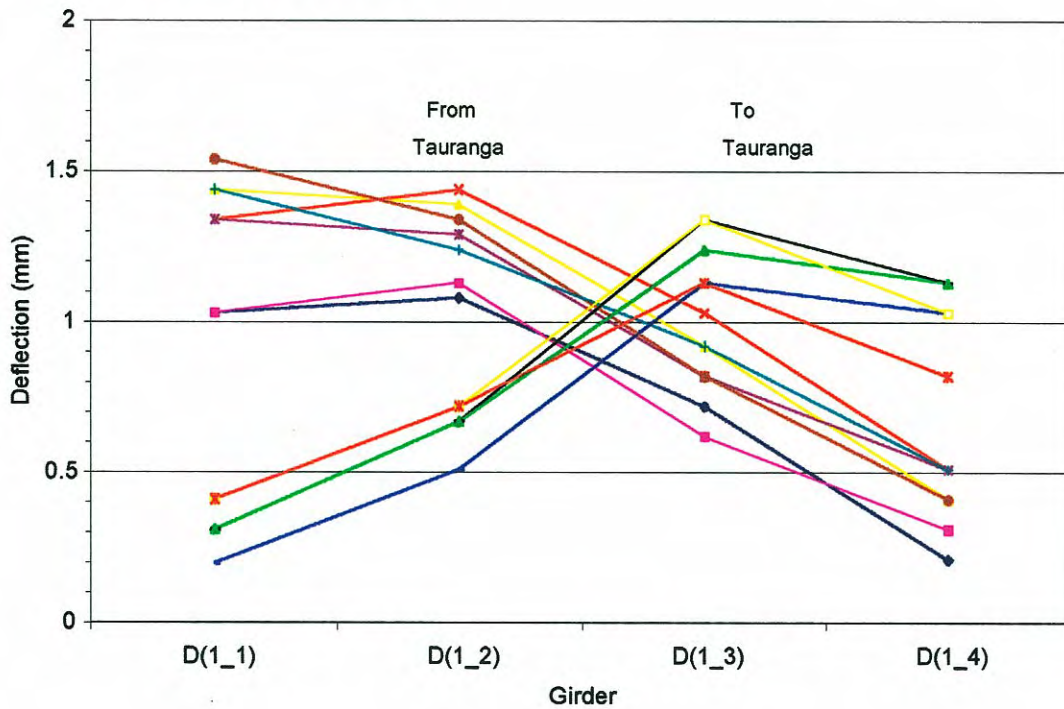
Figure 4.12 Distribution of deflection for known vehicle (directions to and from Tauranga as indicated).

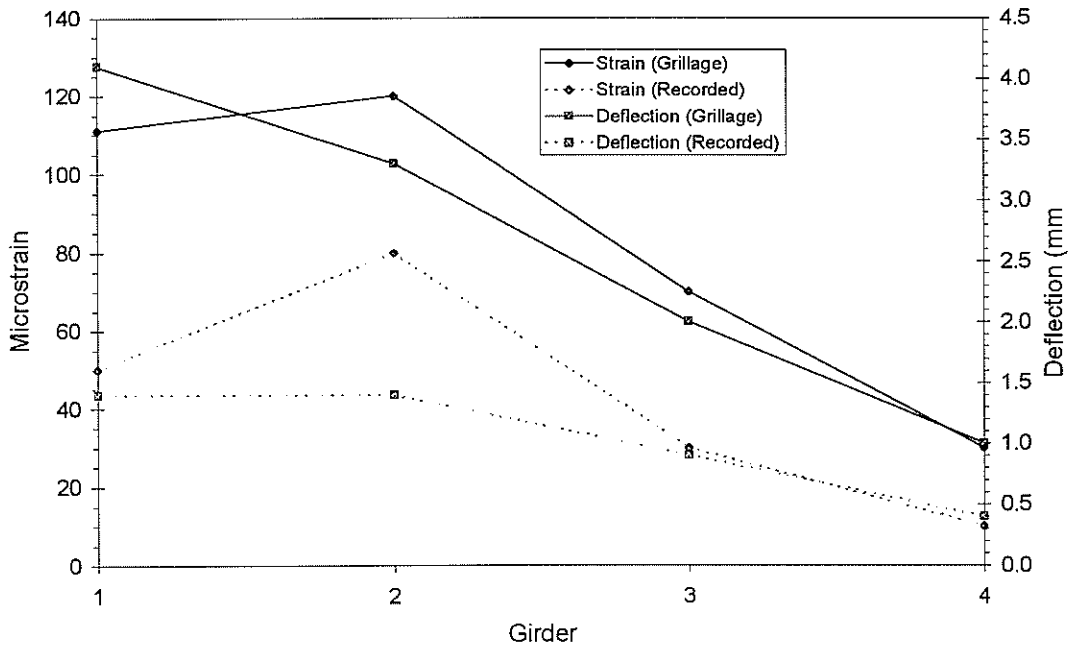
Figure 4.13 Comparison of recorded and grillage results for known vehicle

Figure 4.13 presents a comparison of the known vehicle results from the Health Monitoring procedure and the results from the grillage model. This comparison shows that the recorded strains and deflections from the Health Monitoring are much lower than those predicted from the grillage analysis. The difference in the shape of the distribution shows that the actual behaviour of the edge girders is stiffer than that assumed in the grillage model, while the overall difference in the magnitude of the strains and deflections could be related to a higher actual concrete strength or some continuity with the abutments.

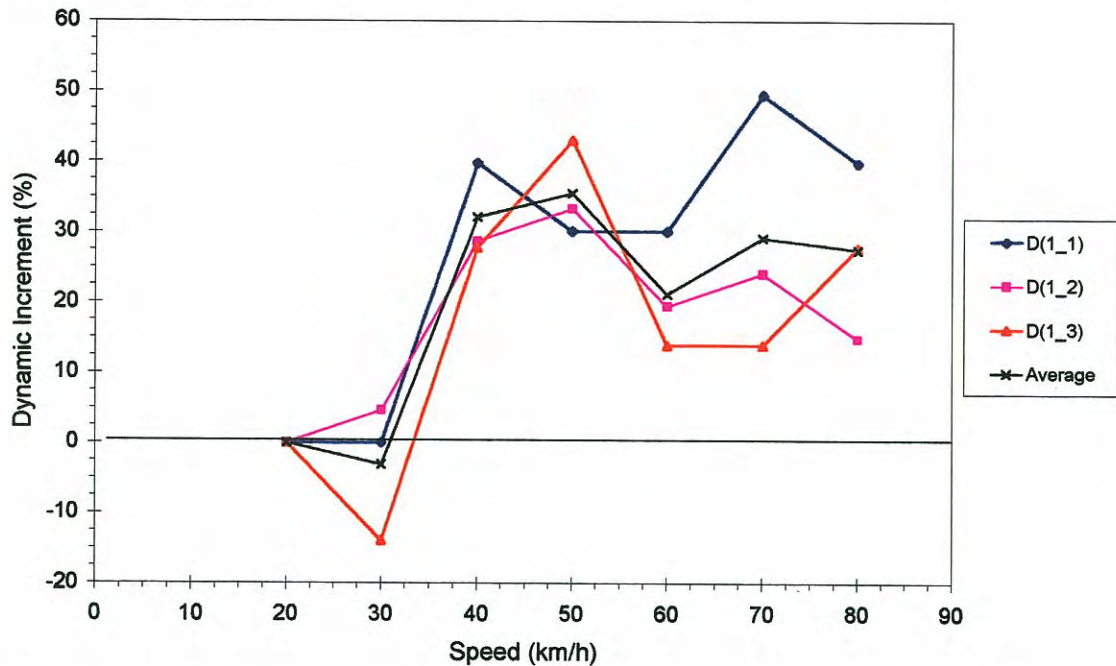
The response of the crawl test was used for the static result in the calculation of dynamic increment. The data are plotted for the three midspan transducers which are most influenced by the vehicles travelling towards Tauranga. Figure 4.14 presents the dynamic increment data for known vehicle travelling from Tauranga. The dynamic effects on this bridge are high, with the maximum recorded dynamic increment around 50% while the highest average value recorded was 35%.

The natural frequency of the structure calculated from the free vibration response of the structure after the vehicle has driven off the bridge is 12 Hz.

Figure 4.14 Dynamic increment versus speed for the known vehicle travelling from Tauranga.

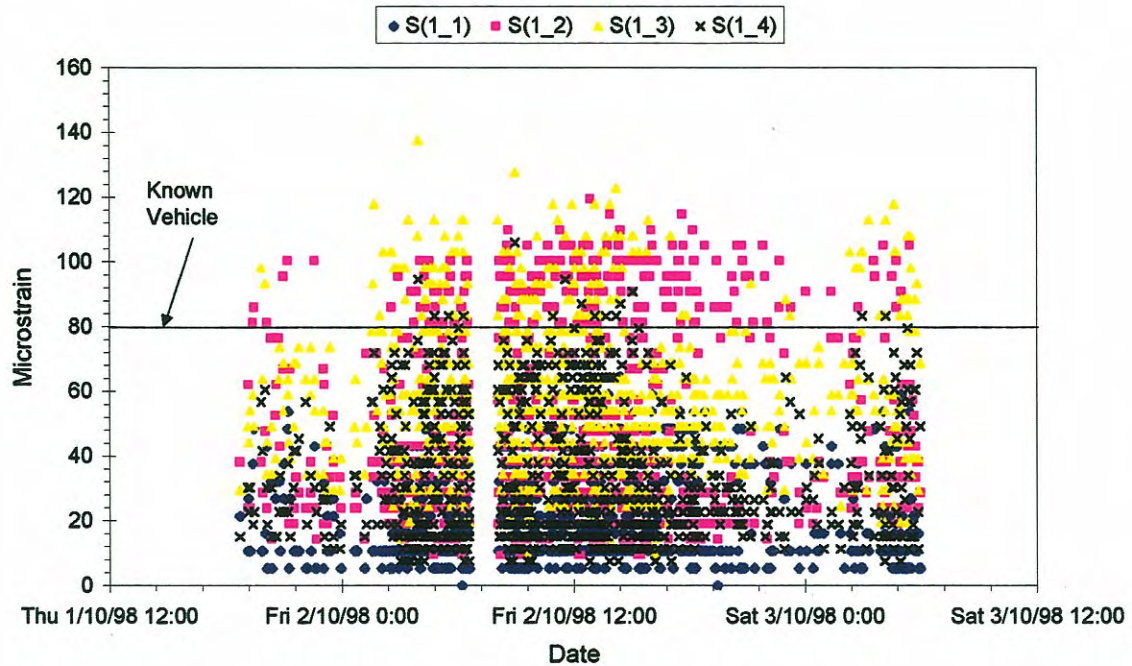
Figure 4.15 Scatter plot of strains, compared with strain imposed by known vehicle.

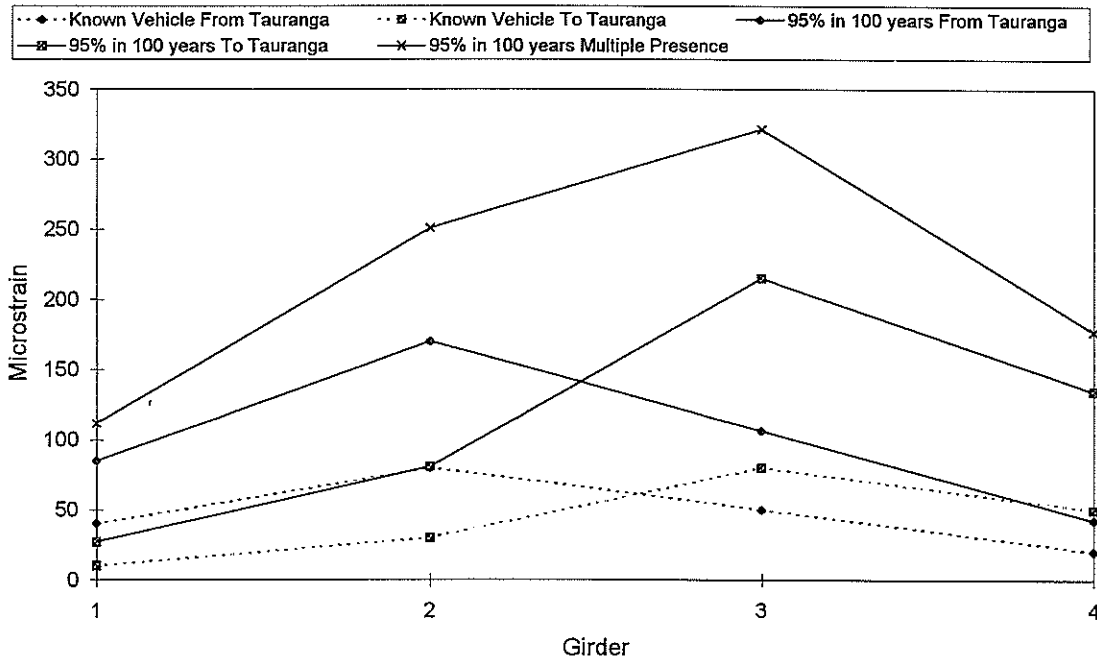
Figure 5.1 Summary of multiple presence assessment based on the Bridge Manual method for 95% in 1 year, and in 100 years.

Figure 5.1 summarises an assessment of the multiple presence effects for midspan bending strain. The diagram is based on the health monitoring data using the method that is consistent with the Bridge Manual. The diagram shows a transverse distribution of strain for each direction and the sum of these two distributions for both the 95% in 1 year serviceability limit state and the 95% in 100 year ultimate limit state. The maximum strains for multiple presence is 321 $\mu\epsilon$.
