**Endurazyme Trials on
Unsealed Roads
in Tararua District,
New Zealand**

Transfund New Zealand Research Report No. 182

M. Darnell, W. Stewart,
Opus International Consultants, Palmerston North
K. Hudson, Duffill Watts & Tse Ltd, Wellington
T. Bennett, Tararua Consultancy, Dannevirke

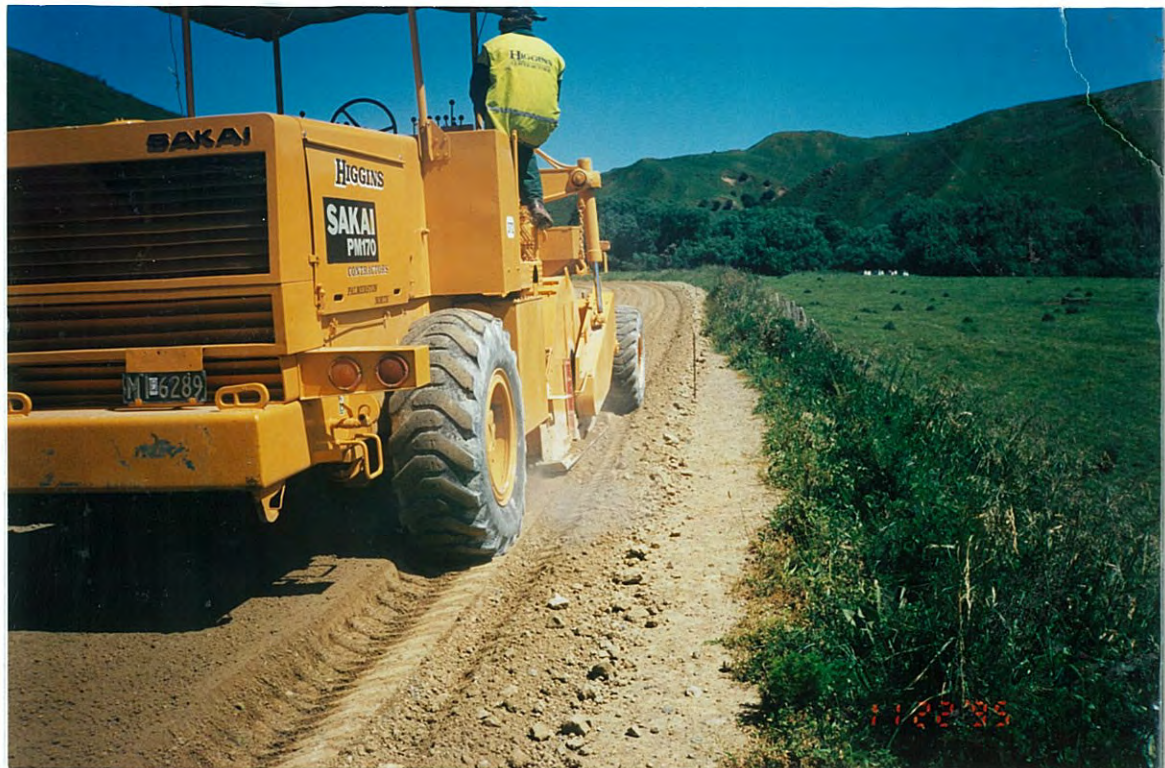
Photo 1 (upper): Section 1 22/11/95
Close up of rotary hoe (Sakai PM170 fitted with carbide tines) mixing Endurazyme into pavement material. Note very fine tilth behind hoe.

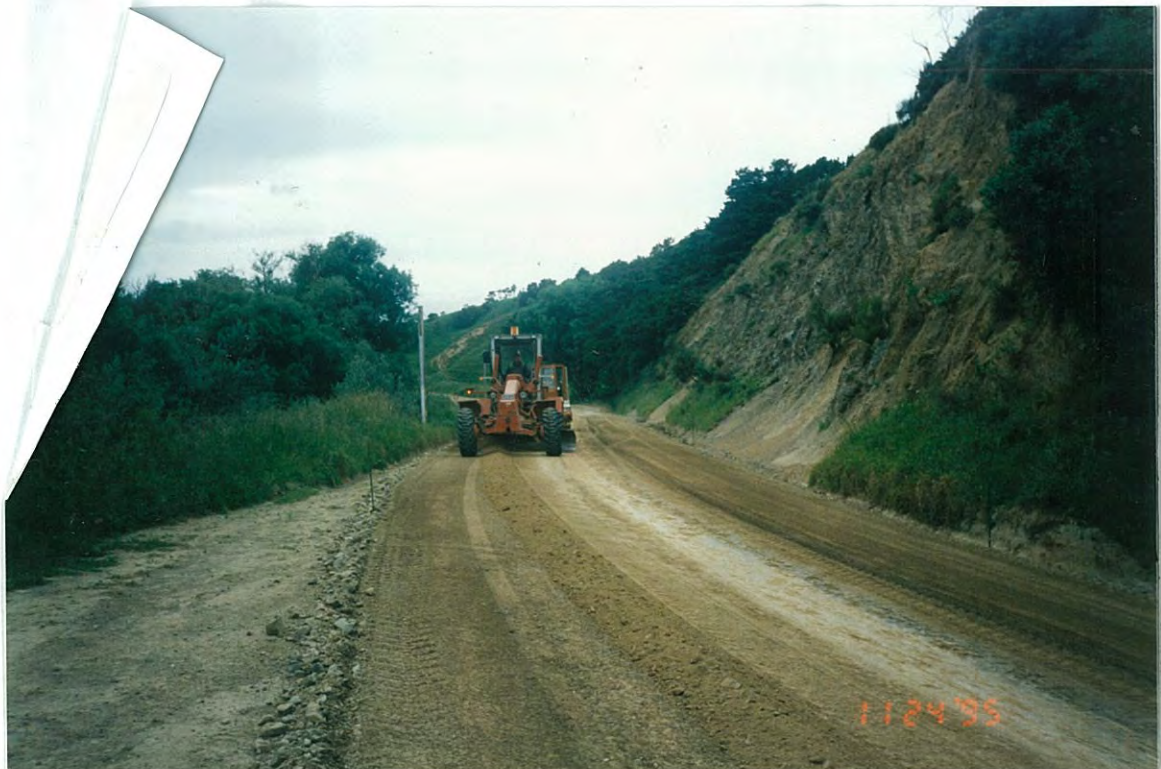
Photo 2 (lower): Section 3 24/11/95
Reshaping of road with grader (14 tonne Faun F156A) following application of Endurazyme and mixing with rotary hoe.

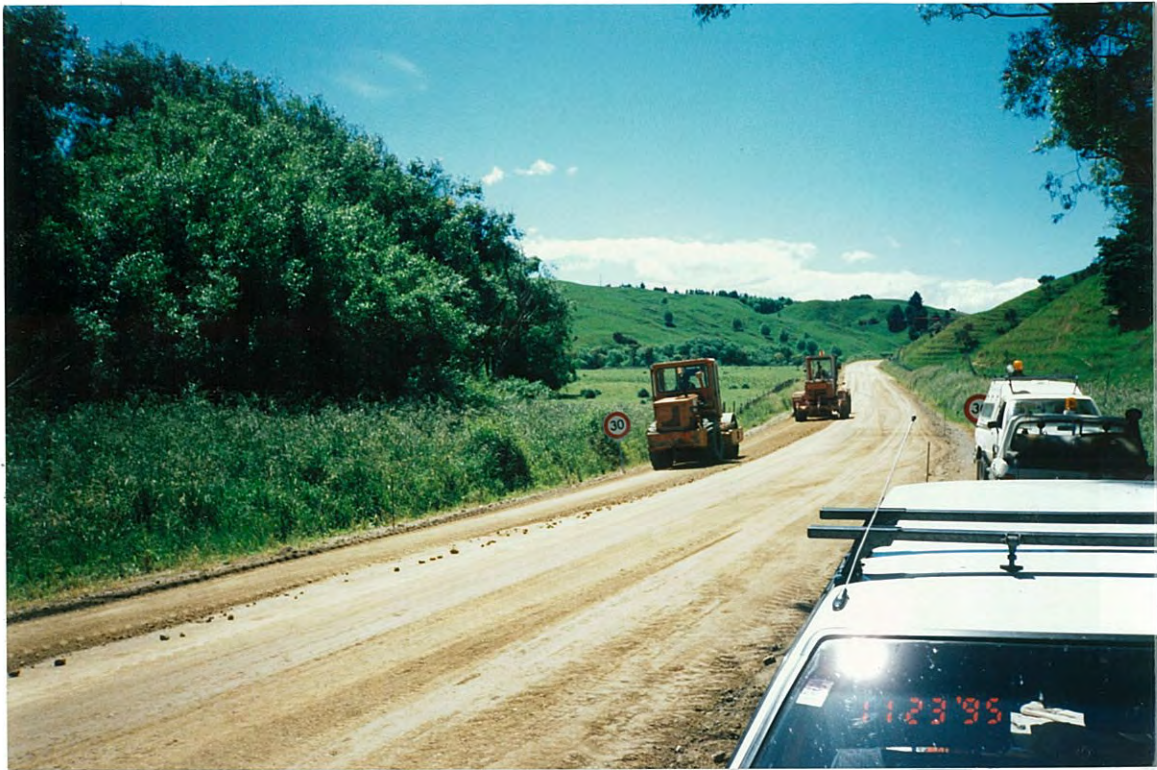
Photo 3 (upper): Section 1 23/11/95
Final shaping of surface - several light passes by the grader were required to bring sufficient fines to the surface. Photo shows grader followed by vibrating roller (Sakai SU700, 7.2 tonne).

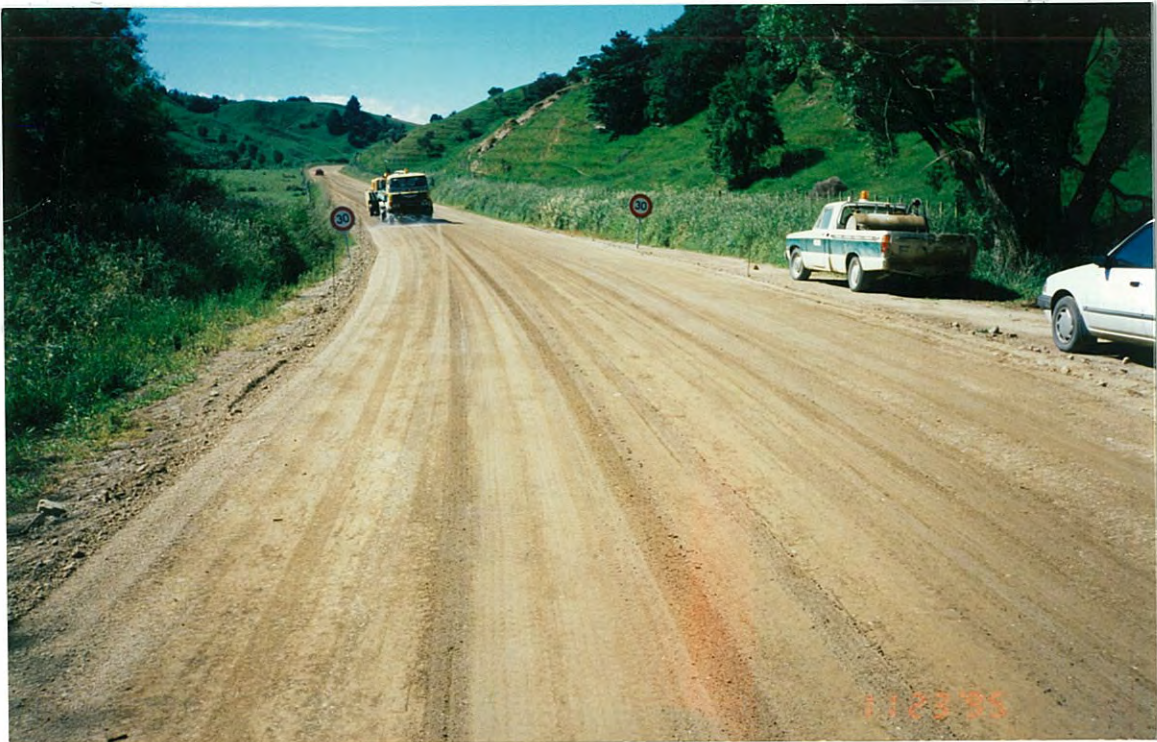
Photo 4 (lower): Section 1 23/11/95
Water cart applying water during the final shaping and compaction. PTR (Bros 7 tonne) following behind water cart.

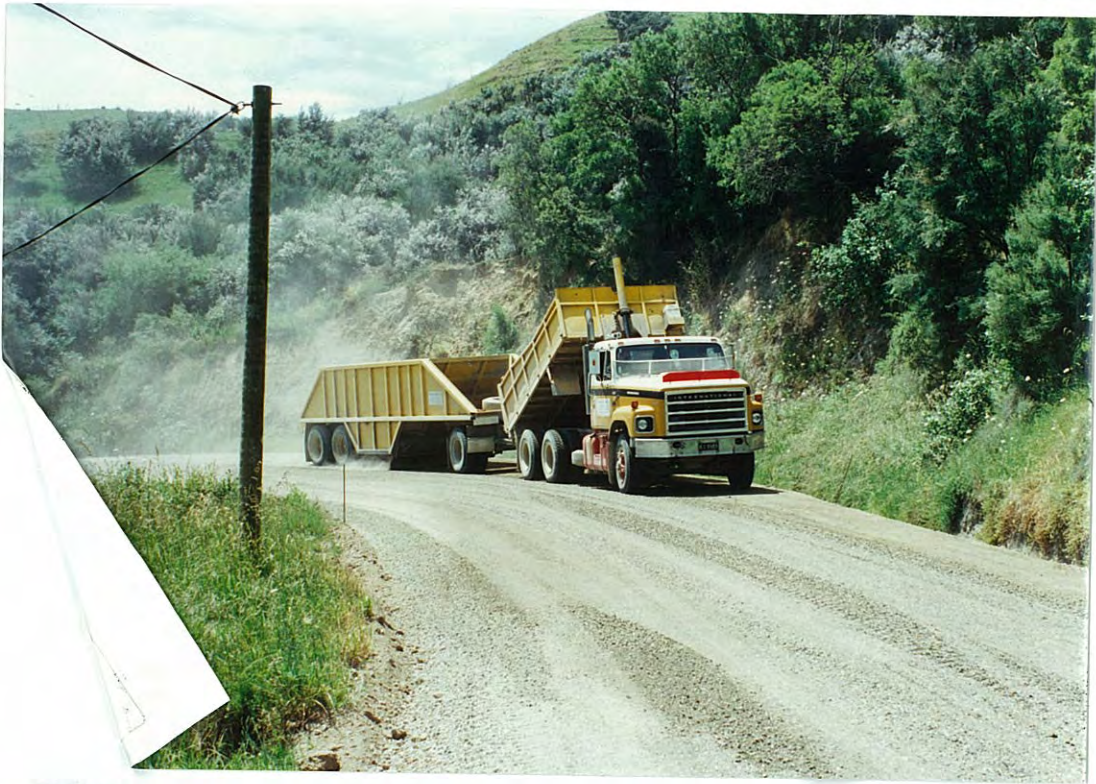
Photo 5 (upper): Section 4
Placement of granular wearing course using truck and trailer units.

The granular wearing course was placed using truck and trailer units. In some areas the required 50 mm aggregate depth was achieved in one lift, while in other areas 3 to 4 lifts were required.

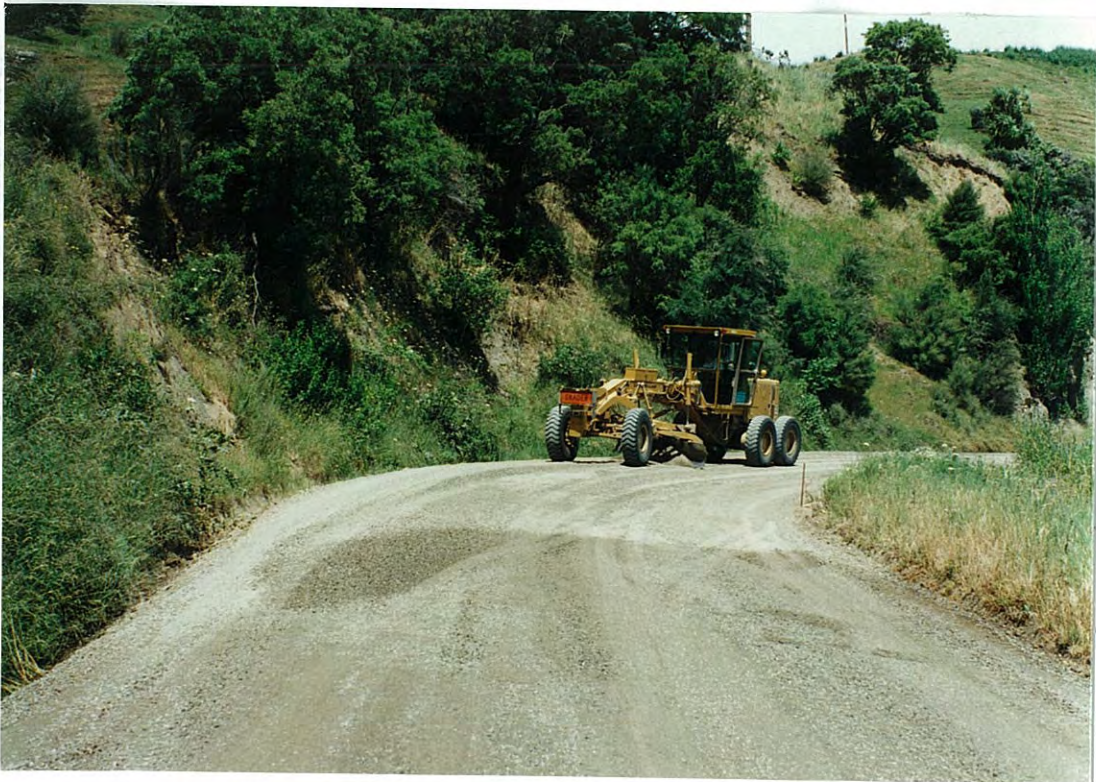
Photo 6 (lower): Section 4
Spreading of aggregate and shaping of road. Compaction was carried using 7.2 tonne vibrating roller, and water was regularly applied to maintain aggregate moisture content during compaction.

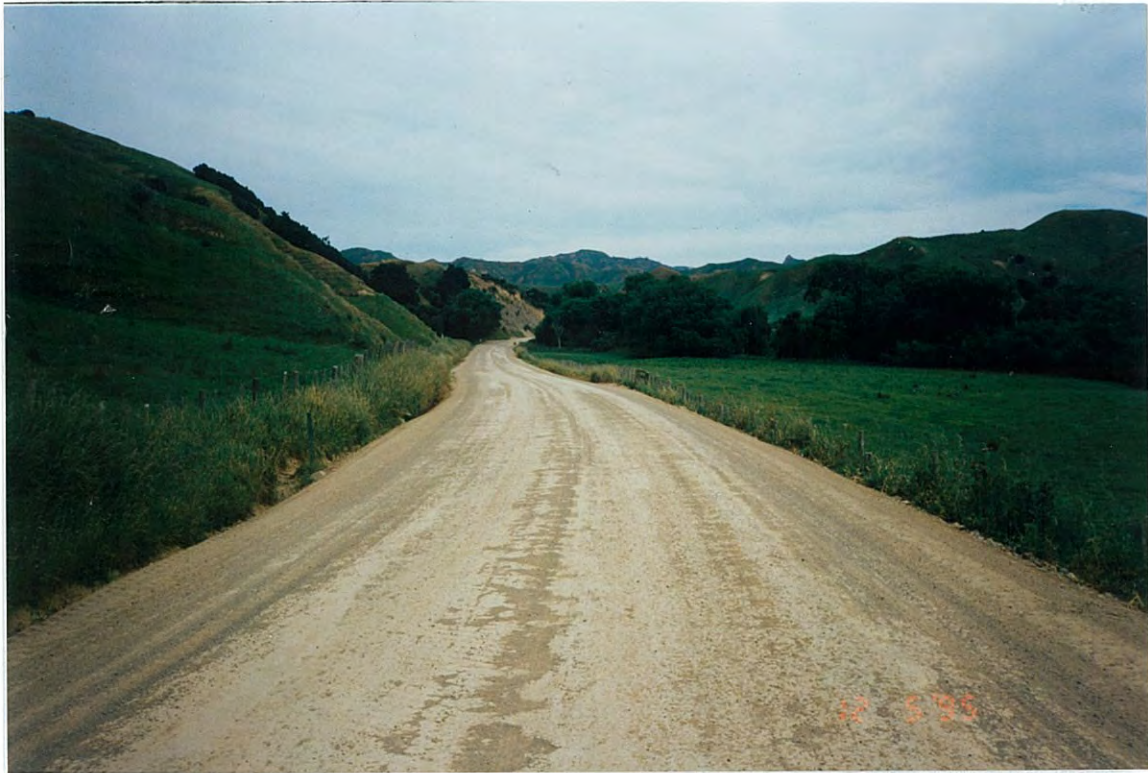
Photo 7 (upper): Section 1
General view of section 1, 1 week following construction. Pavement surface is hard and smooth.

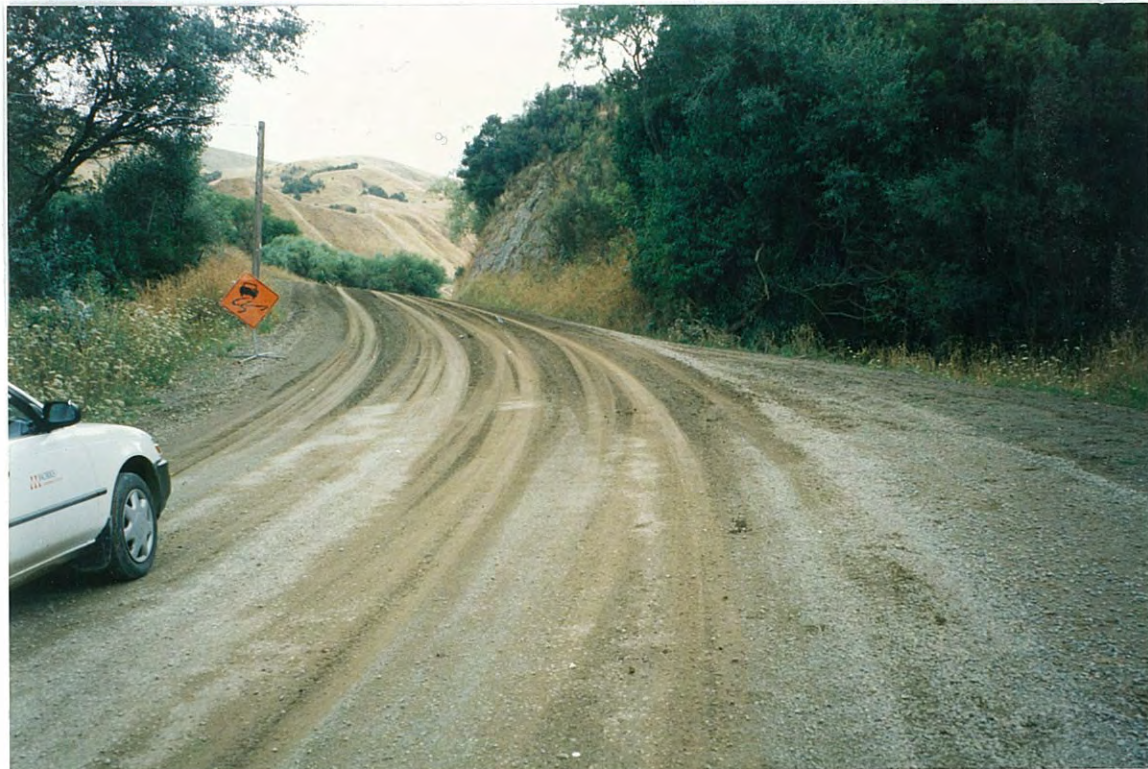
Photo 8 (lower): Join between sections 3 and 4
Following period of heavy rain. Section 4 in good condition. Section 3 is extremely soft on the surface with some ruts up to 25mm. Concern about motorists' safety due to slipperiness of surface.

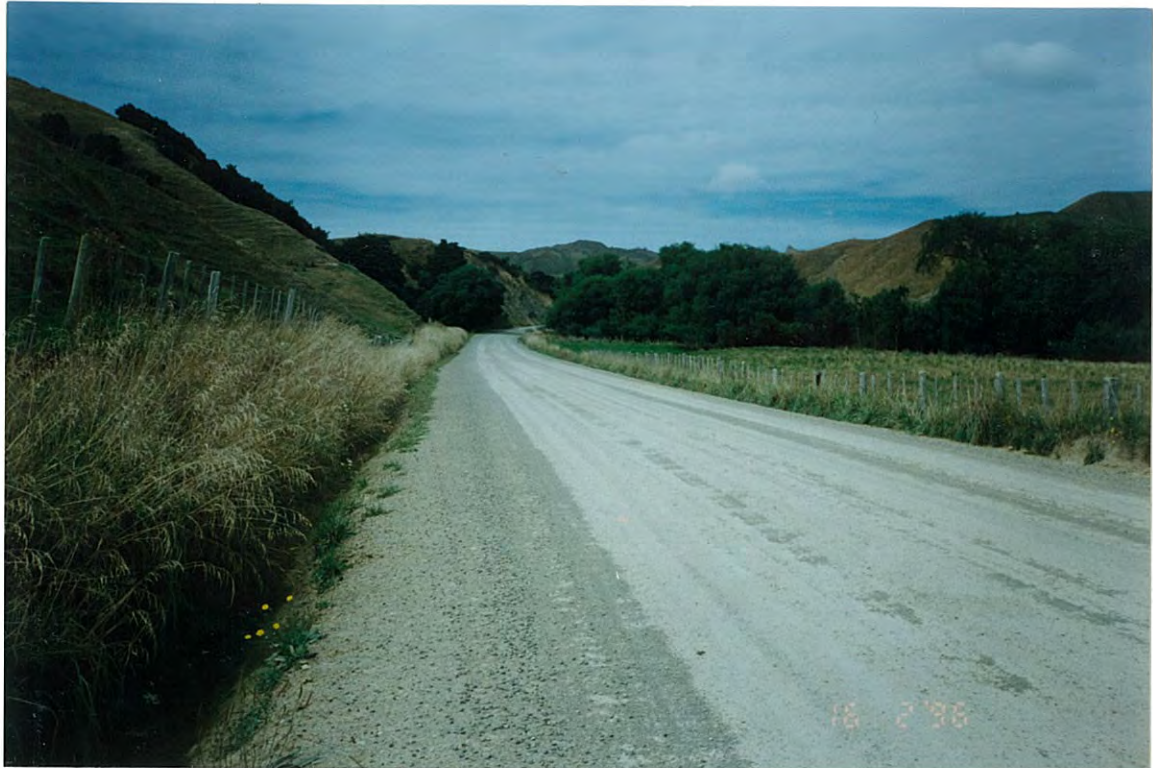
Photo 9 (upper): Section 1
General view of section 1. Pavement is hard, dry and smooth, providing an excellent riding surface.

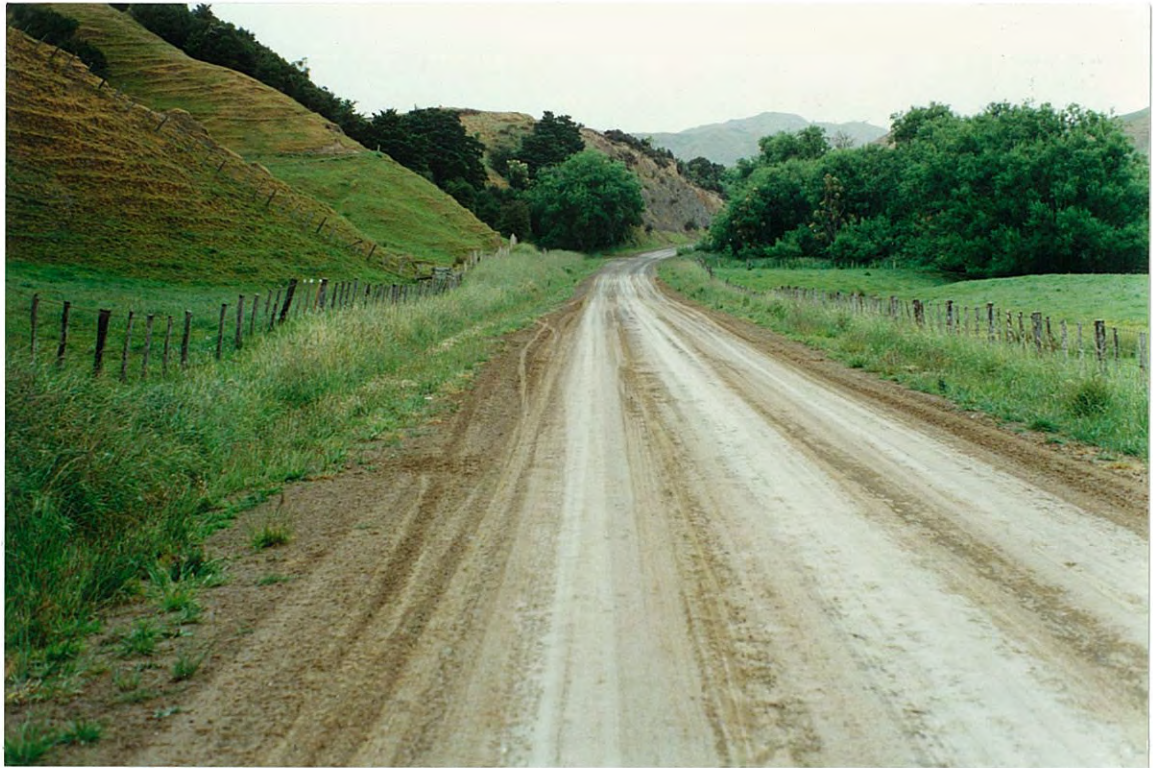
Photo 11 (upper): Section 1

Same view of section 1, 1 hour later. Rain has changed the road surface from hard and dry to soft and slushy in only 1½ hours.

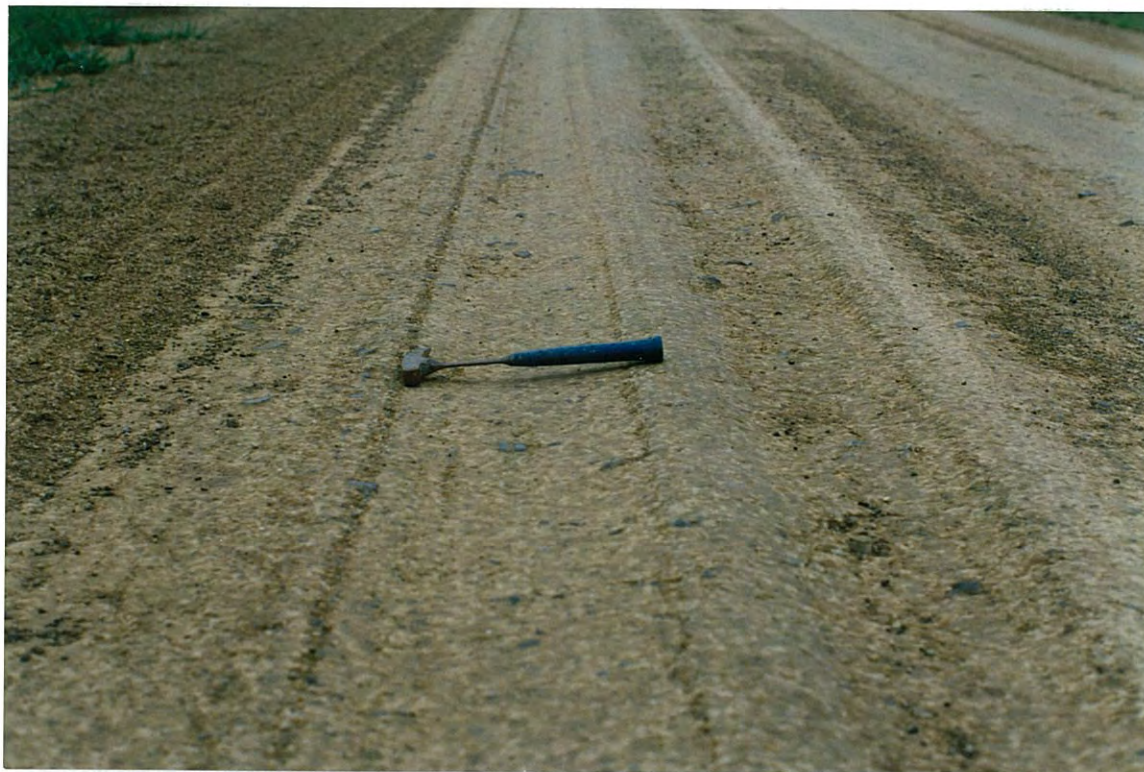
Photo 13 (upper): Section 1
Shallow shear failures causing severe loss of shape within section 1.

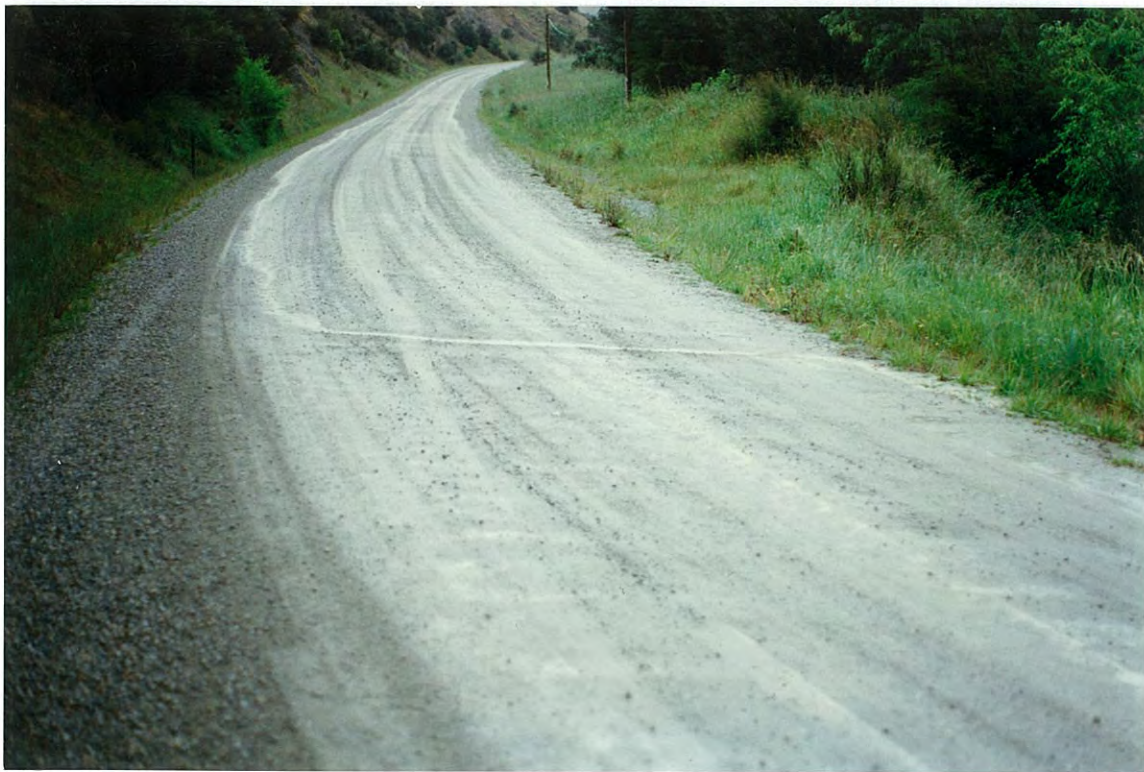
Photo 14 (lower): Section 4
General view of section 4. Granular wearing course remained in good condition, and was not affected by rainfall. Some corrugations and ruts present on the inside of the bend are evident. Water flowing down LHS due to rut development in the wheel track and gravel build-up on the edge of the pavement.

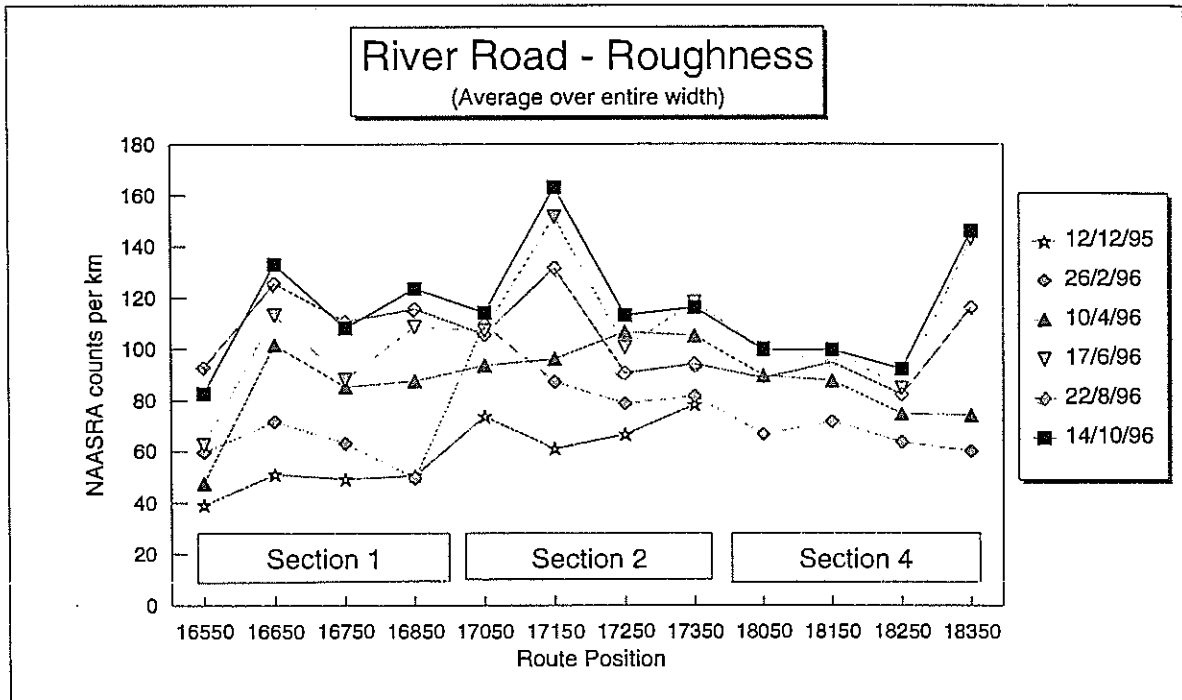
Progression of roughness on River Road trial sections

- Notes:
1. Section 4 was not surveyed on 12/12/95 as it was yet to be completed.
 2. The roughness of the last 100 metres of section 4 is uncharacteristically high when compared to the rest of section 4. One possible explanation for this is that the running course from the adjoining pavement, outside the trial length, has migrated onto the granular wearing course section. Because of the uncertainty of the accuracy of this data, the roughness readings over the last 100 metres of section 4 should be discarded.
