Subgrade Moisture Conditions for Pavement Design of New Zealand Roads

Transfund New Zealand Research Report No. 238

R. Peplow
Bartley Consultants Limited
Auckland, New Zealand

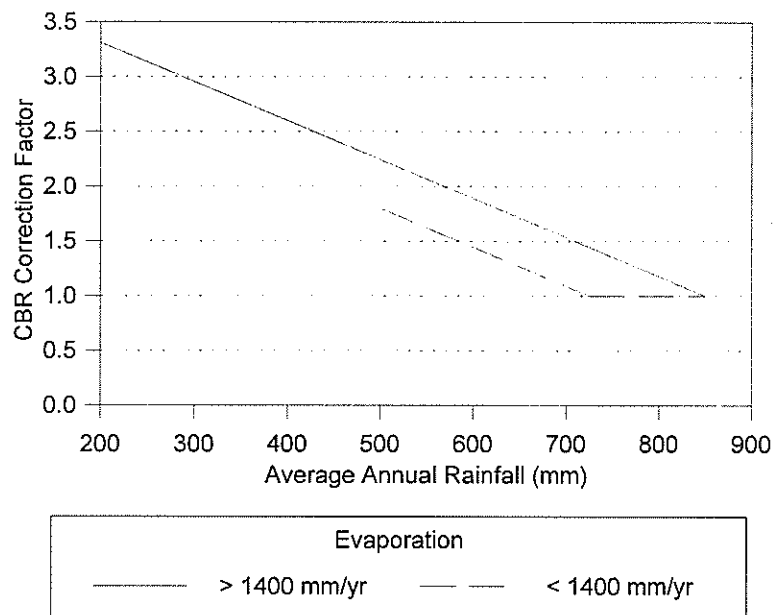
Figure 4.1 CBR Correction Factors for climate effects (from VicRoads 1993).

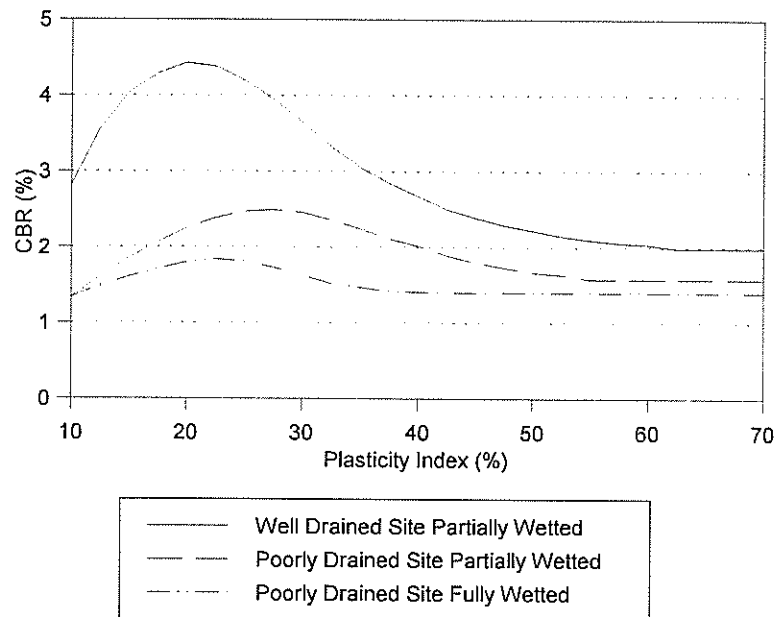
Figure 4.3 Subgrade CBR versus Plasticity Index during in-service phase.

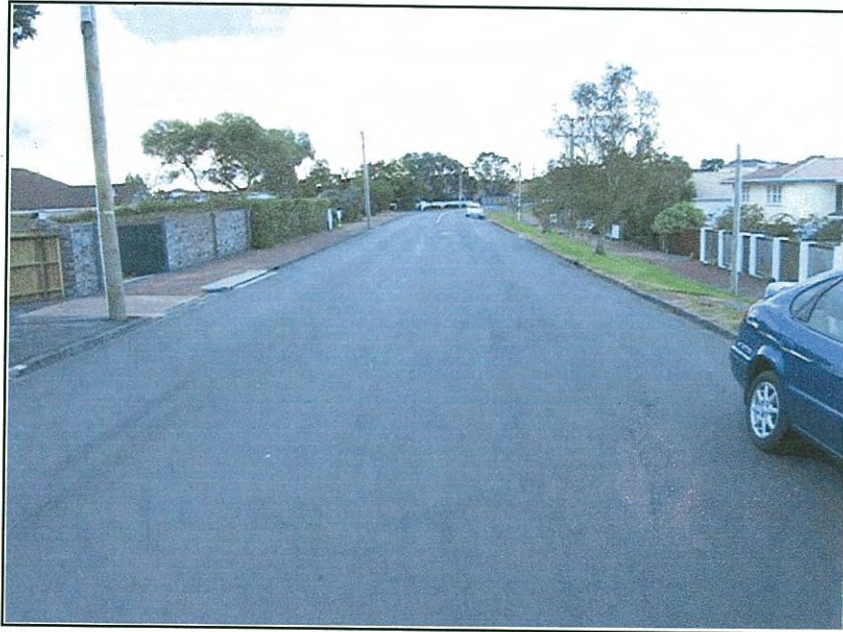
Figure 5.1 General view of Kohimarama Road test site, looking north.

Kohimarama Road is a busy arterial road located in the eastern Auckland suburb of Kohimarama (Figure 5.1). The road pavement alignment generally follows a ridge with a gentle decline from south to north. The carriageway width is 9.2 m and the edges comprise kerbs and channels. The pavement has a dense asphaltic concrete surface and has a grassed berm on one side of the road. The surrounding ground is slightly lower than the road and generally falls away from it.

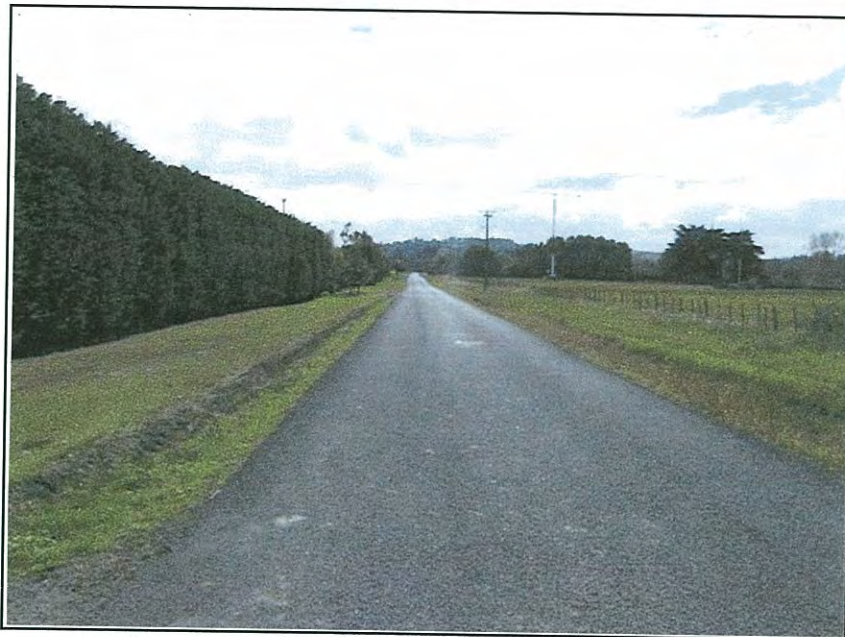
Figure 5.3 General view of Bristol Road test site, looking north.

Bristol Road is a quiet rural road (Figure 5.3) located in Whenuapai, north-west of Auckland City. The pavement alignment falls slightly from south to north. The surrounding ground is generally flat and level with the carriageway. Shallow side drains are provided on both sides of the carriageway.

The test section is located immediately north of Dale Road. The carriageway width is 5.5 m and the edges are unsealed.

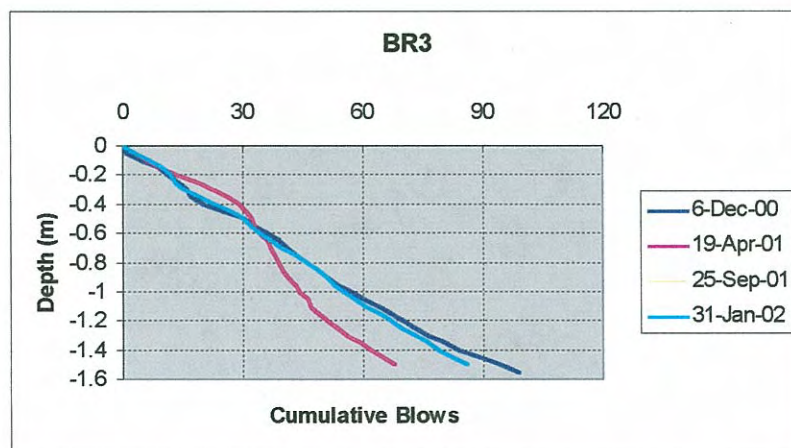
Figure 6.8(c) Subgrade DCP cumulative blows versus depth - Pit BR3.

The results of the (first round of) DCP tests are shown on the test pit logs presented in Appendix 1. The results for all four rounds of testing at each test location are presented in Figures 6.8(a) to 6.8(f). The plots show cumulative DCP blows versus depth.

The DCP profiles for successive rounds of testing at Bristol Road are presented in Figure 6.8(a-f). The plots show cumulative DCP blows versus depth into the subgrade.

The Bristol Road DCP profiles were the most consistent of the three test sections throughout the four rounds of testing. There is an indication of increased DCP resistance for the April 2001 round of tests in the upper portion of the profile at BR1 (Figure 6.8(a)). However, this trend does not follow for the other pavement pit locations, nor is there any apparent correlation in the water content profile for BR1 (Figure 6.7(a)).

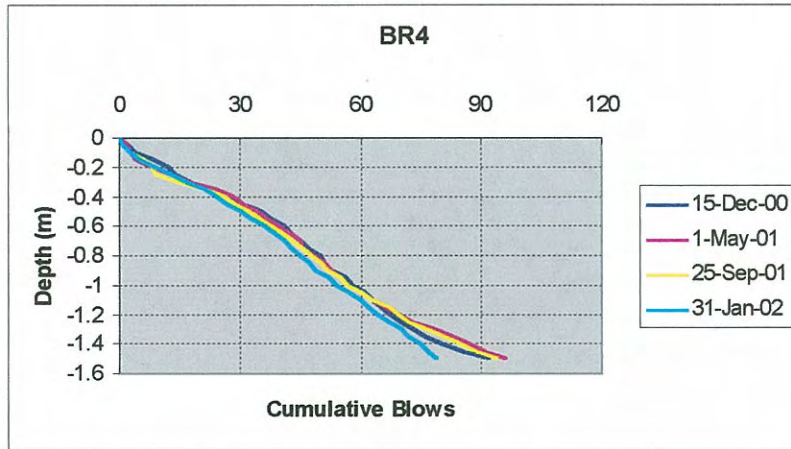
Figure 6.8(d) Subgrade DCP cumulative blows versus depth - Pit BR4.
