School bus safety

September 2010

Baas, PH,¹ SG Charlton,² N Taramoeroa¹ and JP Edgar³ (2010) School bus safety. *NZ Transport Agency research report no.408*. 100pp.

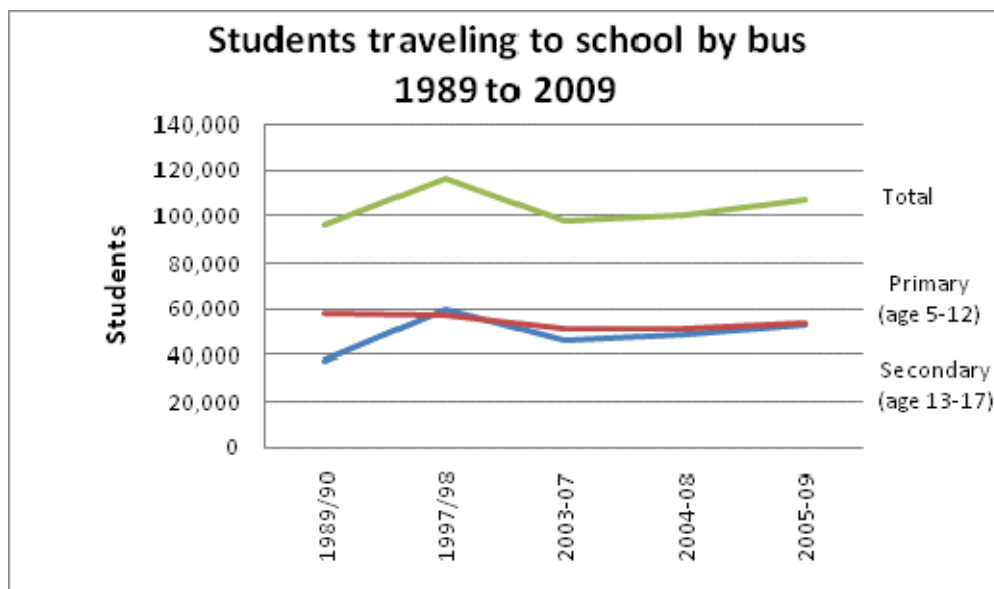
Figure 1.1 Number of students travelling to school by bus between 1989 and 2009

Figure 1.1 shows the number of students travelling by bus to school between 1987 and 2009 inclusive, based on the NZ Household Travel Survey data.

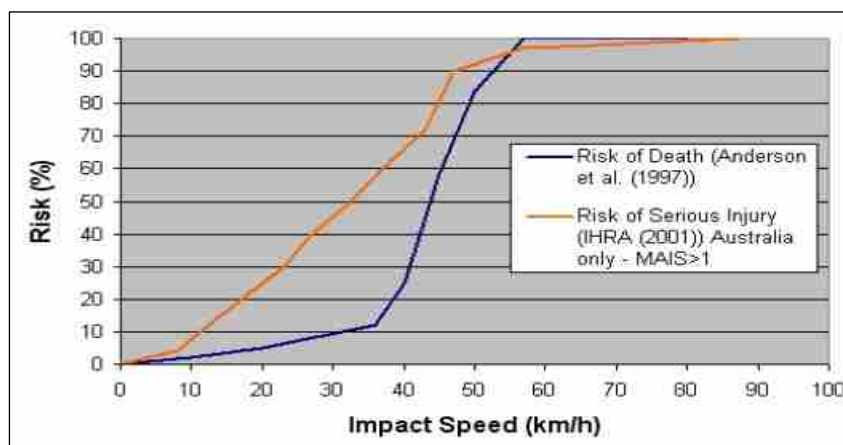
Figure 2.4 Census view on the risk of death and serious injury if pedestrian struck by a car (Archer et al

The third option is to minimise the likelihood of children being killed or injured if they do happen to cross the road in the face of on-coming traffic. In many instances, children have suddenly appeared from behind the bus, giving speeding motorists no time to respond. The only practical option available is to slow down the traffic. However, very few motorists observe, or are aware of, the current 20km/h speed limit when travelling past a school bus and this speed limit has proved to be difficult to enforce. The penalty for travelling 50km/h over the speed limit (ie at 70km/h) is automatic loss of licence. Despite that, average speeds of over 84km/h were recorded on a 100km/h road during the BUSSTAC school bus signs trial (see section 2.4 below). In considering options for slowing down the traffic, it is important to consider two inter-related factors: the dangers posed by speed, and stopping distance. Archer et al (2008) contains the census view of the probability of a pedestrian being killed or seriously injured when hit by a vehicle. A copy of the graph from Archer et al (2008) is shown in figure 2.4. Hamilton-Baillie (2008) noted that human skull thickness and physiology had evolved to be able to survive an impact at our maximum running speed, which is about 30km/h.

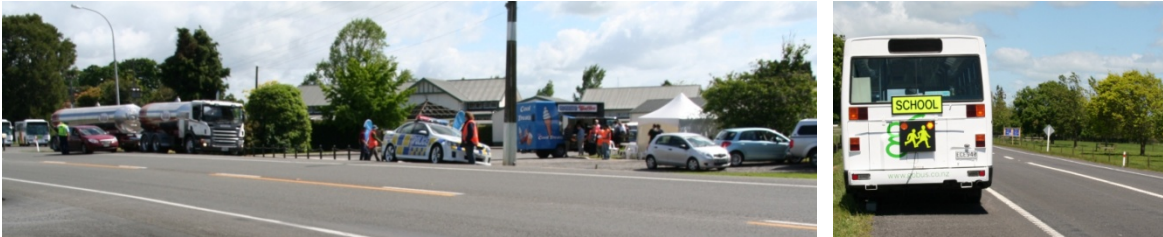
Figure 2.5 Intercept stop location and bus and sign used for the survey

At the end of the survey, the motorists were invited to comment on the other signs. Figure 2.5 shows the intercept stop and the bus that was used.

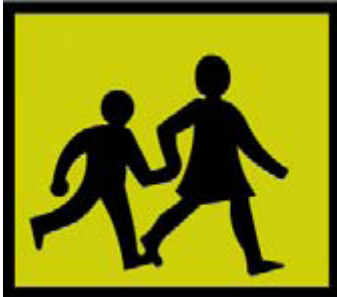
<p>2 Current sign with normal bus hazard lights flashing.</p>	
<p>3 Symbolic sign (570 x 500) to establish the value of using the children symbol.</p>

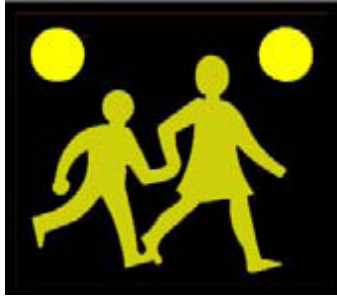
<p>4 Dynamic sign (570 x 500) to establish the value of using a symbolic sign with adjacent flashing lights.</p> <p>Estimated cost \$1,000 to \$1,500 per sign installed (100 or more units).</p>

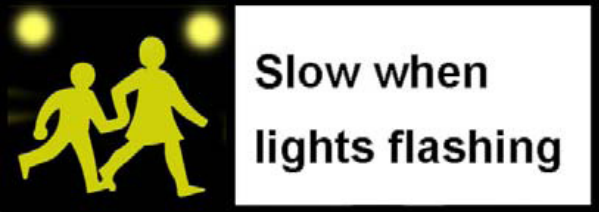
<p>5 Sign 4 plus text to examine any benefits of the accompanying word message.</p>

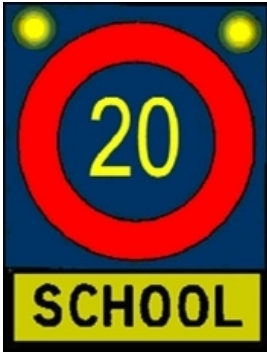
<p>6 LED speed warning sign. New school speed zone sign installed near some schools. The sign is black when not activated. Using the school zone sign would help to raise public awareness of the sign and what it means.</p> <p>A '40' sign was used because of the time and cost involved in constructing a prototype '20' sign. Estimated cost \$2,500 to \$3,000 per sign installed (100 or more units).</p>

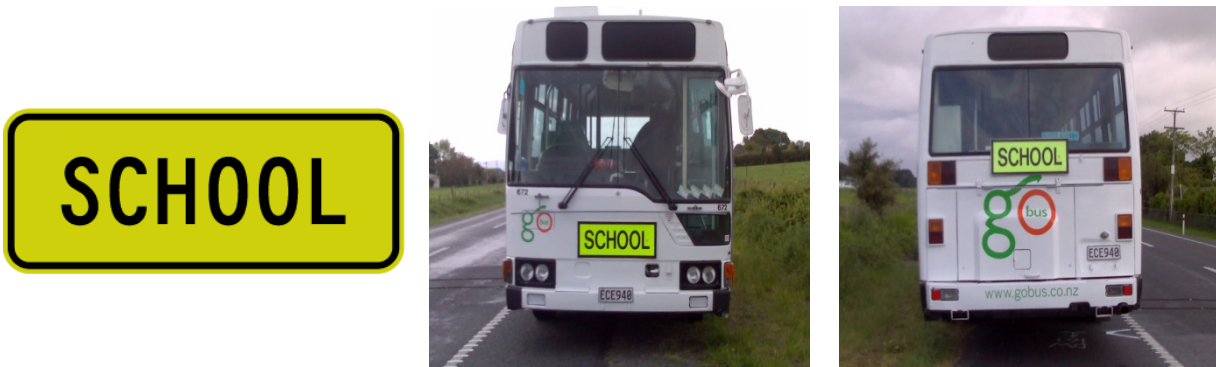
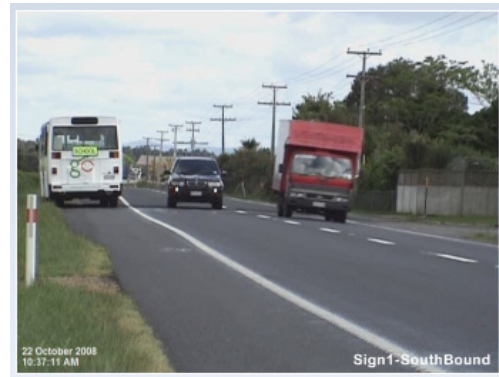
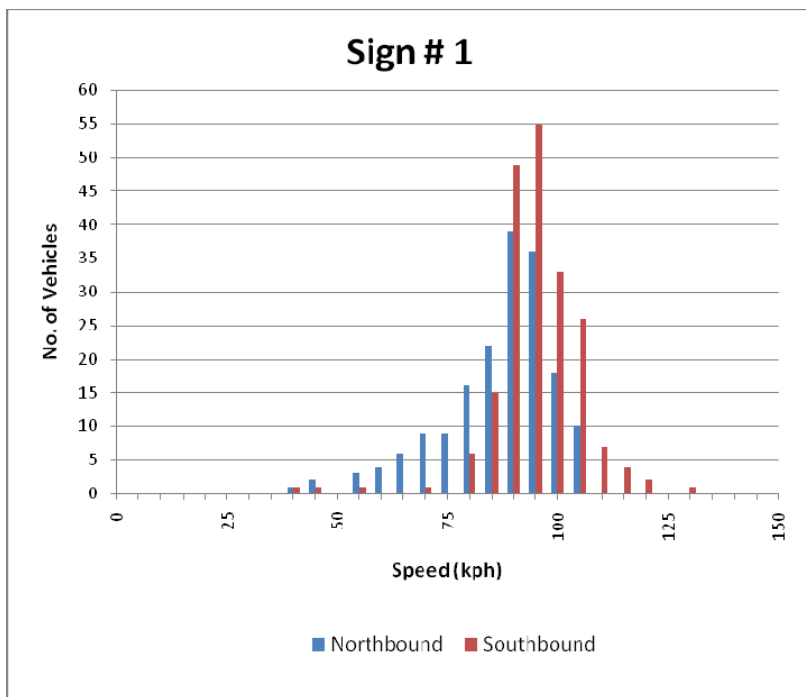
Sign 1: Baseline – (825 x 300) to establish 'status quo' (current sign)

Sign # 1	Northbound	Southbound
Vehicle count	175	202
Average speed	84	93
Standard deviation	13	10
Minimum speed	38	37
Maximum speed	104	129

Dangerous driving incidents in 1.5 hours
 3 involving traffic on bus side of the road
 1 involving traffic on other side of road

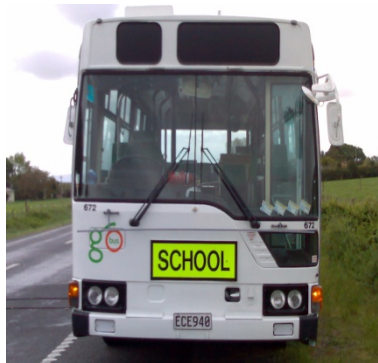
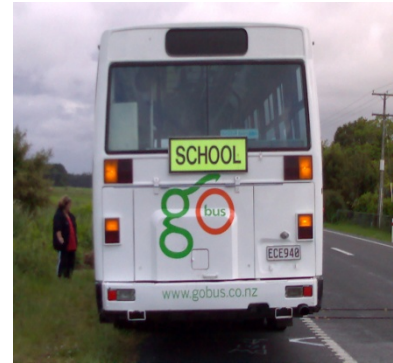
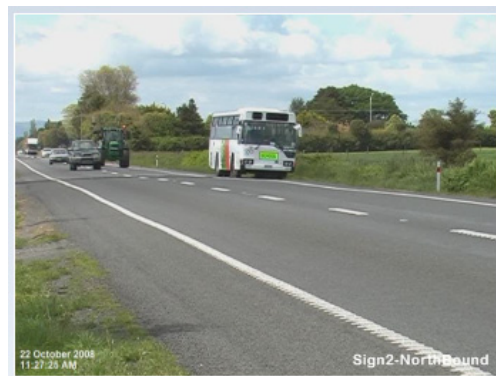
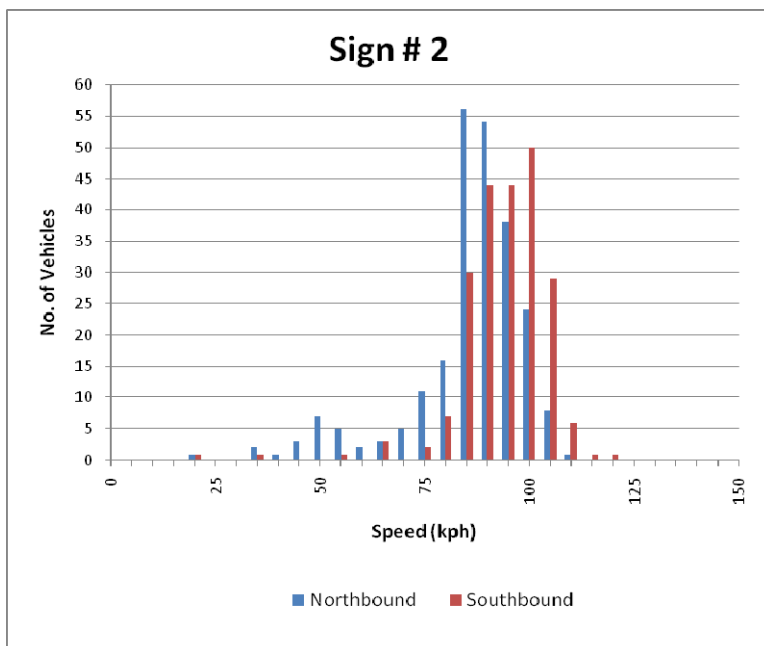
Sign 2: Current sign plus normal bus hazard lights flashing

Sign # 2	Northbound	Southbound
Vehicle count	237	220
Average speed	83.	91
Standard deviation	14	11
Minimum speed	16	19
Maximum speed	106	118

- 1 involving traffic on bus side of the road
- 0 involving traffic on other side of road

- The addition of the bus hazard warning lights on (sign 2) made no discernible difference to vehicle speeds.
- Replacing the current signs with the standard children walking symbolic sign (sign 3) also made no discernible difference.

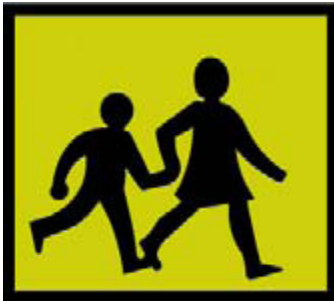
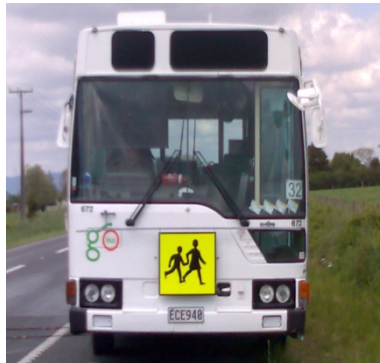
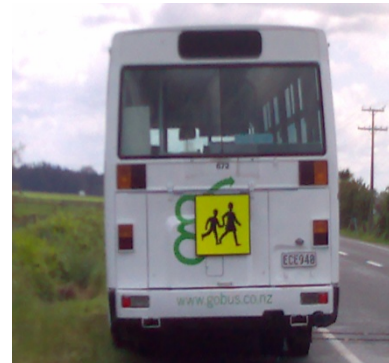
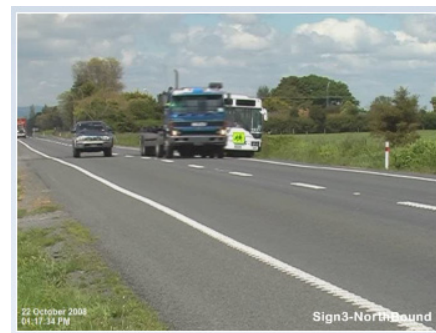
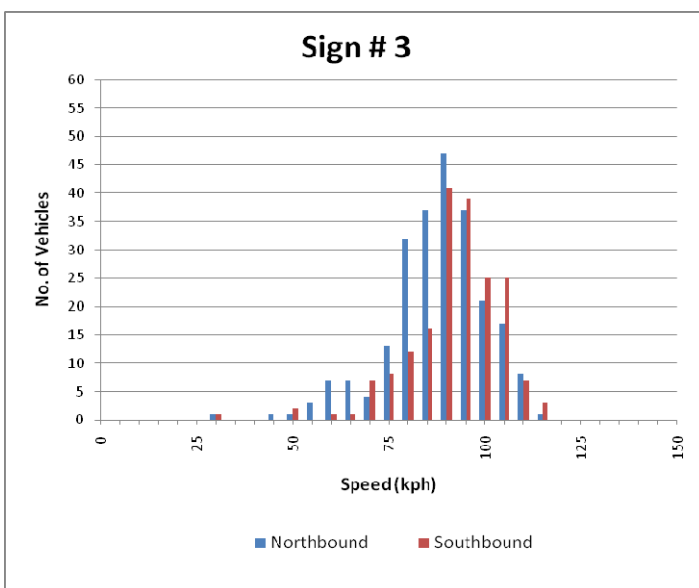
Sign 3: Symbolic sign (570 x 500) to establish value of using children symbol

Sign # 3	Northbound	Southbound
Vehicle count	237	188
Average speed	85	90
Standard deviation	13	12
Minimum speed	27	30
Maximum speed	113	113

3 involving traffic on bus side of the road

0 involving traffic on other side of road

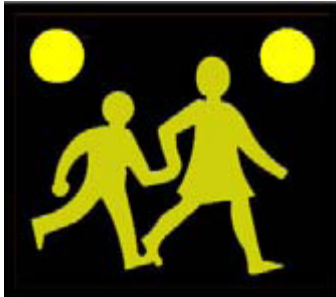
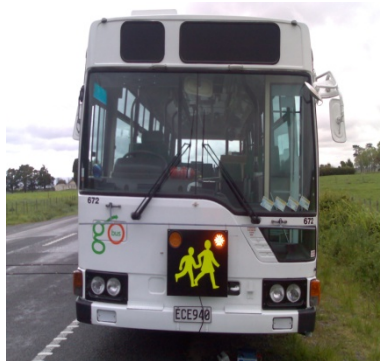
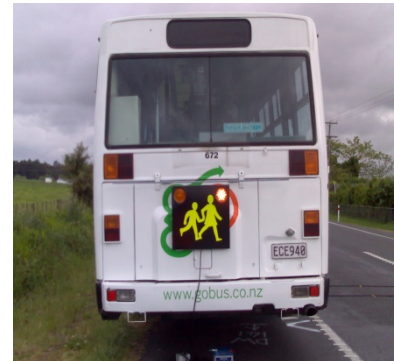
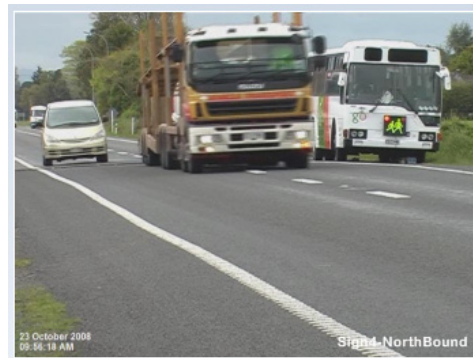
Sign 4: Dynamic sign (570 x 500) to establish value of symbol plus lights, and lights in proximity to signage

Sign # 4	Northbound	Southbound
Vehicle count	244	194
Average speed	69	80
Standard deviation	19	16
Minimum speed	20	15
Maximum speed	104	107

3 involving traffic on bus side of the road

0 involving traffic on other side of the road

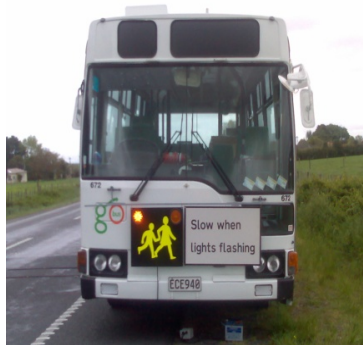
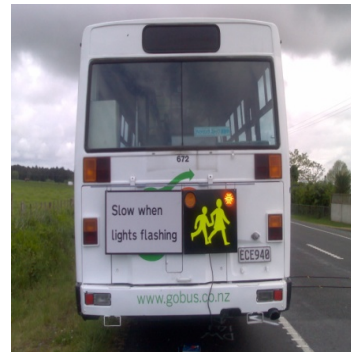
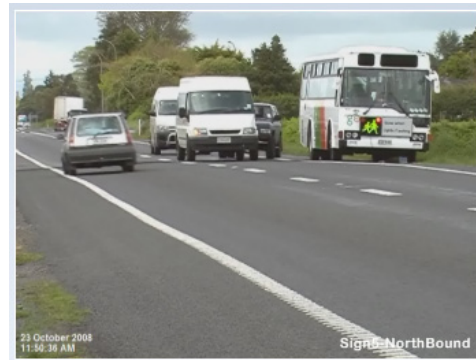
Sign 5: Sign 4 plus text to examine any benefits of the accompanying word message

Sign # 5	Northbound	Southbound
Vehicle count	180	196
Average speed	64	80
Standard deviation	21	17
Minimum speed	16	23
Maximum speed	106	111

Dangerous driving incidents in 1.5 hours
 2 involving traffic on bus side of the road
 0 involving traffic on other side of the road

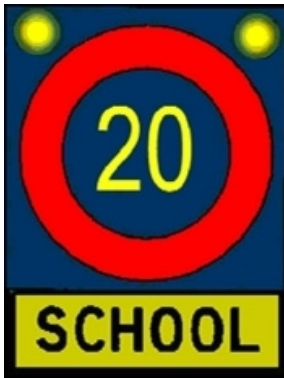
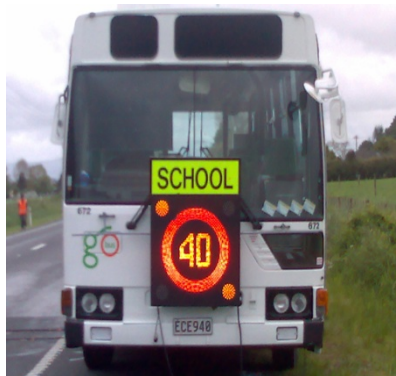
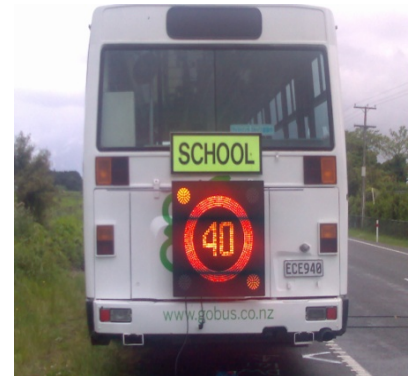
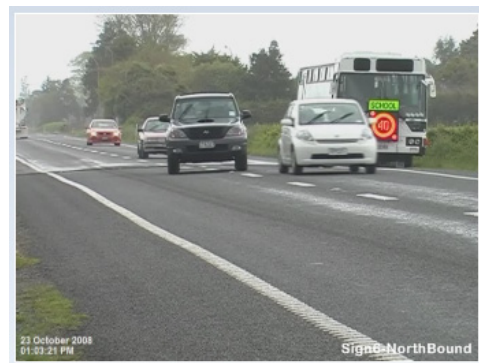
Sign 6: Speed LED sign used for school zones

Sign # 6	Northbound	Southbound
Vehicle count	228	217
Average speed	57	67
Standard deviation	15	17
Minimum speed	30	27
Maximum speed	99	104

Dangerous driving incidents in 1.5 hours
 4 involving traffic on bus side of the road
 0 involving traffic on other side of the road

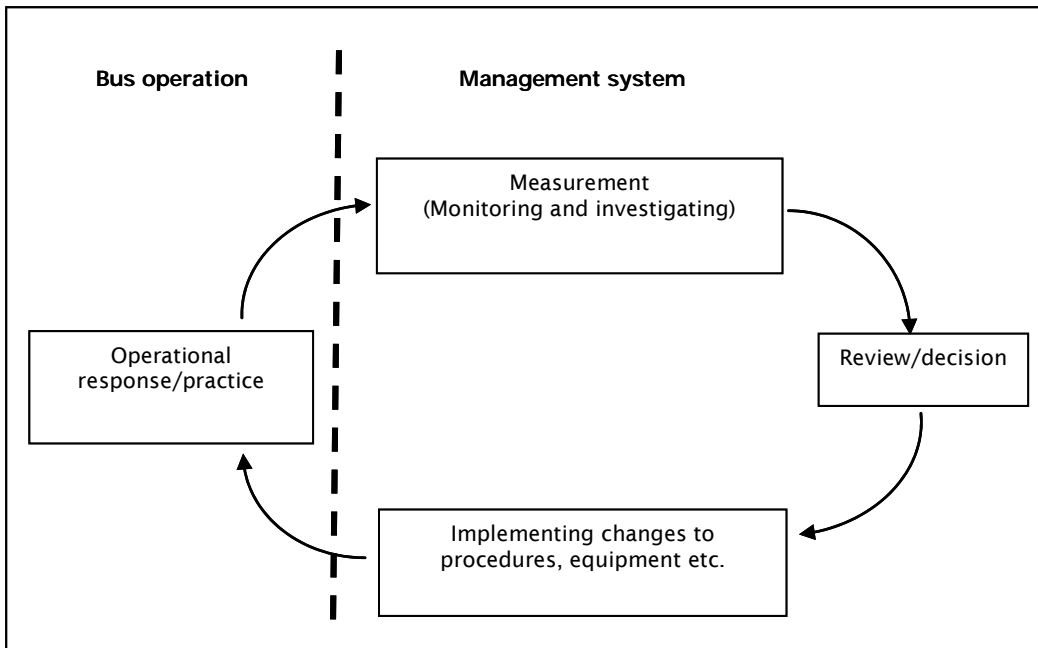
Figure 3.1 Closing the loop

Successful management systems are dynamic, with continuous monitoring of vehicle condition and driver behaviour used to inform decision making and implementation as shown in figure 3.1.

The measurement stage includes accident investigation, recording compliments and complaints, daily walk-around inspections of vehicles, monitoring driver hours, health, infringements, licence status etc, costs, fuel consumption and the other factors involved in operating a school bus.

The next stage is to review and decide on what can be done to reduce the risk of a crash occurring, reduce the level of complaints, improve fuel efficiency, reduce operating costs etc. This requires a deliberate management decision-making process with, for example, regular meetings and staff assigned to investigate different issues to ensure problems are not simply put in the too hard basket.

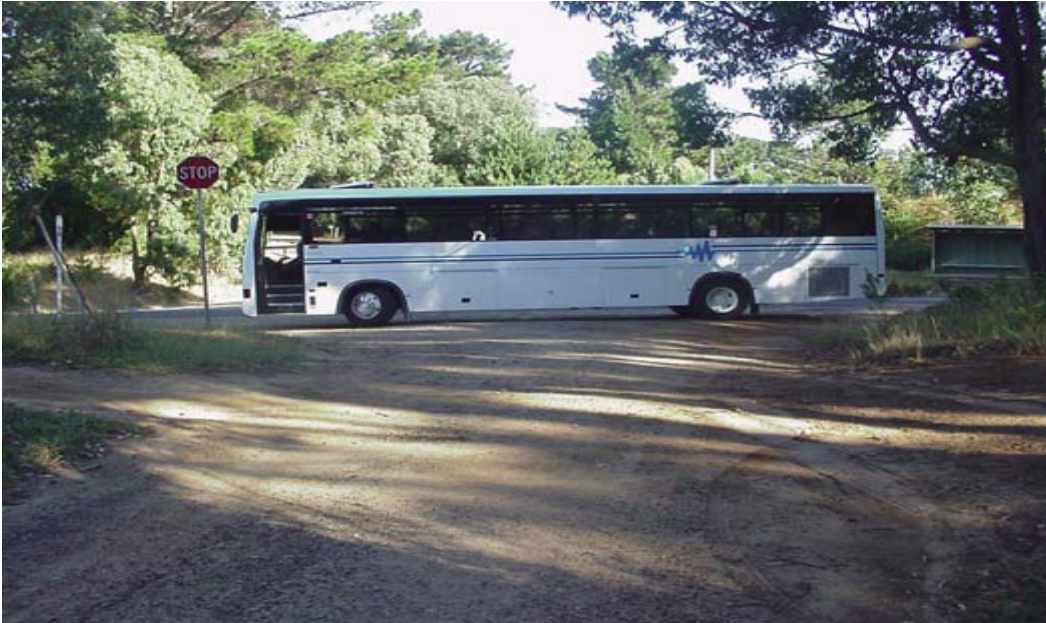
Figure A1 A school bus stop located within an intersection

In some instances the only suitable location identified for buses to stop is within an intersection (refer figure A1). This may be acceptable where traffic volumes on the side road are very small (below 500 vehicles per day) and sight distances from the side road to a stationary bus are good.

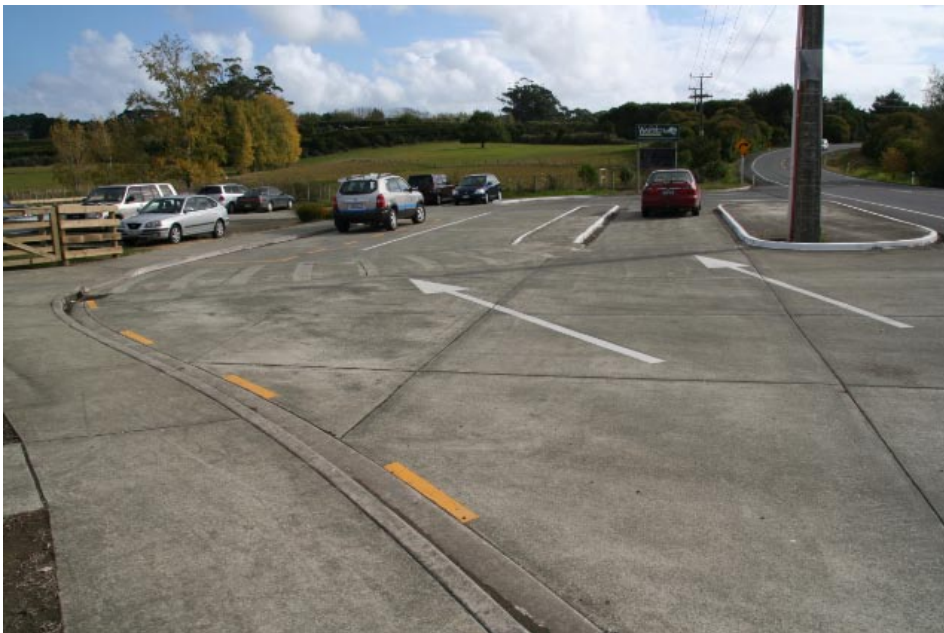
Figure A2 A school-located school bus stop not within the school grounds

If located within the school grounds the frequency of services will primarily influence suitable treatments for school located interchanges. If the facility is not within the school grounds (figure A2) then all of the criteria listed above will determine which treatment is most appropriate.
