**Performance of open graded
porous asphalt in New Zealand
October 2011**

NZ Transport Agency
research report 455

E Fletcher and AJ Theron
MWH New Zealand Ltd, Hamilton

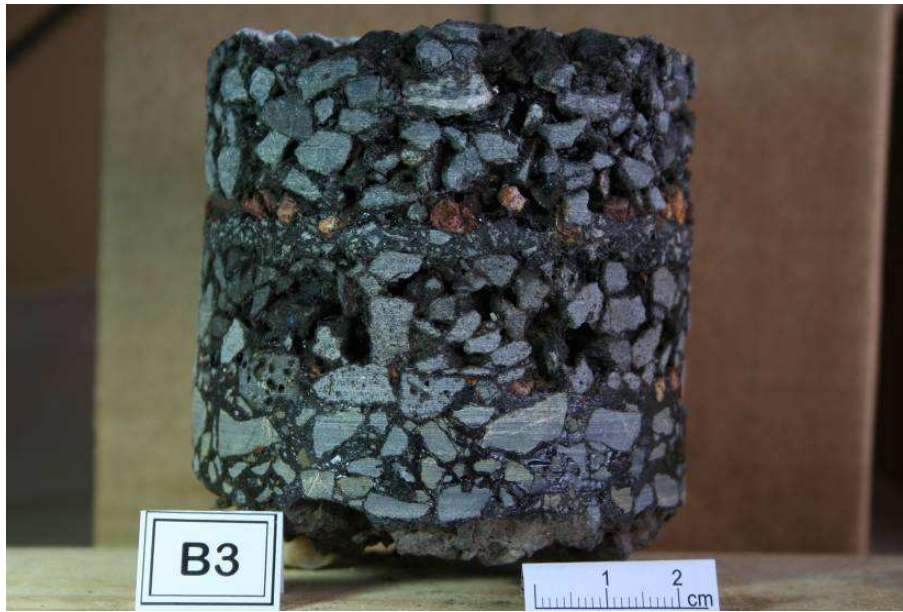
Figure 2.2 Two-layered system

Figure 2.2 shows a core extracted from a multiple-OGPA structure that has a seal and asphalt levelling layer between consecutive OGPA layers (a two-layered system).

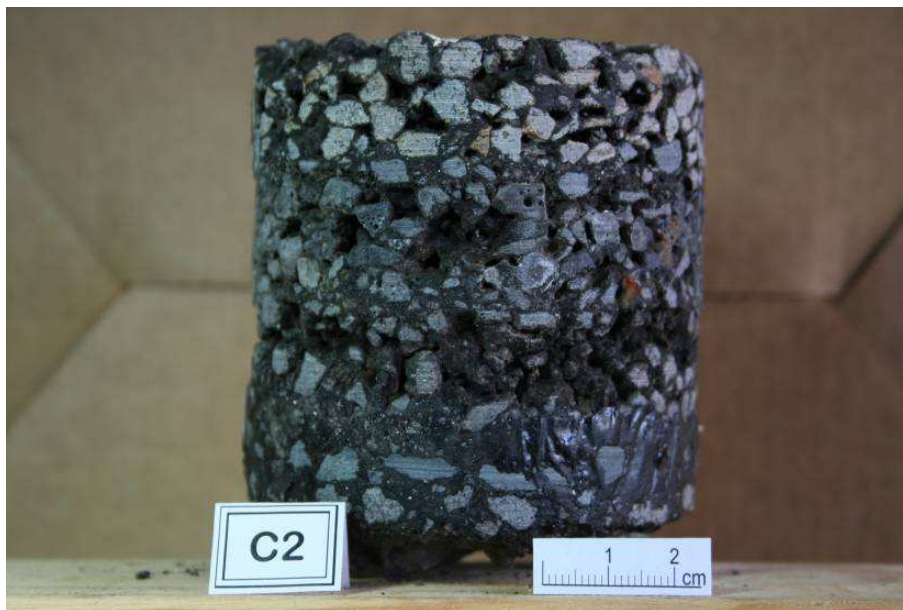
Figure 2.3 Three-layered system

Figure 2.3 shows a core extracted from a multiple-OGPA structure with seal and asphalt levelling layer between consecutive OGPA layers (three-layered system).

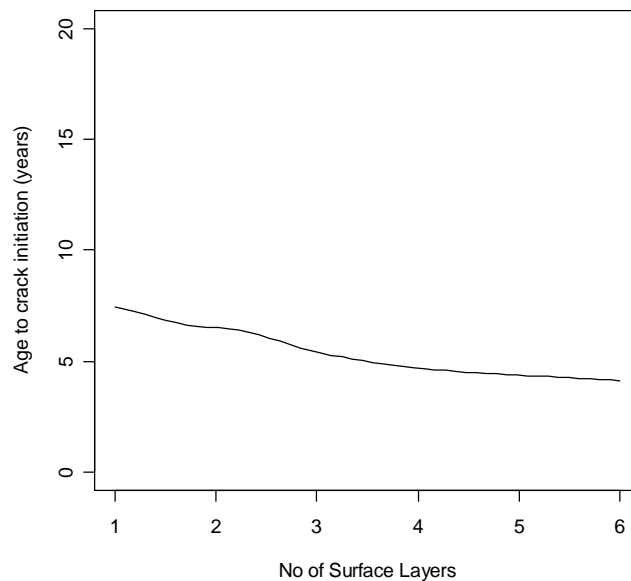
Figure 2.4 Crack initiation with age (OGPA layers)

Over the years, as many as six OGPA overlays have been placed on some sections of the South Auckland State Highway Network. Statistical evidence suggests that the time until initial crack development of the top surfacing layer reduces with each consecutive overlay, as illustrated in figure 2.4.

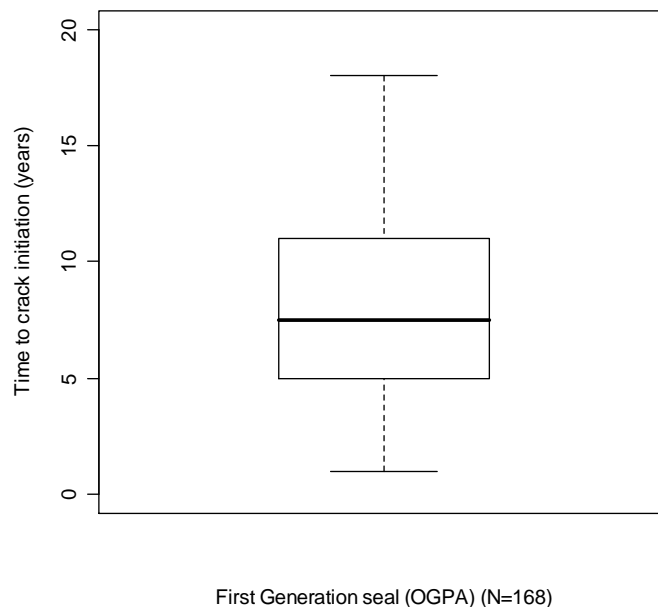
Figure 3.4 Time to crack initiation distribution

A distribution of the time to crack initiation of OGPA layers on the network is illustrated in figure 3.4. The median value for time to crack initiation on the first OGPA overlays is 7.5 years, while the time to crack initiation for 50% of the layers lies between 5 and 11 years. The skew distribution in this chart might be as a result of the range in structural integrity of the pavements and improved performance of some of the bitumen binders used in these overlays.

The poor relationship between OGPA performance, pavement strength and surface age might be confirmation that this layer should be regarded as a non-structural layer. It would appear that factors other than surface age and pavement strength affect the performance of OGPA surface layers.

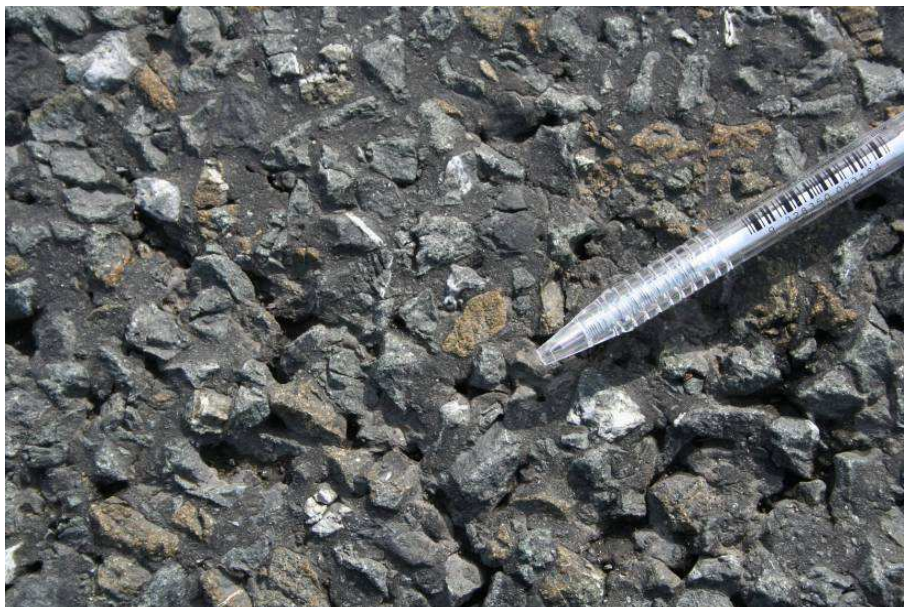
Retexturing of OGPA surfaces that had low skid resistance (ie lacked in SCRIM requirements) was attempted. These trials were conducted with the use of specially designed equipment that was designed to mechanically abrade the surface, thereby restoring the surface texture. On OGPA mixes, the retexturing damaged the older surfaces – the process was found to be more suited to SMA mixes.

Figure 4.1 Retextured OGPA surface (note the newly formed faces)

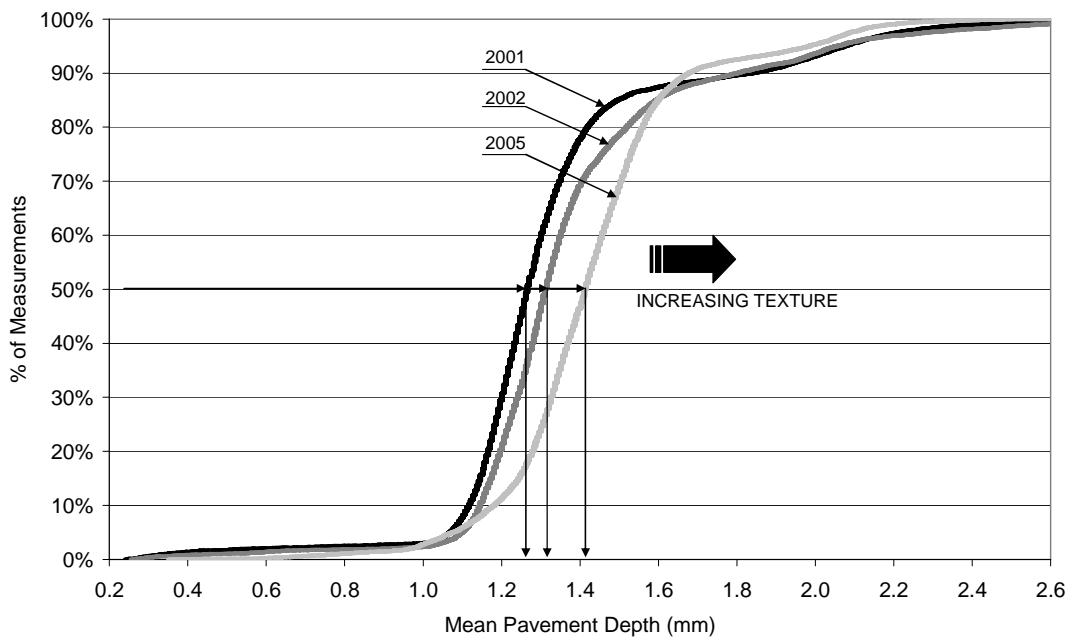
Figure 4.2 Surface texture (MPD)

It was expected that the texture depth of an OGPA layer would increase over time, due to an increased level of ravelling and cracking on the surface because of binder hardening. This is confirmed in the trends presented in figure 4.2.

The average MPD increased from 1.27mm in 2001 to 1.41mm in 2005, suggesting that the mean texture depth on the OGPA network was increasing with time. Although the reliability of the MPD measuring system is unknown, it shows some potential in measuring the condition of OGPA, which can be useful as a decision-making tool in the management of the OGPA road network.

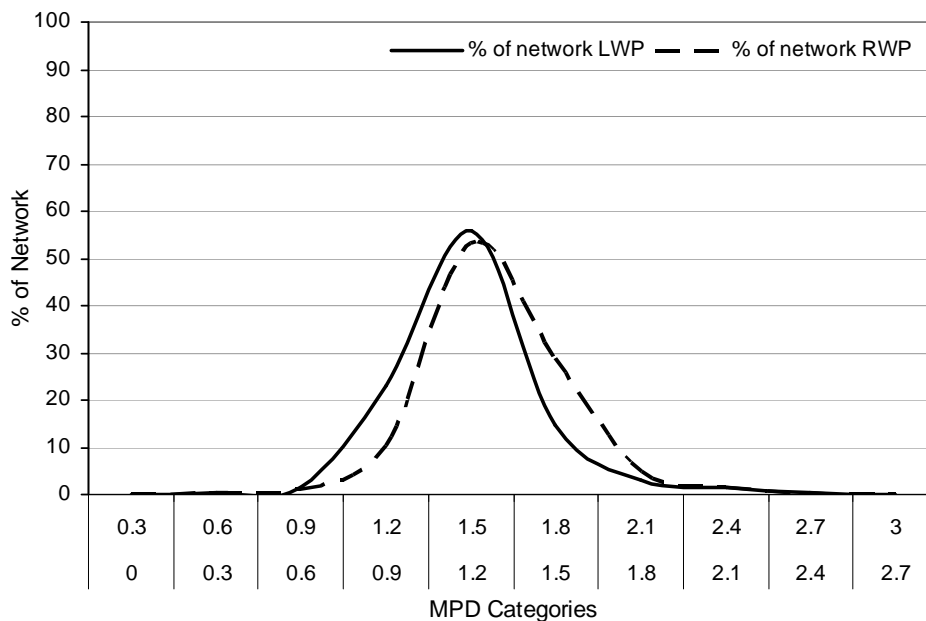
Figure 4.3 Distribution of mean pavement depth (MPD)

Figure 4.3 shows a marked difference in the texture of the wheelpaths – the right wheelpath seems to be coarser than the left wheelpath. Closer inspection of the surface revealed that the left wheelpath was more silted up than the right wheelpath, which contributed to its lower texture depth.

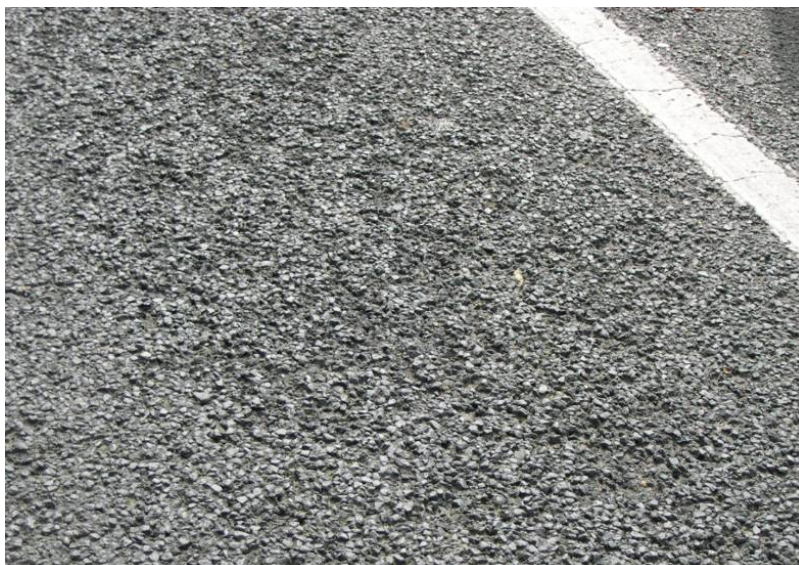
Figure 4.5 Ravelling due to ageing of the bituminous binder

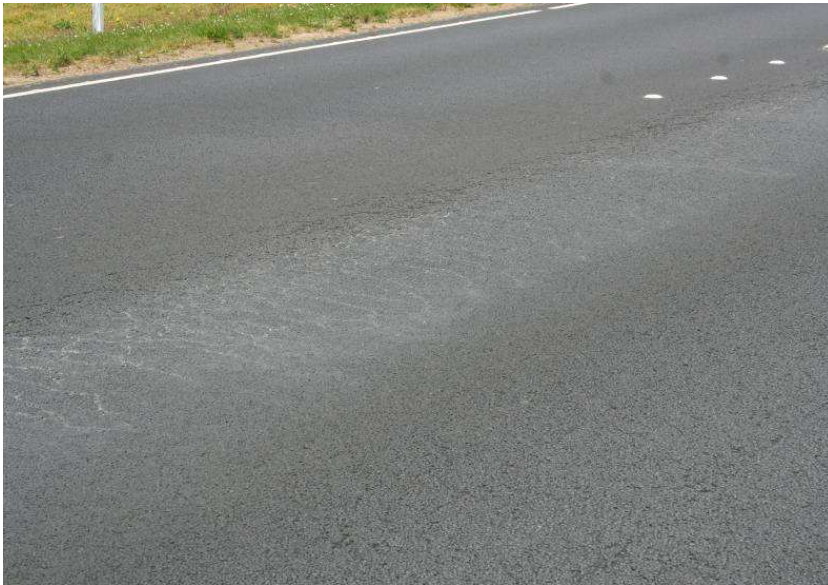
Figure 4.6 Cracking and pumping of the pavement surface due to pavement rutting and moisture retention in the OGPA surface

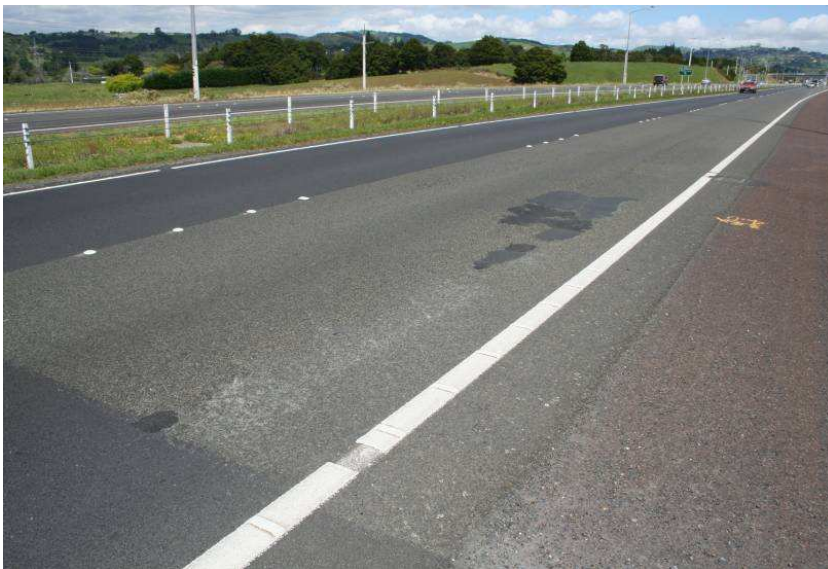
Figure 4.7 Pavement rutting and subsequent failure of the OGPA surfacing

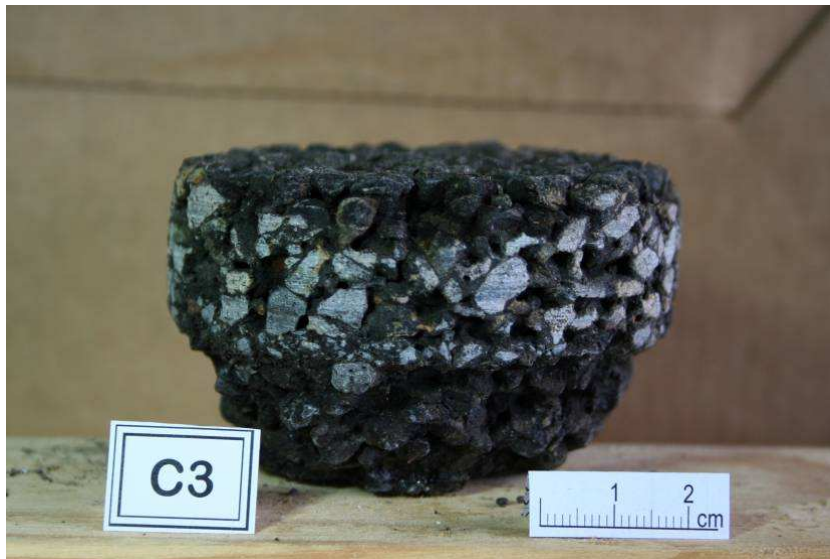
Figure 4.8 Multiple OGPA exposed to constant wet conditions in the bottom layer because of impeded side drainage (stripping of binder has occurred)

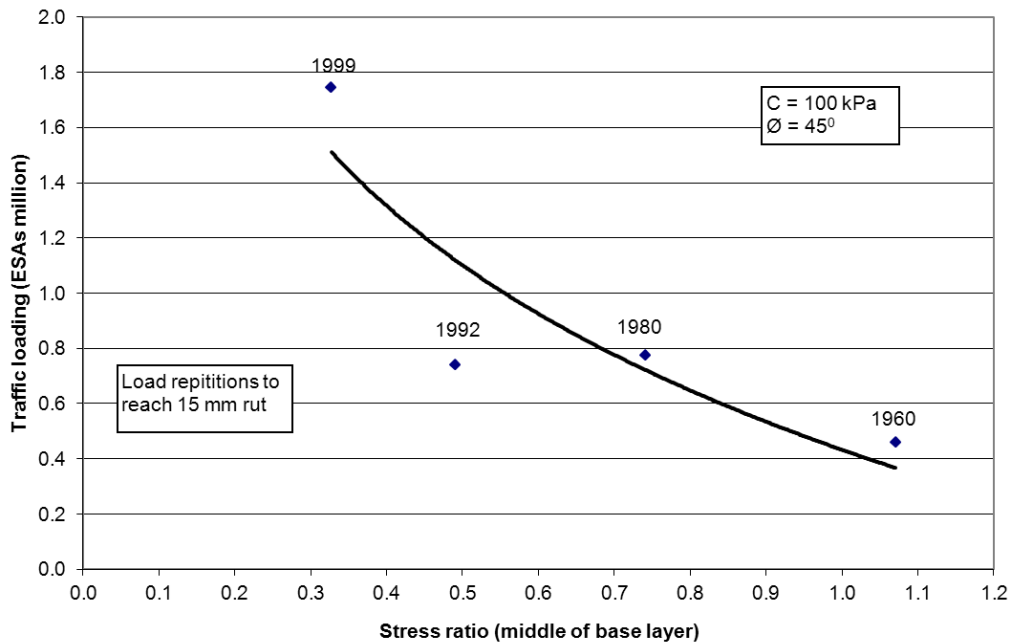
Figure 4.11 Performance curve

The age/stiffness relationship illustrated above (and confirmed by the 1997 Transport Research Laboratory (TRL) study) allows the reader to model a multiple-OGPA system and calculate the stress reduction in the other pavement layers (as demonstrated in this section. We are confident that the stiffness values are accurate and measured stiffness fits as expected from classic rheological models. Terminal stiffness was also derived from measurement (ITT⁵ on cores and beams from ravelled sections and confirmed through known universal terminal bitumen stiffness). By following these principles, overlaying of sections that have reached terminal stiffness can be avoided, or pre-treatment of such sections can be undertaken (filling with emulsion membrane sealing etc). If stiffness measurement (ITT or beam test) is undertaken at regular intervals on a network level, the condition of an OGPA surfacing can be tracked with time and overlays can be programmed accordingly.

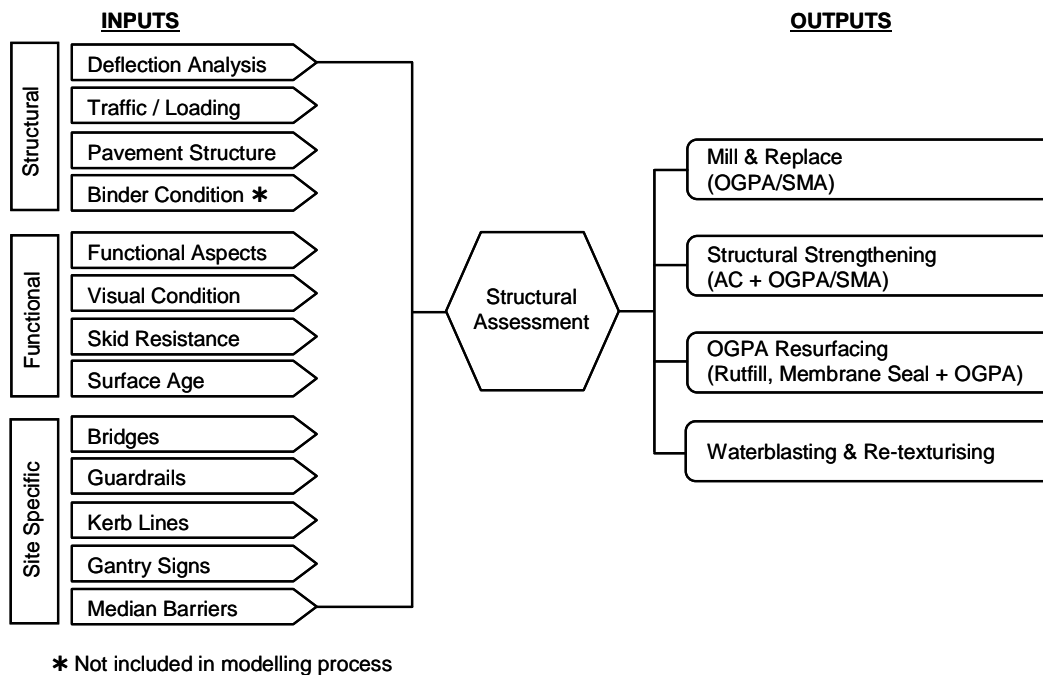
Figure 5.2 Finalising works programme

The process for finalising the works programme is illustrated in figure 5.2

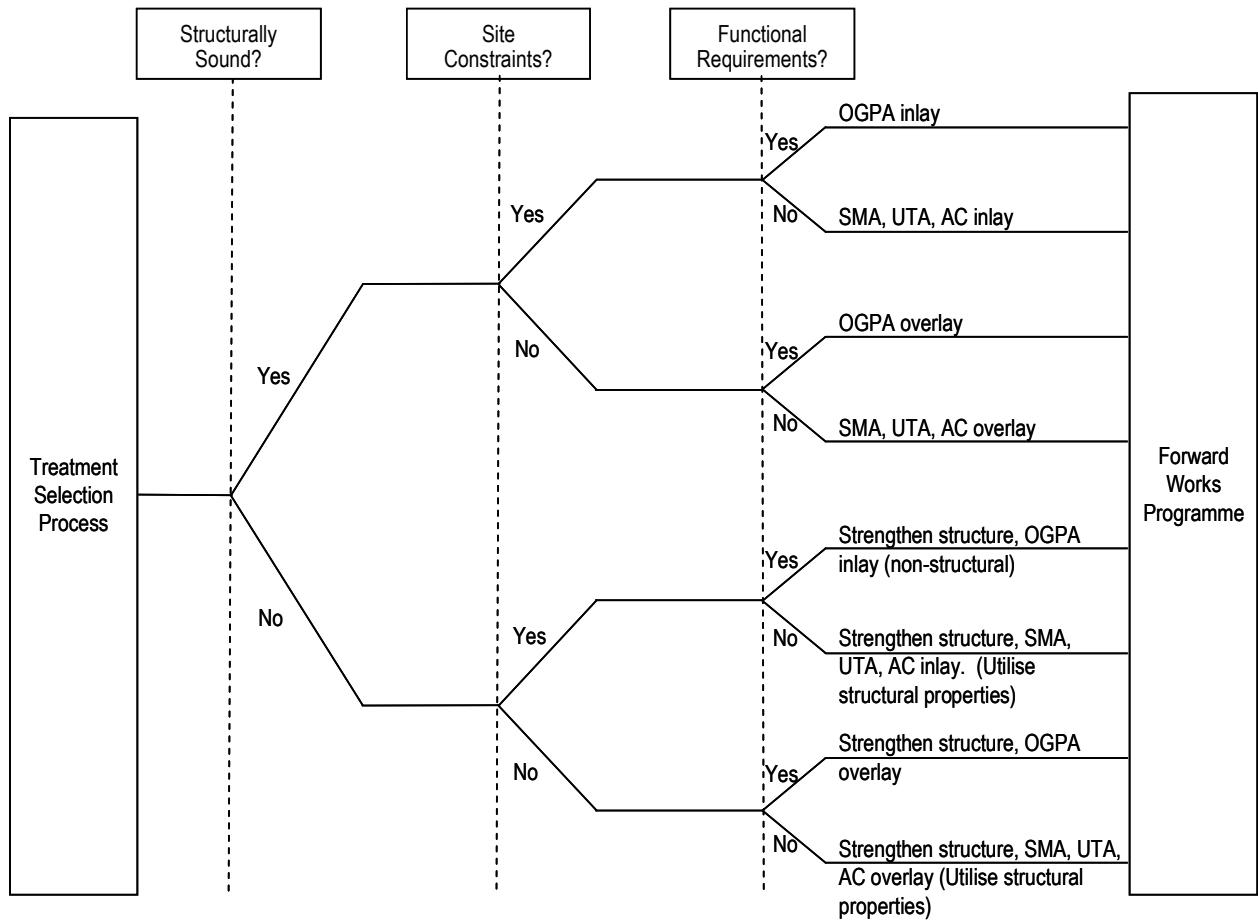
Figure 5.3 Proposed network maintenance decision-making structure

In the case of a sound pavement section ($SNP \geq 2$) on which the functional properties of an OGPA surfacing are required, and where the section has no site constraints such as kerb lines, guardrails, etc, the decision-making structure suggests milling off the existing OGPA surfacing prior to replacing it with new OGPA. The current maintenance practice under these conditions (no site constraints) would not necessitate milling off the existing surfacing. The long-term implications of this approach need to be monitored, as the potential of a water reservoir sandwiched in the multiple layers could lead to bitumen stripping and consequent failure. However, there has not yet been any evidence of this occurring to any significant degree.
