Flushing in chipseals

PR Herrington
Opus Research, Opus International Consultants Ltd

NZ Transport Agency research report 576
Contracted research organisation – Opus International Consultants Ltd

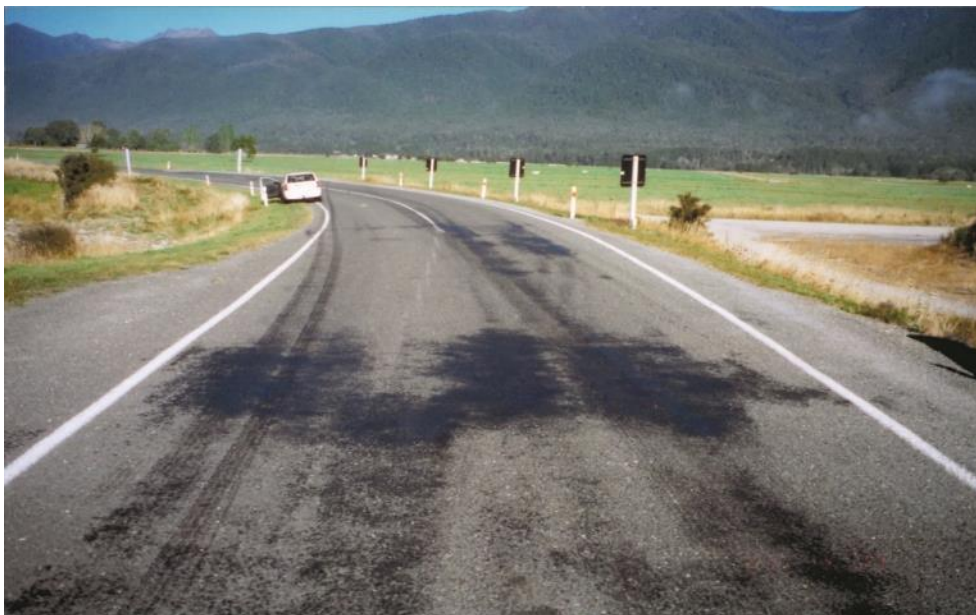
Figure 1.1 Seal with flushed patches and showing bitumen tracking in left wheel path

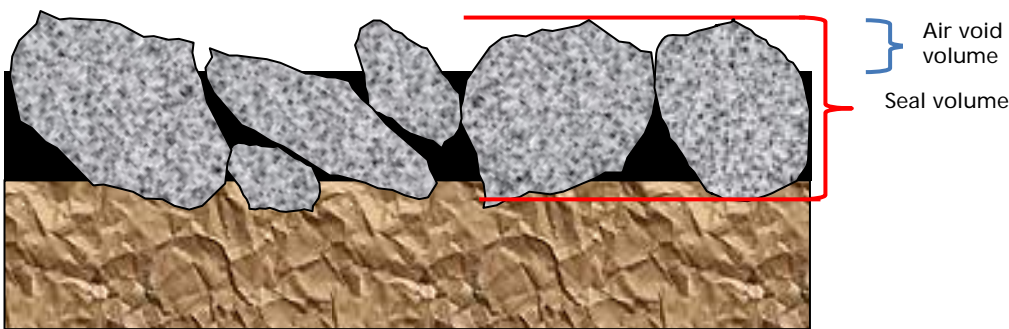
Figure 2.1 Chipseal layer volumes

Chipseal flushing can be understood in terms of the composition of the seal layer volume (shown schematically in figure 2.1).

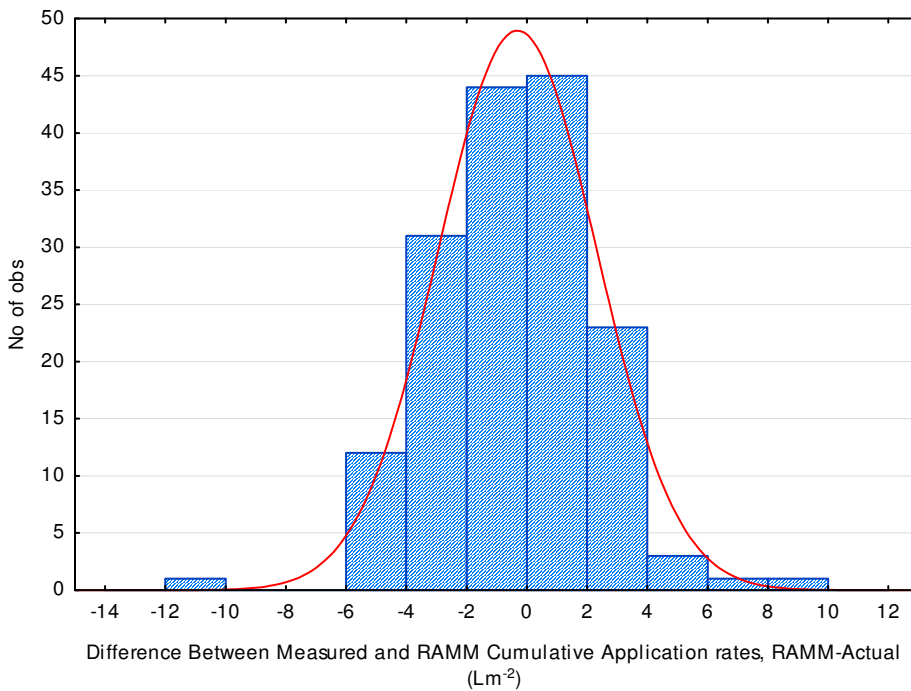
Figure 2.3 Comparison of actual and RAMM cumulative application rates

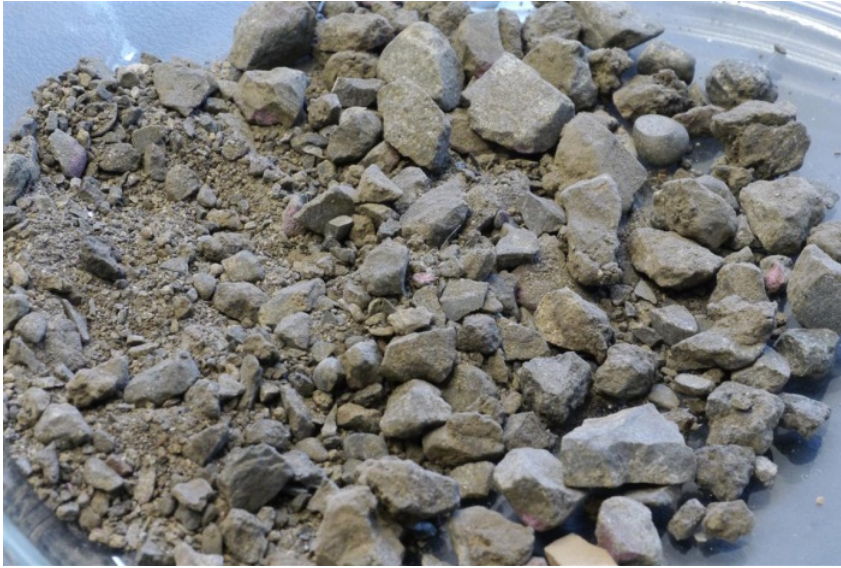
Figure 2.4 Example of aggregate breakdown material from a multi-layer chipseal core constructed from grade 2, 3 and 5 chip only

Abrasion, polishing and breakdown of the sealing chip under traffic will reduce the size of the sealing chip and hence the available surface texture. An example of breakdown material from a chipseal core constructed from grades 2, 3 and 5 chip only is presented in figure 2.4. As shown in the following sections, an approximately continuous grading of material is observed.

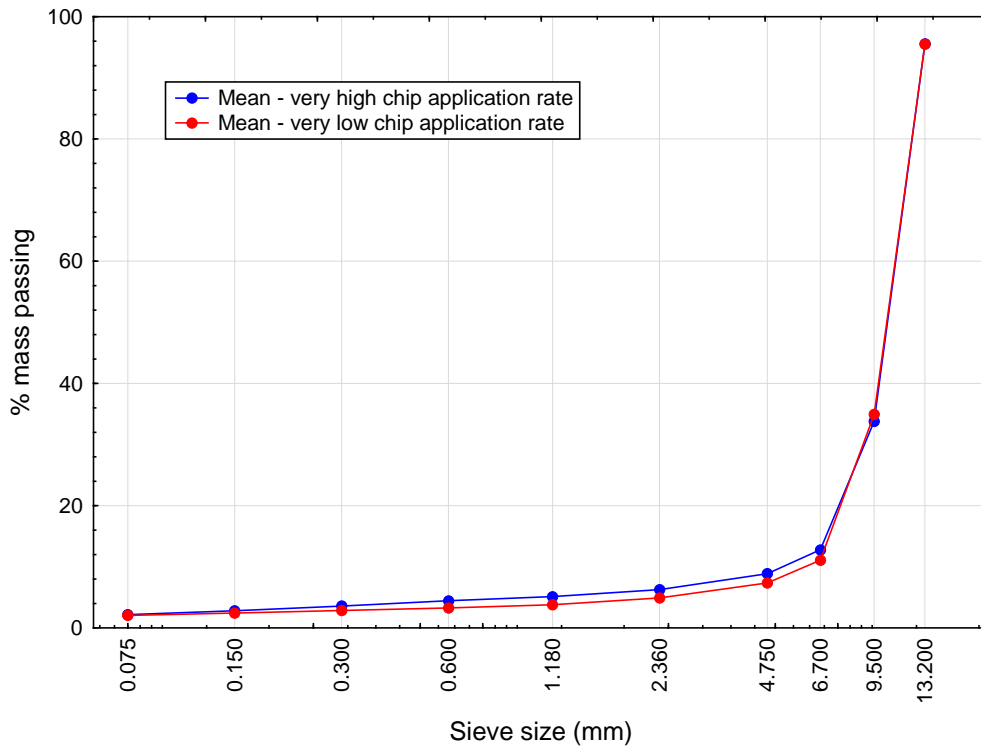
Figure 2.9 Aggregate gradings Clintons Road

The fines present in the seals are a combination of those present in the underlying seal (although this effect was minimised by only extracting the top 15mm of seal) and those generated by traffic over the five years from construction, so it is possible that small differences due to chip application levels may have been masked. The level of over-chipping was also substantially less than that in the laboratory experiment discussed above but at the upper end of that which would occur in practice (Waters 2011). In practice also traffic will rapidly distribute loose chip outside of the wheel paths in contrast with the laboratory experiment where the chip was constrained.

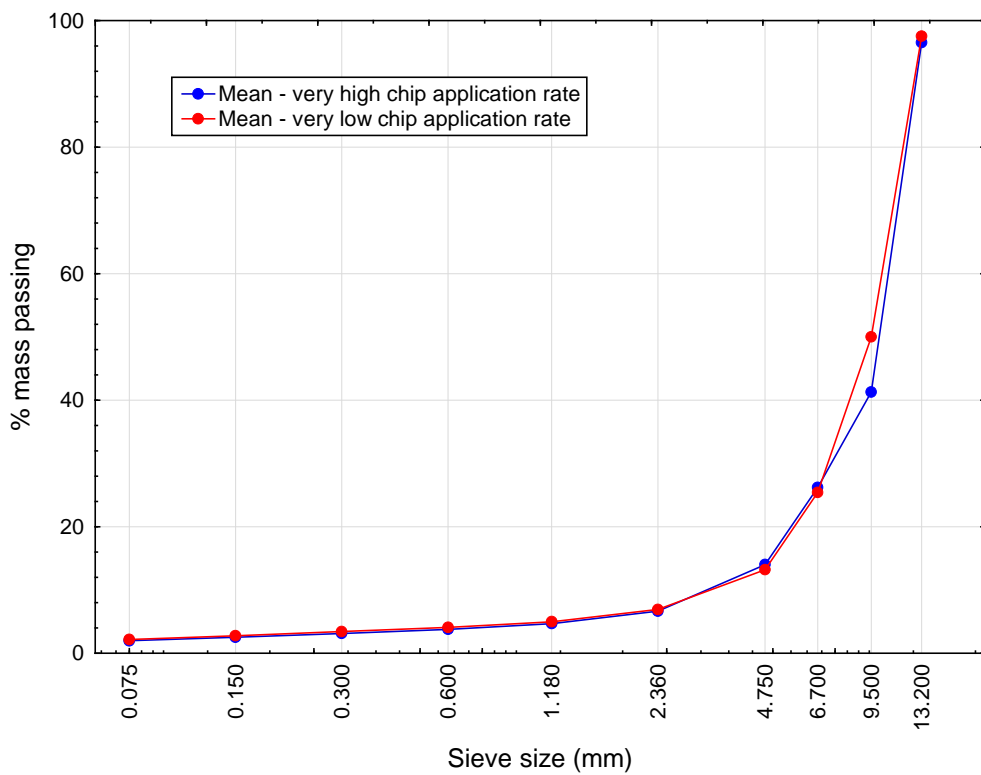
Figure 2.10 Aggregate gradings Telegraph Road

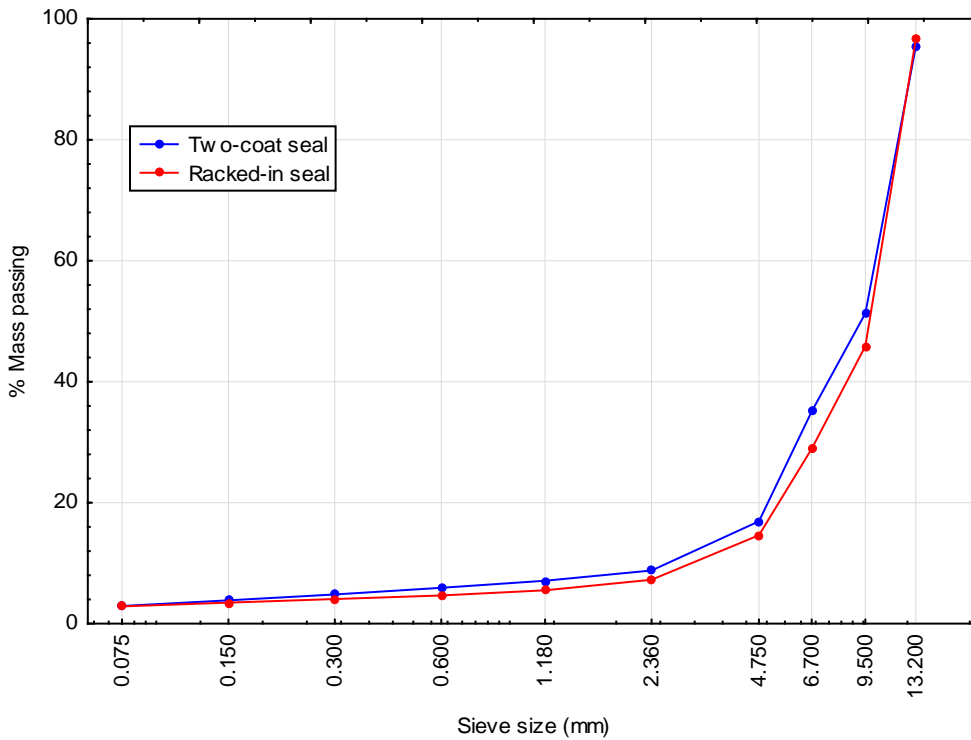
Figure 2.12 Aggregate gradings SH2 Featherston site

Substantial differences were found between the two sites for the larger sieve sizes though this may just reflect the differing and unknown proportions of grade 3 to grade 5 chip used in the two seals.

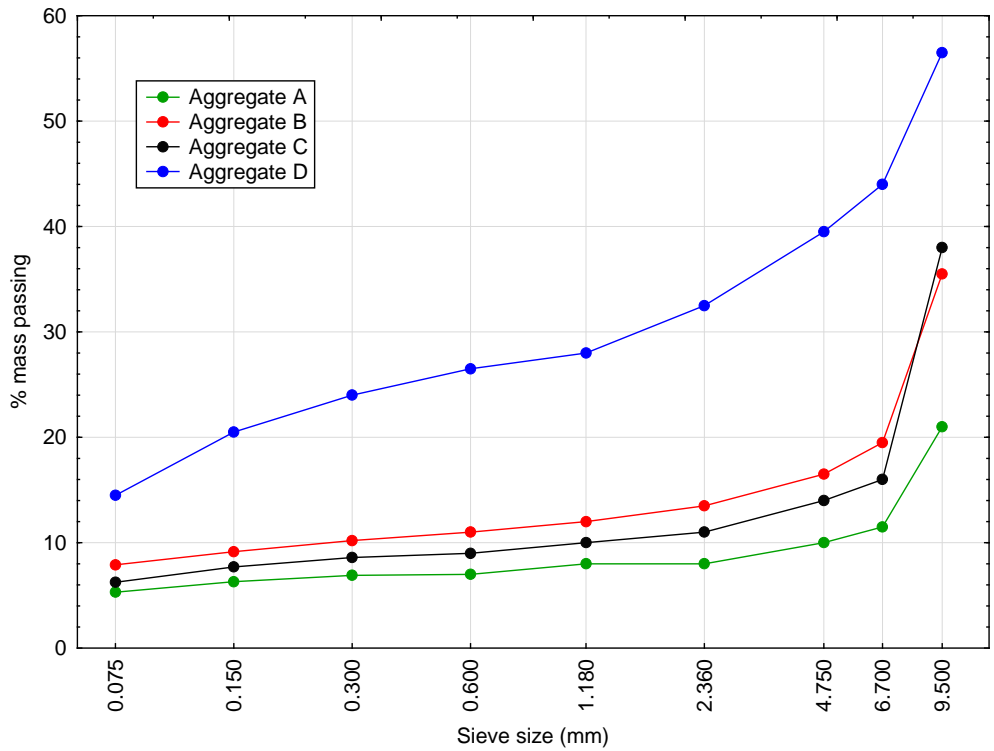
Figure 2.14 OMD test results for four different aggregate sources

The results, shown in figure 2.14, show a substantial variation in the formation of breakdown material amongst the four aggregates. Figure 2.15 shows the results overlaid with gradings from three of the flushed field cores used in the analysis in section 2.3.2. The field cores were constructed from different grade 3 (and 3/5) aggregates so a direct comparison with the OMD tests results is not possible, but the gradings show a similarly wide range giving some confidence that the test conditions are a reasonable simulation of field conditions.

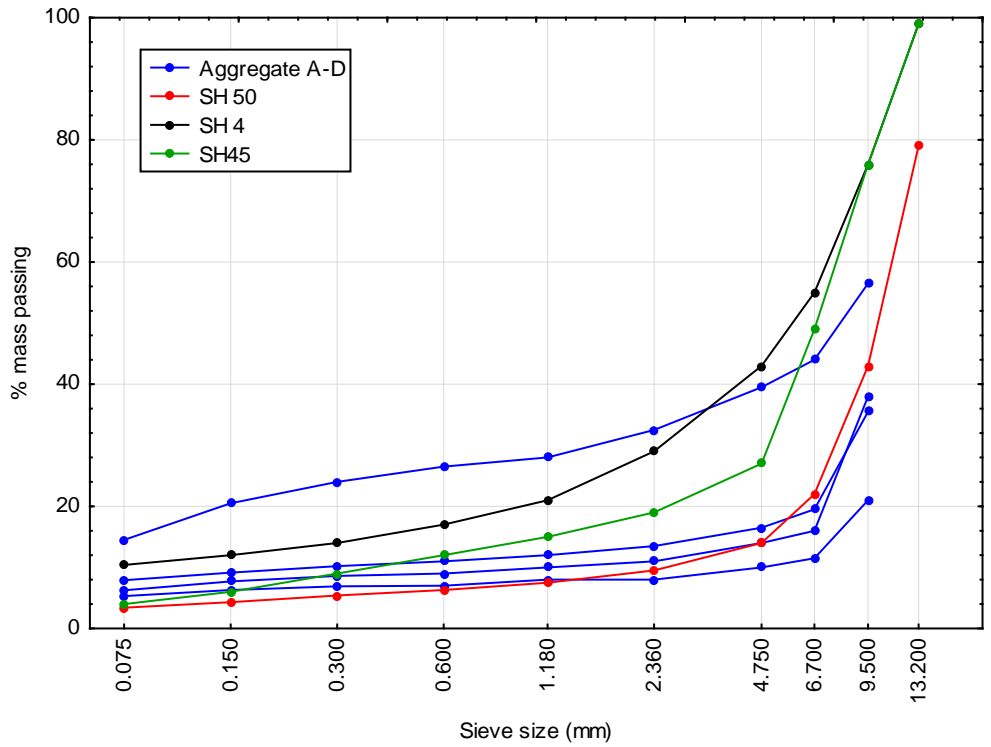
Figure 2.15 OMD test results for four different aggregate sources compared with field core gradings

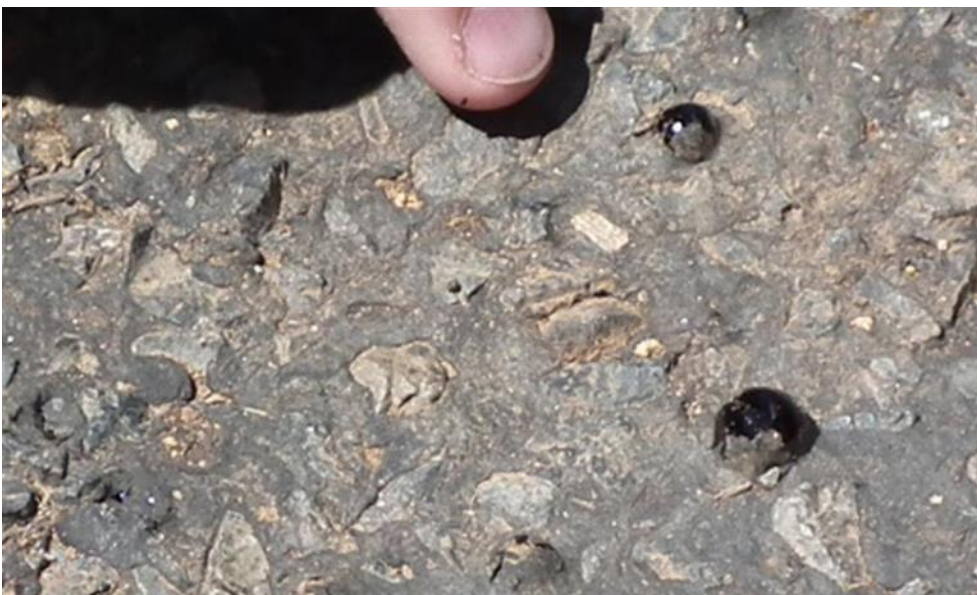
Figure 2.17 Bitumen blisters forming in hot weather (Melbourne, Australia)

Water has long been implicated as a potential cause of flushing (Major 1972), most obviously through the formation of blisters or 'volcanoes' caused by venting of water vapour (figures 2.17 to 2.23). In hot weather bitumen blisters form, which under the correct conditions can later be found to contain liquid water.

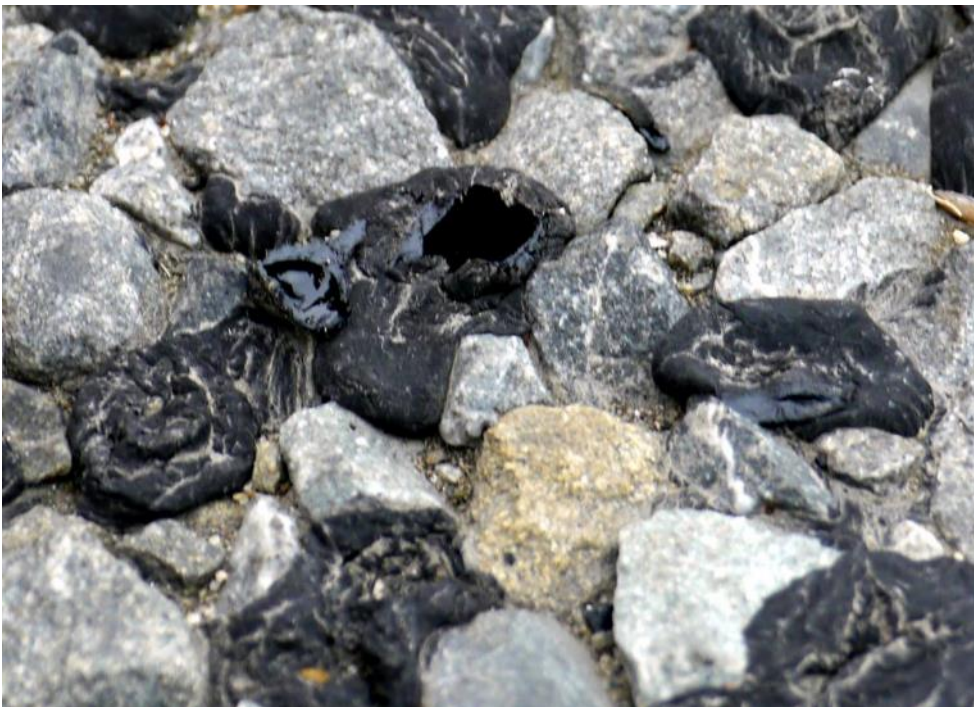
Figure 2.19 Blisters after cooling. The central blister has had the top removed to show the hollow interior (SH75 Banks Peninsular)

Venting of water in this way is extremely common and is in fact almost always observed where flushing has occurred. The blisters may burst or remain intact on cooling to form a hollow shell (figure 2.19) or collapse to form a 'blob' of bitumen sometimes referred to as 'spot flushing'. In trafficked areas the blisters are rapidly flattened, but their position is apparent as vent holes, sometimes several millimetres in diameter (figure 2.20).

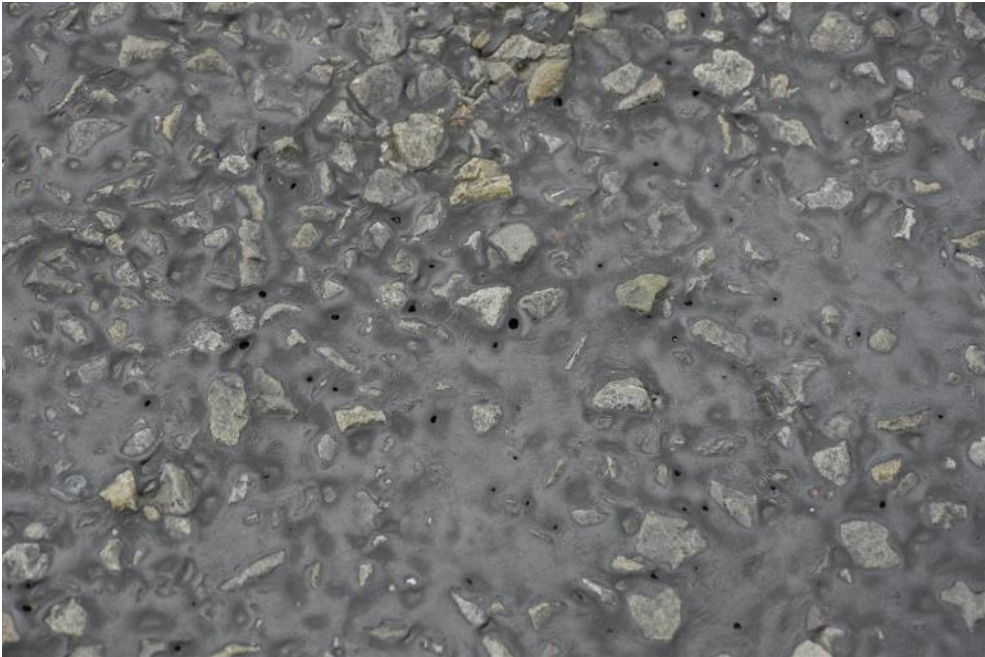
Figure 2.20 Water vapour vent holes in a flushed wheel track (SH2 Featherston)

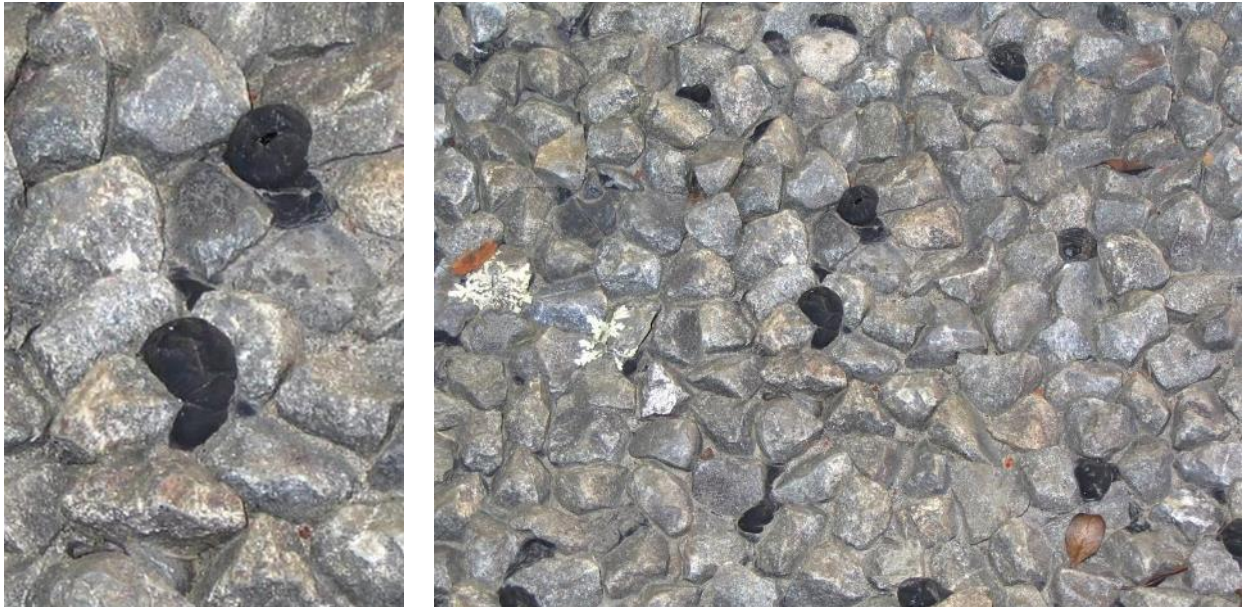
Figure 2.22 Bitumen blisters formed on an artificial seal constructed on a steel plate and exposed outdoors

As well as appearing in the wheel tracks, blisters can be commonly observed on the road shoulder and on areas of seal that have little or no traffic (eg figure 2.21). Venting has also been observed on artificial seals constructed on steel plates and exposed outdoors 200mm above the ground (figures 2.22 and 2.23).

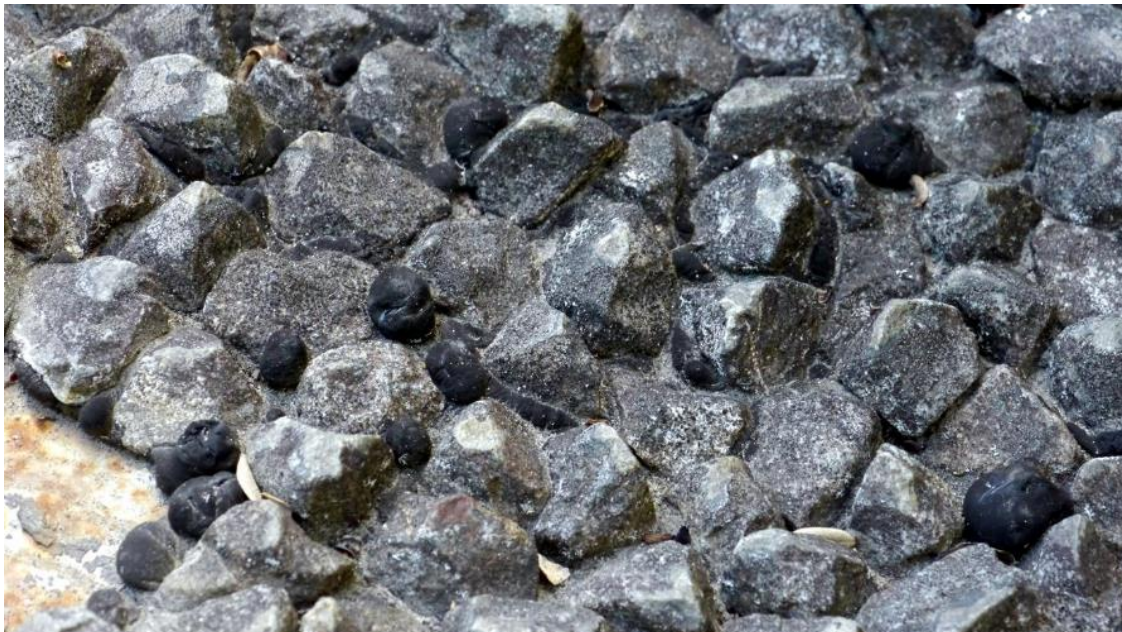
Figure 2.23 Bitumen blisters formed on an artificial seal constructed on a steel plate. The base plate is visible on the bottom left where earlier a sample had been removed

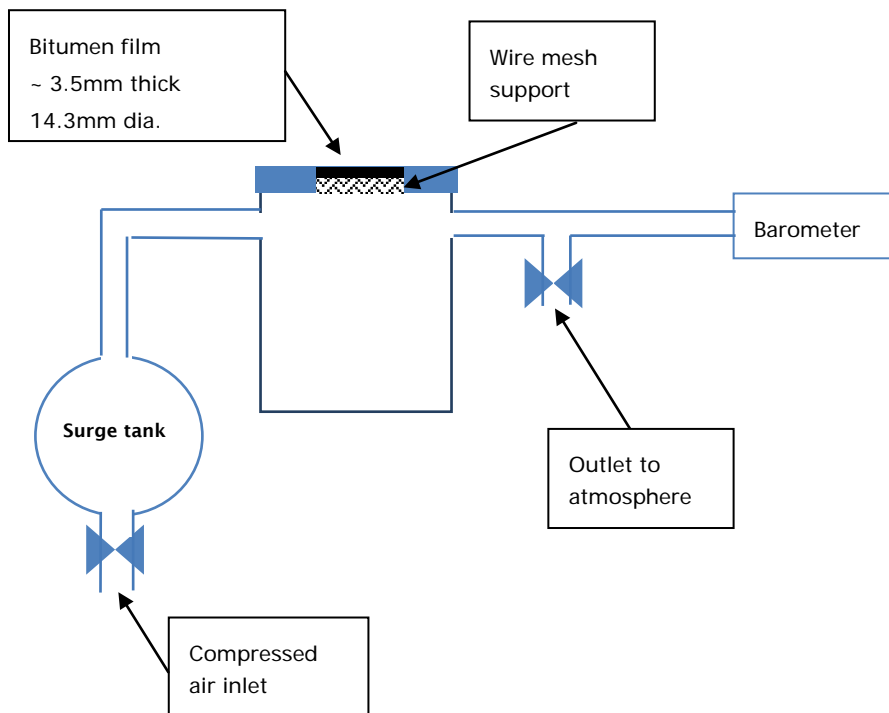
Figure 2.24 Apparatus for estimating rupture pressure for a 40/50 bitumen

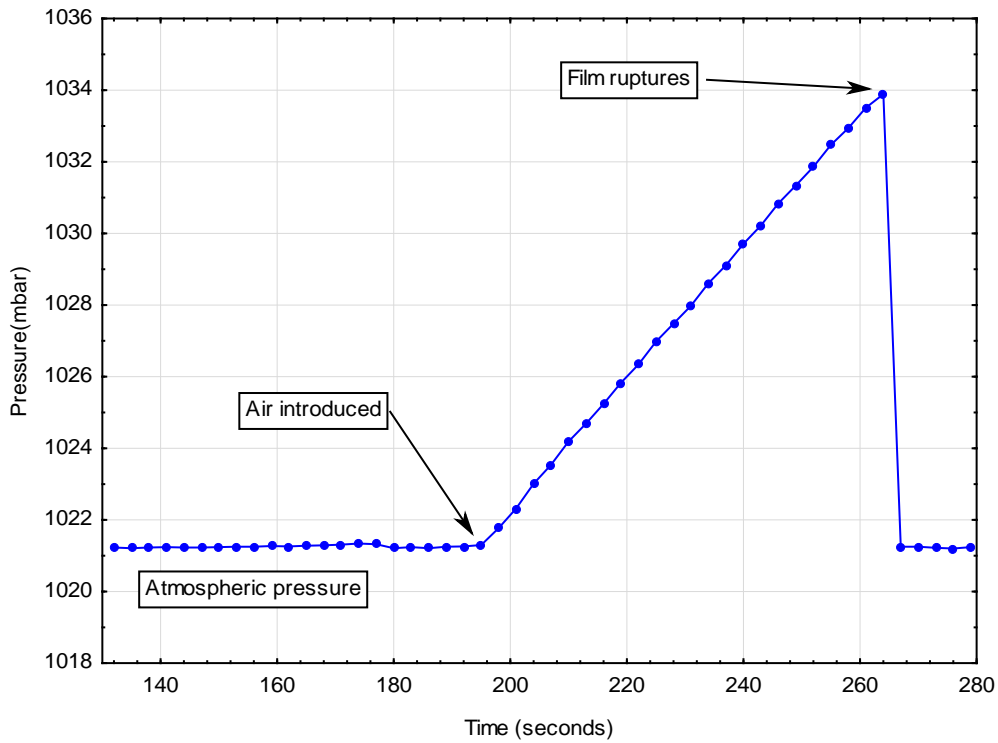
Figure 2.25 Rupture of a 3.5mm film of 40/50 bitumen pressurised at 0.19mbar s⁻¹

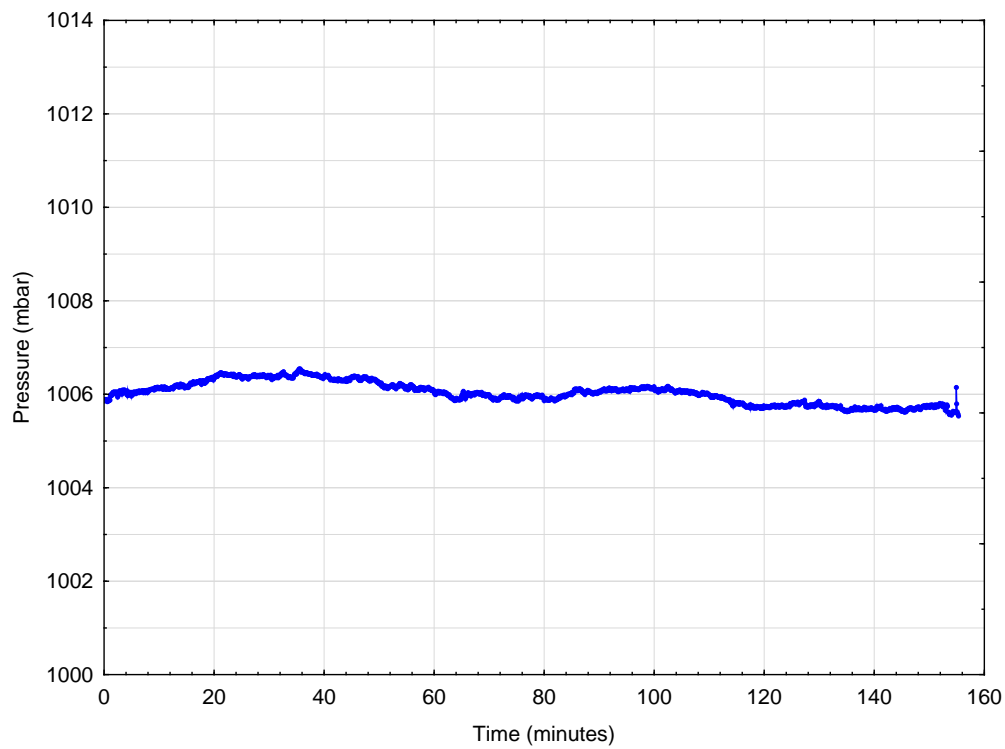
Figure 2.27 Pressure changes on heating the basecourse column with the base unsealed

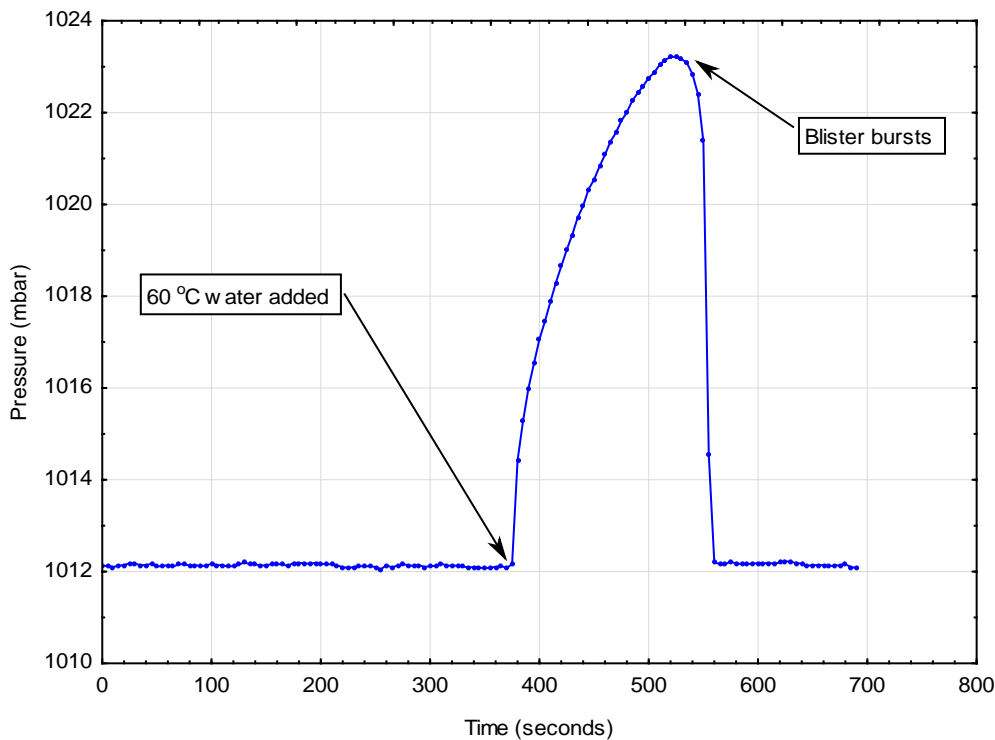
Figure 2.28 Pressure changes on rapid heating of the basecourse column with the base airtight

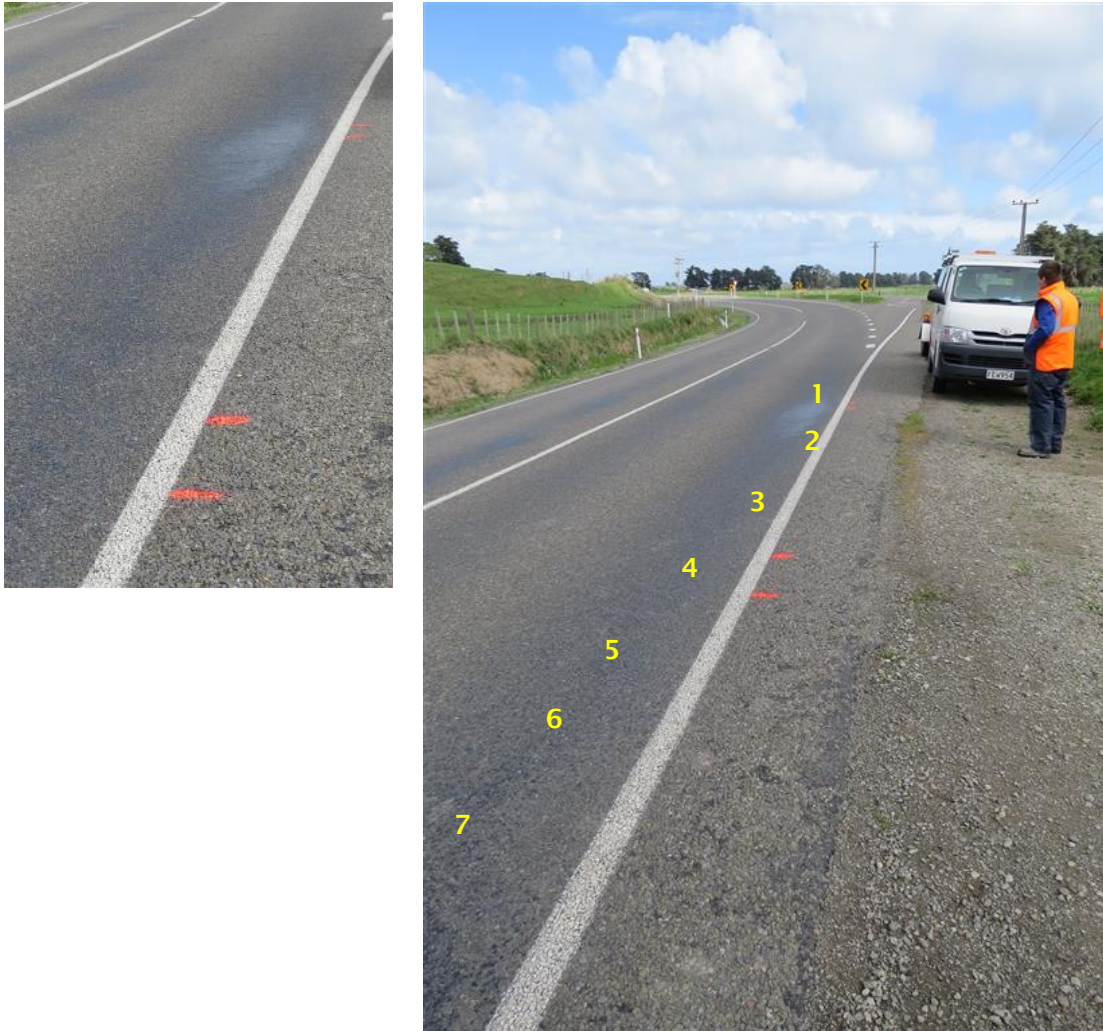
Figure 2.29 Site 1 showing flushed patch and core positions

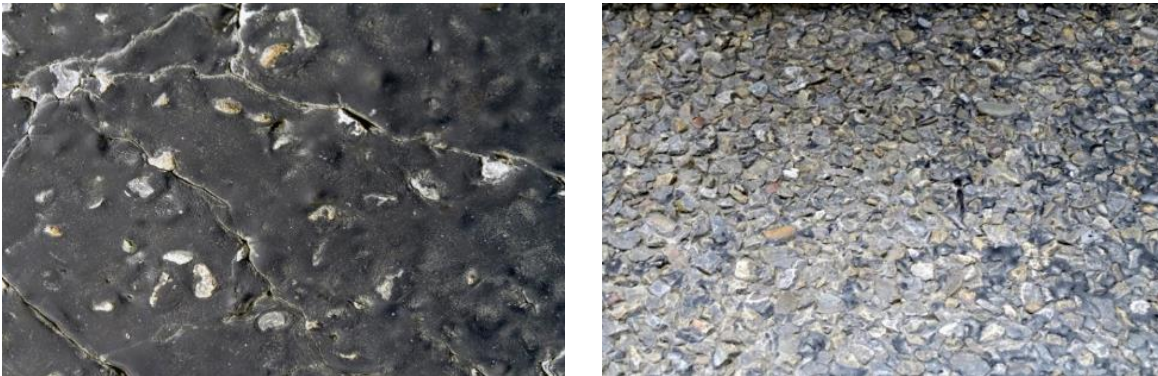
Figure 2.30 Site 1, comparison of flushed patch (showing vent holes and cracks) and well- textured surface (with some spot flushing evident) at about the position of core 4

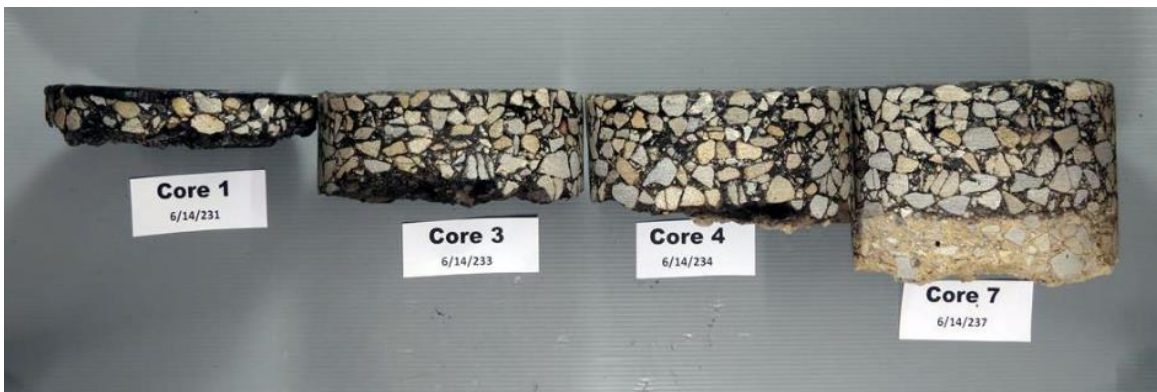
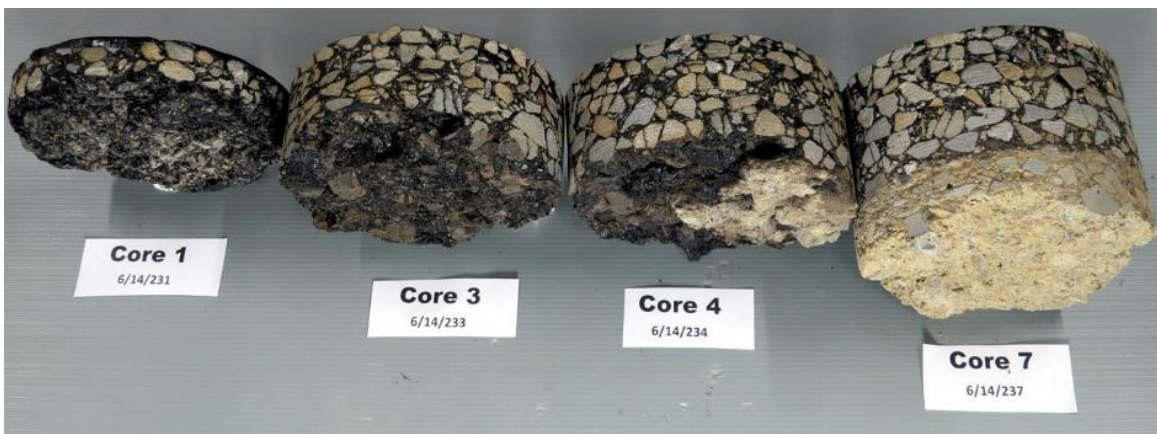
Figure 2.31 Site 1 cores showing a progression of seal loss through stripping. Core 1 (flushed) to core 7 (well textured)

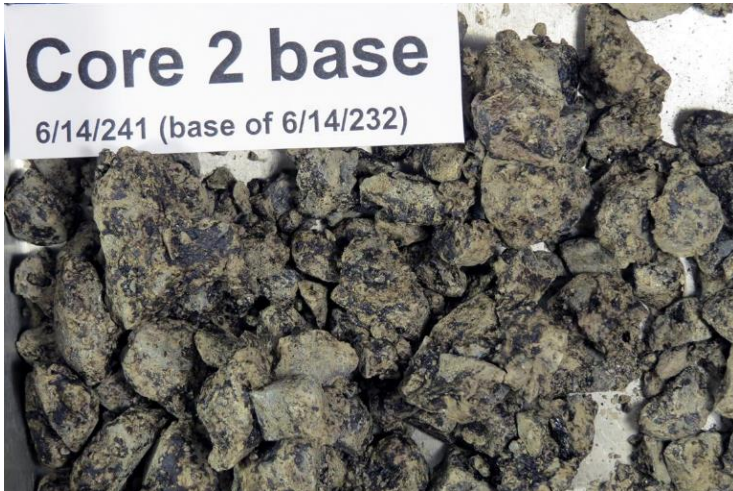
Figure 2.32 Site1, stripped, loose aggregate recovered from the base of core hole 2

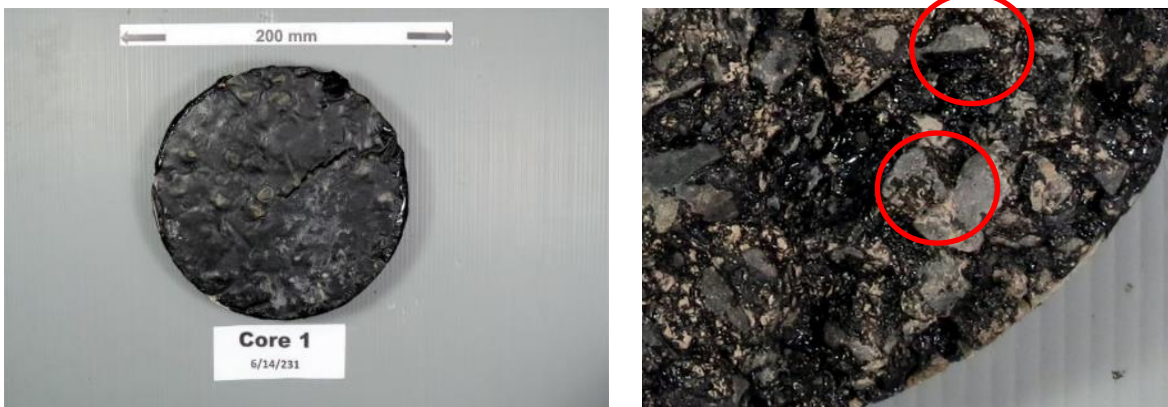
Figure 2.33 Site 1, top and bottom of core 1 showing stripped aggregate

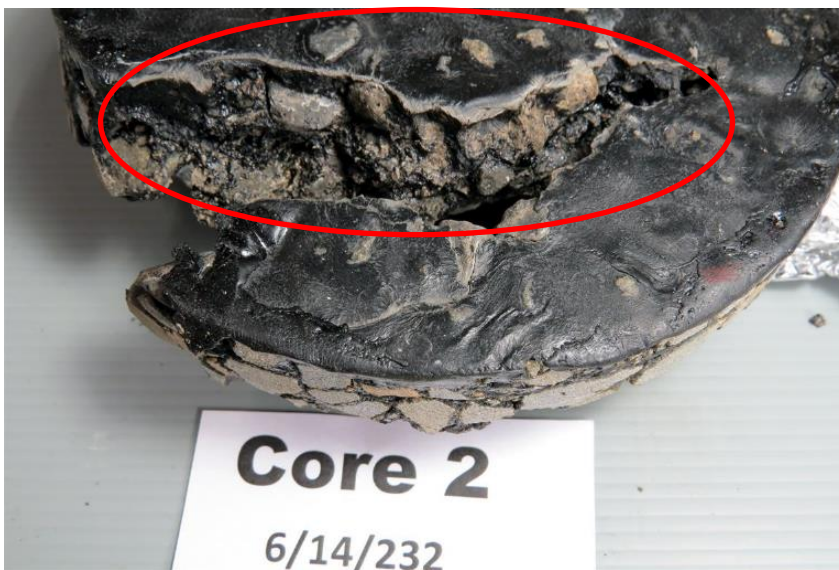
Figure 2.34 Site 1, crack in core 2 opened to reveal stripped clean aggregate on the sides of the crack

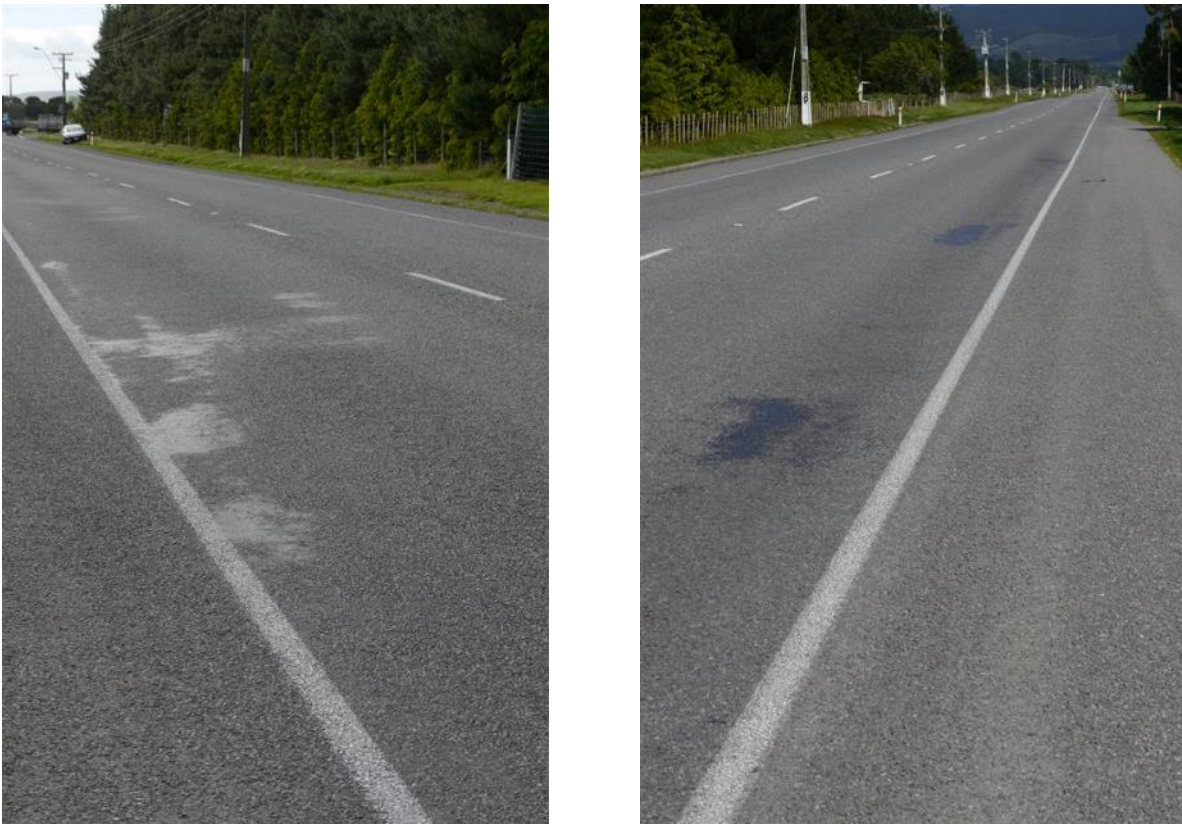
Figure 2.35 Site 2, flushed patches

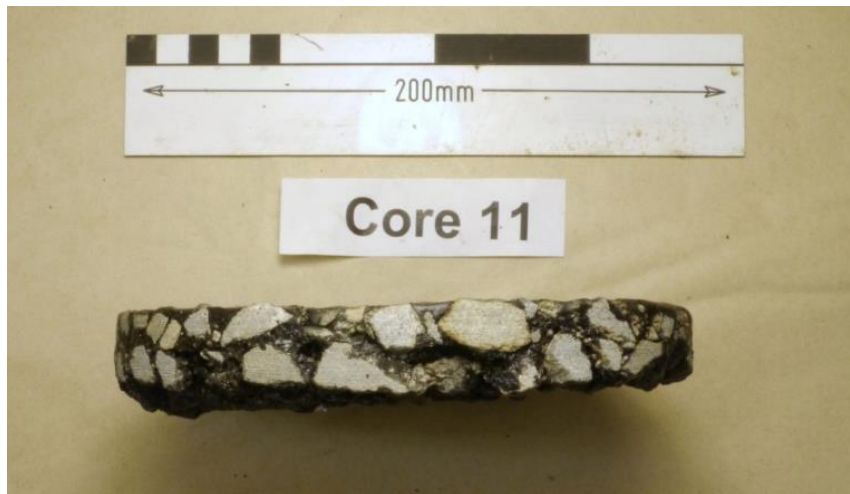
Figure 2.38 Site 2, intact top section of core 11 from a flushed patch

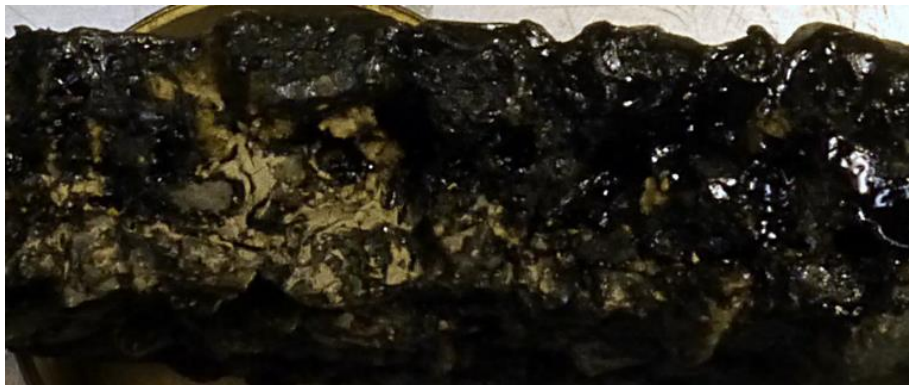
Figure 2.39 Site 2, close up of core 11 cross section from a flushed patch, manually broken to reveal the internal structure and evidence (deposited basecourse fines) for water migration through the layer

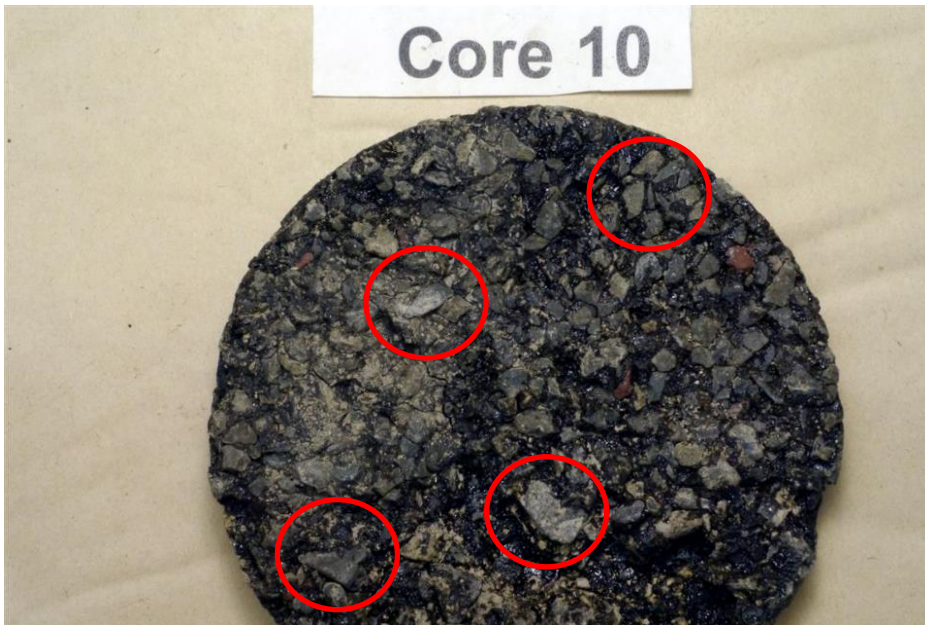
Figure 2.40 Site 2, base of specimen from flushed patch (about 20mm below top surface) showing stripped aggregate

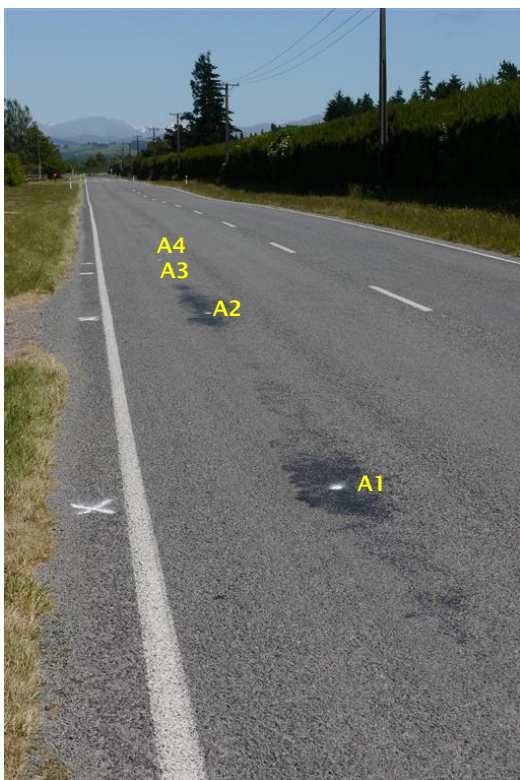
Figure 2.41 Site 3 flushed patches

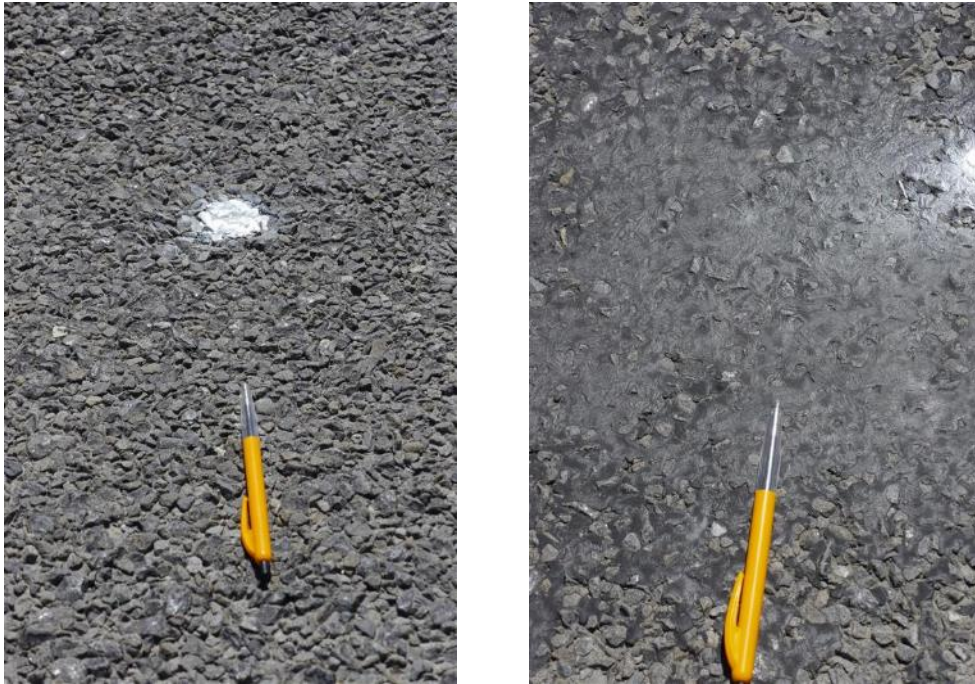
Figure 2.42 Site 3, texture adjacent to flushed patches (left) and flushed patch texture (right)

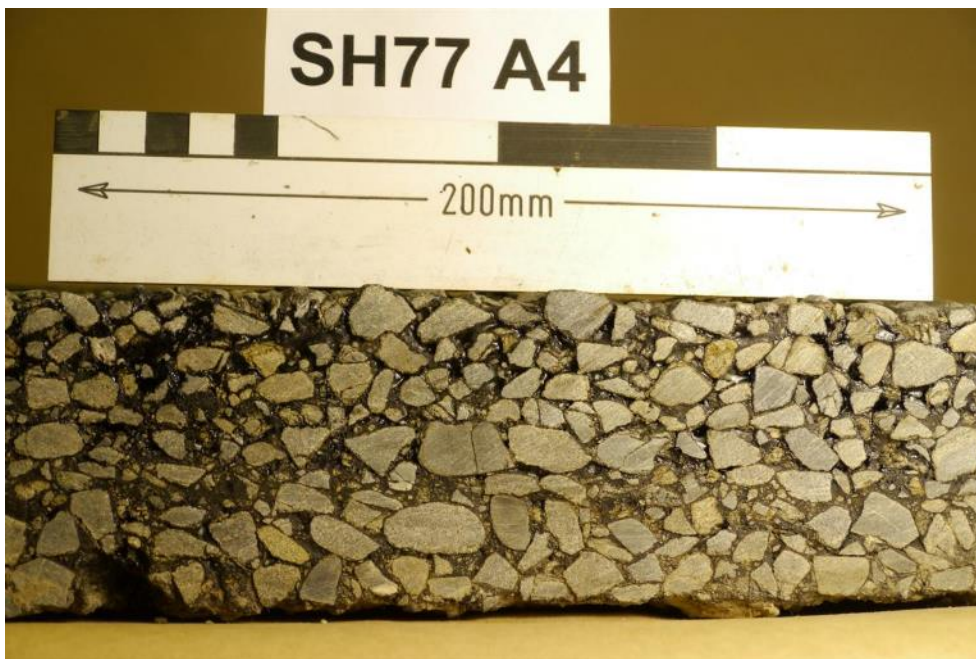
Figure 2.43 Site 3, profile of specimen from a textured area

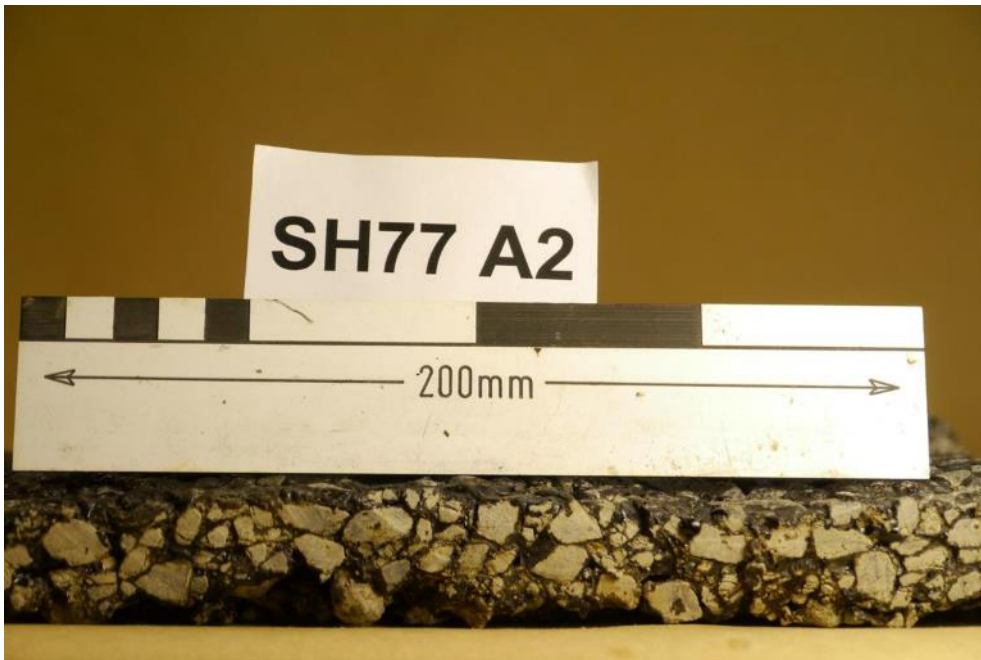
Figure 2.44 Site 3, profile of specimen from a flushed area

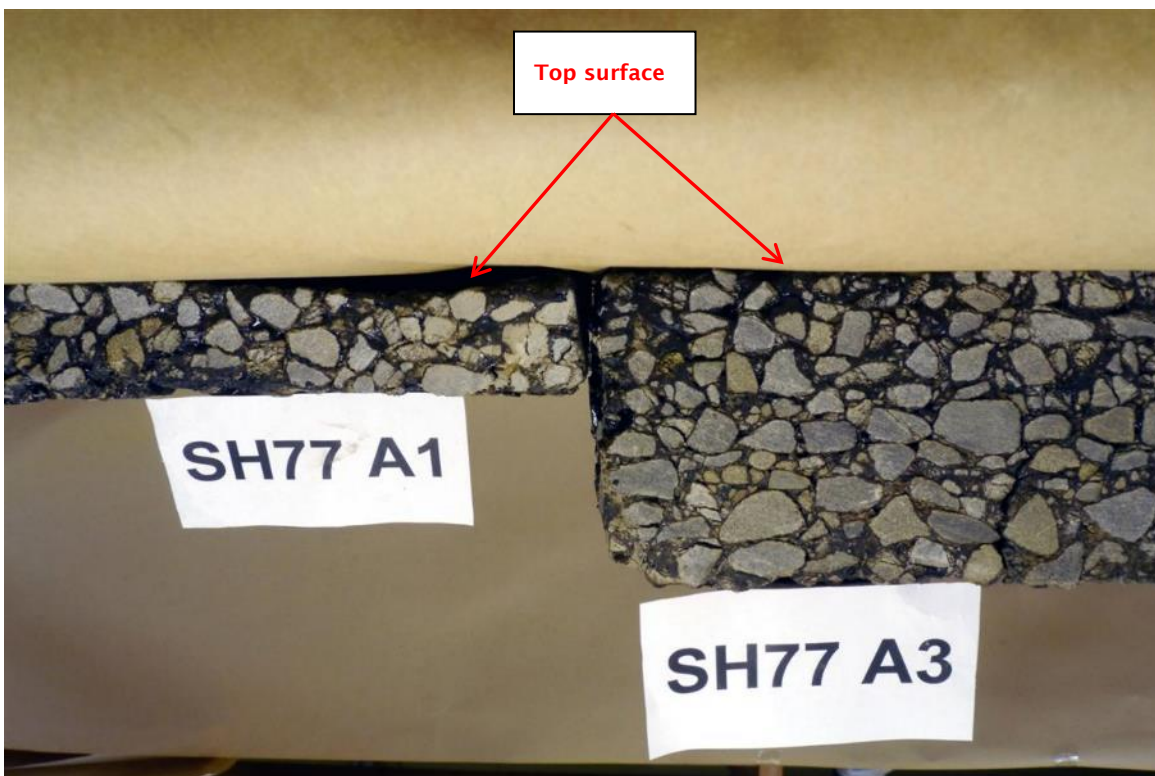
Figure 2.45 Site 3, comparison of intact specimen thickness (illustrating extent of loss due to stripping)
