Flushing in chipseals

PR Herrington
Opus Research, Opus International Consultants Ltd

NZ Transport Agency research report 576
Contracted research organisation – Opus International Consultants Ltd

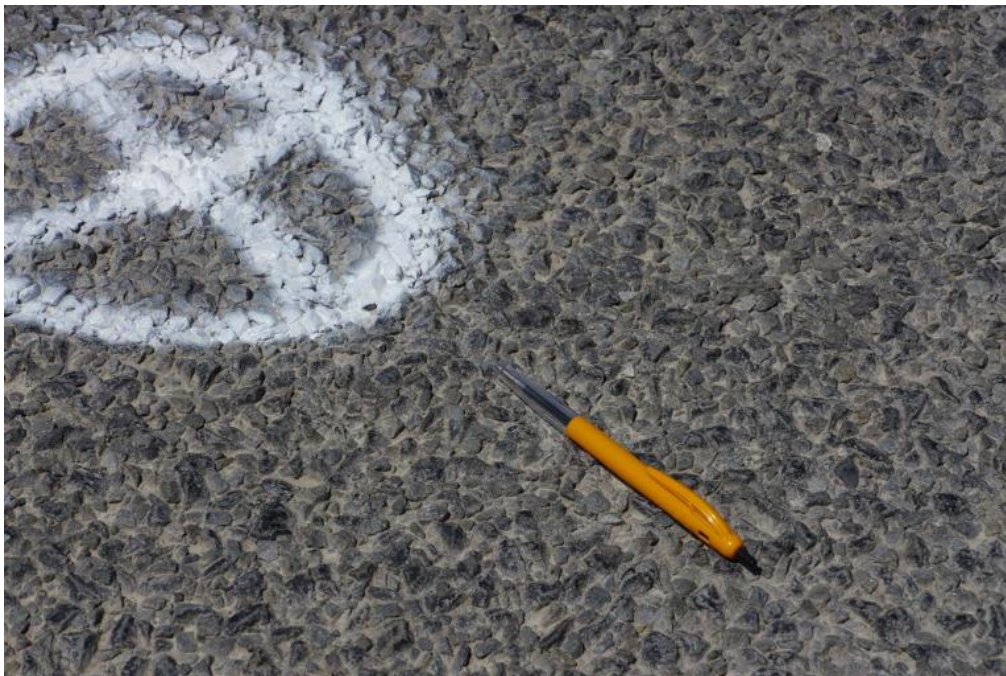
Figure 2.47 Site 4, texture adjacent to flushed patch

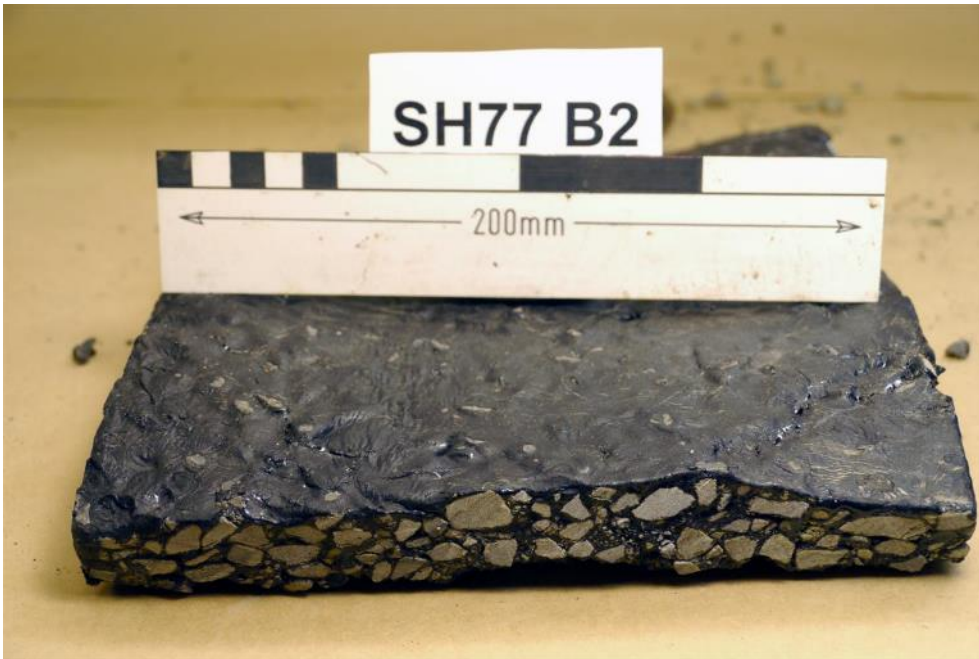
Figure 2.48 Site 4, specimen from flushed patch

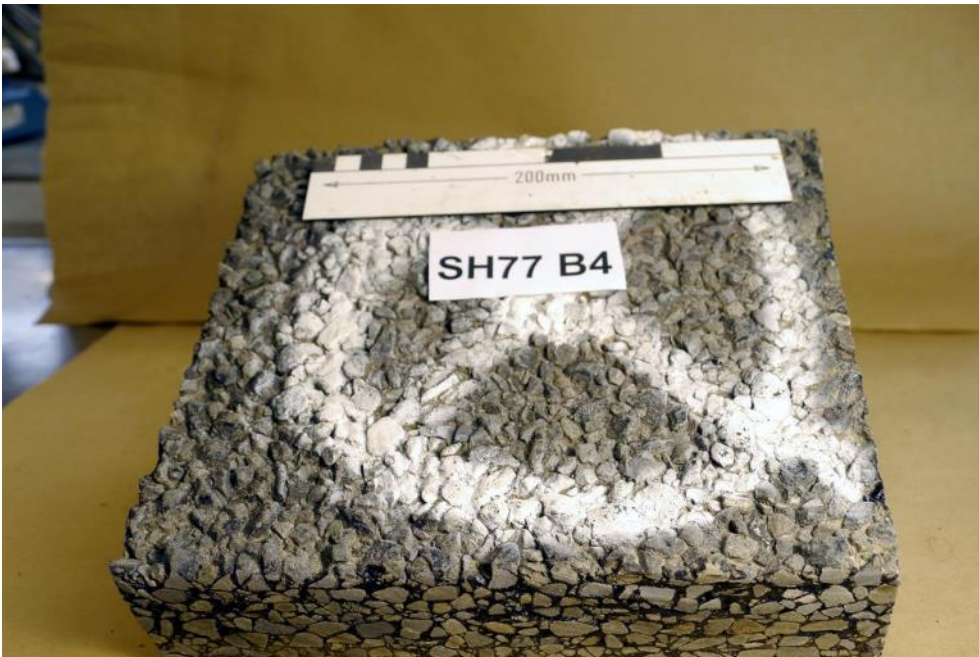
Figure 2.49 Site 4, specimen taken adjacent to the flushed patch

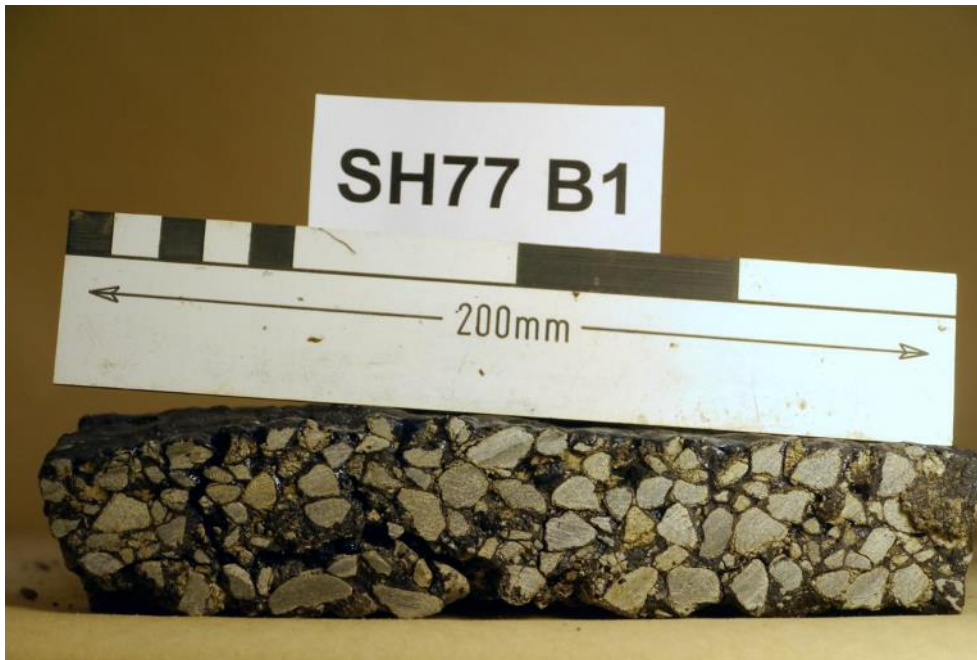
Figure 2.50 Site 4, specimen from flushed patch

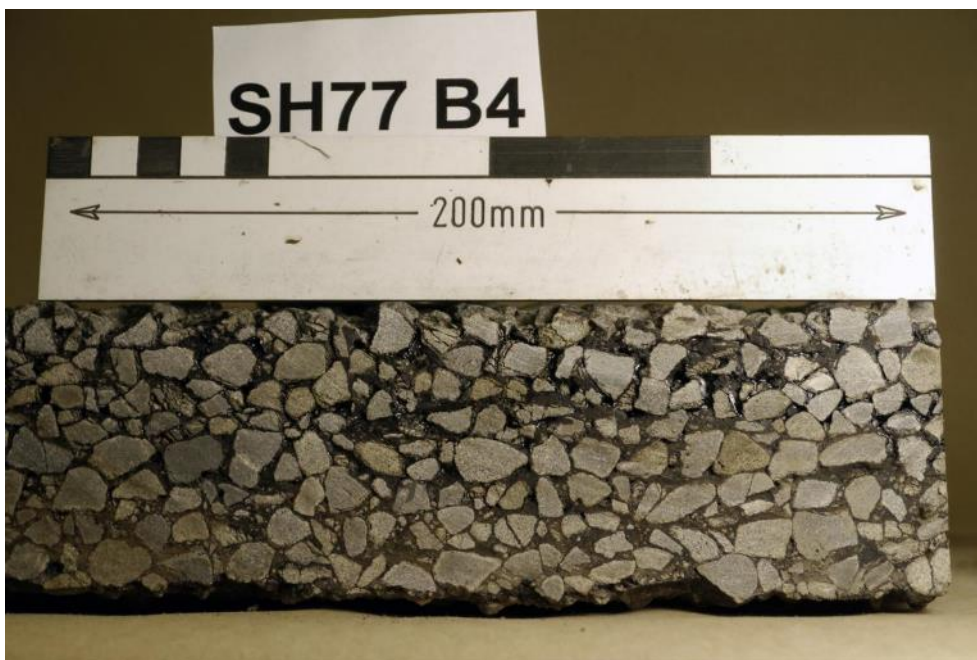
Figure 2.51 Site 4, specimen taken adjacent to the flushed patch

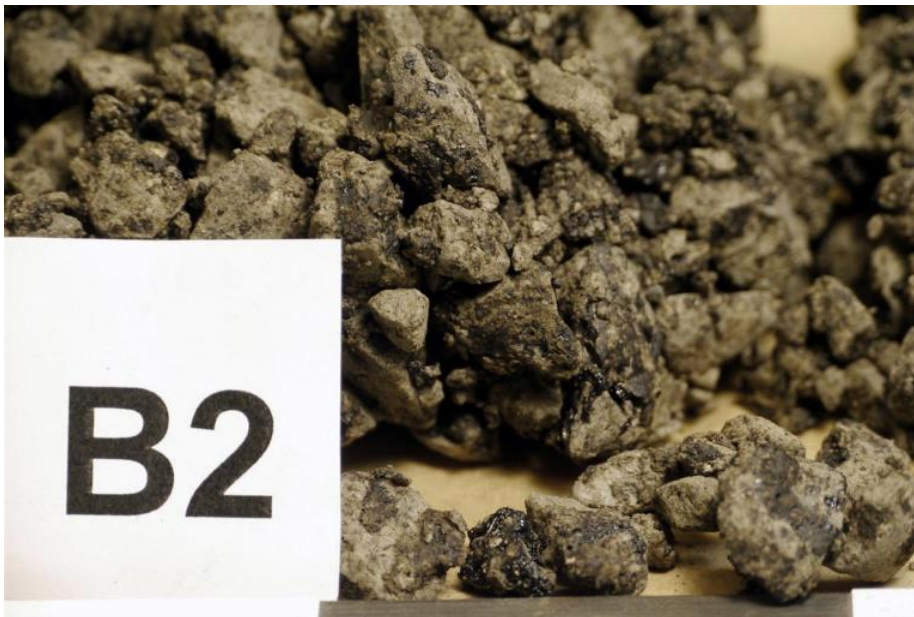
Figure 2.52 Site 4, material from the bottom of flushed patch specimen showing stripped aggregate

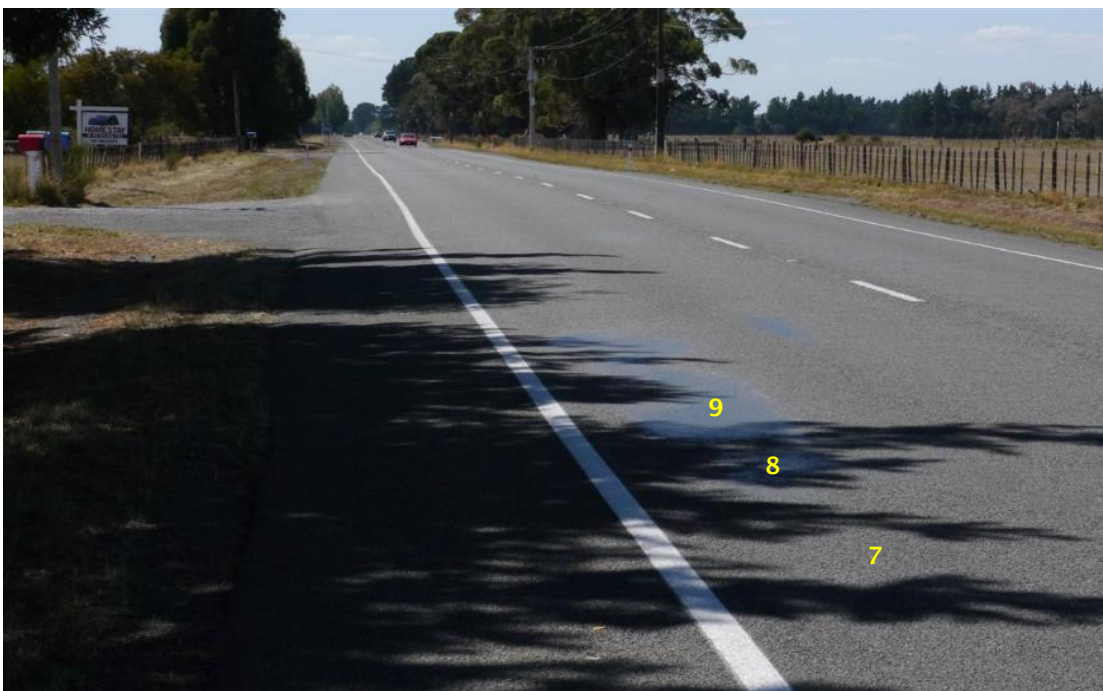
Figure 2.53 Site 5, flushed patch and core locations

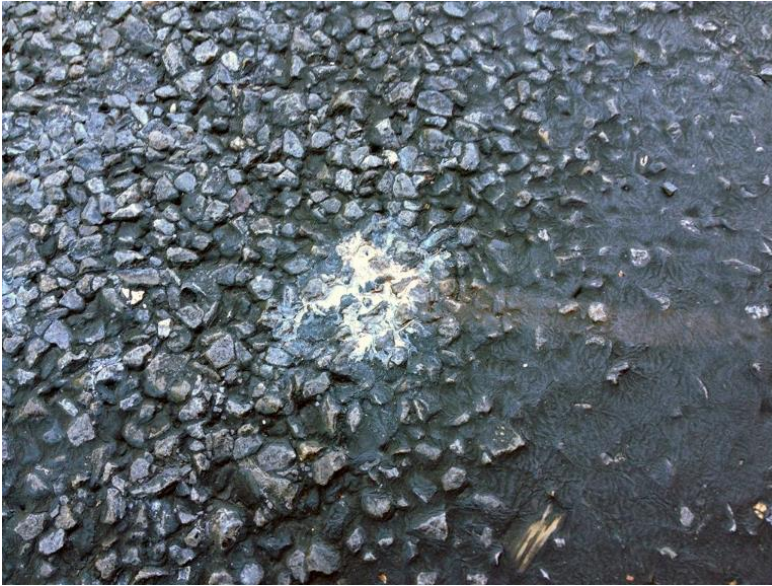
Figure 2.54 Site 5, flushed patch texture showing basecourse fines 'pumped' through the seal (evidence of water migration through the entire seal layer)

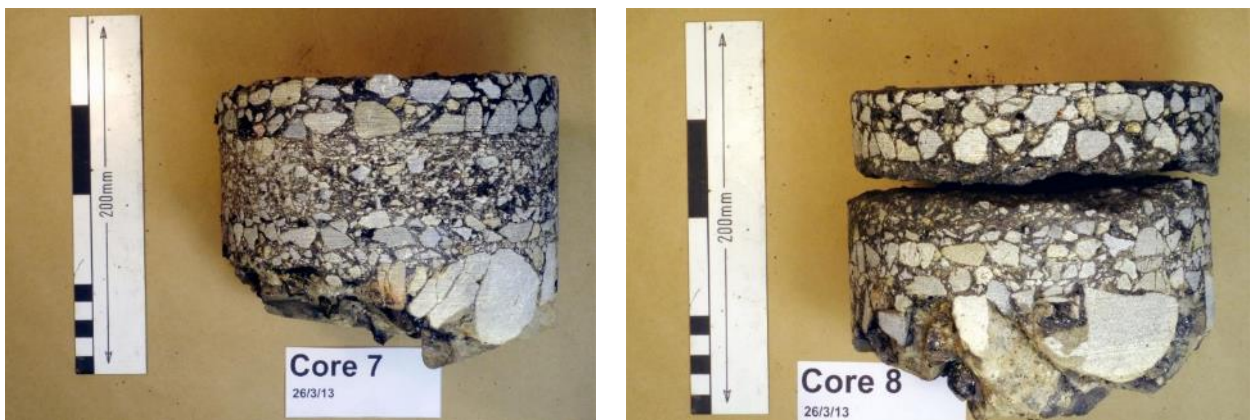
Figure 2.55 Site 5, specimens from textured area and partially flushed seal showing the full depth of the seal layer down to the (bitumen bound) basecourse. An asphalt layer is present two seal coats down from the surface. Stripping in this layer core 8 resulted in failure when extracting the core

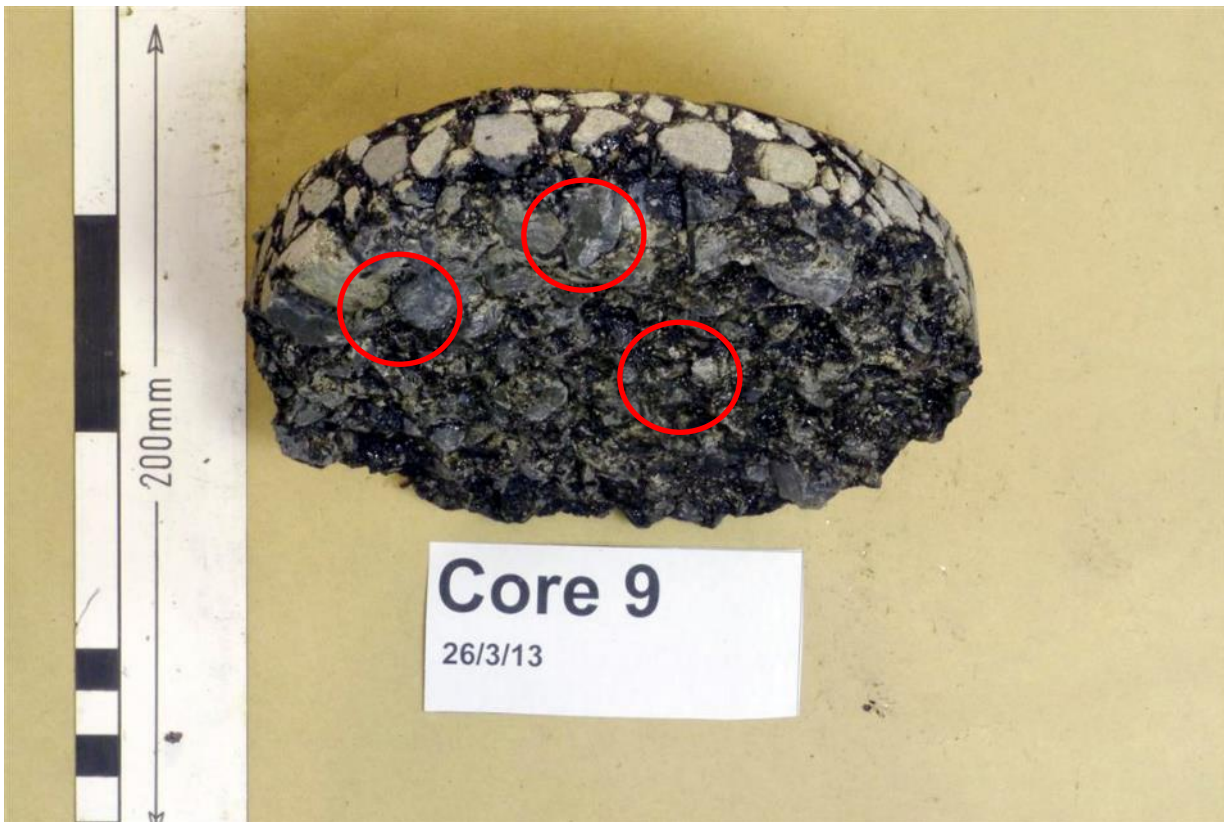
Figure 2.57 Site 5, base of specimen from flushed patch texture showing stripped seal

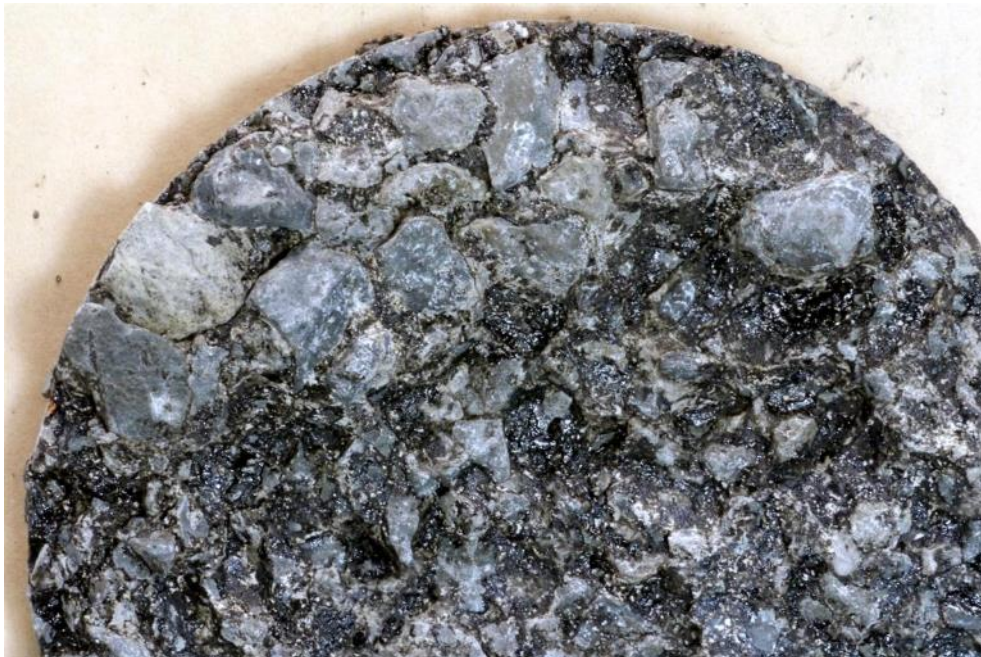
Figure 2.58 Site 5, base of specimen (core 9) from flushed patch showing stripped seal

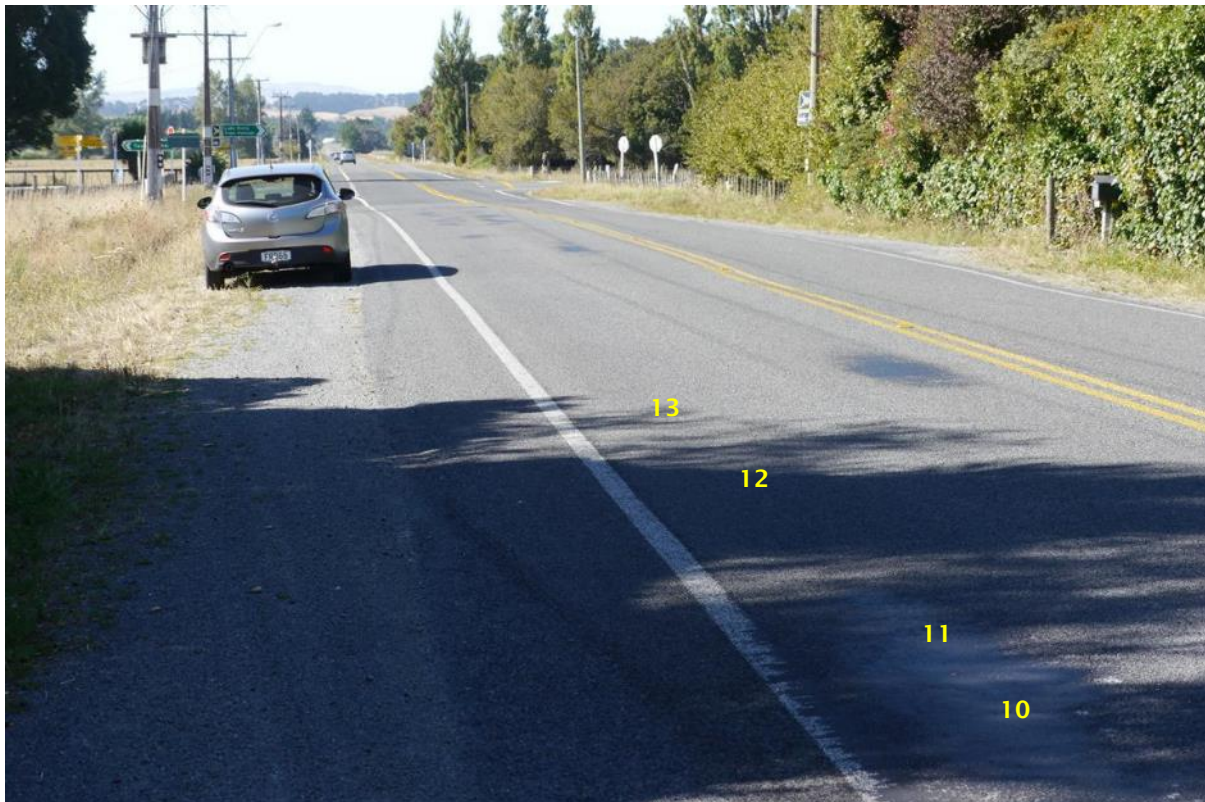
Figure 2.59 Site 6, flushed patch (in shade at bottom right)

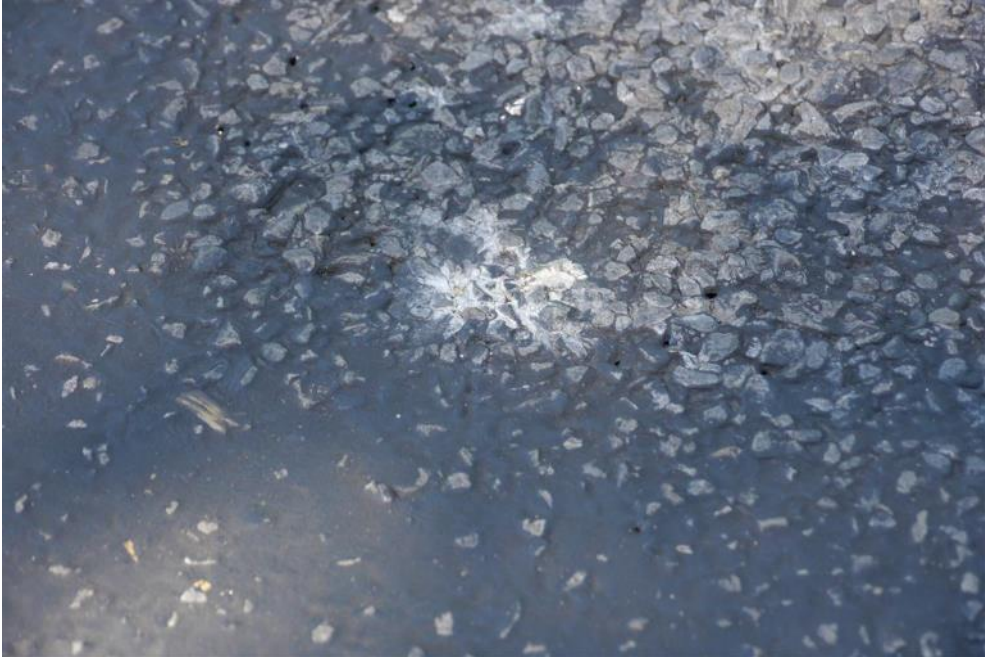
Figure 2.60 Site 6, vent holes and basecourse fines in flushed patch

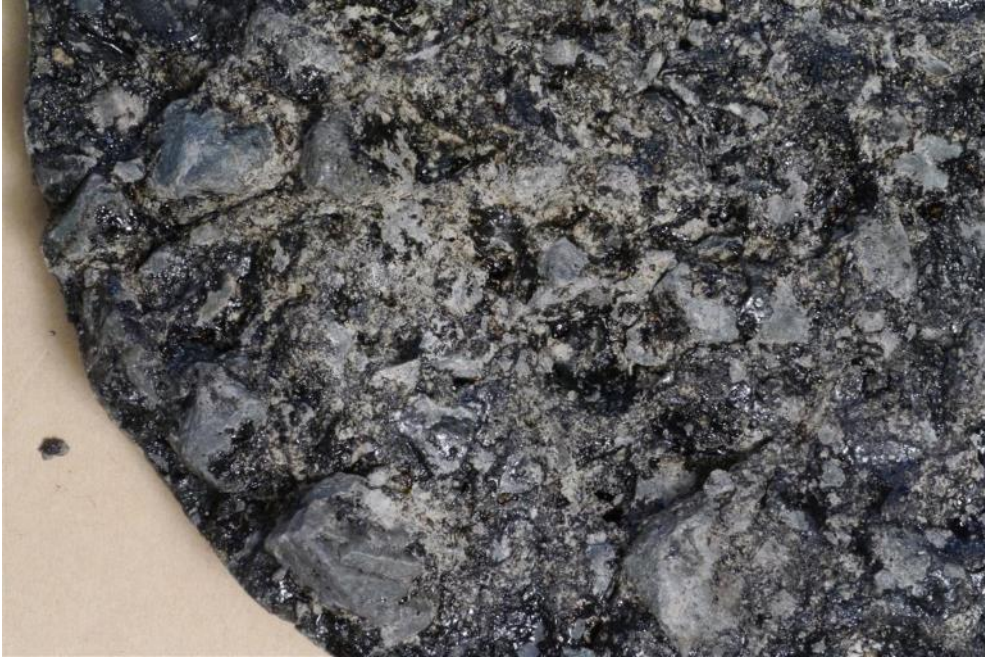
Figure 2.61 Site 6, base of core 10 (flushed patch) showing stripping

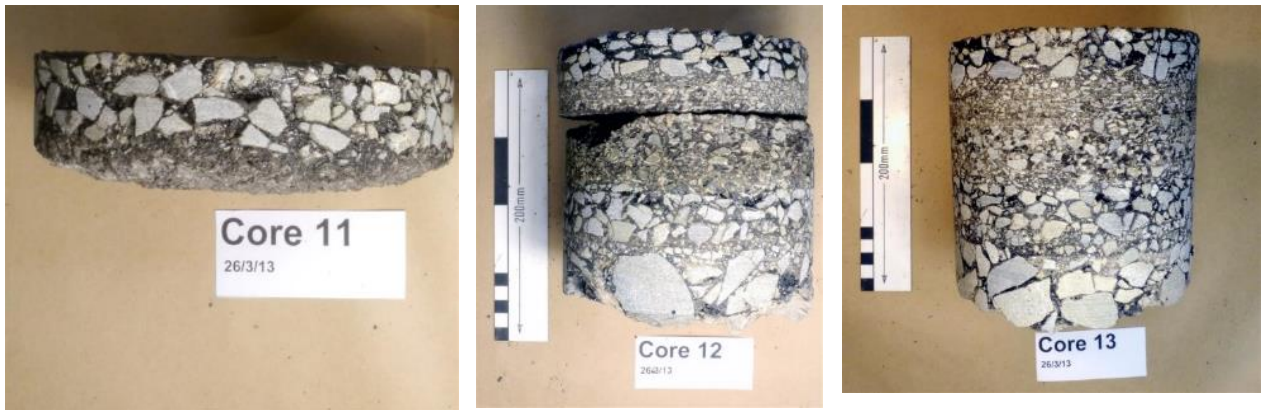
Figure 2.62 Site 6, cores 11, 12 and 13 showing the progression of stripping damage from the heavily flushed patch (core 11) to good seal texture (core 13)

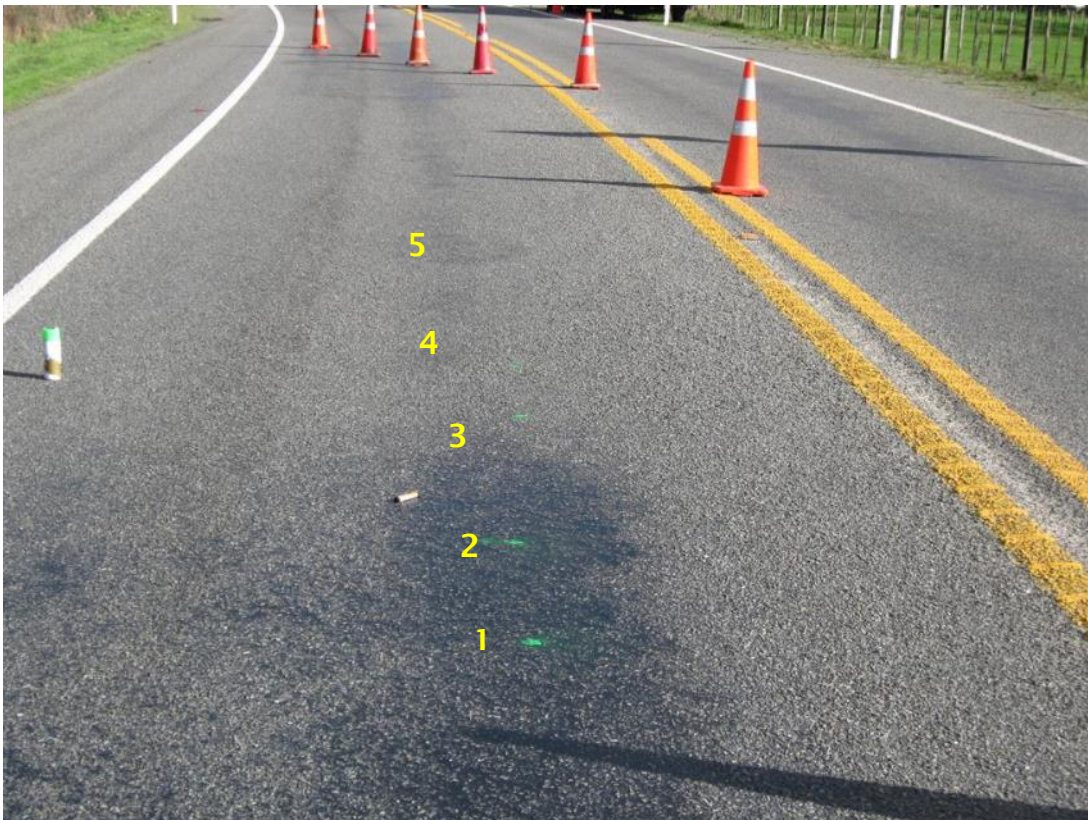
Figure 2.63 Site 7, showing the core positions

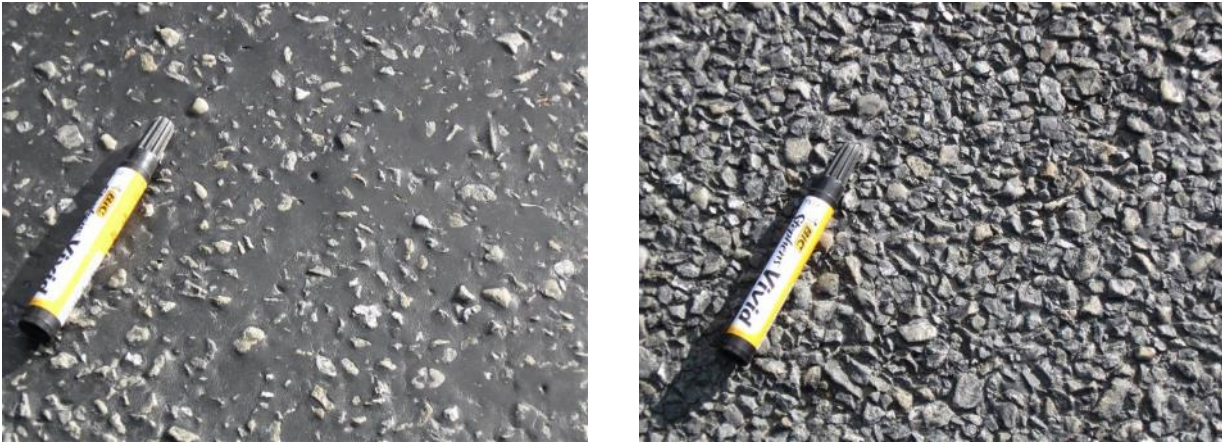
Figure 2.64 Site 7, flushed patch texture showing venting holes and adjacent well- textured seal

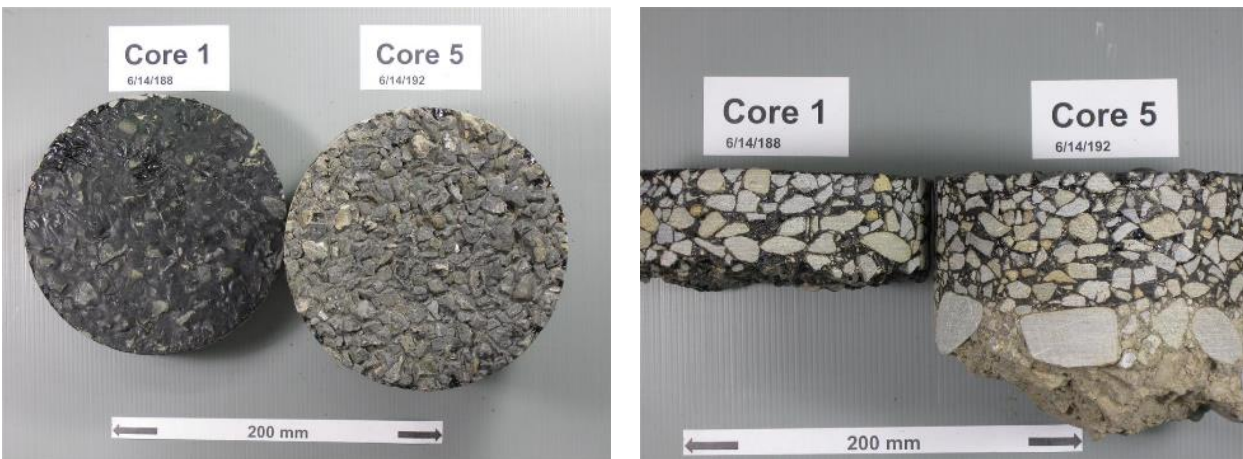
Figure 2.65 Site 7, cores 1 and 5 showing the loss of about 15mm of seal from core 1 (present as loose aggregate in the hole)

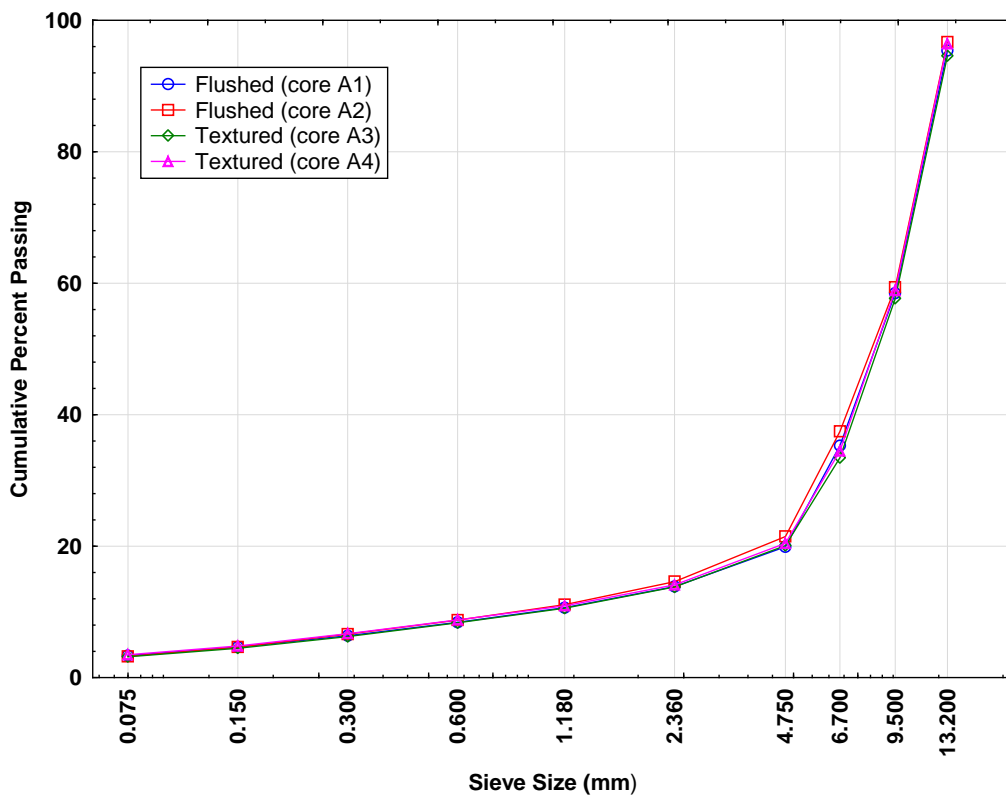
Figure 2.66 Site 3, SH77 comparison of aggregate gradings for flushed and textured samples

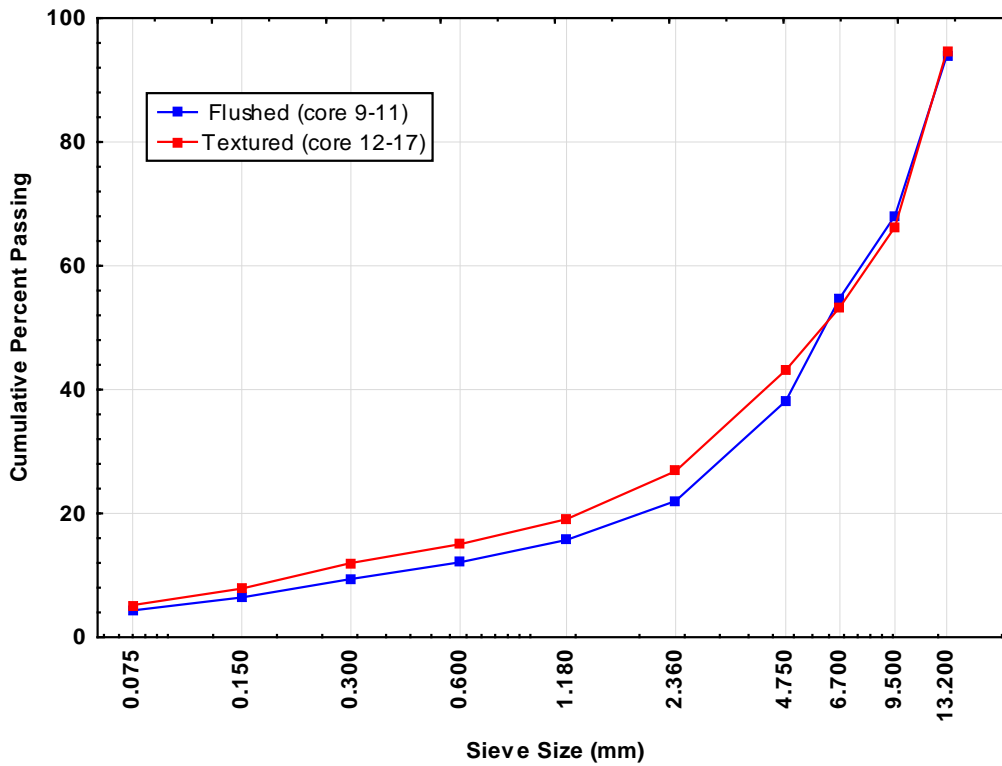
Figure 2.67 Site 2, SH2 comparison of aggregate gradings for flushed and textured samples

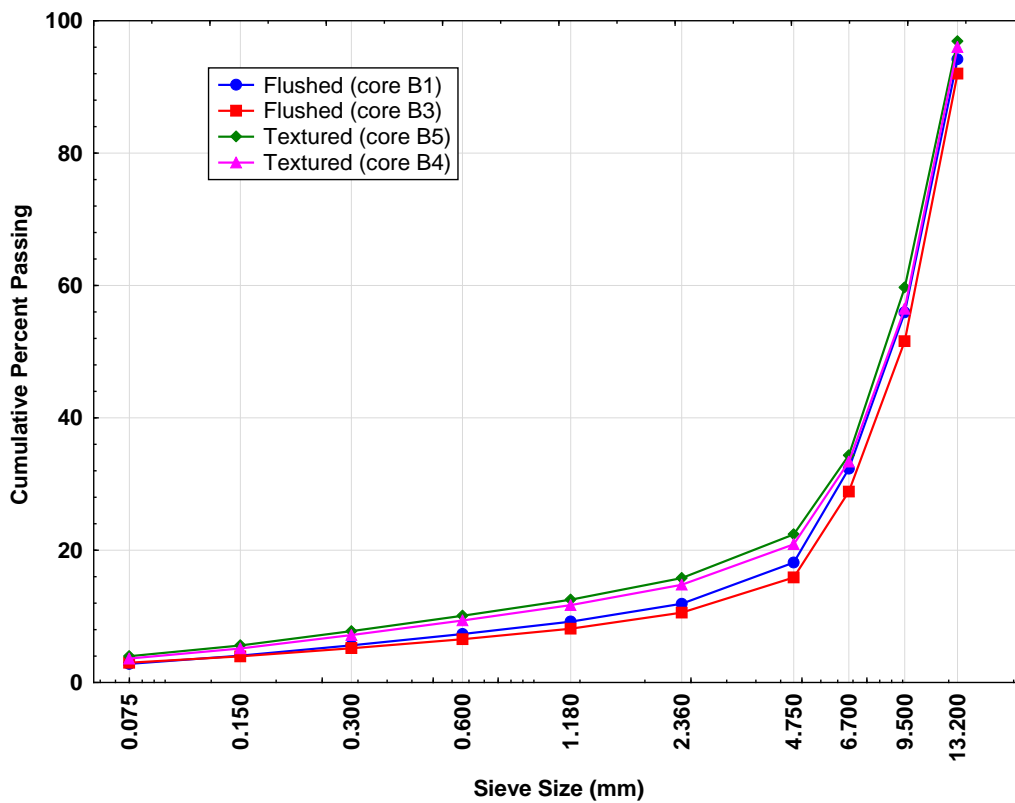
Figure 2.68 Site 4, SH77 comparison of aggregate gradings for flushed and textured samples

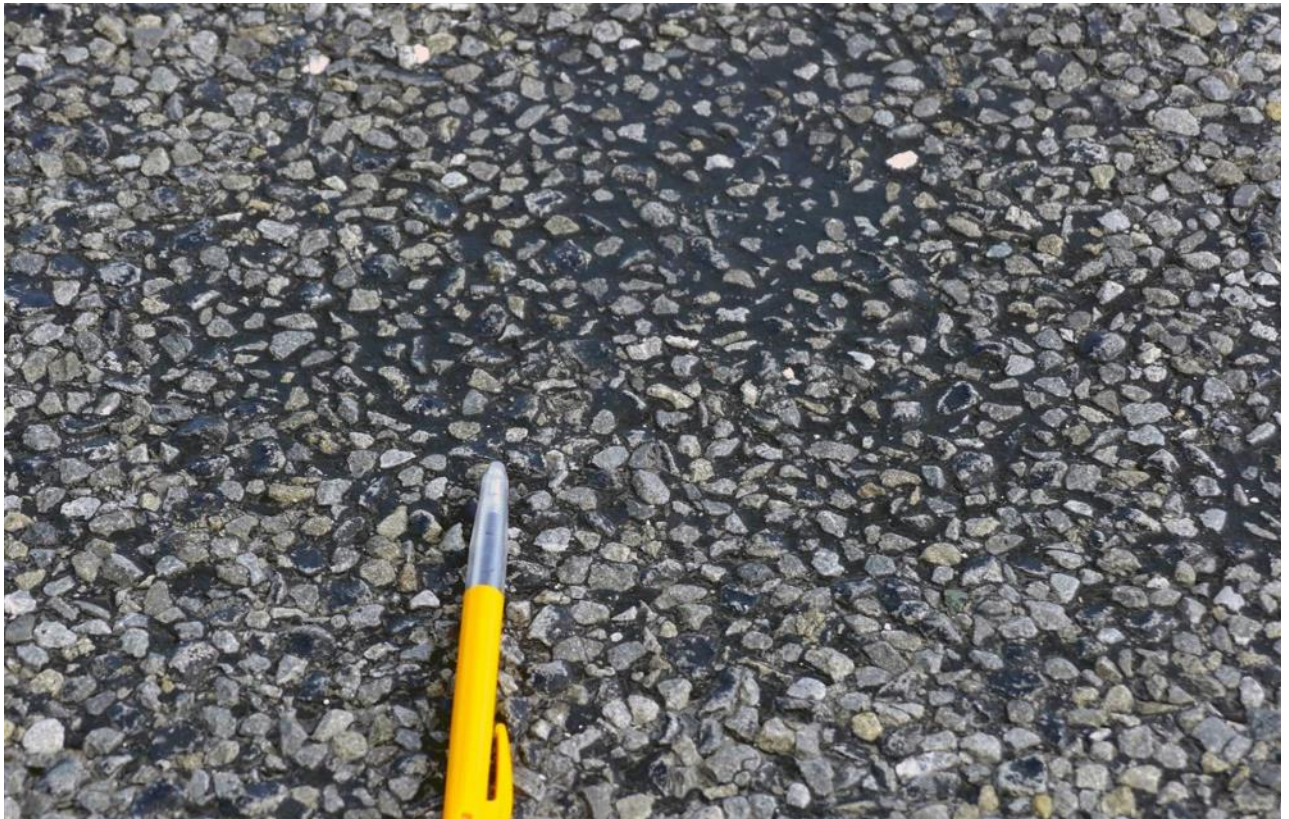
Figure 2.69 Flushing in the wheel path of a one- year- old first- coat seal (SH73 Annavale)

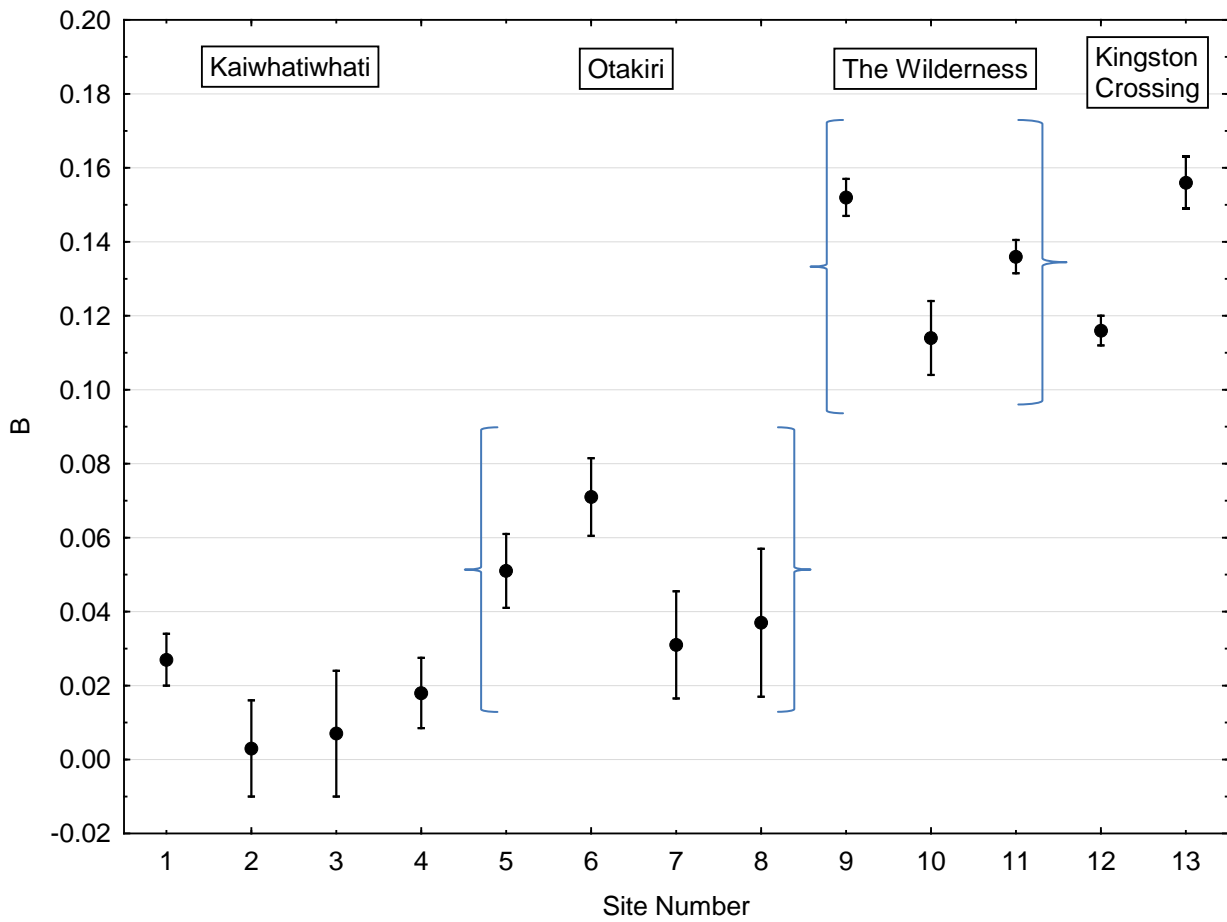
Figure 2.71 Rate of texture loss for trial sites

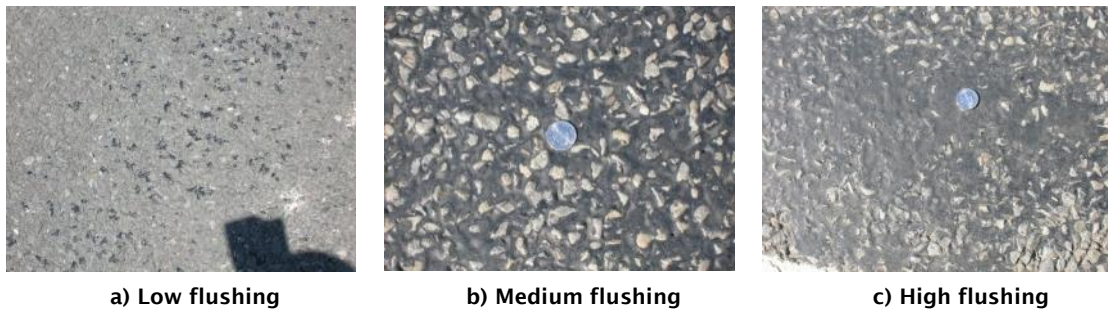
Figure 3.1 Illustration of flushing ratings used in the LTPP database

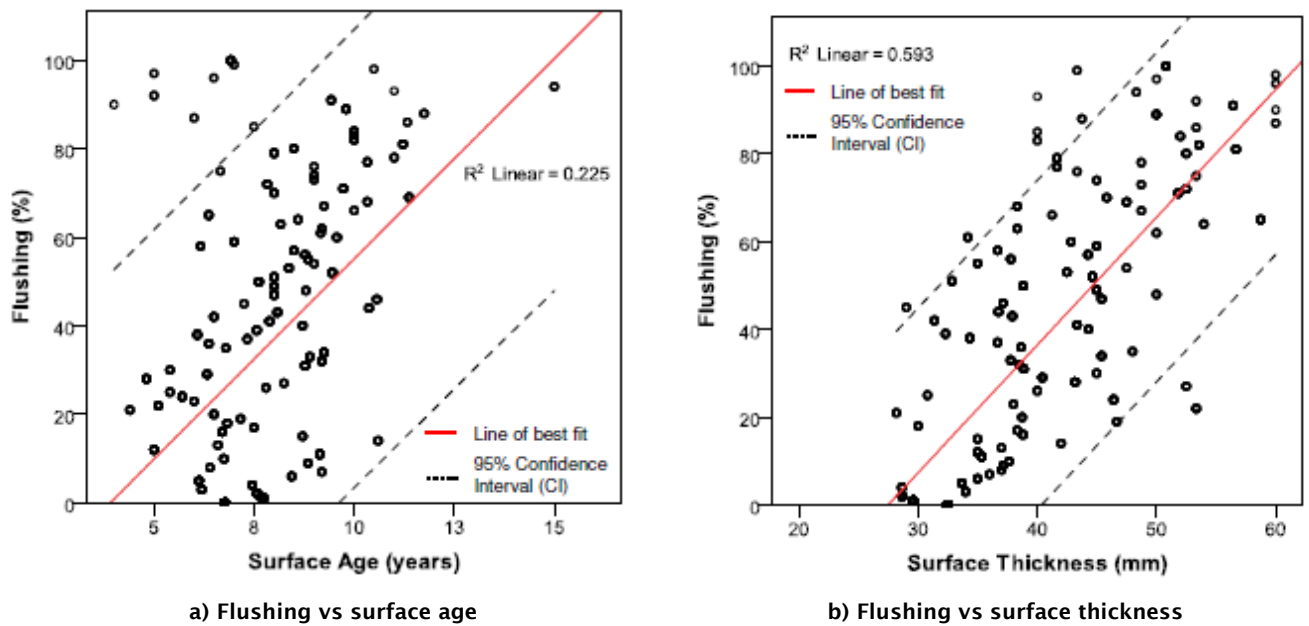
Figure 3.2 Correlation between flushing and pavement surface characteristics

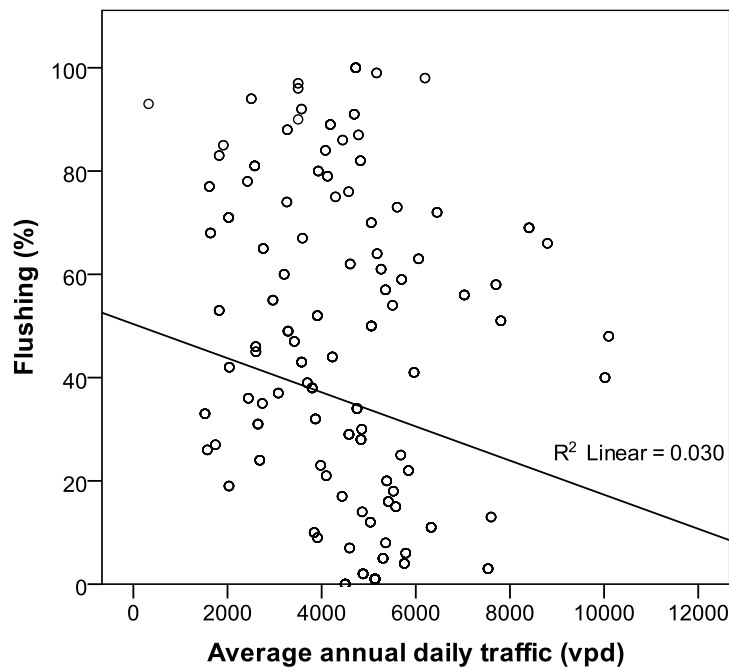
Figure 3.5 Relationship between flushing and traffic volume

The lack of a strong correlation between flushing and traffic volume was attributed to the design of the LTPP sites. The traffic volumes measured on the LTPP sites were between 42vpd and 24,360vpd, and these traffic volumes would have covered the range of traffic volumes expected on these LTPP sites. The LTPP pavements would have been constructed to satisfactorily withstand their expected traffic volumes and as a result flushing development due to heavy loading would have been minimised. If the LTPP pavements were exposed to significantly higher traffic volumes than those observed in the data set, traffic volume could become a significant variable causing flushing. In order to incorporate the effects of chipseal design characteristics, surface aggregate size should be incorporated into regression analyses.

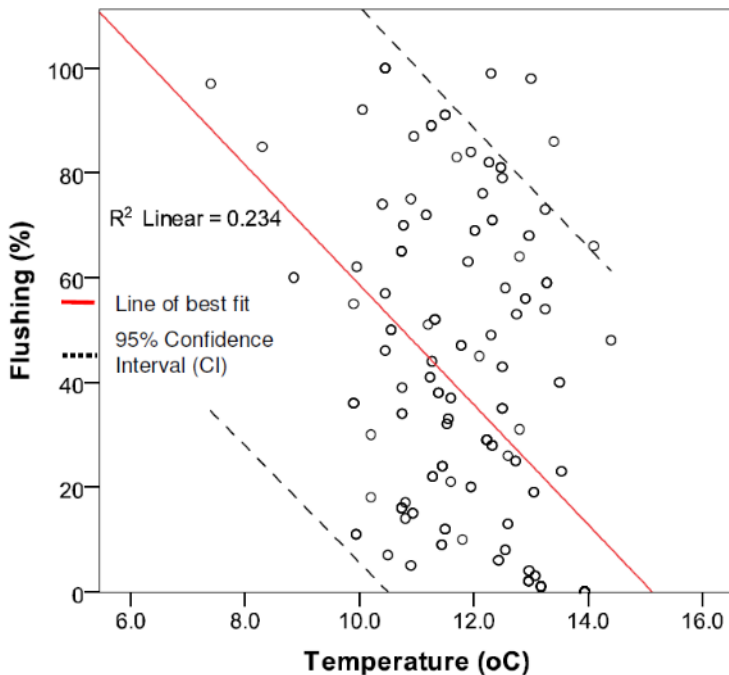
Figure 3.6 Correlation between flushing and mean air temperature

The negative correlation between flushing and temperature was contradictory to what was expected. A positive correlation was expected between flushing and temperature as binder behaviour with respect to temperature indicated that softer binder was associated with high temperatures, which can lead to more flushing. Furthermore, the lack of a stronger correlation between flushing and temperature was surprising, as available literature (Lawson and Senadheera 2009) indicated temperature was likely to have a significant effect on the occurrence of flushing. It was determined that the effects of temperature were being altered to an extent by factors such as the amount of bituminous binder in the seal layers which determines the extent to which binder migration can occur, or the presence of harder binder which can minimise temperature-related flushing. These factors would have been a part of the seal design process which would have assigned binder quantities and grades according to the expected temperatures of a site. As a result of this seal design process, temperature-related flushing would have been minimised. Moreover, it was concluded that the temperature data available in the LTPP database, which presented the average air temperature of the pavement sites, was inadequate at accurately representing the correlation between flushing and temperature, and the temperature of the pavement surface would better represent the effects of temperature on flushing. However, pavement surface temperature data was not available in the LTPP database and so the effects of pavement surface temperature could not be explored in this data analysis. Additionally, the relationship between flushing and humidity was found to have a weak R^2 value of 0.07. The effects of humidity on chipseal pavements would have also been taken into account in the design process of the seals. For the above reasons, temperature and humidity were not included in the regression model.

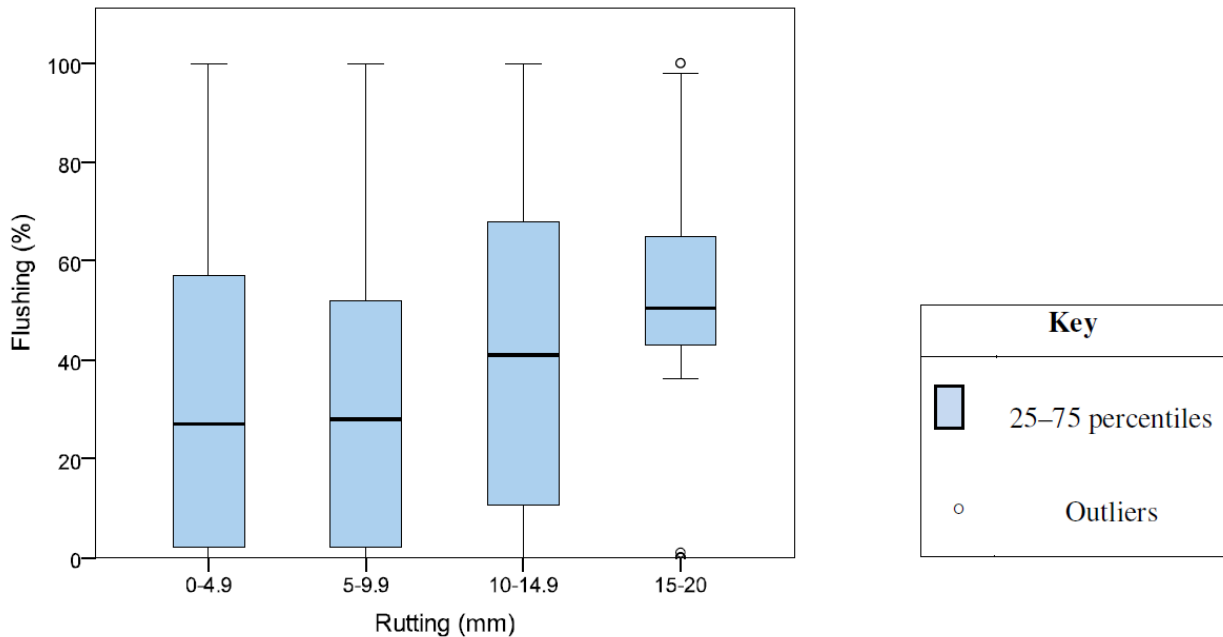
Figure 3.7 Relationship between flushing and rutting

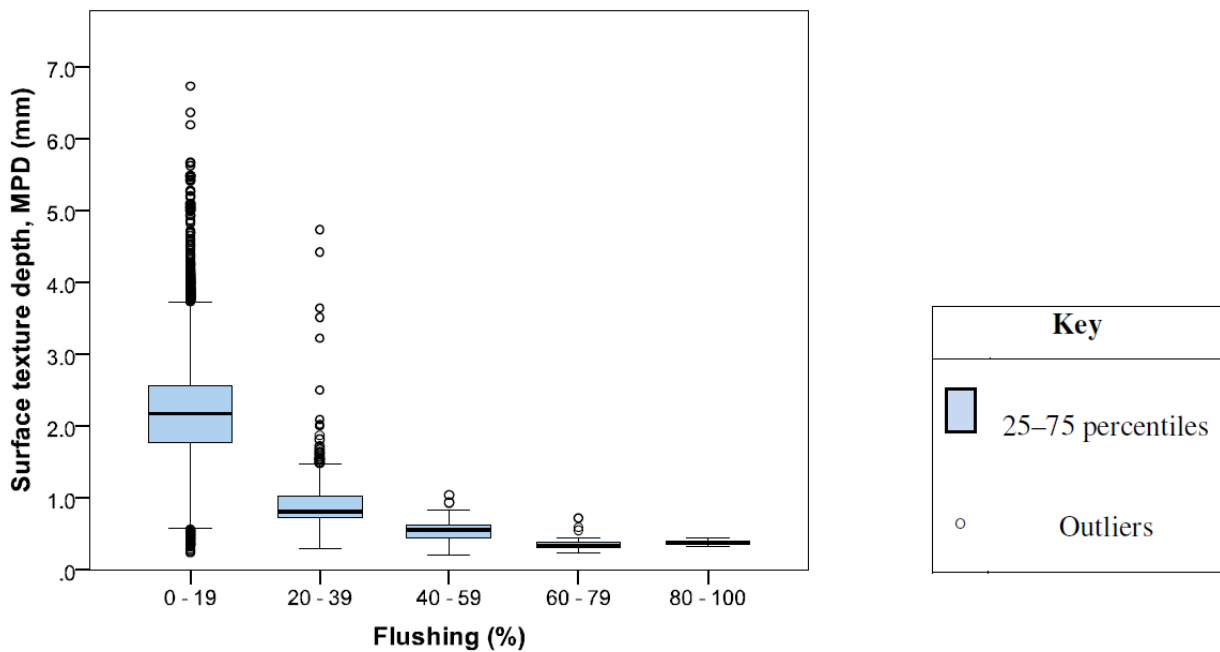
Figure 3.9 Relationship between flushing and surface texture

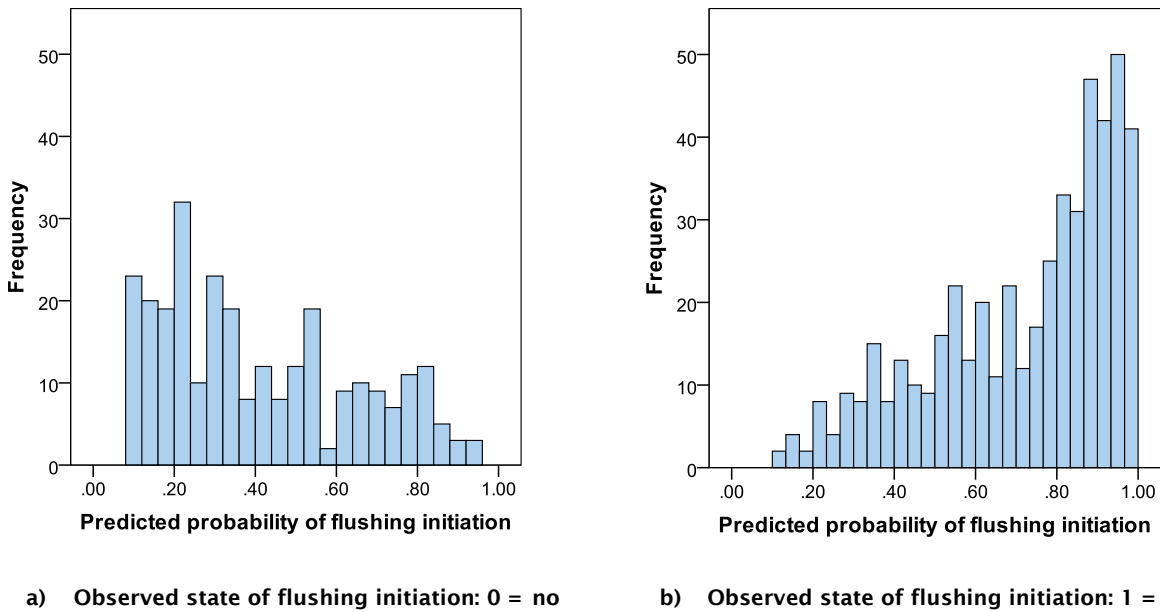
Figure 3.12 Predicted probabilities for flushing initiating on LTPP pavement sections

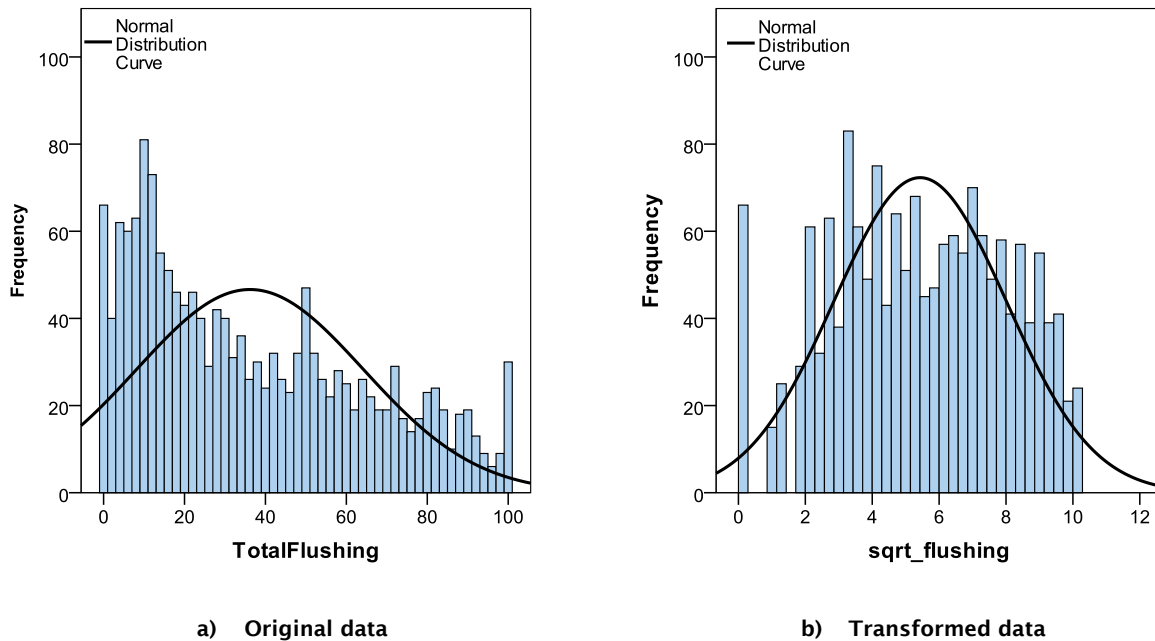
Figure 3.13 Distribution of original dependent variable TotalFlushing data and the transformed data
