Flushing in chipseals

PR Herrington
Opus Research, Opus International Consultants Ltd

NZ Transport Agency research report 576
Contracted research organisation – Opus International Consultants Ltd

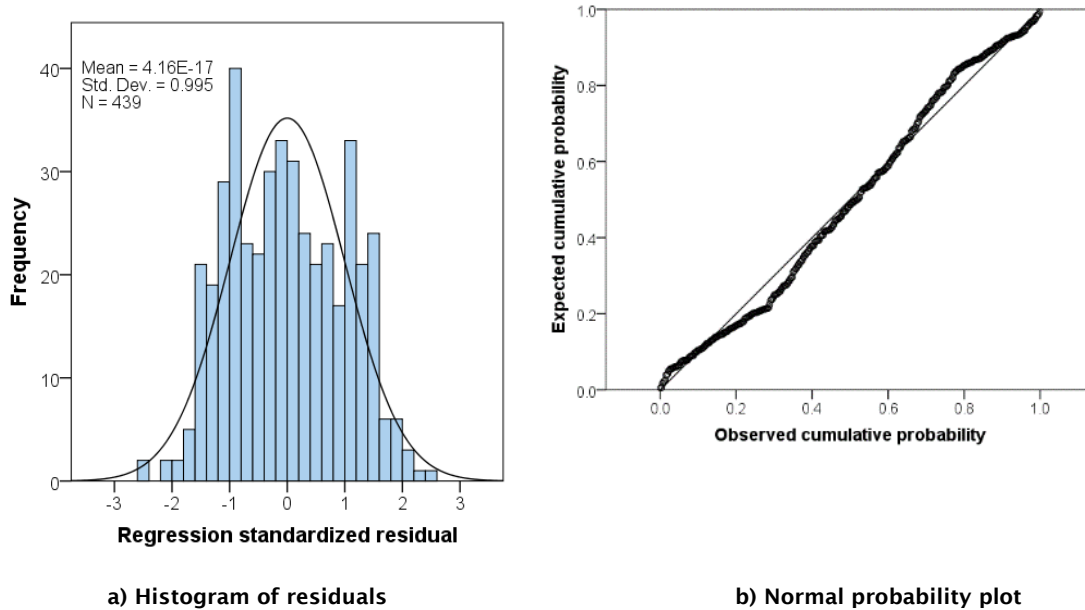
Figure 3.15 Evaluation of residuals from linear regression for second and higher generation seals

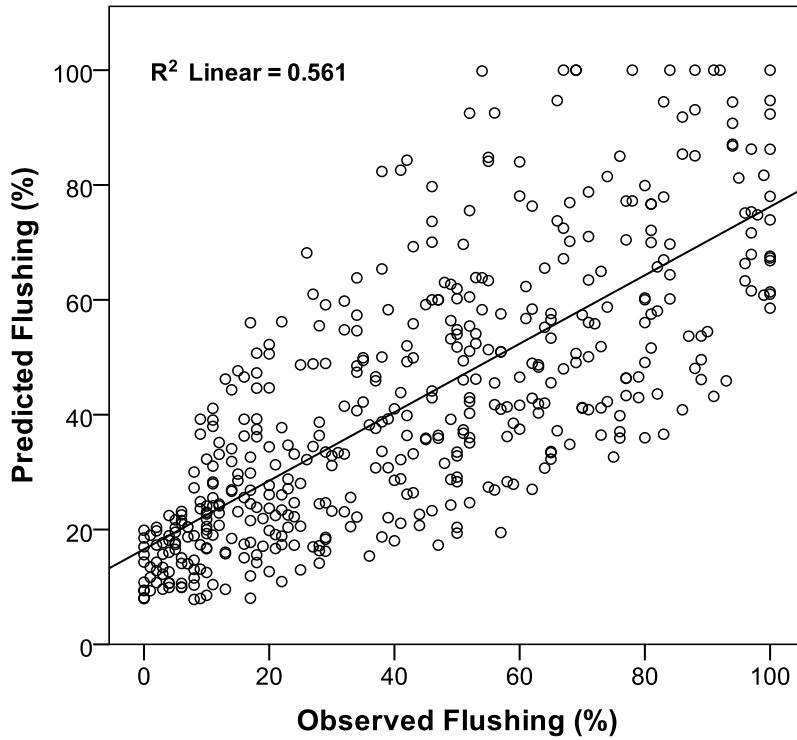
Figure 3.16 Model predictions for flushing progression on second and higher generation seals

The predictive strength of the model for first generation seals was expected to be low because the mechanisms that cause flushing on first generation seals can vary much more than the mechanisms that cause flushing on second and higher generation seals.

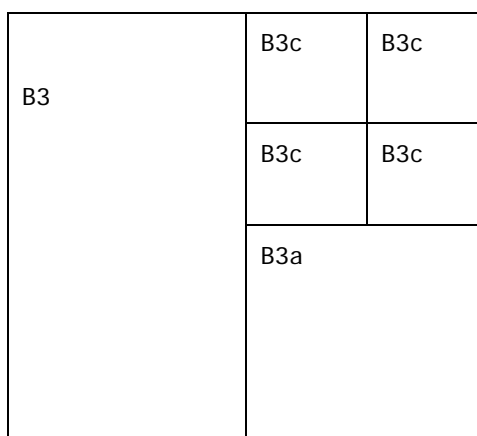
Figure A.1 Cut faces for SH77 seal slab
