Transition from visual condition rating of cracking, shoving and ravelling to automatic data collection

May 2017

TFP Henning, University of Auckland
GJ Morrow, Opus International Consultants Ltd

NZ Transport Agency research report 617
Contracted research organisation –Auckland Uniservices Ltd

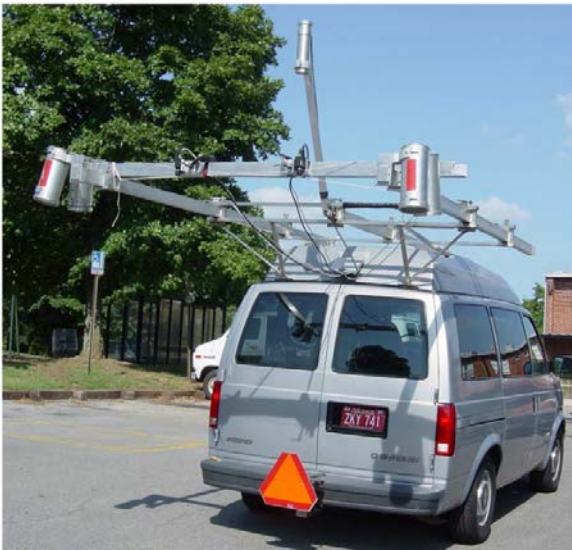
Figure 2.1 Digital data collection vehicle (Wang 2004)

Figures 2.1 and 2.2 show photographs of digital data collection techniques. One of the known limitations of these techniques is the strong sensitivity to the lighting of the photographed area. This is a particular issue for chipseals where the texture creates shadows that are interpreted as defects when an automated pixel processing is used.

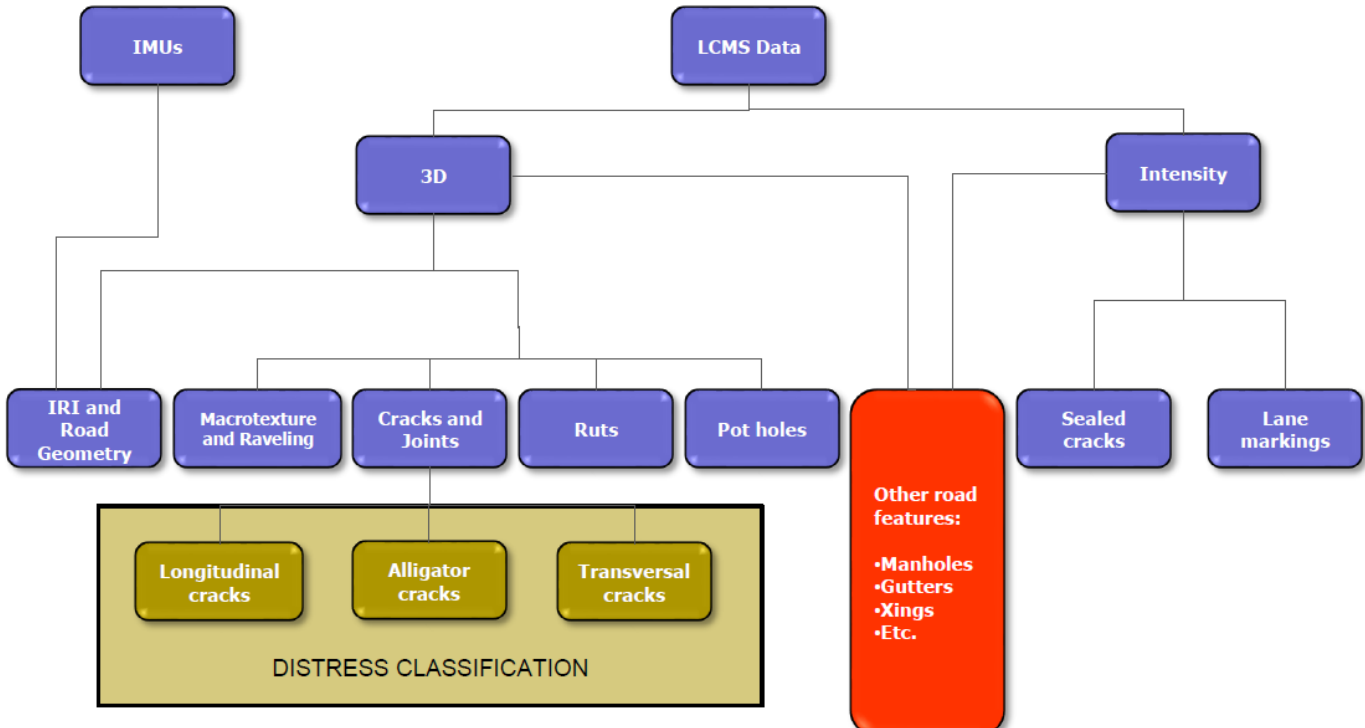
Figure 2.6 Defects identified with LCMS (Source Pavemetrics)

Although the system was primarily developed for crack detection the scanned images help identify many other defects such as roughness, rutting, potholes and ravelling, as shown in figure 2.6. For example, figure 2.7 illustrates how the LCMS data could be used for identifying bleeding.

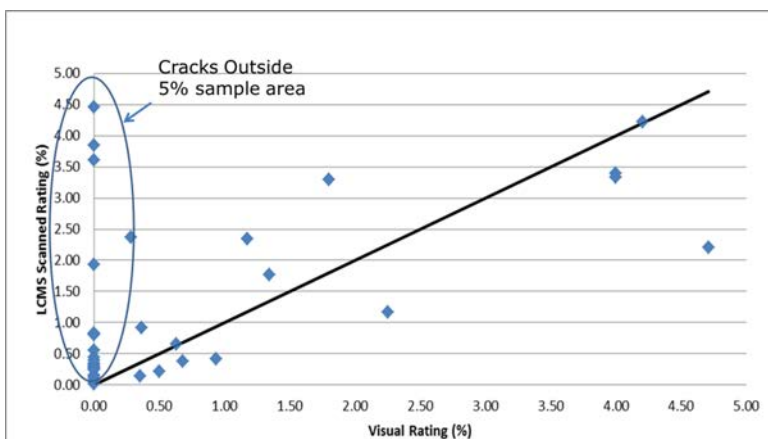
Figure 2.12 Comparing 100% LCMS surveys with 10% sampling RAMM surveys (Henning and Mia 2013)

One of the main advantages of automated defect identification is that it allows for a 100% survey regime as opposed to the current sampling process adopted for the RAMM surveys. The challenge of any sampling process is that it is only a representation of the true population behaviour. Tapper et al (2013) showed no RAMM sampling size yielded exactly the same outcome as a 100% survey. From a pragmatic perspective, the Tapper et al study (2013) recommended increasing the RAMM surveys to a minimum 20% sample size. Henning and Mia (2013) also considered the impact from different sample sizes, and figure 2.12 illustrates their findings, which suggest the LCMS picks up more cracks than the manual raters. The report named two reasons for the additional observed cracks:

- A certain percentage of additional cracks were observed outside the RAMM-rated assessment lengths that may have showed no cracks.
- In some cases the LCMS identified or confused other defects as cracks, such as mechanical damage to the road surface.

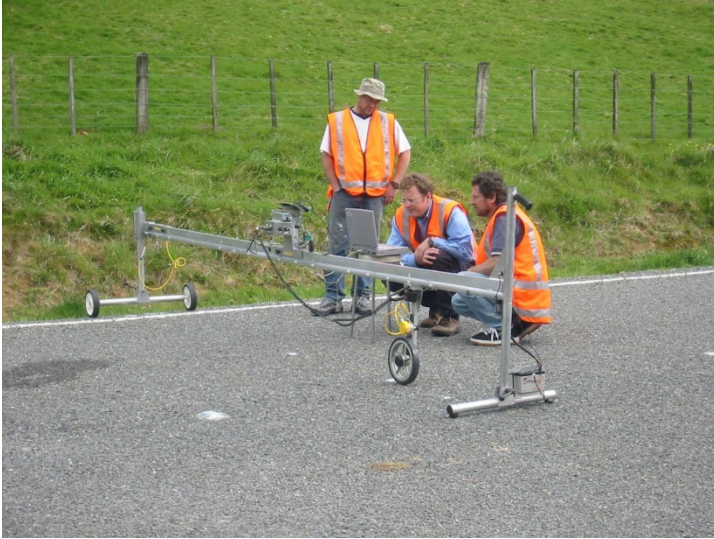
Figure 3.2 New Zealand LTPP programme rutting measurements (Henning et al 2004)

- a manual assessment of all defects, involving the recording of the exact extent and dimensions of the defects
- manual measurement devices, used for rutting, roughness and texture depth (refer to figure 3.2)
- traffic counts, undertaken using classification loop counters
- the recording of all maintenance
- recording changes to sites through detailed site notes and photographs.

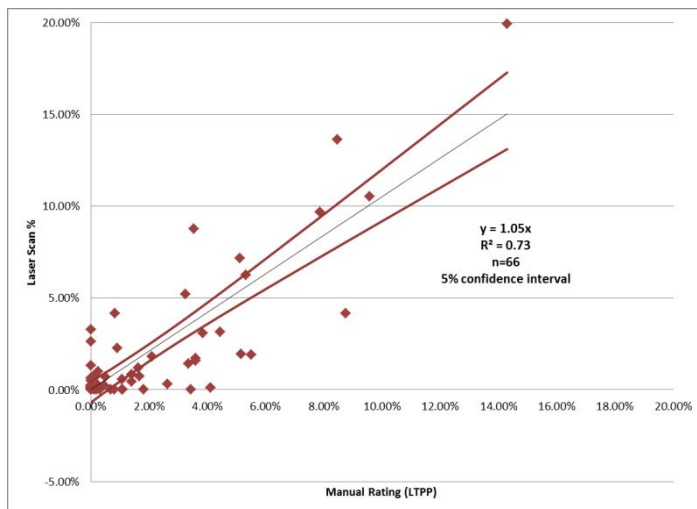
Figure 4.1 Comparing scanning laser measured cracks with the LTPP manually assessed cracks

The observations from the figure are:

- The line of equality has a slope of 1.05, suggesting laser measures would have a bias of 0.05% compared with manual measurements.
- The R^2 between the measures is 0.73, suggesting an element of scatter between the two measures. The scatter is on both sides of the line of equality, thus suggesting a lack in bias from the scanner.

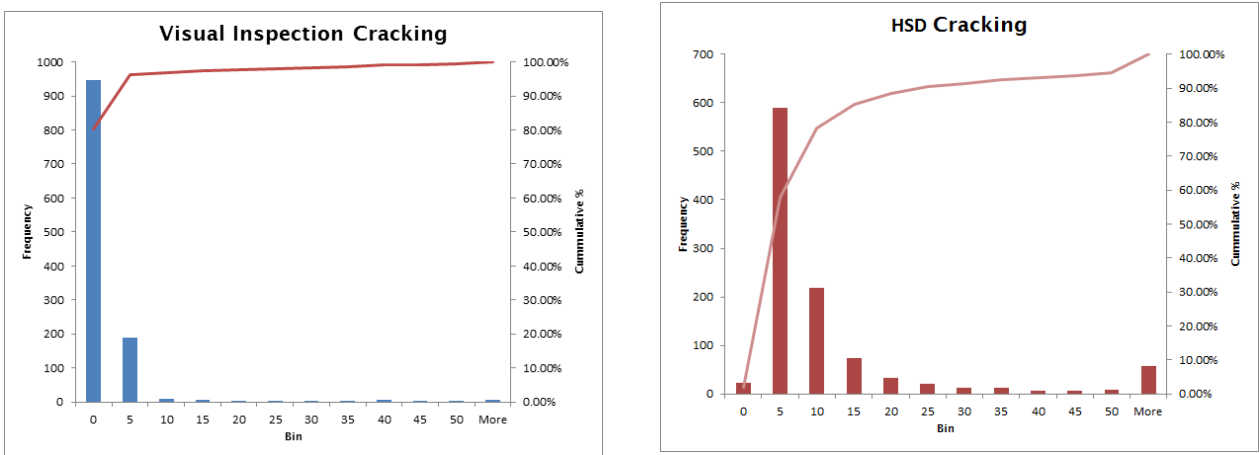
Figure 4.7 Comparing the cracking distribution for visual survey (sampled) and LCMS 100%

There is a magnitude shift in crack values between the results of the LCMS and those of the visually measured cracking. This difference is attributed to three factors:

- potential false positive cracking identified with the LCMS
- the statistical shift going from a sample to full survey results will result in higher values being observed
- an under reporting from the visual surveys.

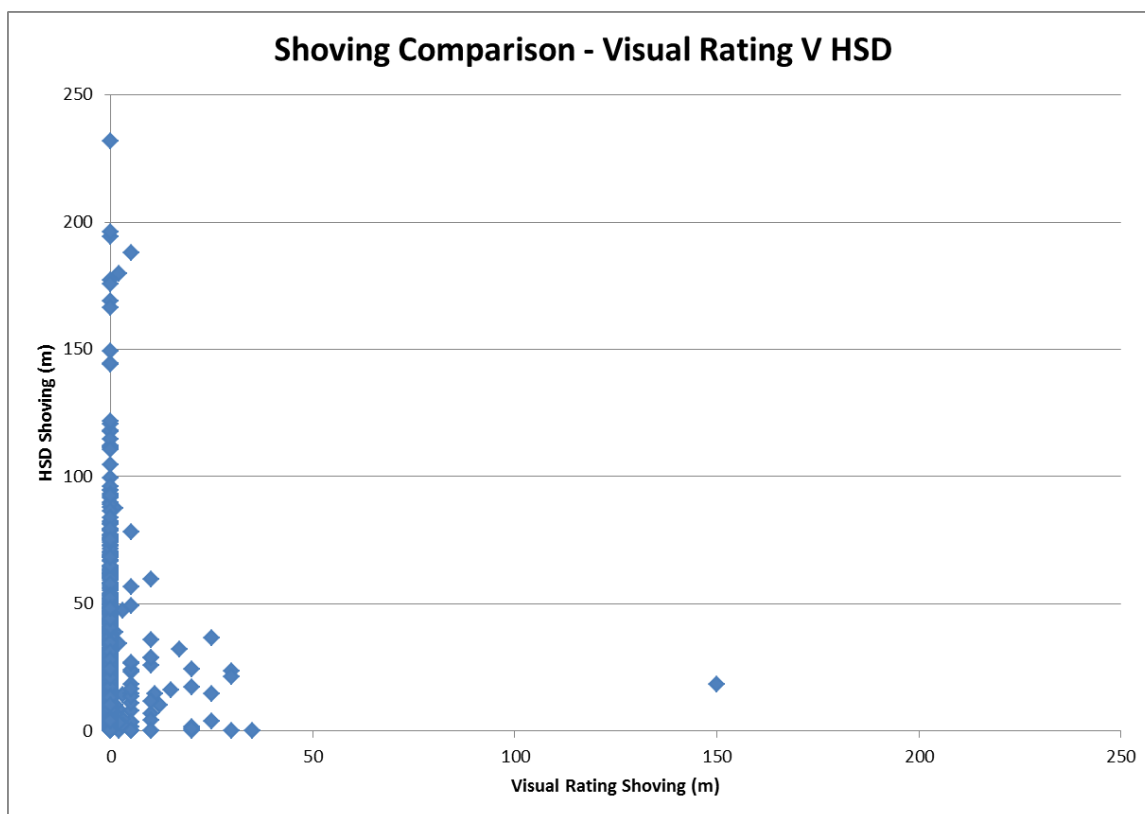
Figure 4.12 Comparing automated shoving detection to manual measurements

It appears from the figure there were a number of false positive measurement picked up through the scanning laser. The following section investigates the actual occurrence of shoving on the network.

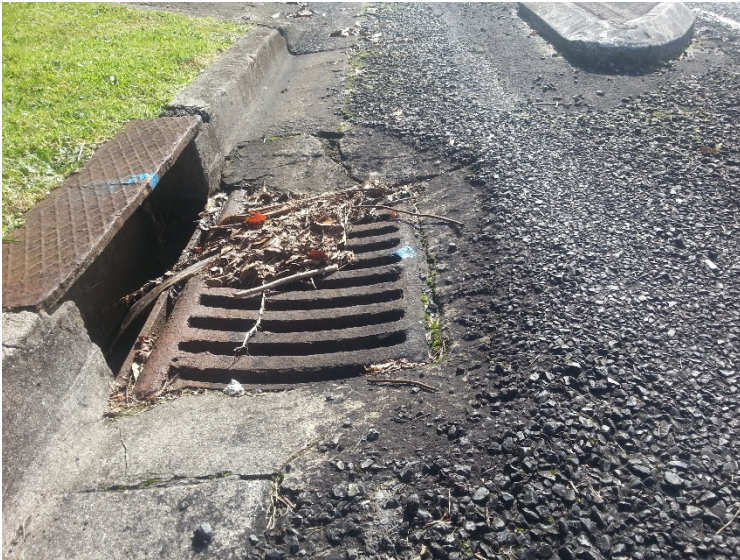
Figure 4.13 Note drop off into catch pit, greater than 5mm

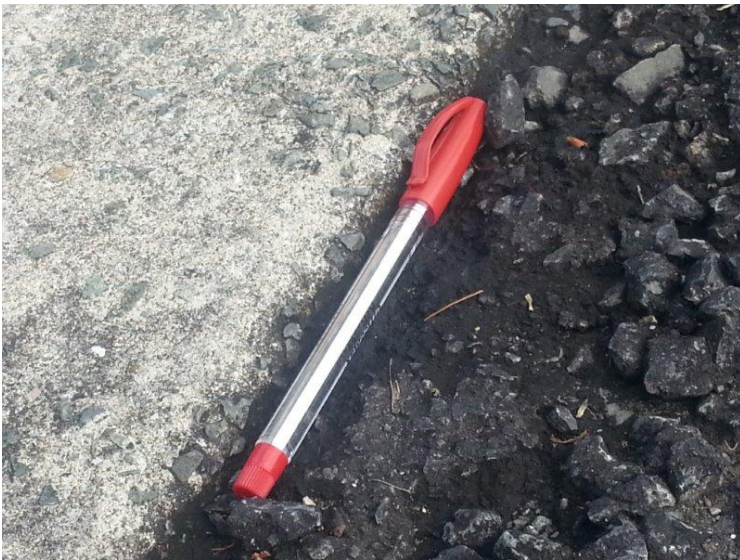
Figure 4.14 Scabbed surface or high lip at the channel often greater than 5mm

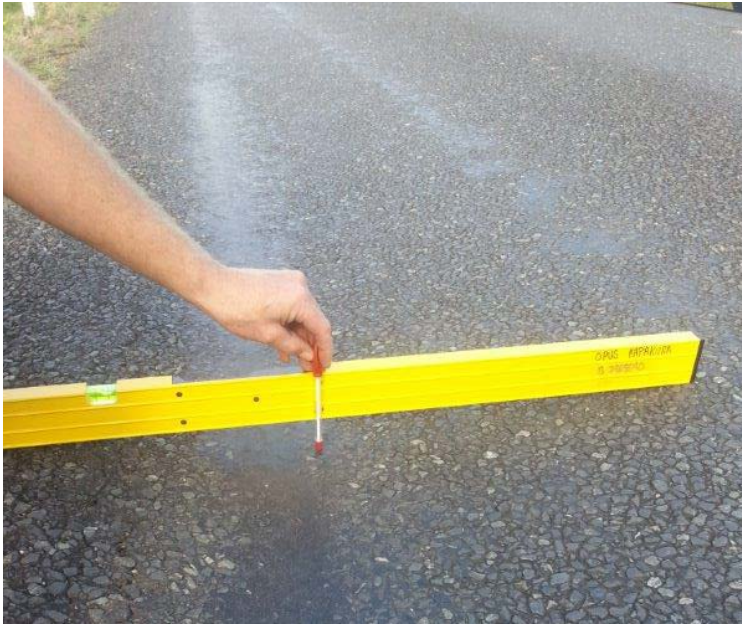
Figure 4.15 The straight edge shows more clearly the vertical height. The eye can generally pick up > 10mm, but finds it hard to pick up < 10mm

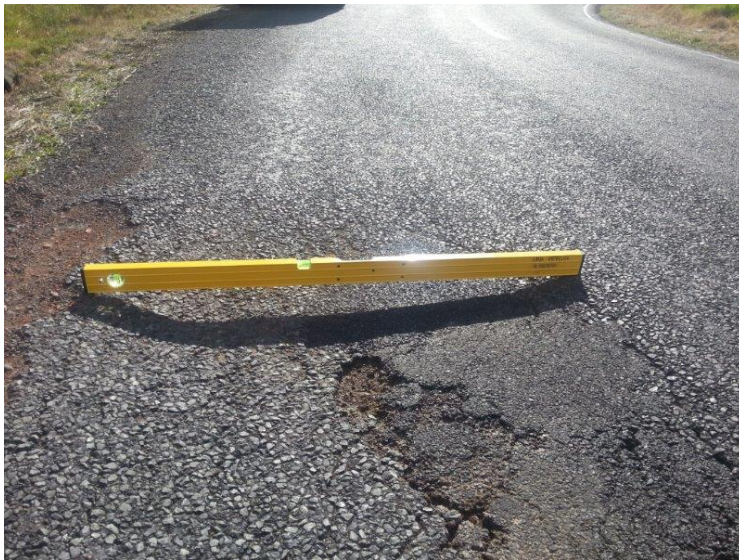
Figure 4.16 Shoving with a clear vertical height

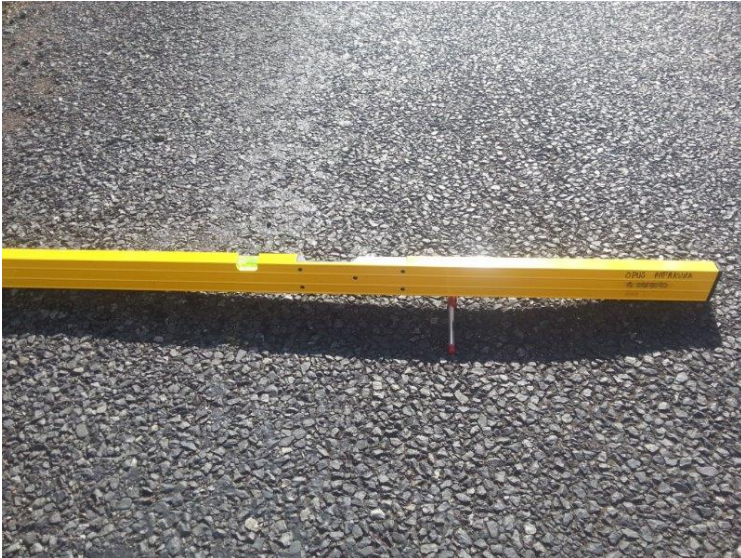
Figure 4.17 A very shallow rut, hard for the eye to detect, but it is greater than 10mm as the pen fits underneath

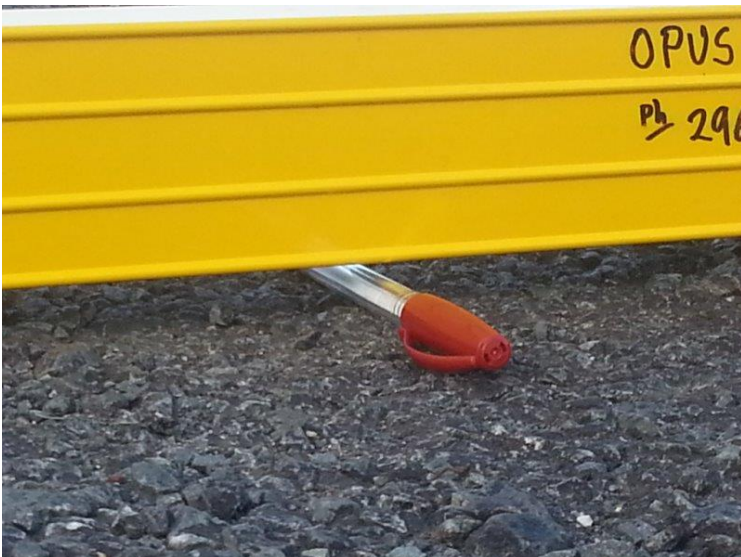
Figure 4.18 A closer view of a shallow depression that can be exaggerated when chip loss occurs at the same point. For larger size chip this depth can be greater than 5mm

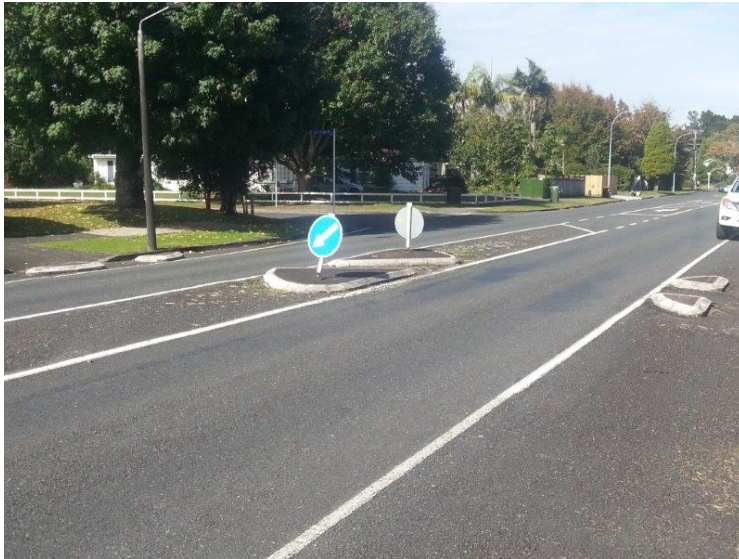
Figure 4.19 Note the mountable islands in the middle of the road. Shoving was reported through the algorithm at these locations

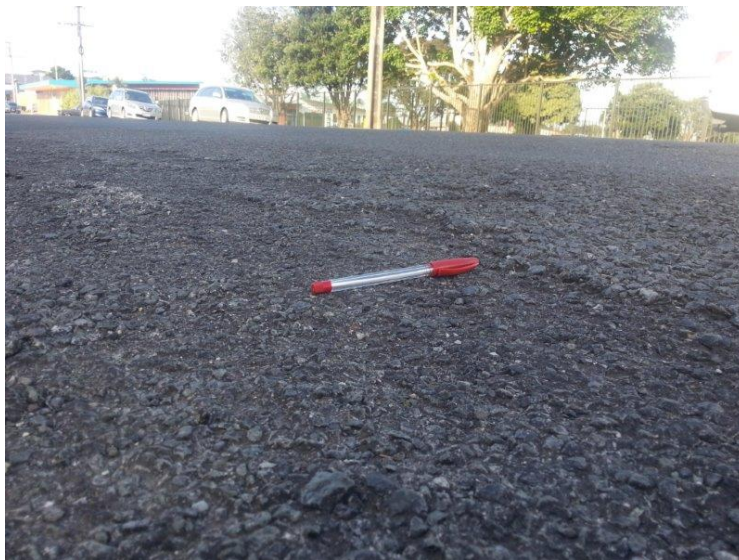
Figure 4.20 A closer view of the vertical height that exists when scabbing occurs in larger stone chipseals
