Okahu & Puhoi Viaducts Deck System Review

27 March 2020

Okahu & Puhoi Viaducts
Deck System Review
Temporary Reinforcement Trusses

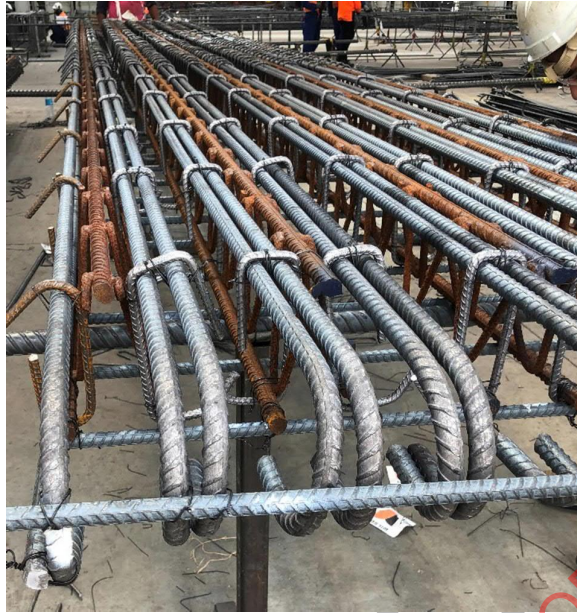
The permanent deck is therefore expected to behave like a series of stiffer links connected by less stiff connections at points where bending moment is highest. The higher strains associated with the sharper deck curvature will cause cracking in the deck cover concrete. That is to top cover concrete above the girders and the bottom cover concrete between the girders.

Photo 5: Deck panel in the process of being tied and

Further cyclic traffic loading will also result in the fractured TRT chords 'working' within the deck creating cavities for moisture to collect. This could cause premature corrosion of all the reinforcement within the deck close to these locations.

3. That the bridge designer reviews their design to consider the effect of incorporating the TRTs into the permanent deck. This should include the potential fatigue failure mechanism identified in Section 3 in relation to long term deck performance and durability.
