SH1, Karo Drive Wellington Crash Reduction Study

A REPORT PREPARED FOR
New Zealand Transport Agency

Reference: 12334
January 2013

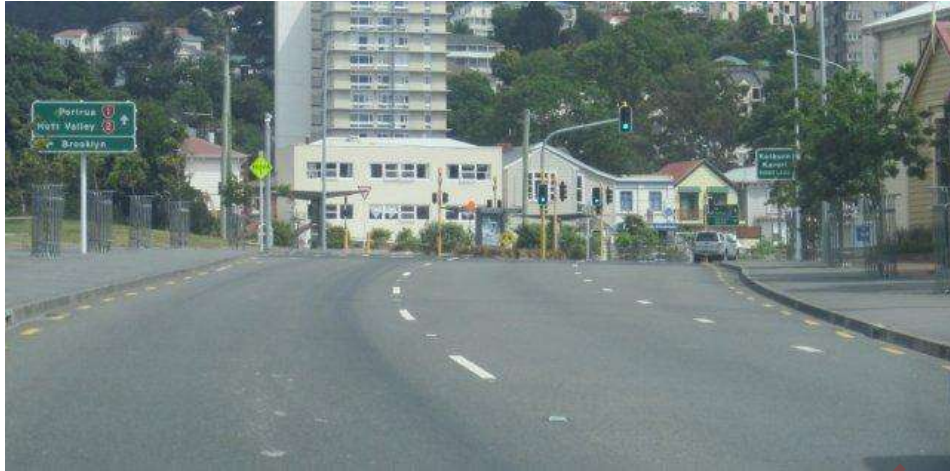
Photo 3 – Karo Drive approaching Victoria Street

1. Significant red light running from both Karo Drive and Victoria Street approaches is evidenced by the crash data.
2. The curvature of the Karo Drive approach coupled with buildings on the inside of the curve and the open area on the outside of the curve mean that the intersection at Victoria Street is not easily definable as an intersection in advance, compared to seeing the Cuba Street intersection, for example, when proceeding along Karo Drive (see **Photo 1**). When leaving the Cuba Street intersection westbound on Karo Drive, the Victoria Street intersection is not visible (see **Photo 2**) and neither the full array of signals nor the layout of the intersection can be seen from half way between Cuba Street and Victoria Street (see **Photo 3**). In addition, the limit line on Karo Drive cannot be seen in advance due to a slight vertical curvature in the carriageway. If some drivers do not “register” the signalised intersection ahead, there is the risk of them proceeding through a red signal display.

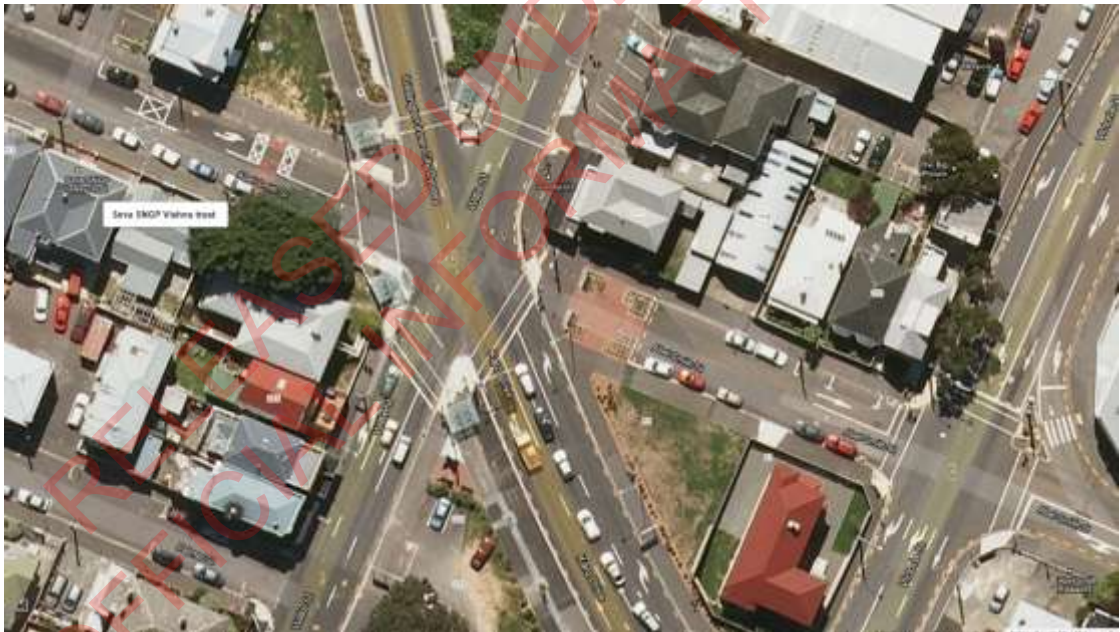
Figure 4

As noted in section 1.1, Karo Drive is one-way westbound whilst Willis Street is one-way northbound and the fifth leg at the intersection, Abel Smith Street, is two-way. The current intersection layout can be seen in Figure 4, with two westbound through lanes on Karo Drive to The Terrace Tunnel (the left hand lane is also shared for access to Abel Smith Street) and a dedicated right turn lane into Willis Street. On Willis Street there are three lanes at the Karo Drive intersection: a dedicated left turn lane for the shared movement to Abel Smith Street and The Terrace Tunnel, a shared through and left turn (to The Terrace Tunnel) lane and a second through lane. Traffic from Abel Smith Street can turn left to The Terrace Tunnel or Willis Street, though the former movement is difficult to undertake and only suitable for smaller vehicles.
