Pūhoi To Warkworth (P2Wk)– Landslide Risk Assessment

# Geotechnical Review of Cut Slopes and Landslide Risks

Revision E

Date: 11 April 2023

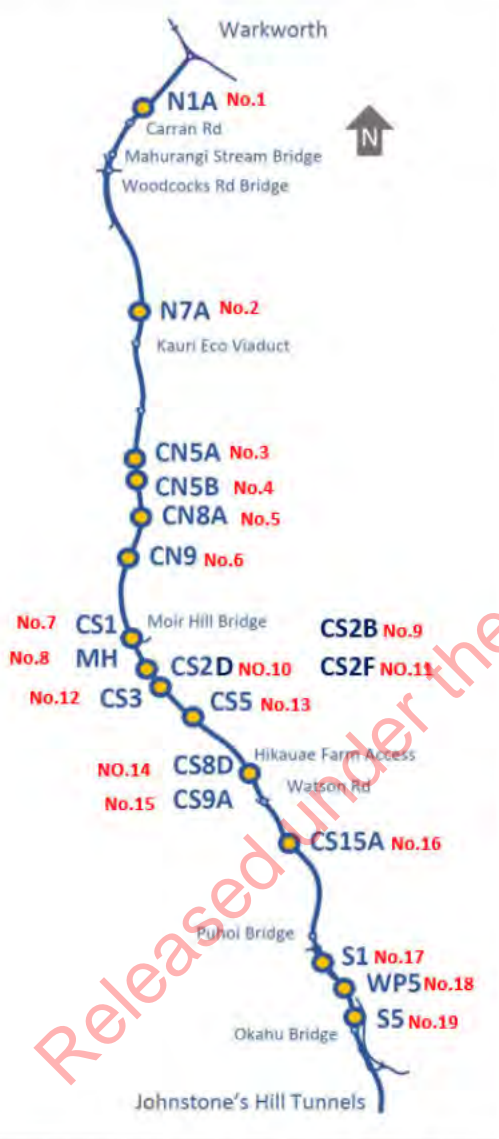
Figure 1: Landslide Locations along the P2Wk Alignment

Multiple landslides including at temporary works slopes have occurred during the construction since late 2019. Based on the provided CJV weekly progress reports, 19 landslides are being tracked for their progress with regards to their respective status on design, peer review and remedial works completion.

The followings risk items have been identified:

- Soil slope failures, predominantly failing along the soil rock transition zone,

- Topsoil slumps and surficial erosion,
- Softening of ground (soil, weathered rock, fill) caused by groundwater seepage or surface water run-off,
- Surficial failure rock slopes and rockfall behind mesh draping,
- Wedge failures at rock slopes between rock bolts or at location without rock bolts,
- Scour/erosion and debris flow from soil slopes or soil-rock interface above rock slopes.

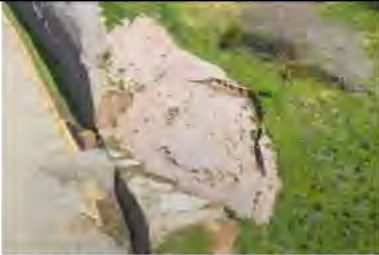
Risk Item	Example	Potential Causes	Locations
1. Soil slope failures, predominantly failing along/above the soil rock transition zone

CN1 North-west (September 2021, now repaired)	<ul style="list-style-type: none"> <li>• Cut slope too steep for geological conditions, i.e. conditions and inclination of soil-rock transition zone,</li> <li>• High groundwater levels or groundwater seepage,</li> <li>• Surface water runoff infiltration into slope,</li> </ul>	<ul style="list-style-type: none"> <li>• Transition into cut slopes from embankment fills,</li> <li>• Soil slope above rock cuts,</li> <li>• CN1 North-west,</li> </ul>

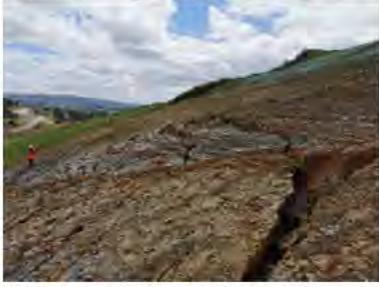
2. Slope failures within transitional rock or highly weathered rock at previous landslides

CN5B East (12 November 2021)	<ul style="list-style-type: none"> <li>• Surface water runoff infiltration into exposed fractured and highly weathered rock mass or zone of transitional rock,</li> <li>• Groundwater seepage,</li> </ul>	<ul style="list-style-type: none"> <li>• Exposed highly weathered and fractured transitional rock near cut slope surface, particularly where not protected by topsoil,</li> <li>• CN5B East,</li> </ul>

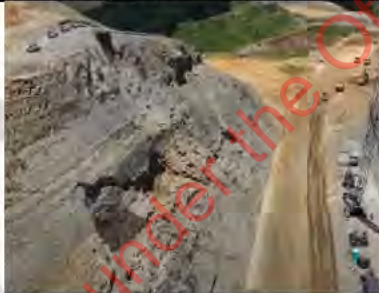
4. Wedge failures at rock slopes between rock bolts or at location without rock bolts Wedge failure may result in large scale failures.

CN5B East	<ul style="list-style-type: none"> <li>• Intersection defect sets,</li> <li>• Heavily faulted rock mass,</li> <li>• Too steep cut slopes for encountered geology,</li> <li>• Insufficient rock support (rock bolts),</li> <li>• As-built cuts are steeper than design,</li> </ul>	<ul style="list-style-type: none"> <li>• Refer to <a href="#">Table 11</a> for locations of 85°/64 ° steep rock cuts,</li> <li>• CN5B East &amp; West,</li> </ul>

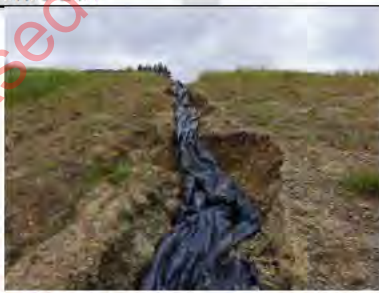
5. Scour/erosion and debris flow from soil slopes or soil-rock interface above rock slopes

CS2F East (2 November 2021, now replaced by rock lined swale drain)	<ul style="list-style-type: none"> <li>• Insufficient cut off drains at top of slope,</li> <li>• Long and steep slope faces without sufficient slope face erosion protection,</li> <li>• Highly erodible soils/rock exposed at slope face,</li> </ul>	<ul style="list-style-type: none"> <li>• CS2F East,</li> <li>• CS3 East,</li> </ul>

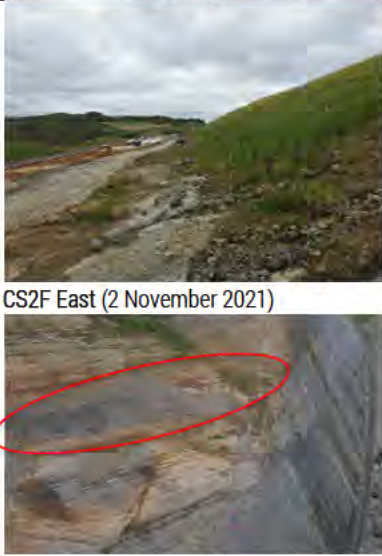
Risk Item	Example	Potential Causes	Locations
<p>6. Rockfall from debris above rock cuts, potentially rolling or dropping on the SH1.</p> <p>Refer to revised rockfall risk assessments in Section 4.2.</p>

<p>CS2F East (2 November 2021)</p> <p>CN5B East (buttress fill)</p>	<ul style="list-style-type: none"> <li>Exposed weathered and highly fractured rock,</li> <li>Steep slopes above rock cuts without sufficient rockfall catch area or protection,</li> <li>Rock lining fill from swale drains or buttress fill,</li> </ul>	<ul style="list-style-type: none"> <li>Refer to <a href="#">Table 11</a> for locations of 85° steep rock cuts,</li> <li>CN5B (buttress),</li> <li>CN5B East &amp; West,</li> <li>CS2F East,</li> <li>CS3 East,</li> </ul>
<p>7. Topsoil slumps and surficial erosion</p>

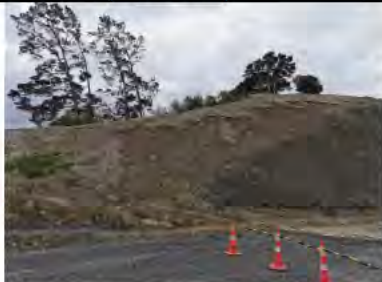
<p>CS16D</p>	<ul style="list-style-type: none"> <li>Soil slopes with smooth surfaces or topsoil placed on rock cuts,</li> <li>Too loosely placed or thick topsoil,</li> <li>Topsoil placed prior to winter (rainfall) season,</li> </ul>	<ul style="list-style-type: none"> <li>Soils slopes, particularly at transition into cut slopes from embankment fills, where batters could be steeper than 2H:1V,</li> <li>CS16D,</li> </ul>

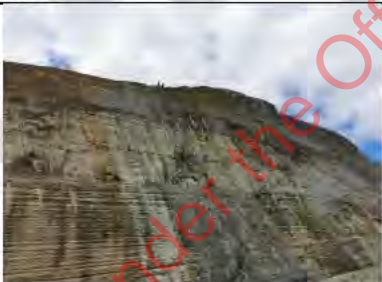
<p>8. Surficial rock dropouts and rockfall behind mesh draping without affecting rock cut integrity.</p>

<p>CN5B</p>	<ul style="list-style-type: none"> <li>Defect sets of rock mass,</li> <li>Ongoing weathering of exposed rock surface,</li> <li>Groundwater seepage,</li> </ul>	<p>All location of steep rock cuts. Refer to <a href="#">Table 11</a>.</p>

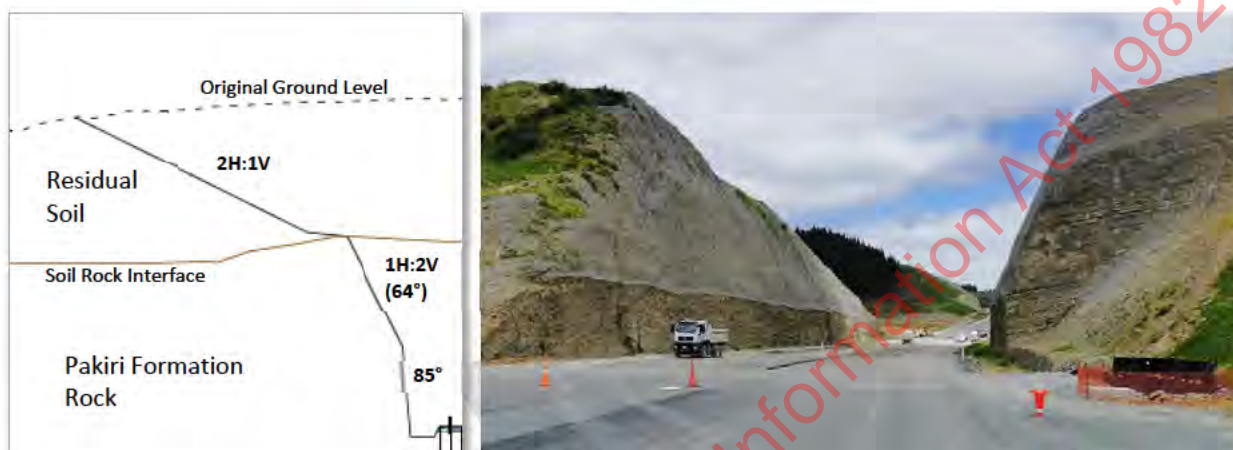
Figure 2: Typical Rock Cut Geometry

CN5B Photo dated 12 November 2021

The project drone flyover videos suggest that at some of the rock cut slopes larger rock dropouts/voids and wedge-type failures are present resulting in vertical and partially overhanging rock cuts. Due to the camera view angle of the drone towards to cut slope, a review of the rock conditions based on the drone videos is not feasible. Specific Design Engineer Instructions (i.e. DEI 0493 for the western site at CN5B) were issued to address the site observations and rock stabilisation requirements.

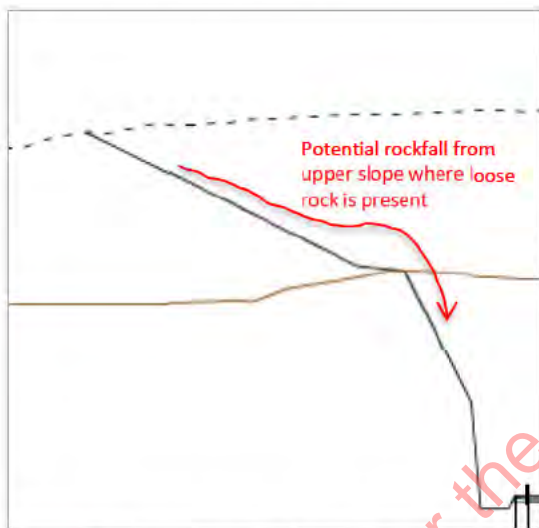
Figure 3: Potential Rockfall Risk

Based on the provided design reports, the design addresses the rockfall from the steep rock cuts. It appears that potential rockfall from the upper slopes (typically 2H:1V), where loose transitional rock or debris, rockfill at toe buttresses or rock-lined swale drains may be present, was not addressed.

We have highlighted the potential rockfall risks at various cut slopes in our previous draft reports (Rev A, B and C). In absence of any rockfall trials and simulations, and based on our desktop review and site observations only, the potential risk of rockfall at the high-risk locations have previously been identified at the following cuts:

- **CN1 West**
  - Up to 28m high 2H:1V steep slope above rock with exposed weathered rock. Any loose material could roll down the 2H:1V slope and fall/bounce on the SH1 carriageway.
- **CN5B East & West**
  - The constructed buttress fill using the specified 'high strength structural fill' within upper the cut slope appears to comprise loose material, which shows sign of failure.
  - Up to 33m high 2H:1V steep slope above rock with exposed weathered rock. Any loose material could roll down the 2H:1V slope and fall/bounce on the SH1 carriageway.

- CS3
  - The upper 2H:1V steep slope above rock shows exposed weathered rock. Any loose material could roll down the 2H:1V slope and fall/bounce on the SH1 carriageway.
- CS16D
  - The slope comprises a constructed rock-lined chute.
  - The upper 2H:1V steep slope above rock shows exposed weathered rock. Any loose material could roll down the 2H:1V slope and fall/bounce on the SH1 carriageway.

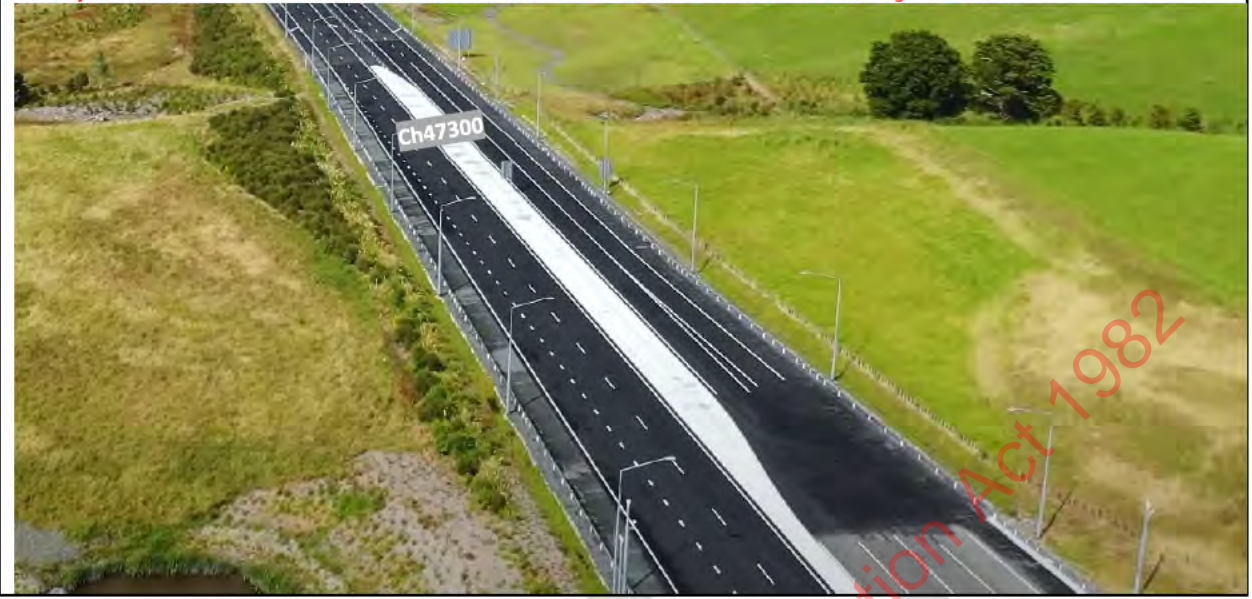
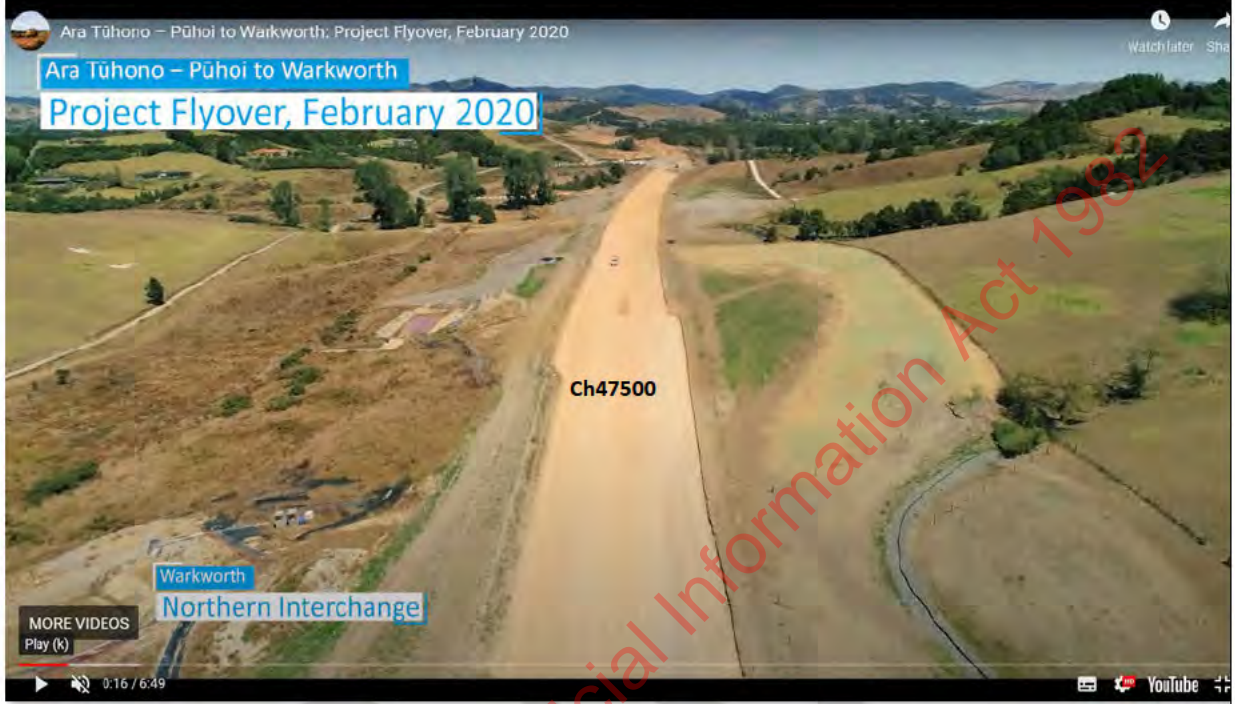
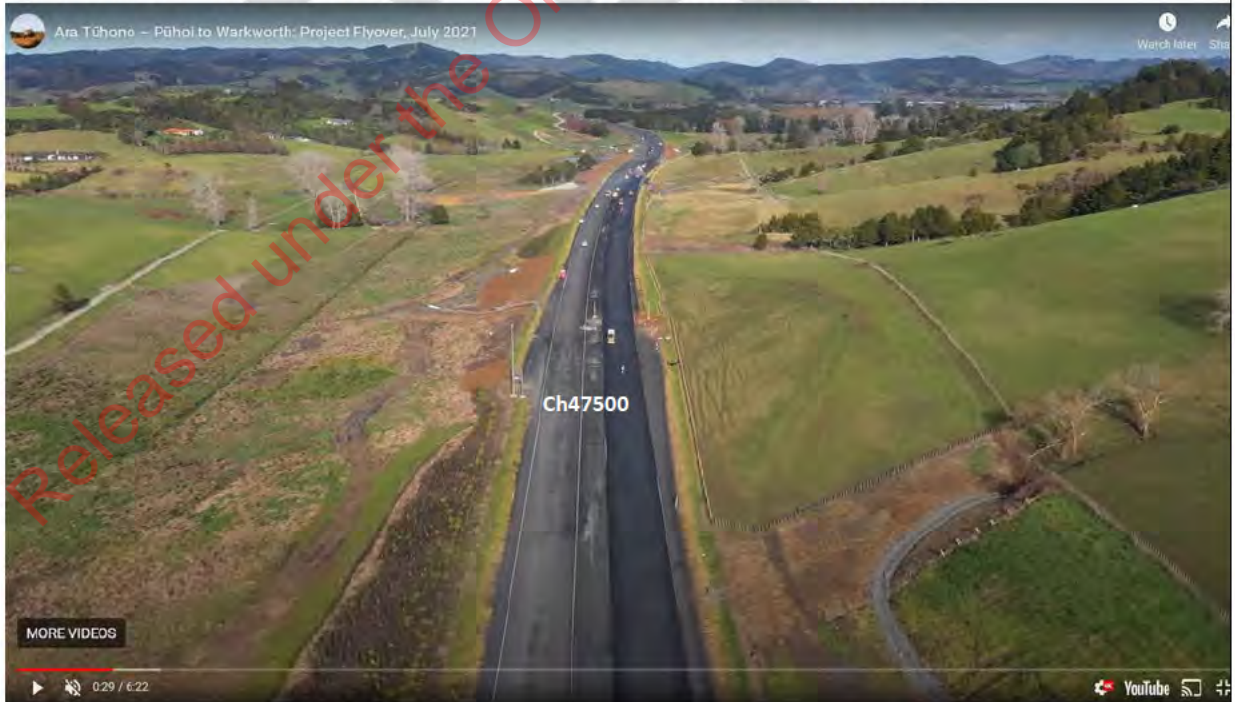
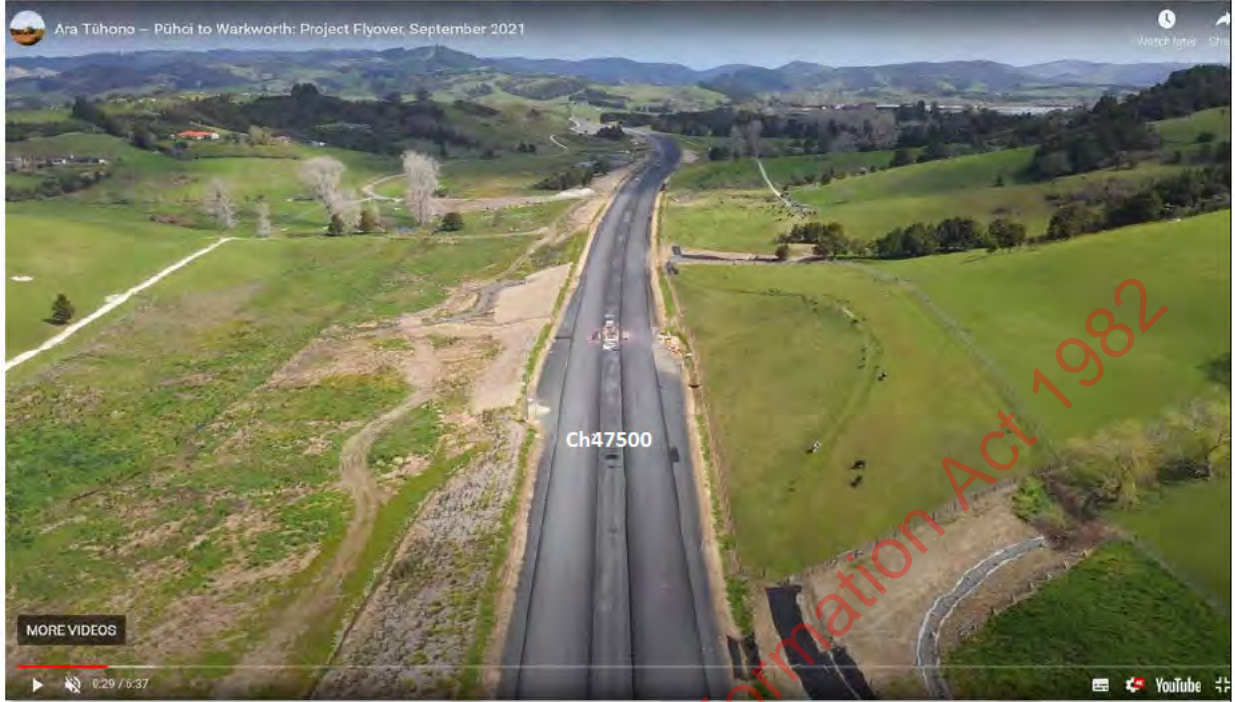
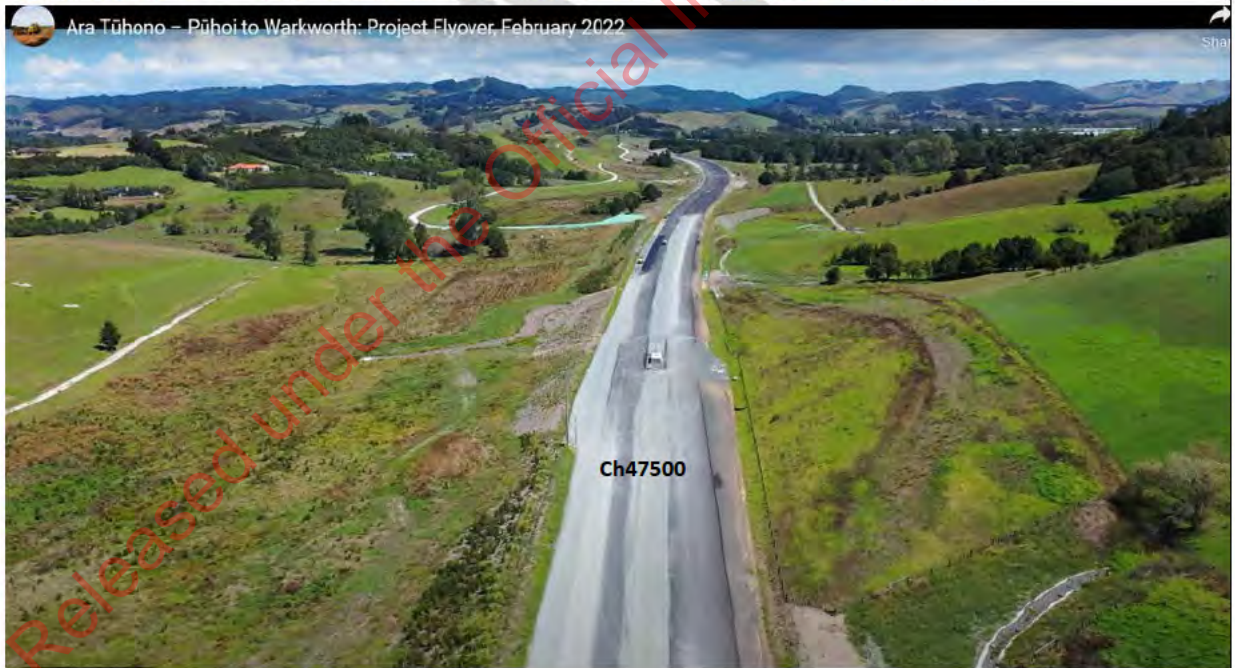
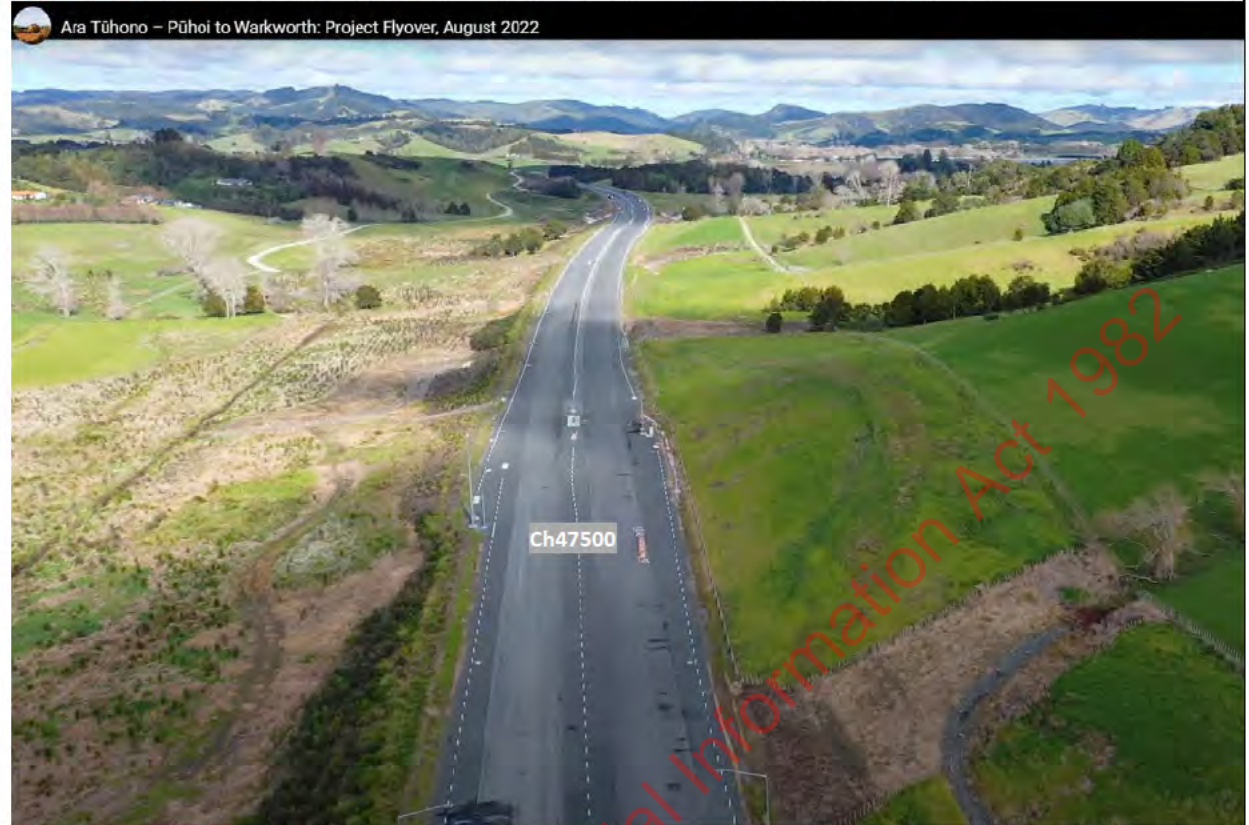
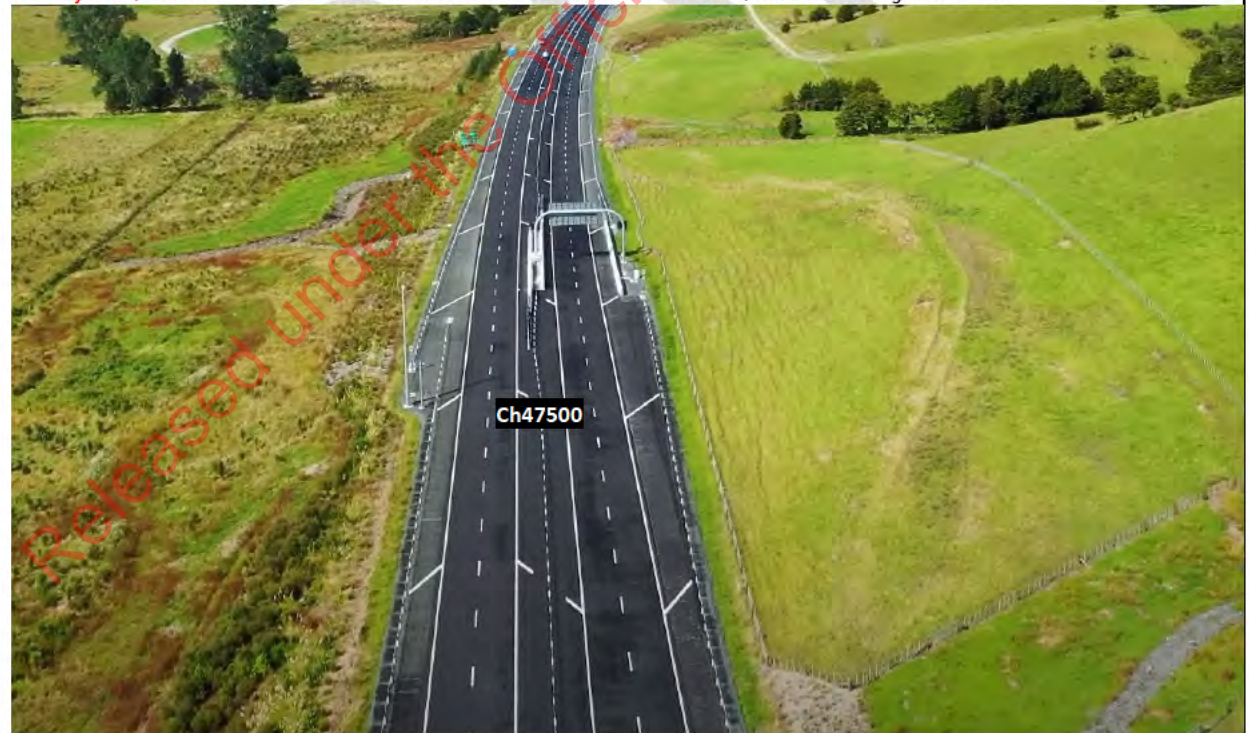
There appears to be topsoil creep movement on the cut slope in July 2021. Horizontal lines on the grassed surface are still presented in the January 2023 aerial footage. The risk of future slope failure is considered **very low**.

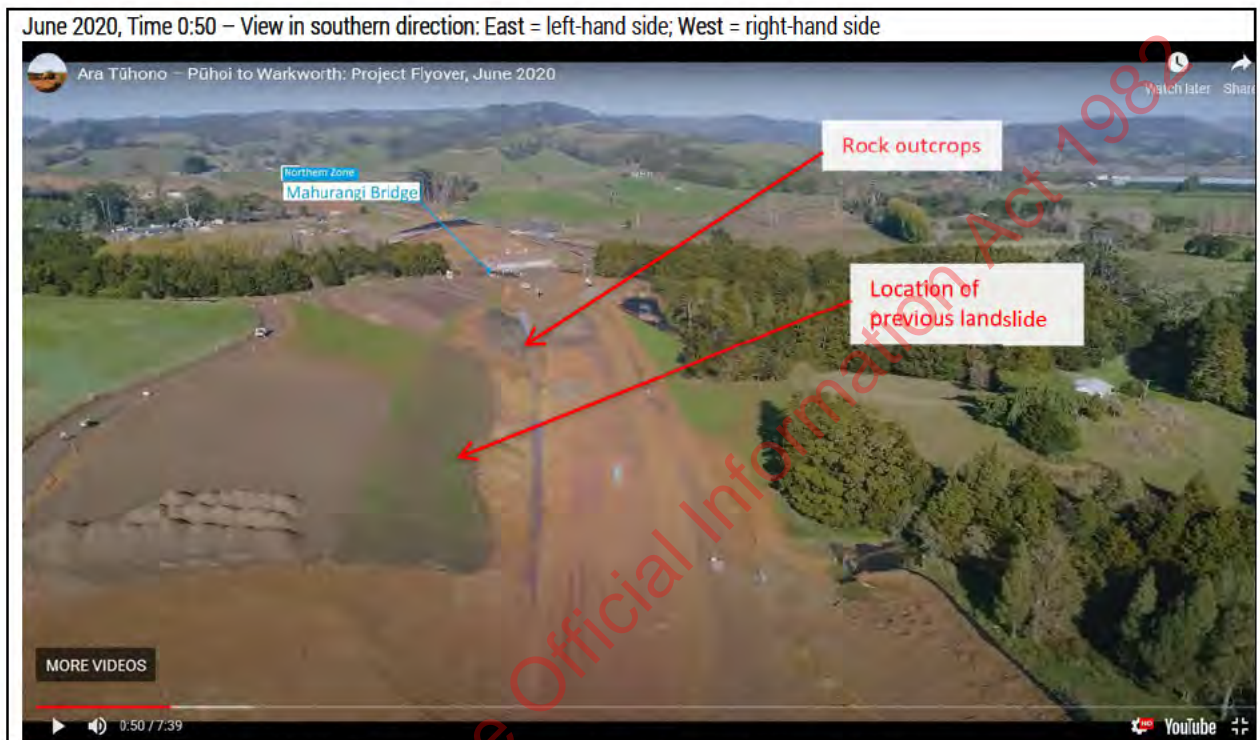
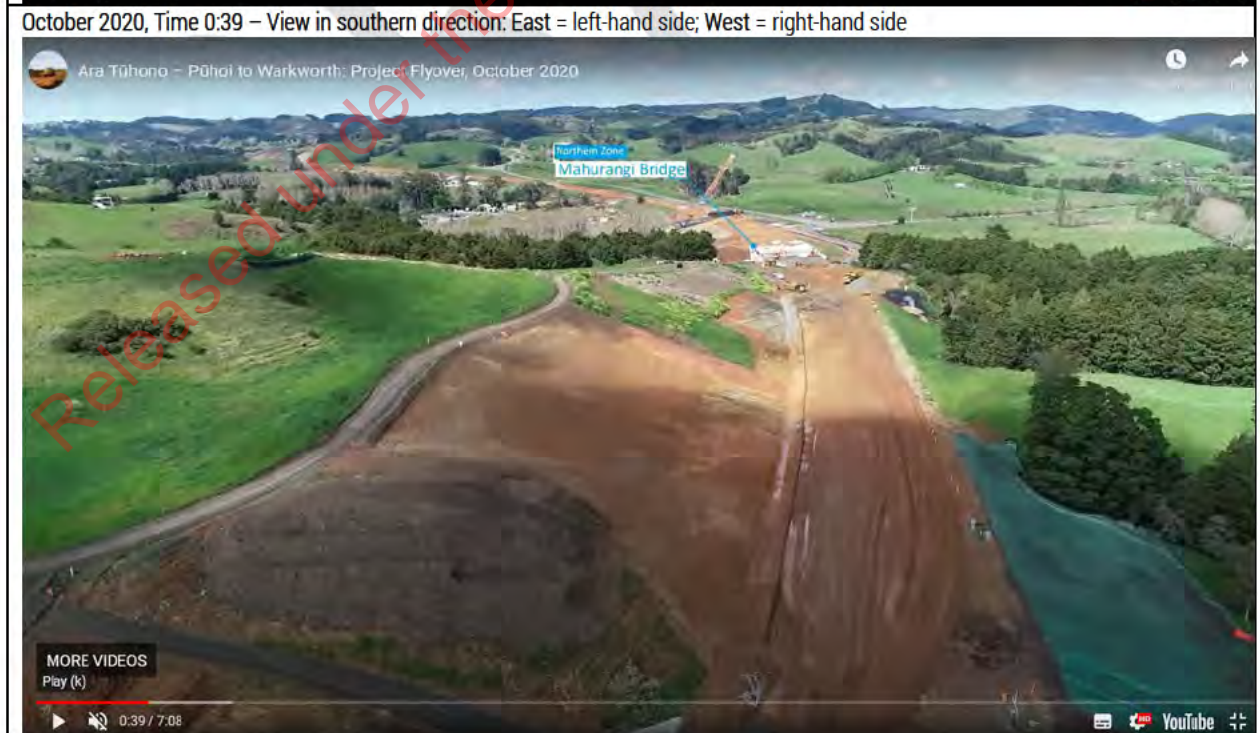
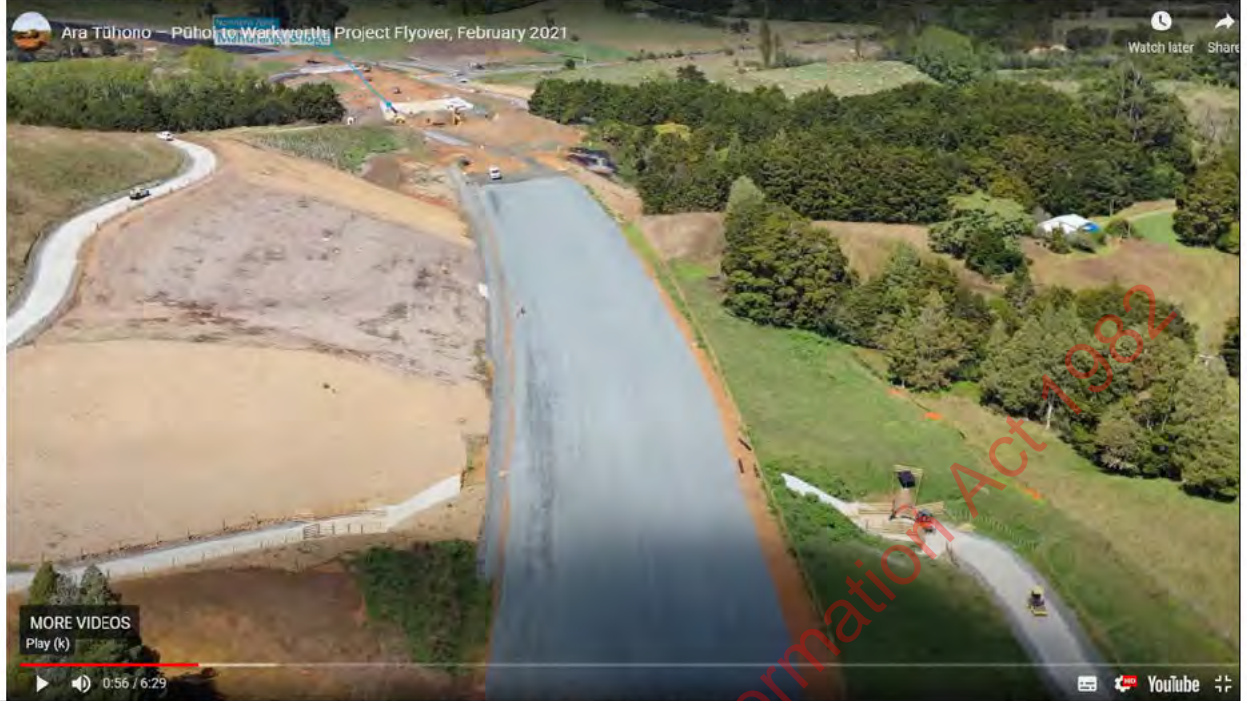
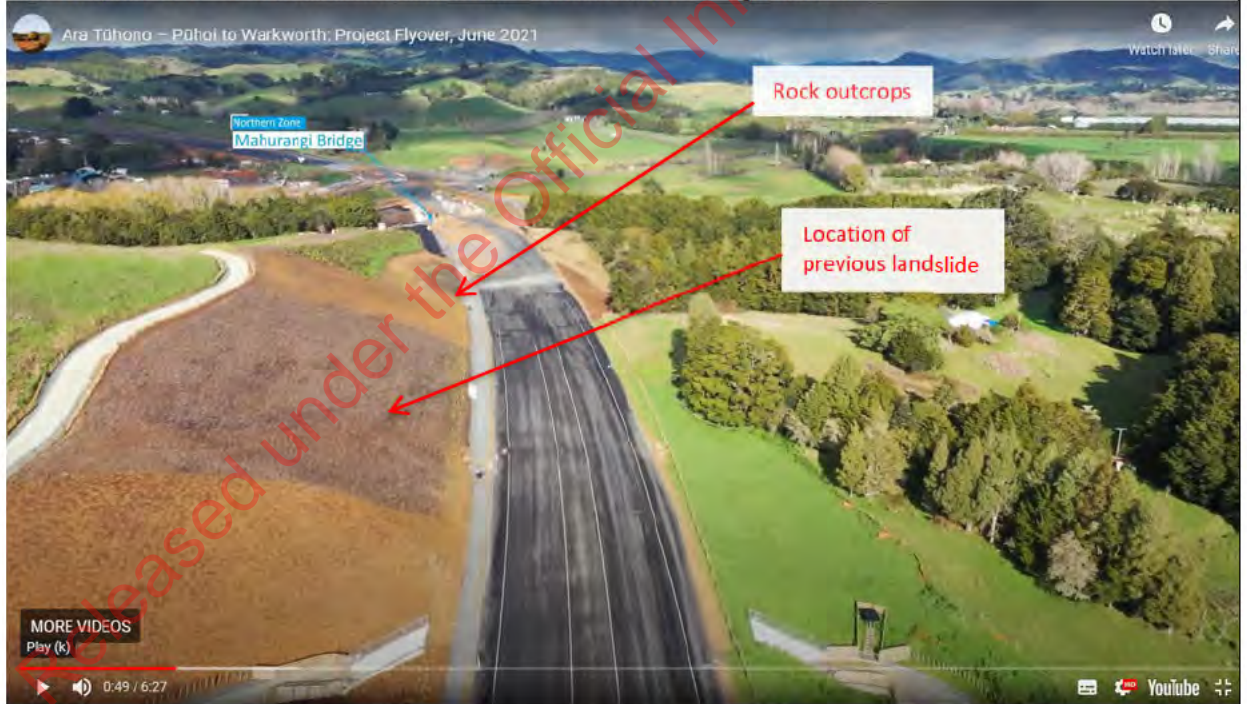
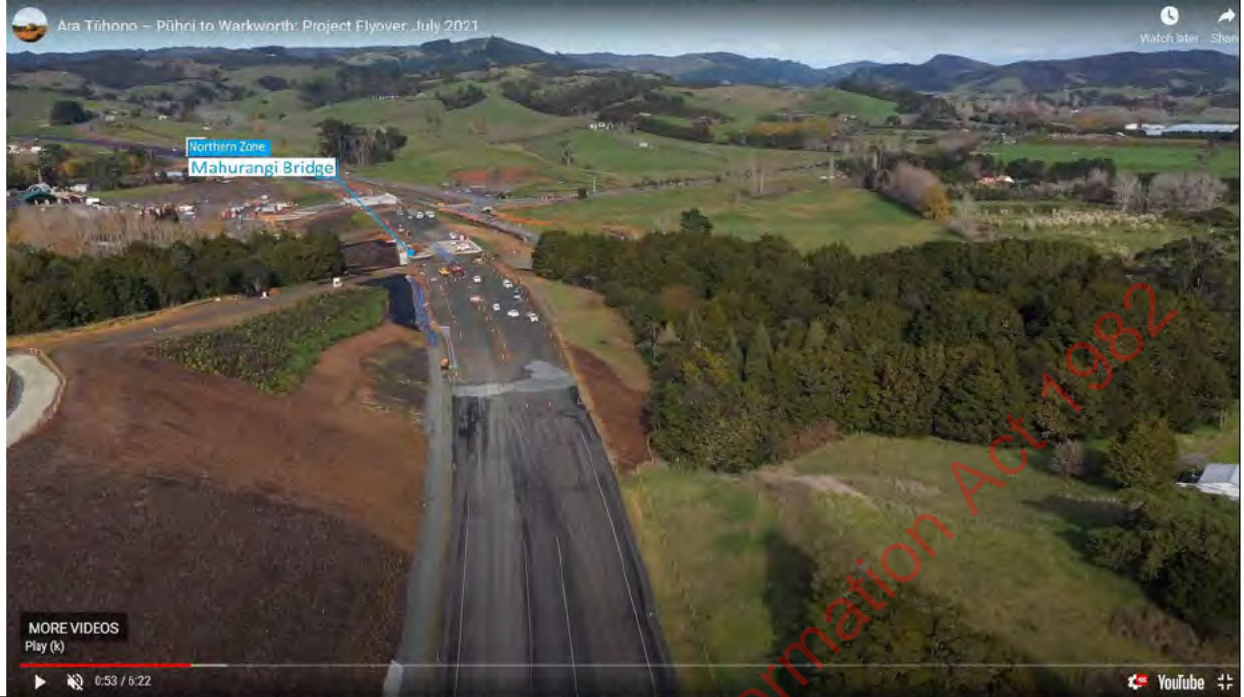
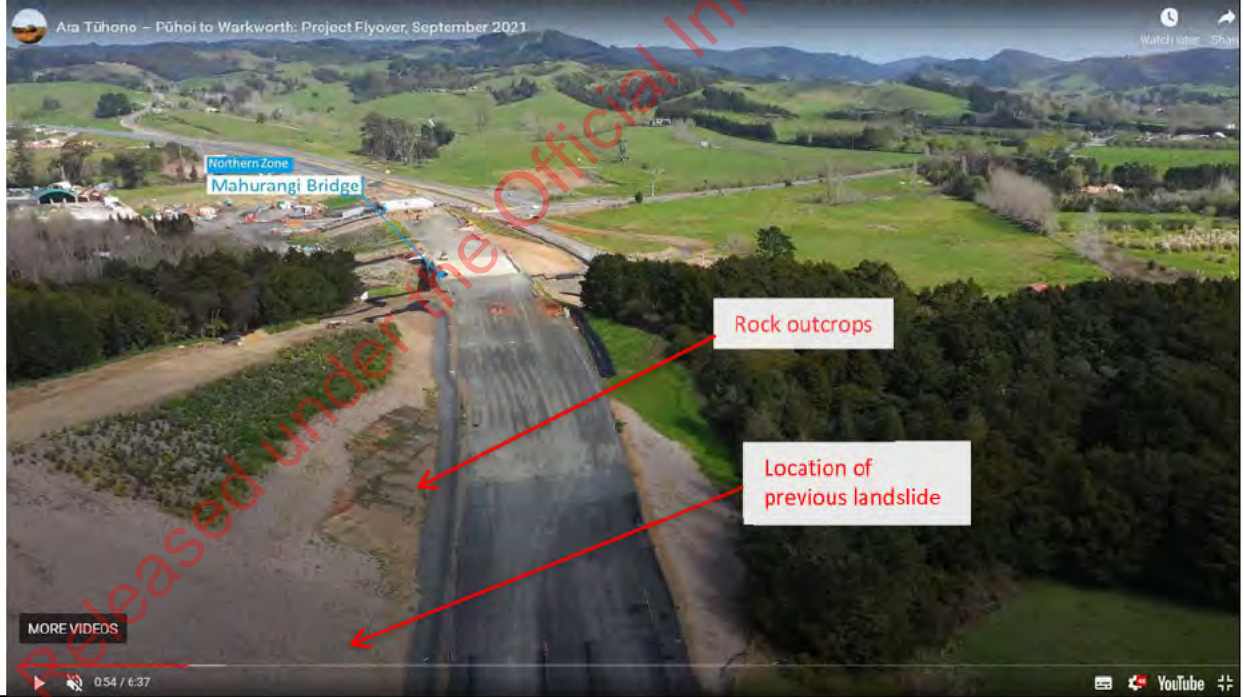
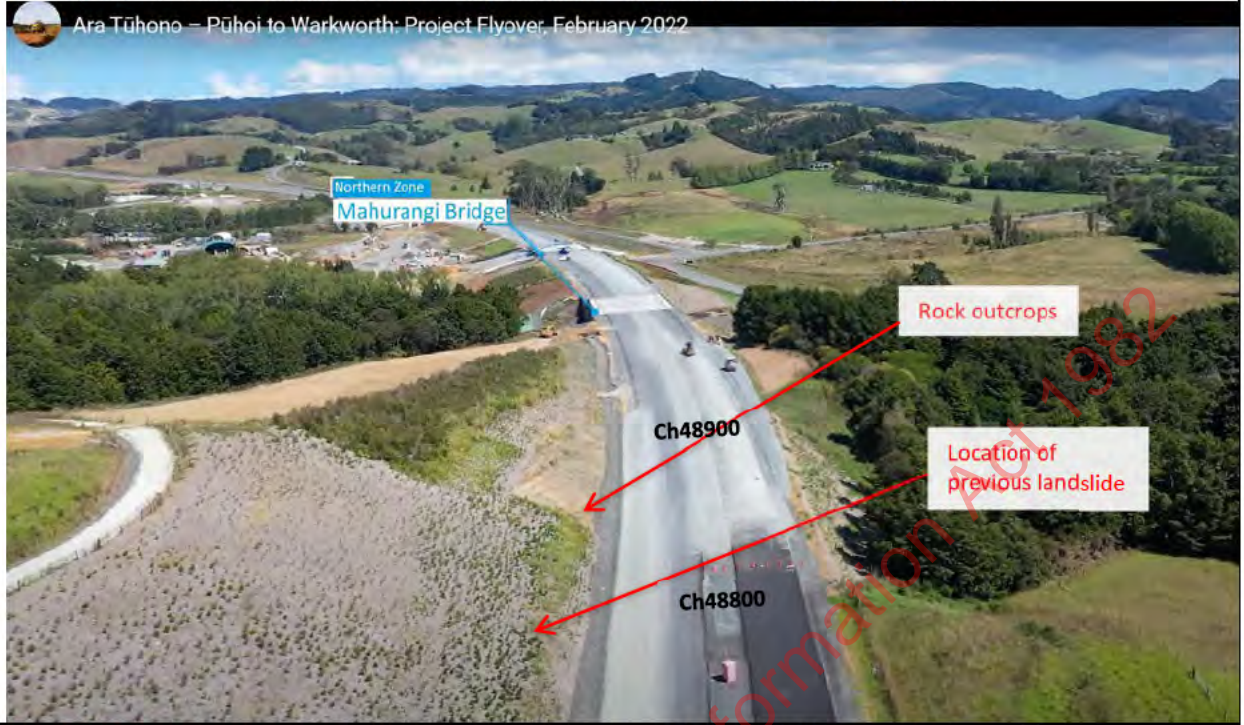
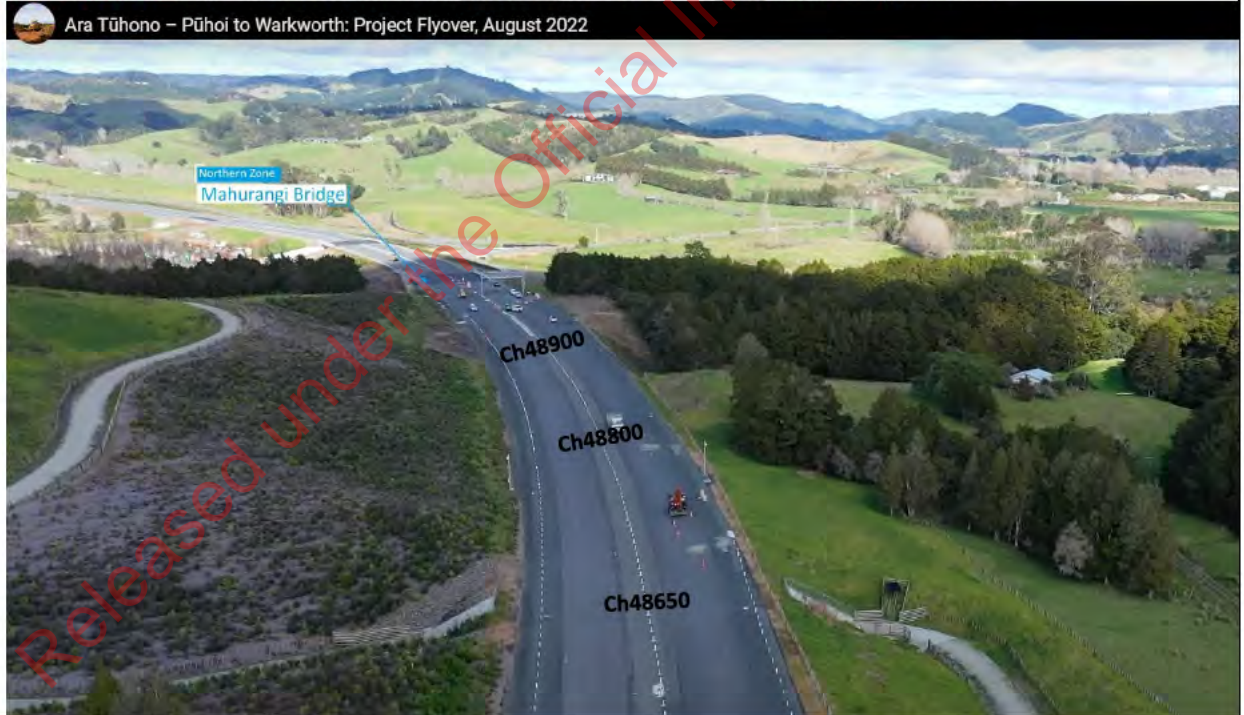
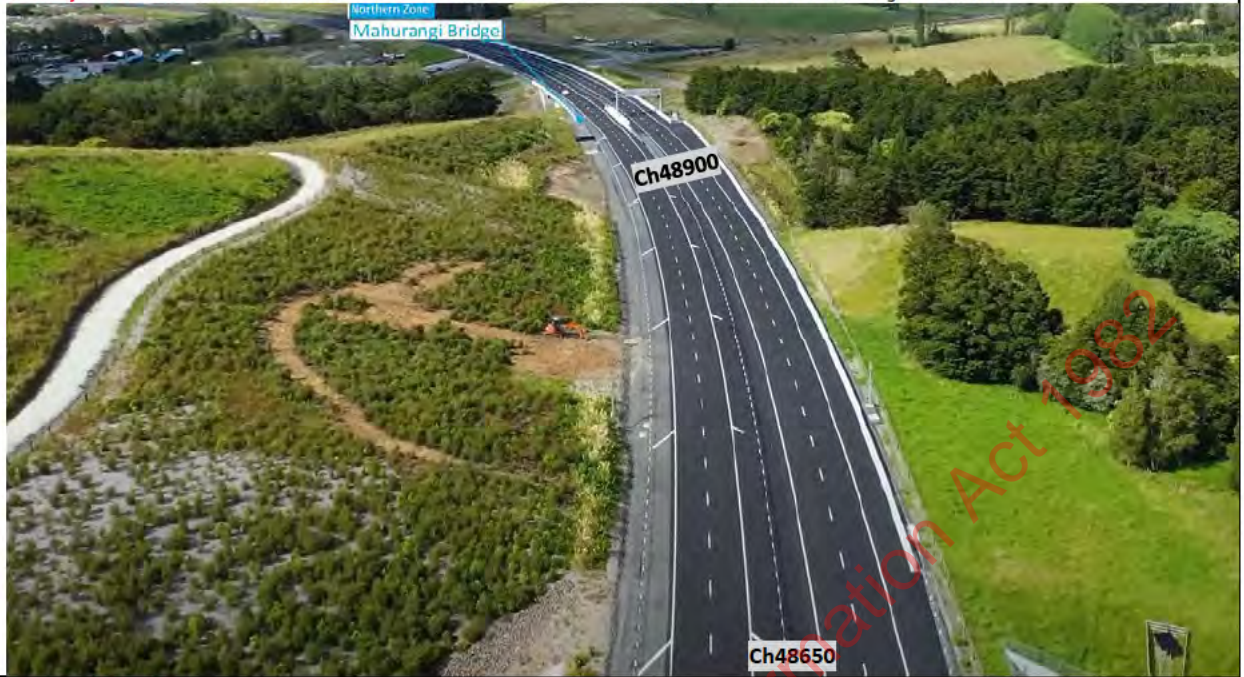
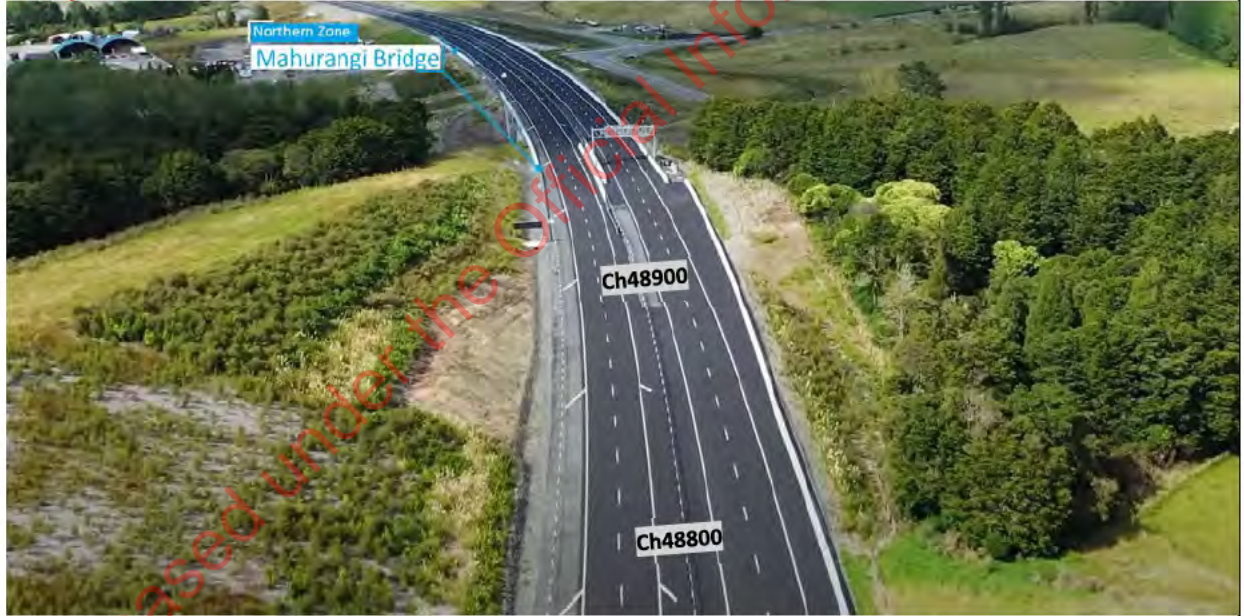
## 7.6 N1A – Landslide 1

Existing Landslide	Yes (No 1), N1A – East, Ch48,710 – Ch48,780
Cause of Landslide	<ul style="list-style-type: none"> <li>• Evidence of historic landslide activity within and above the excavation footprint.</li> <li>• A secondary softened shear planes orientated parallel to bedding fabric.</li> <li>• The presence of a saturated material above the soil/rock interface</li> </ul>
Date Landslide occurred	<p>March 2020.</p> <p>Further large movements were observed since September/ October 2022. Additional remedial works are required. The slope section at Ch48,700-48,800 is currently considered as an active landslide.</p>
Cut within area of historic landslide	Yes. Low risk sloping in north-western and western direction (Refer drawing P2Wk-DRG-GG-00-0302-D).
Geotechnical Investigations	BH388A, BH6120, BH6010, BH7005, BH6011, BH387, TP367 (Selected investigations, refer to P2Wk-DRG-GG-03-0302 and 0303 for complete information)

Very wet and saturated ground was observed at the toe of slope at Ch48,700-48,800 where the recent slope movement was observed.
Risk of Future Slope Failure	<p><b>East:</b> The risk of future slope failure is considered very high as parts of the slope (approx. Ch48,700 – 48,800) have active slope movements. The overall weighted risk rating is a moderate risk. The overall risk rating has been increased from low risk to moderate risk since the Revision D Report.</p> <p><b>West:</b> Very low risk.</p>

Soil Rock Transition Zone	5° to 10°
Rock Cut	Rock cut exposure at the eastern side of cut slope formed 4H:1V
Remedial Works Design	DEI 0440, DEI 0444 (Ch48700 – 48730, Soil Stabilisation)
Remedial Works Details	<p><b>First landslide:</b></p> <ul style="list-style-type: none"> <li>• 5x counterfort drains at slip location Ch48,710 – Ch48,780,</li> <li>• Buttress fill</li> <li>• Reshaped from 3H:1V to 4H:1V</li> </ul> <p><b>Second landslide (Ch48,700 – 48,800) October/November 2022</b>          To be confirmed. Final details were not available at the time of writing this report.</p>
Independent Peer Review	Refer to PSM Report PSM4203-029R Draft Rev 4 – Appendix A (only applies for the first landslide)
Rock Cut Slope	Rock outcrop at lower part of cut slope is cut at 4H:1V
Groundwater Seepage Monitoring	<p>Seepage monitoring undertaken on the 14/07/2021 and within 48hours of rainfall. Groundwater seepage observations are as follows:</p> <ul style="list-style-type: none"> <li>• Soil slope was topsoil/mulched at time of inspection</li> <li>• Seepages recorded at northern end of cut slope</li> <li>• Seepage and landslide recorded on eastern cut slope side</li> <li>• Seepages recorded at soil-rock transition</li> <li>• Minor seepage from rock face and typically increased seepage directly after rainfall</li> </ul>
