Pūhoi To Warkworth (P2Wk)– Landslide Risk Assessment

# Geotechnical Review of Cut Slopes and Landslide Risks

Revision E

Date: 11 April 2023

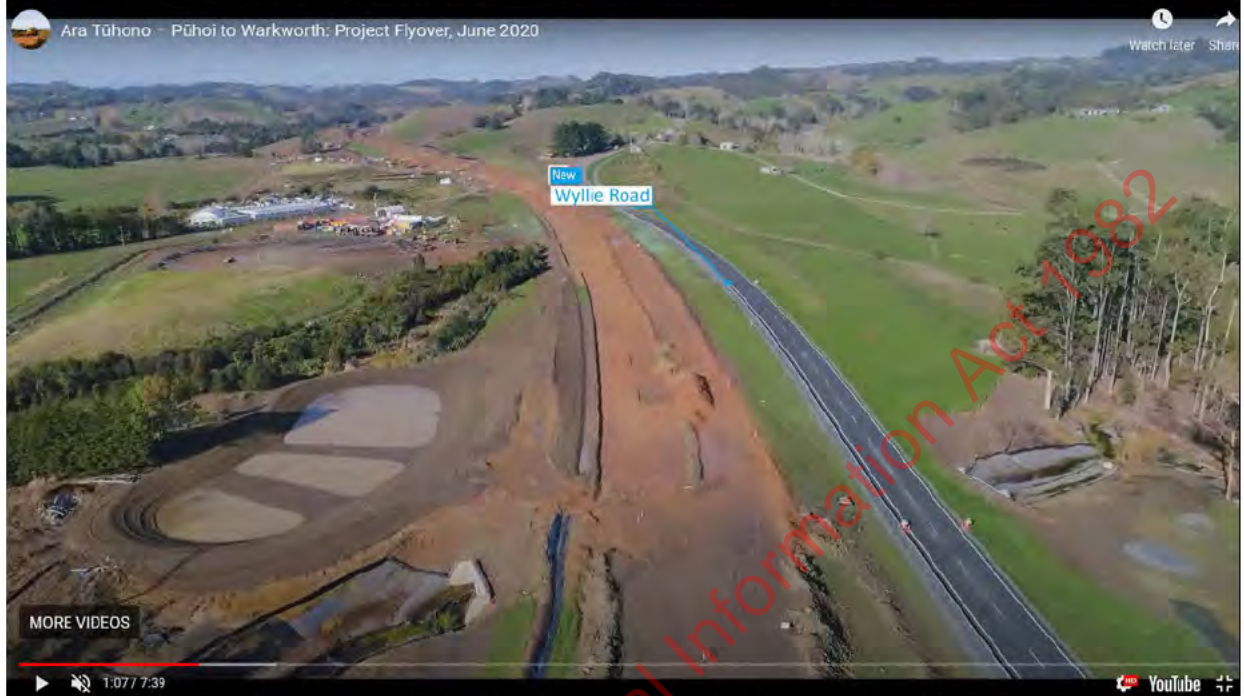
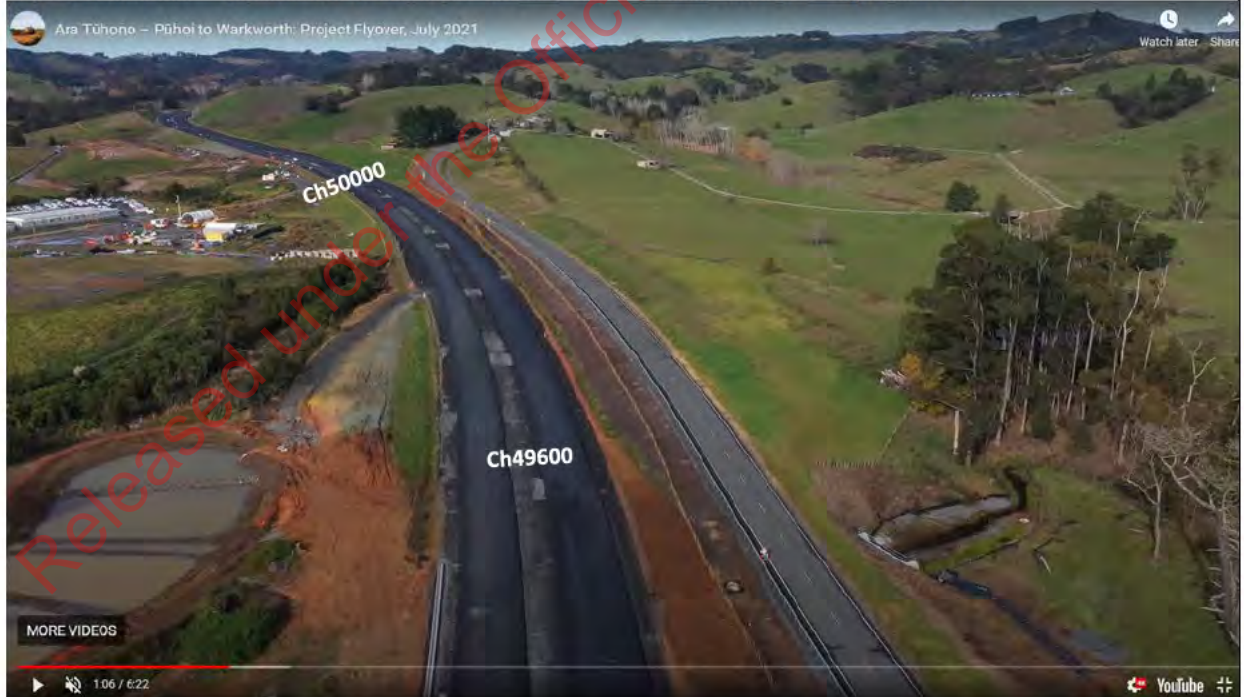
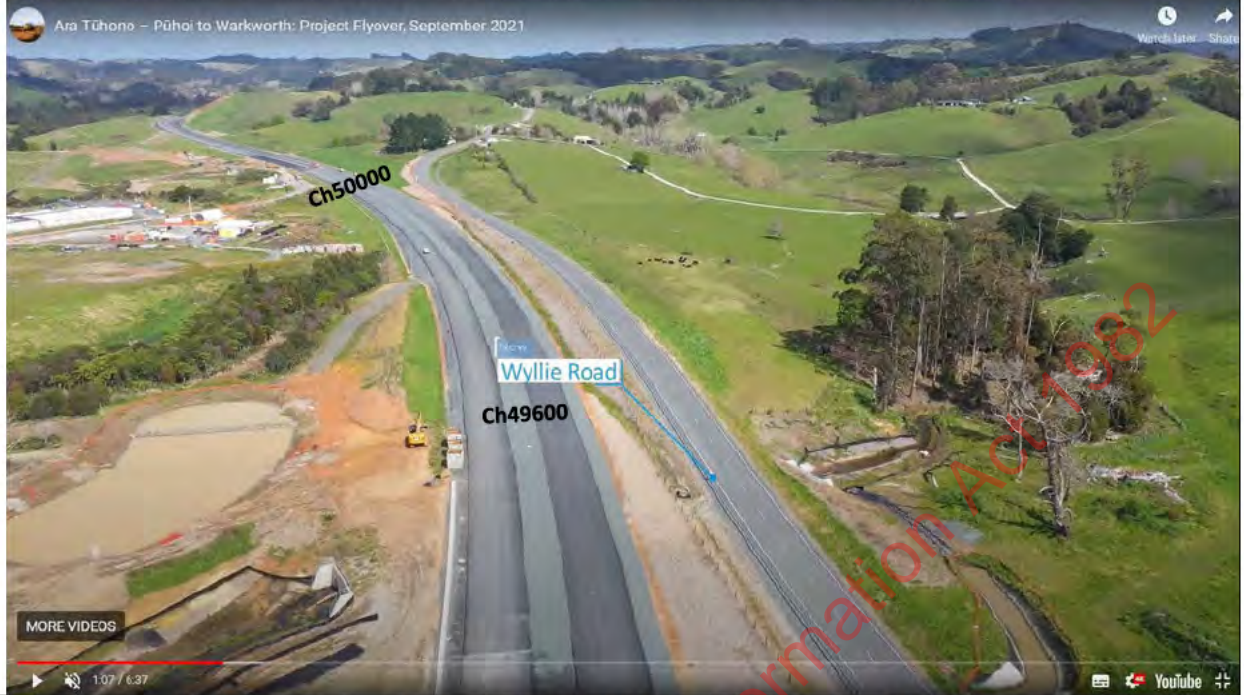
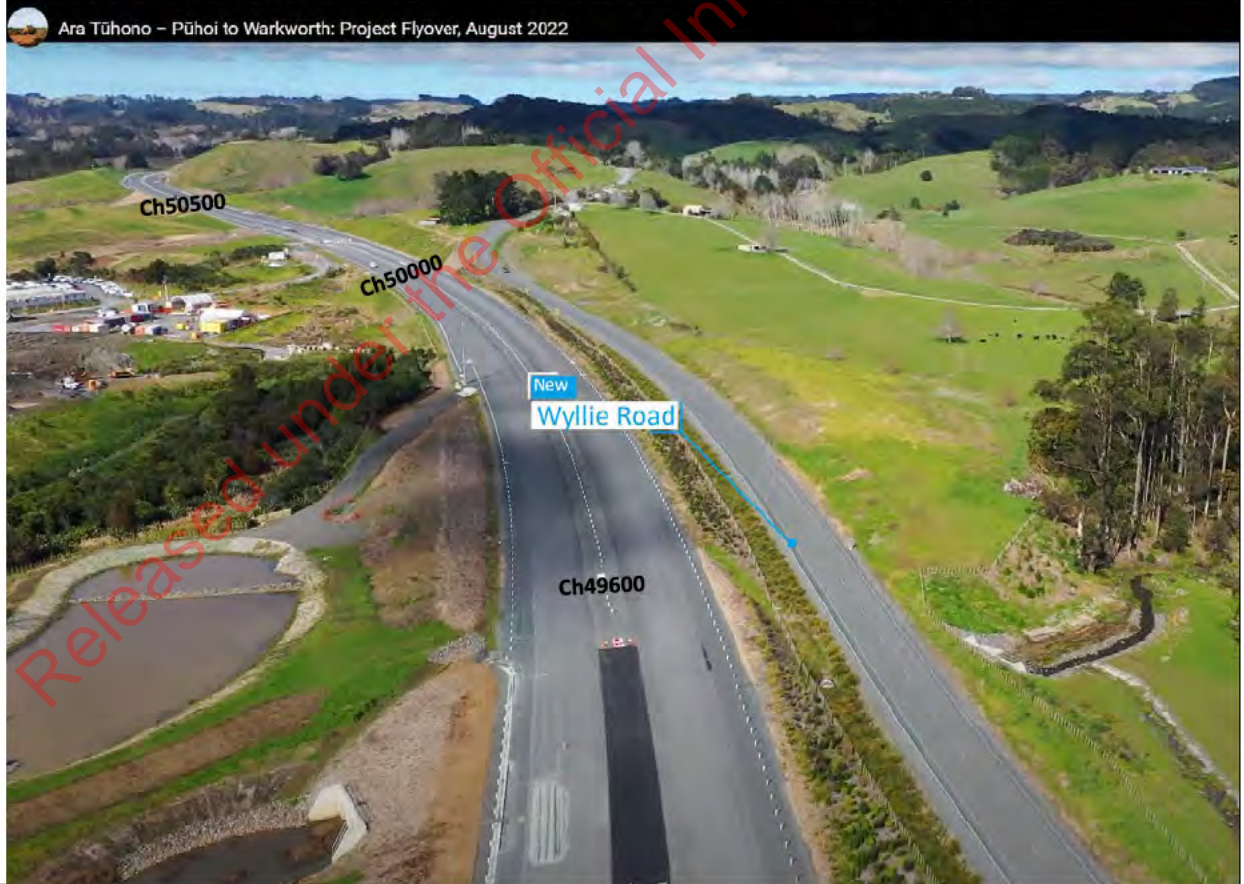
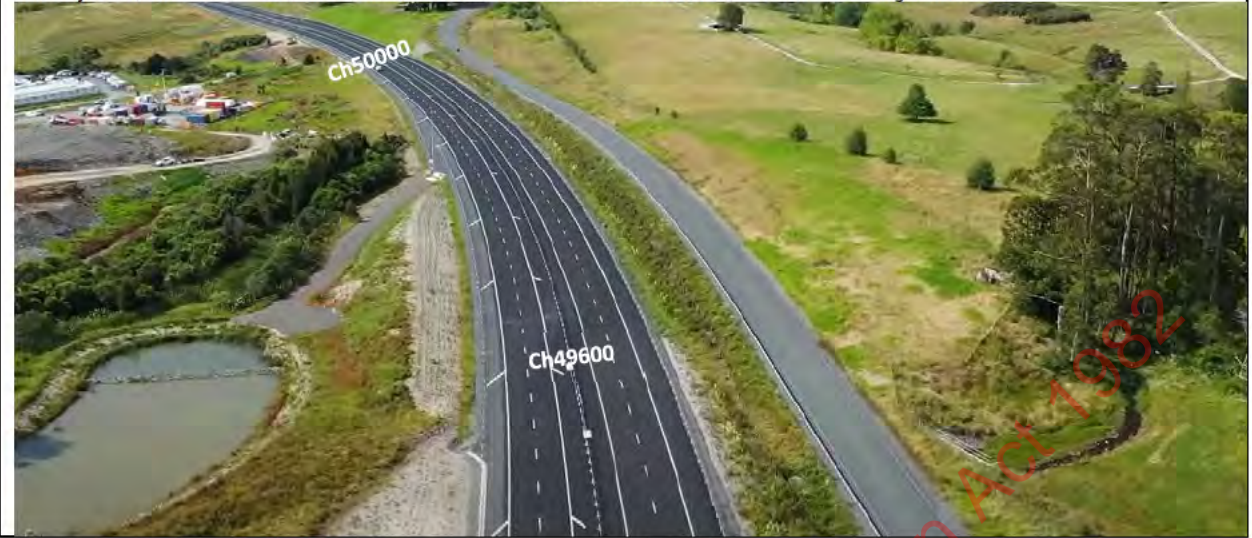
7.7 N4C

Risk of Future Slope Failure	<p><b>East (LHS):</b></p> <ul style="list-style-type: none"> <li>- The risk of future slope failure is considered <b>very low</b>. Low slope height. Topography dipping away at the back of the cut slope.</li> </ul> <p><b>West (RHS):</b></p> <ul style="list-style-type: none"> <li>- The risk of future slope failure is considered <b>very low</b>. Low slope height.</li> </ul>

The risk rating at both sides has been reduced from low risk to very low risk since the previous Revision D Report.

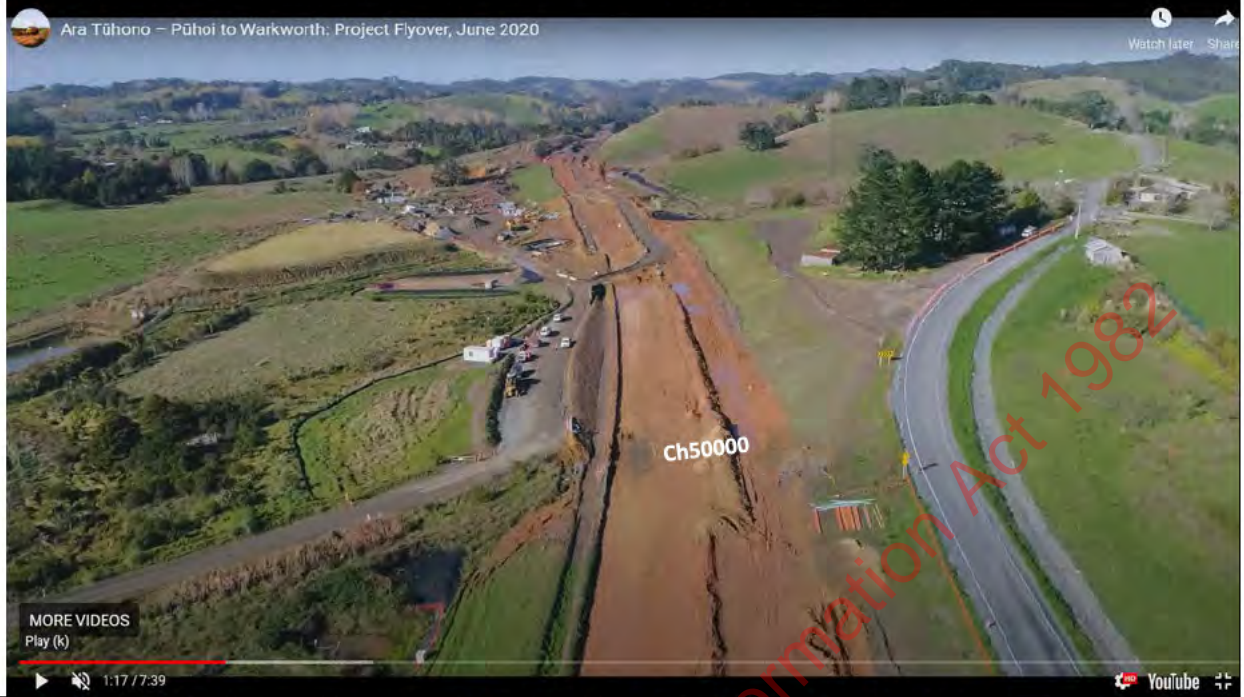
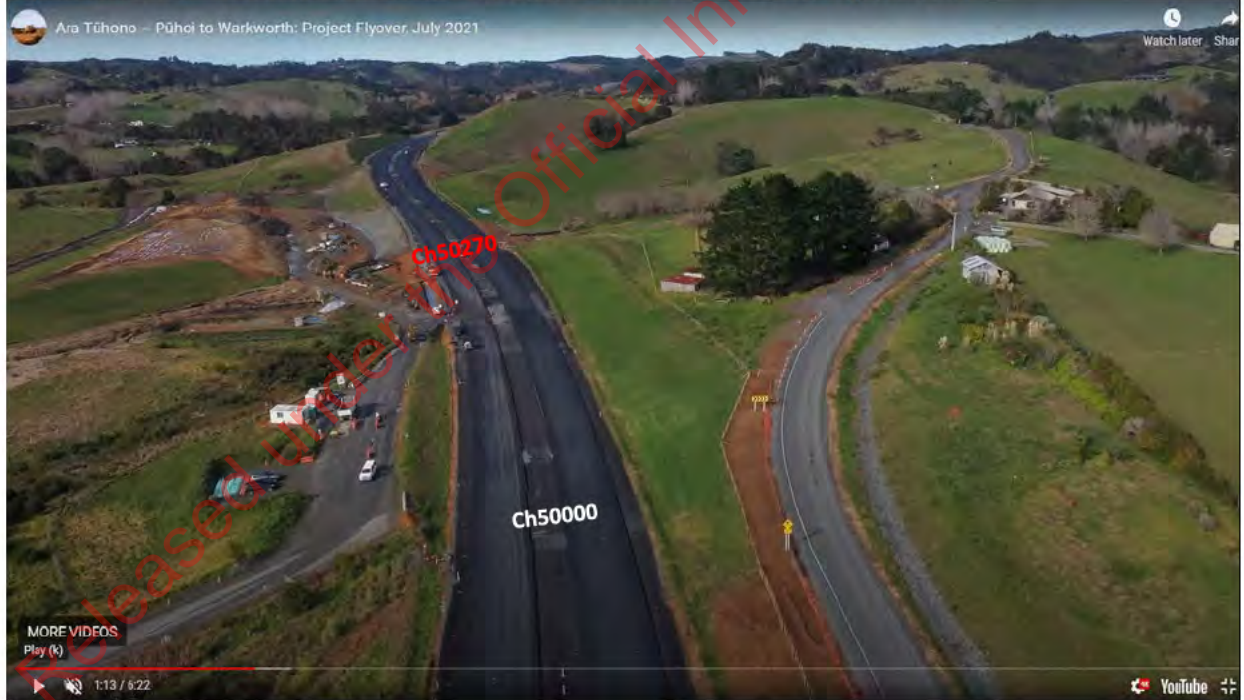
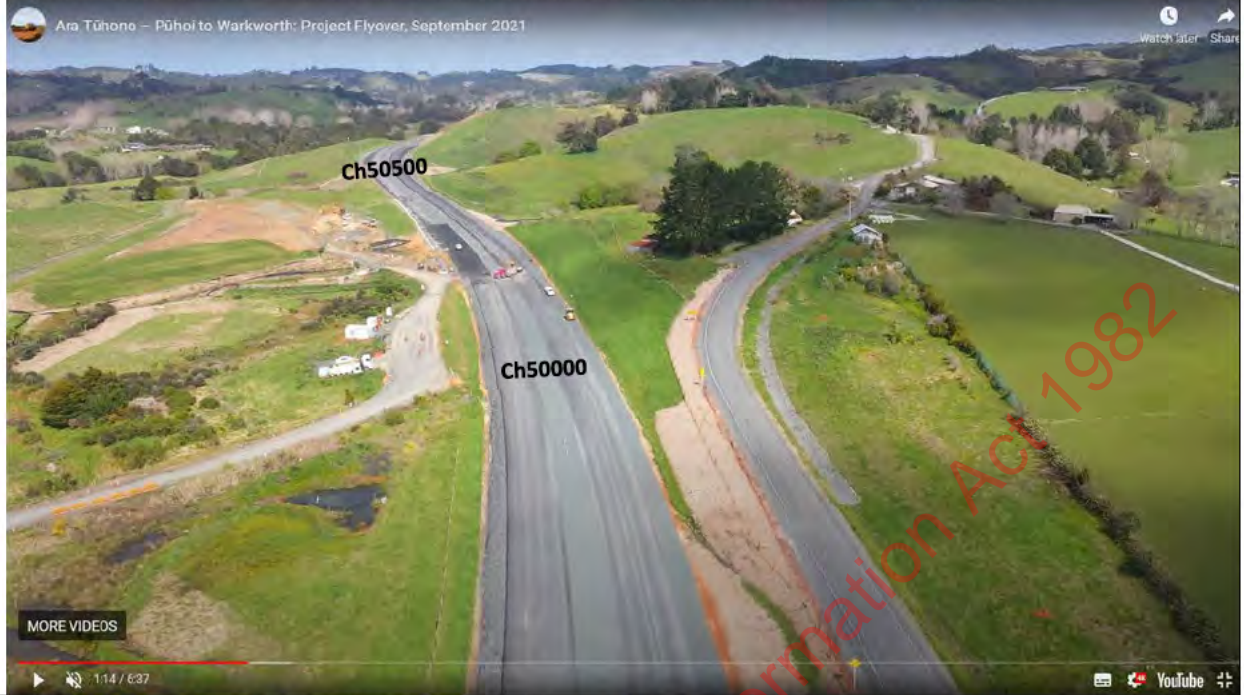
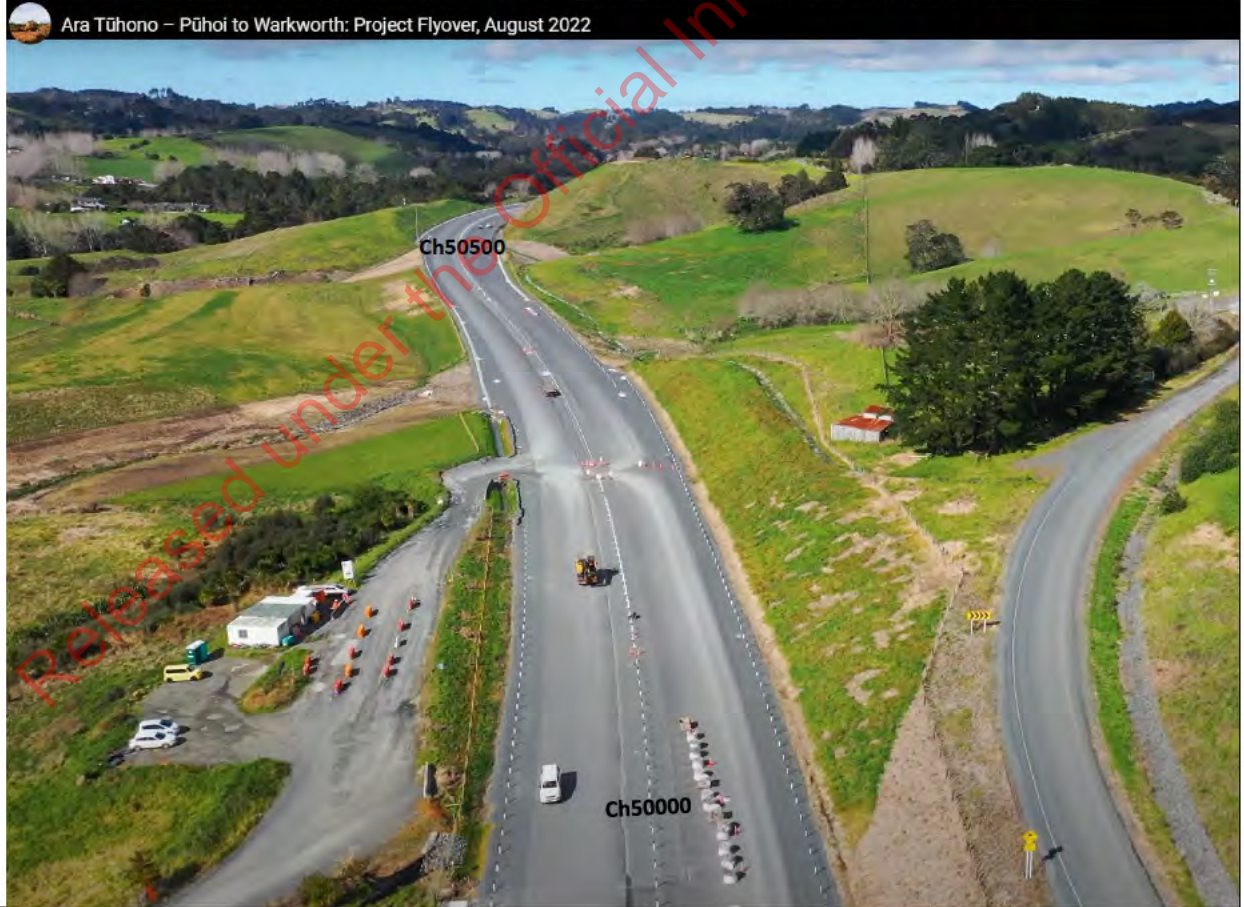
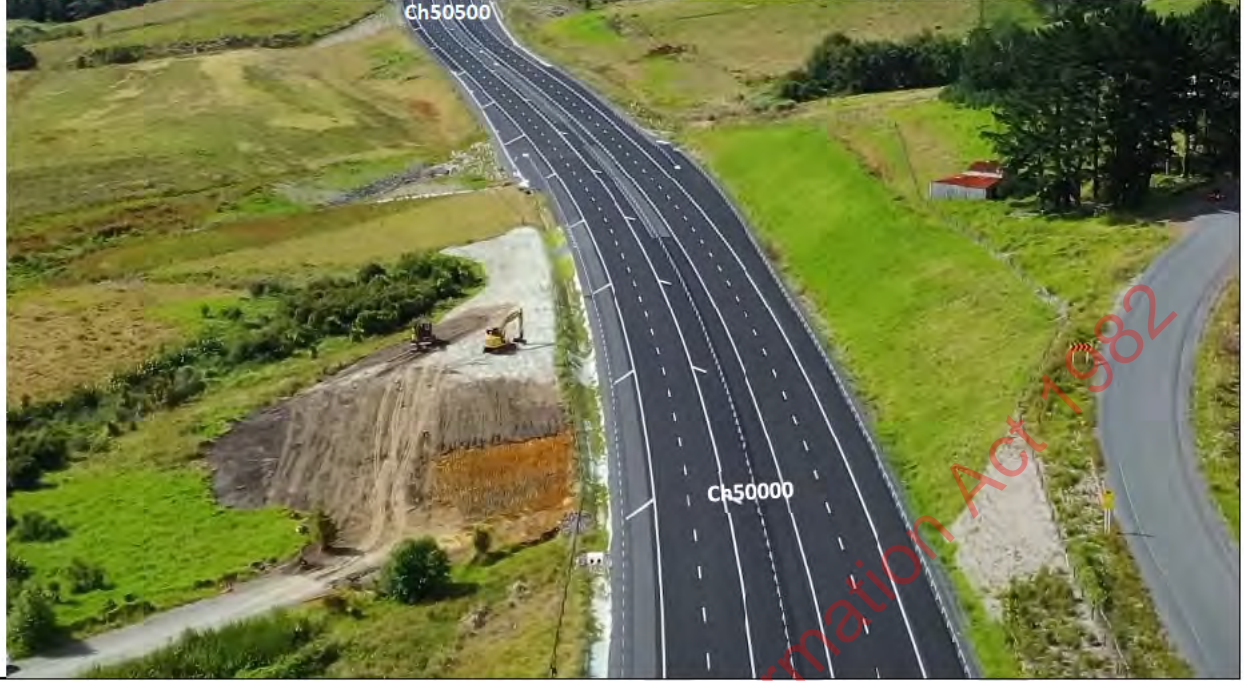
7.8 N4E

Soil Rock Transition Zone	Transition zone dips at 5-15deg from West to East approx. 3m below toe of slope
Rock Cut	No rock cut or rock exposures at cut slope.
Remedial Works Design	None required.
Remedial Works Details	Not applicable
Peer Reviewed in PSM Report Rev 4	Not reviewed
Groundwater Seepage Monitoring	No groundwater seepage monitoring carried out.
Risk of Future Slope Failure	<p><b>East (LHS):</b> The risk of future slope failure is considered <b>very low</b>. Low slope height. Topography dipping away at the back of the cut slope.</p> <p><b>West (RHS):</b> The risk of future slope failure is considered <b>very low</b>. Low slope height.</p> <p>The risk rating at both sides has been reduced from low risk to very low risk since the previous Revision D Report.</p>

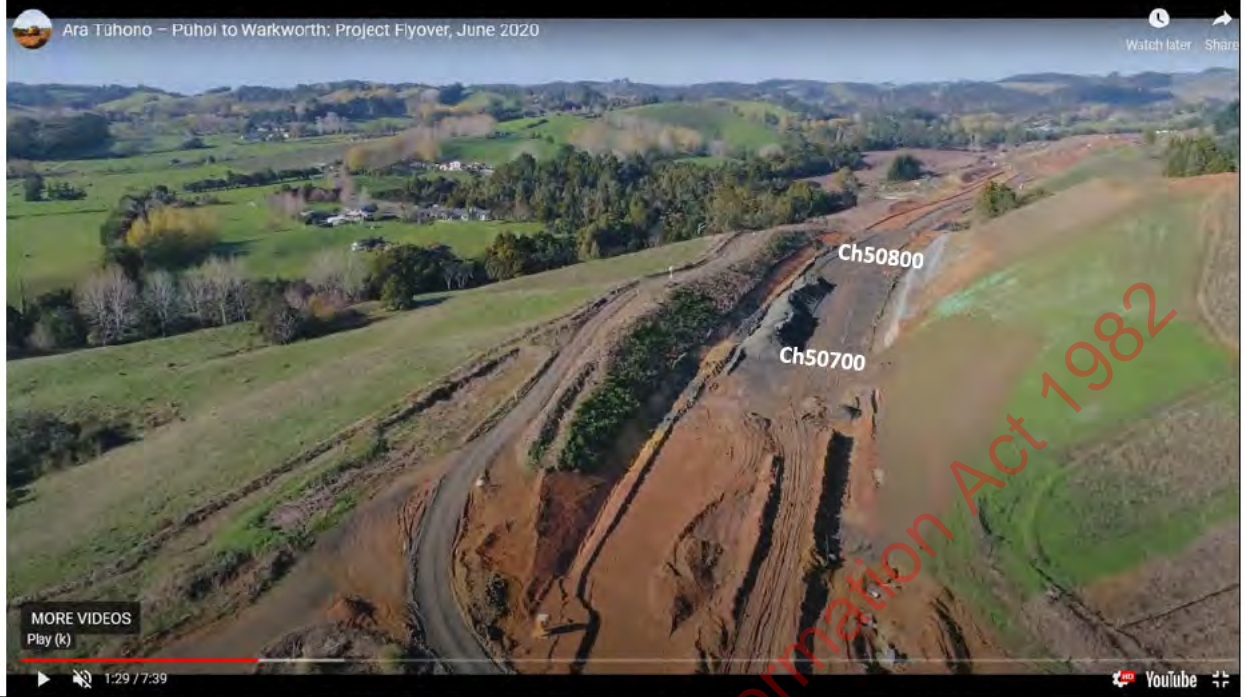
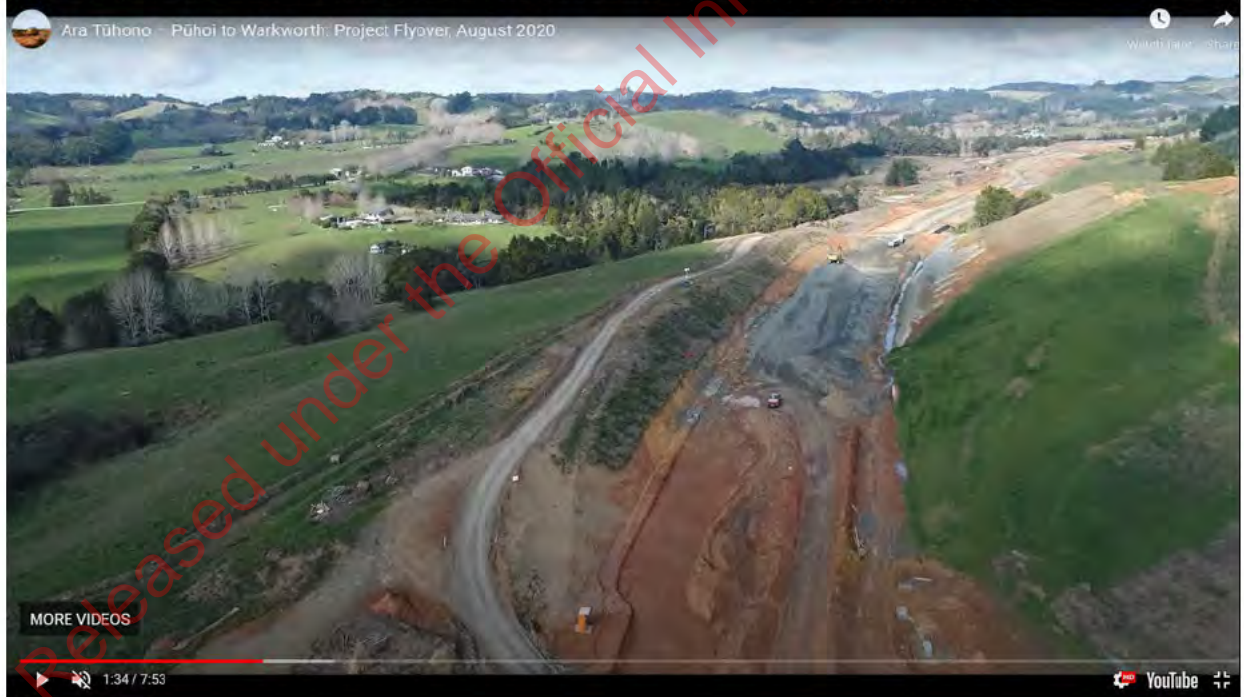
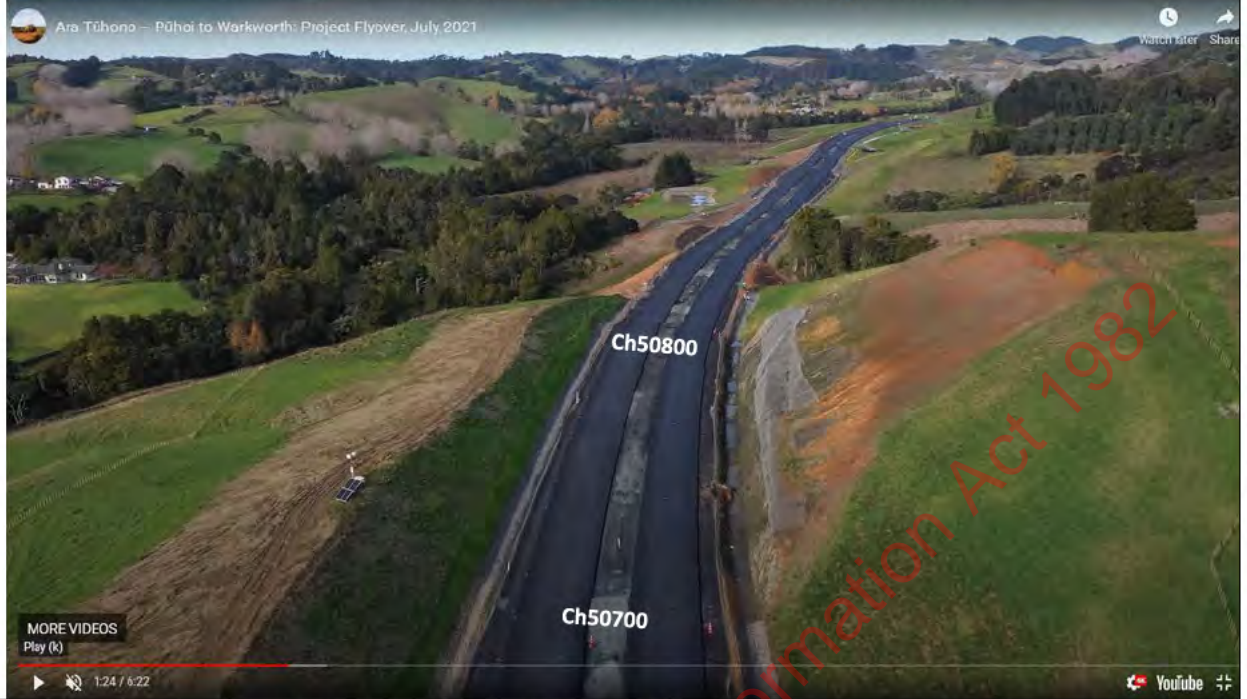
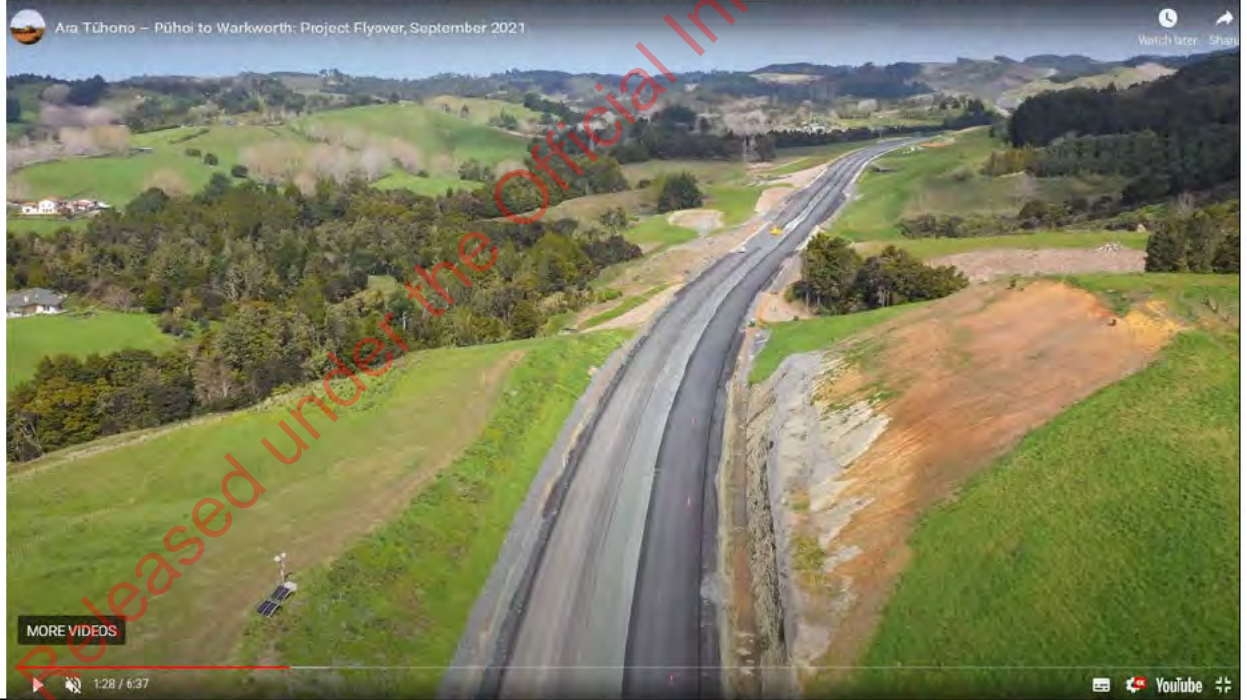
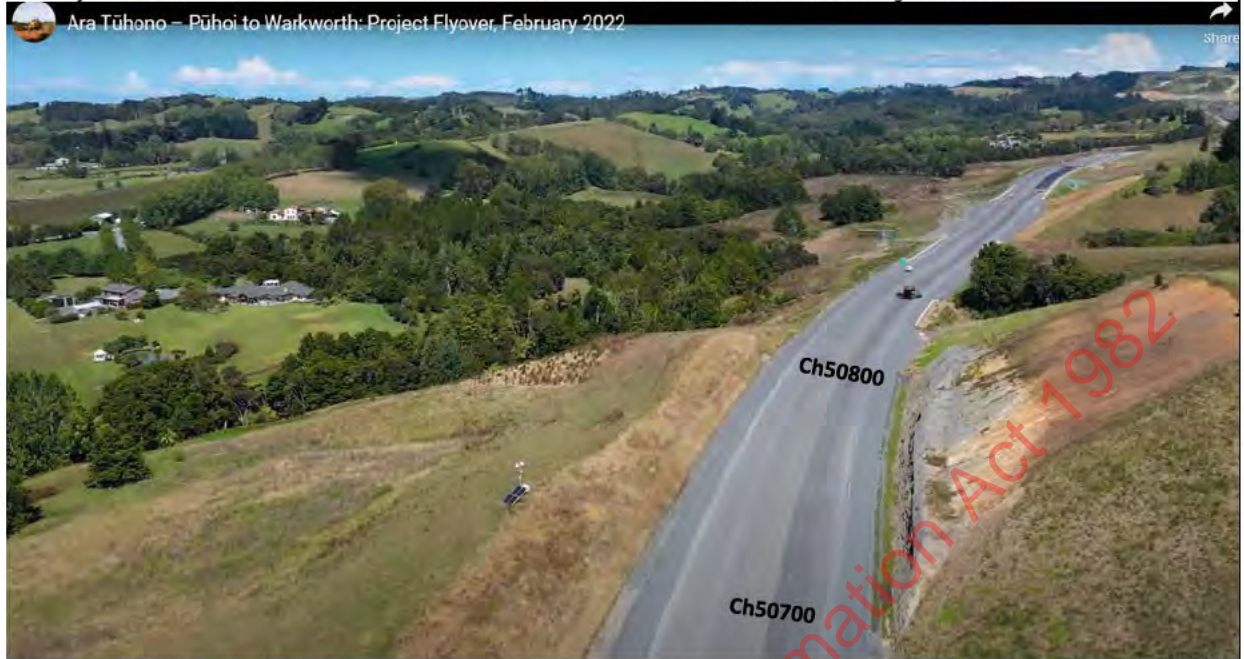
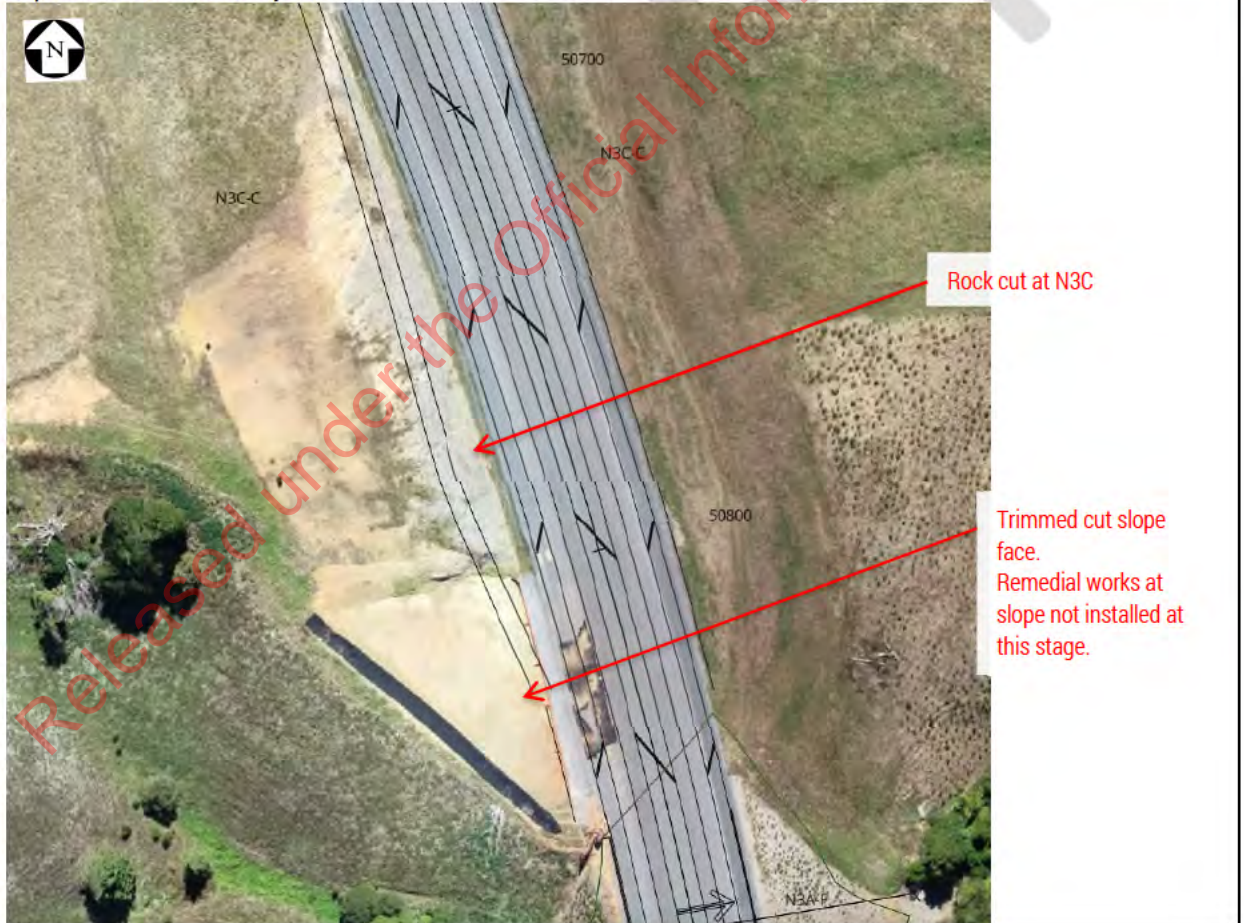
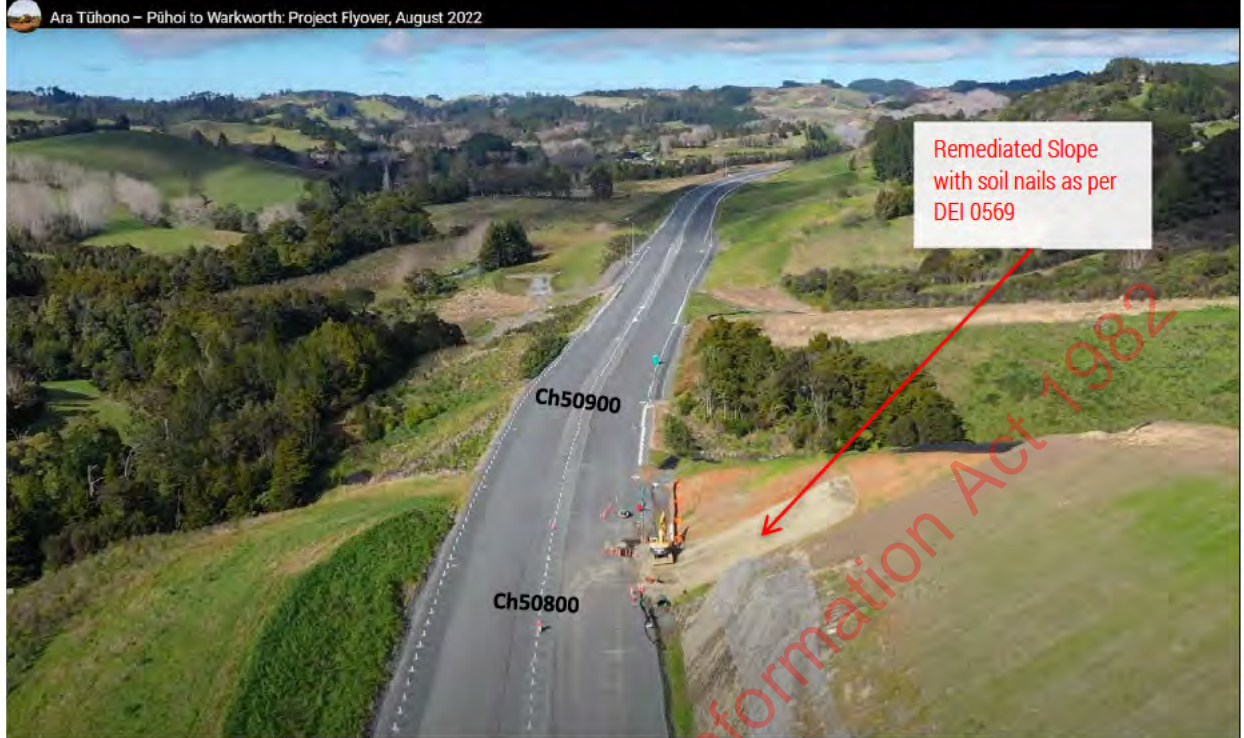
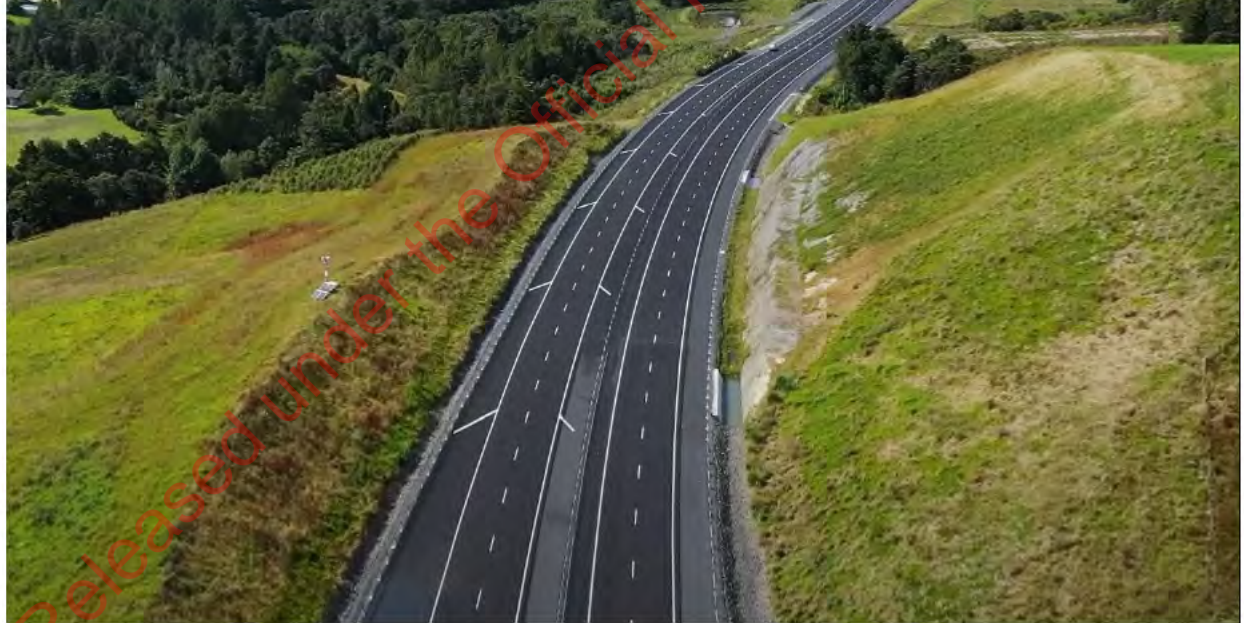
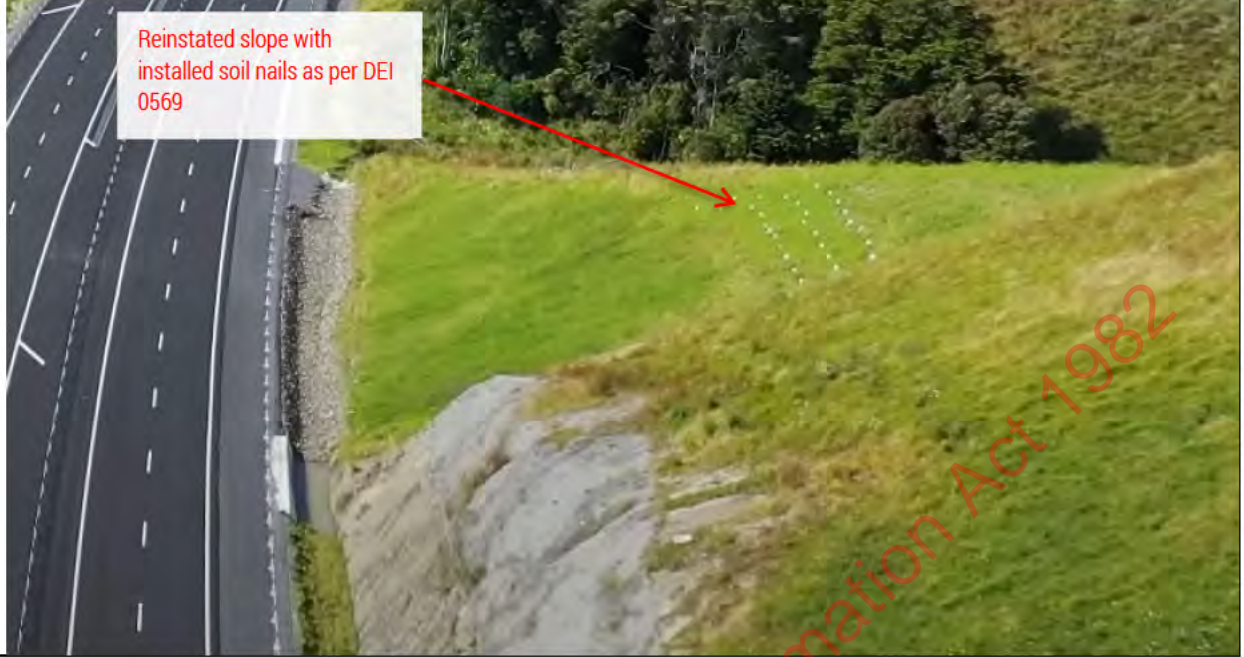
7.9 N3C

Existing Landslide	<p>Not part of the landslide remedial works scheme. A new landslide showing tension cracks was reported s 9(2)(b)(ii) and prior to the site inspected dated 2 Nov. 2021. During the July 2022 rainfall event, the p occurred as the remedial works were not carried out.</p>
Cause of Landslide	<p>Sliding on weathered rock / soil bedding shear planes.</p>
Date Landslide occurred	<p>Initial tension cracks in October/ November 2021. Landslide with large movements in July 2022.</p>
Cut within area of historic landslide	<p>Low risk at south-western part (RHS)</p>
Geotechnical Investigations	<p>BH223, BH379, TP6103, TP6122, TP4014, TP6123</p>
Site Geology	<p>The design report Section 5.3.7.6 described the following conditions: "The soil/rock interface is abrupt, which means that the residually weathered soil transitions to rock without a gradational</p>

Risk of Future Slope Failure	<p><b>East (LHS):</b> The risk of future slope failure is considered low. Low slope height. Topography dipping away at the back of the cut slope</p> <p><b>West (RHS):</b> The risk of future slope failure is considered low despite the slope height and the topography at the back of the cut slope. The soil slip at Ch50800 to Ch50840 at the southern side of the rock cut has been repaired in August 2022. The slipped material has been removed and soil nails and subsoil drains are installed.</p> <p>The risk rating is consistent with the Revision D Report.</p>

Soil Rock Transition Zone	Transition zone is dipping at 10-15° from West to East.
Rock Cut	64° steep, up to 14m high rock cut at western side (RHS) in slightly weathered Pakiri Formation (Unit P5)
Remedial Works Design	Removal of slipped material and soil nails.
Remedial Works Details	7 rows of soil nails as per DEI 0569 (remedial works design of tension crack prior to the landslide). It appears that only 3 rows of soil nails were installed after the slope was reinstated. As-builts are not available to us.
Peer Reviewed in PSM Report Rev 4	Not applicable as landslide occurred after the report was prepared.
Groundwater Seepage Monitoring	<p>Seepage monitoring of the western cut slope was undertaken on the 14/07/2021 within 48 hours of rainfall and an engineering geological site inspection on the 2/11/2021. Groundwater seepage observations and engineering geological observations are as follows:</p> <ul style="list-style-type: none"> <li>• Soil slope was typically dry however grassed/vegetated at time of inspection</li> <li>• Seepage recorded from rock bedding and joint structure</li> <li>• Seepage recorded from soil-rock transition at bench</li> <li>• The slip/failure as observed on 2/11/2021 at southern end between Ch50800 and Ch50840 has been repaired by means of soil nails in March 2022. Refer to DEI 0569.</li> <li>• Seepage/trickle recorded from transition cut between soil and rock slope located directly beneath slip with wet and softened ground present.</li> <li>• Relict bedding structure visible within the highly to completely weathered soil and rock above the bench.</li> <li>• Minor erosional rilling of highly to completely weathered soil and rock</li> </ul>

Reinstated slope with installed soil nails as per DEI 0569

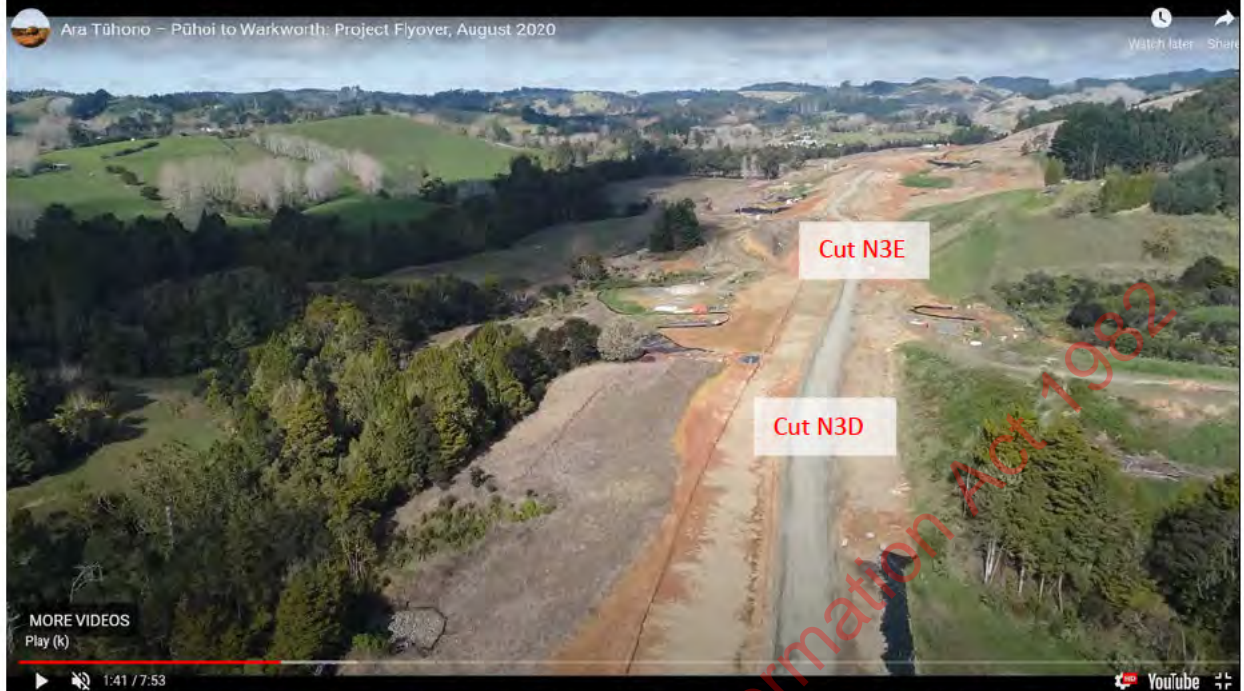
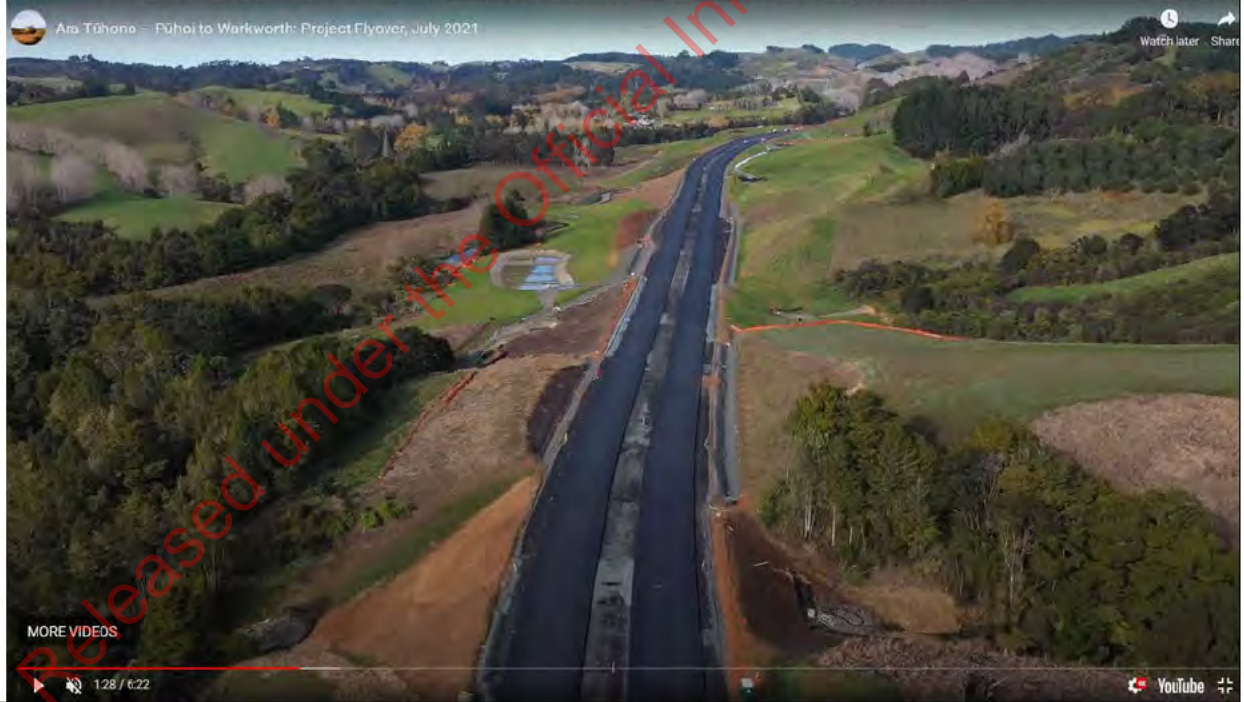
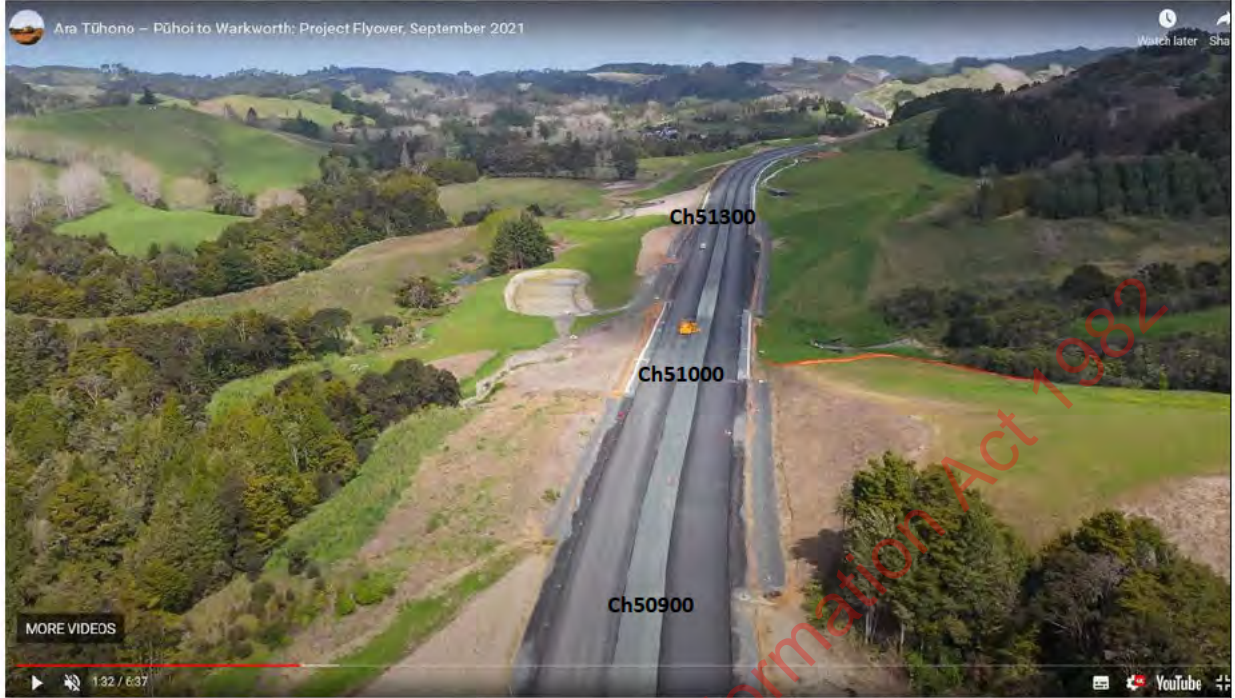
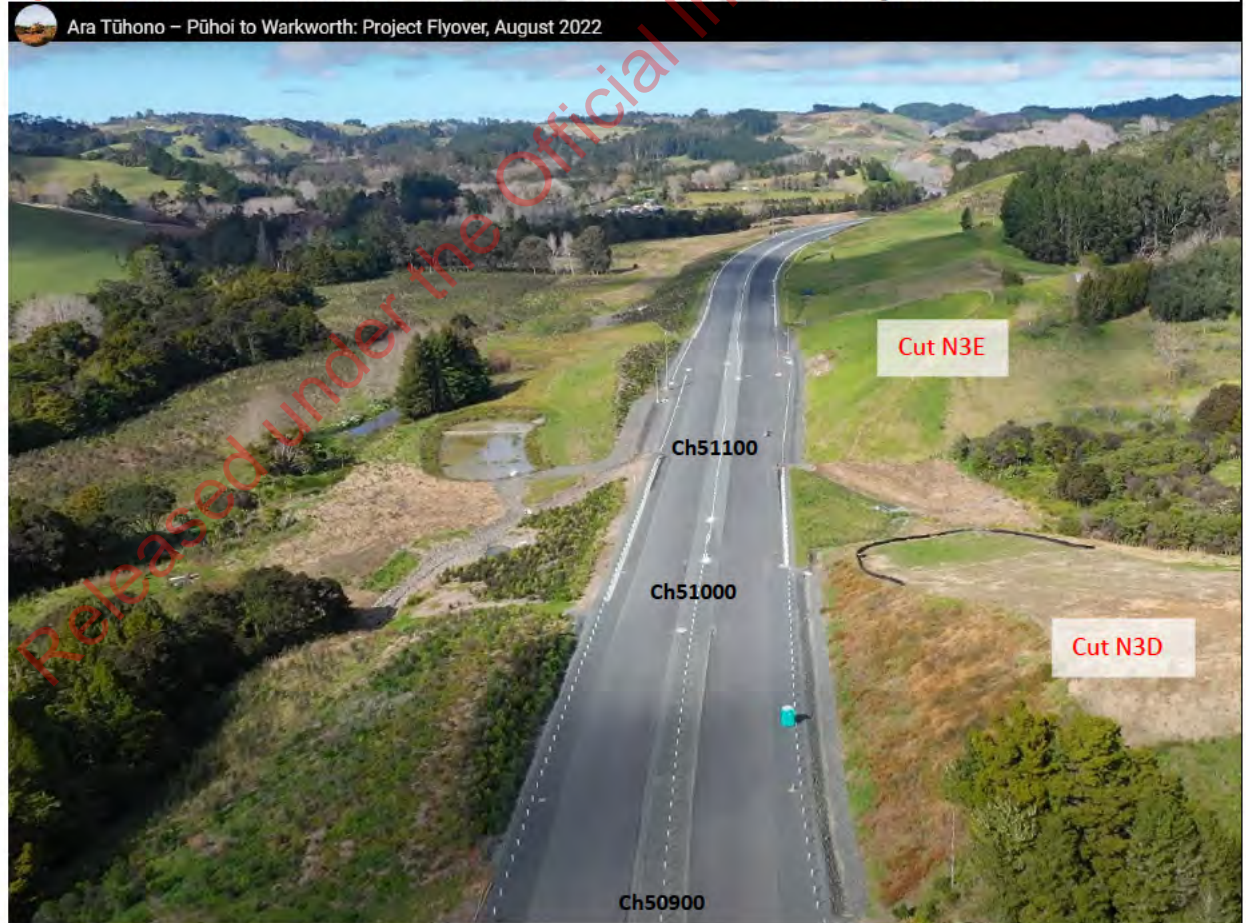
7.10 N3D

Geotechnical Investigations	TP6042, TP6043, TP358, TP359
Site Geology	No geological section provided in the report. Based on geotechnical investigation data, residually weathered Pakiri Formation soils are expected.
Soil Rock Transition Zone	Not clear, cannot be determined based on test pit investigations.
Rock Cut	No rock cut or rock exposures at cut slope obvious from drone flyover footage.
Remedial Works Design	None required.
Remedial Works Details	Not applicable
Peer Reviewed in PSM Report Rev 4	Not reviewed
Groundwater Seepage Monitoring	No groundwater seepage monitoring has been carried out at this slope.
Risk of Future Slope Failure	<p>East (LHS): The risk of future slope failure is considered <b>very low</b>.                  West (RHS): The risk of future slope failure is considered <b>very low</b>.                  The risk rating at the western side has been reduced from low risk to very low risk since the previous Revision D Report.</p>

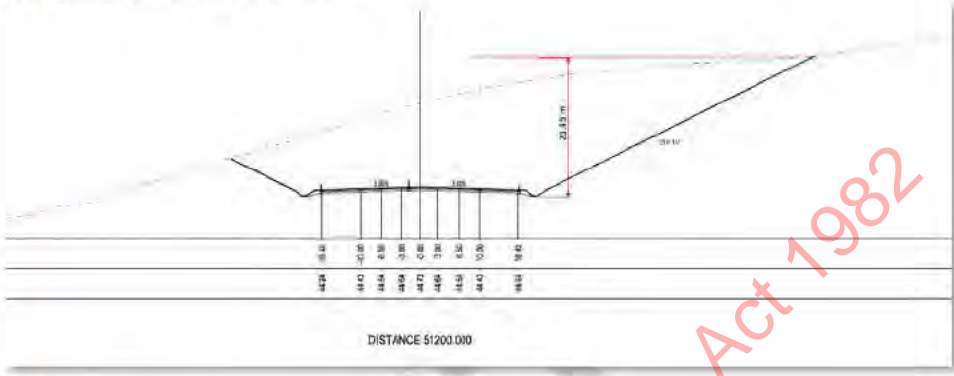
7.11 N3E

Chainage	Ch51,085 – Ch51,295
Typical Design Slope Geometry	<p>East (LHS): 2H:1V up to 6m high                  West (RHS): 2H:1V up to 24m high</p>

Existing Landslide	None reported to s 9(2)(b)(ii) and 9(2)(ba)(i)
Cause of Landslide	Not applicable
Date Landslide occurred	Not applicable
Cut within area of historic landslide	Low risk at south-western part (RHS)
Geotechnical Investigations	BH4028, BH6020, TP6150, TP6051, TP356
Site Geology	<p>No geological section provided in the report. Based on geological maps and nearby cross section, the N3E is mainly cut in Residual Pakiri Formation.</p> <p>The report Section 5.3.7.8 states "<i>The upper 19m of the cut is within stiff Pakiri Formation residual soils with the lower 5m above cut level within Pakiri Formation rock. Groundwater is expected to be encountered during excavation of the cut.</i>"</p>
Soil Rock Transition Zone	Localised rock outcrop at lower slope at western (RHS) side is observed on the drone flyover footage. No rock at eastern cut slopes. Rock transition zone likely dipping in eastern direction, mainly below cut slope faces.

Rock Cut	<ul style="list-style-type: none"> <li>• Based on flyover footage, cut is formed in residual soil (likely Pakiri formation based on geology).</li> <li>• N3E, West: Small outcrop at lower slope</li> </ul>

Remedial Works Design	None required.
Remedial Works Details	Not applicable
Peer Reviewed in PSM Report Rev 4	Not reviewed
Groundwater Seepage Monitoring	Seepage monitoring undertaken on the 14/07/2021 within 48hours of rainfall: <ul style="list-style-type: none"> <li>Slope was dry at time of inspection with no obvious seepages recorded/encountered</li> </ul>
Risk of Future Slope Failure	East (LHS): <ul style="list-style-type: none"> <li>The risk of future slope failure is considered <b>very low</b>.</li> </ul> West (RHS): <ul style="list-style-type: none"> <li>The risk of future slope failure is considered <b>low</b>.</li> </ul>
