Pūhoi To Warkworth (P2Wk)– Landslide Risk Assessment

# Geotechnical Review of Cut Slopes and Landslide Risks

Revision E

Date: 11 April 2023

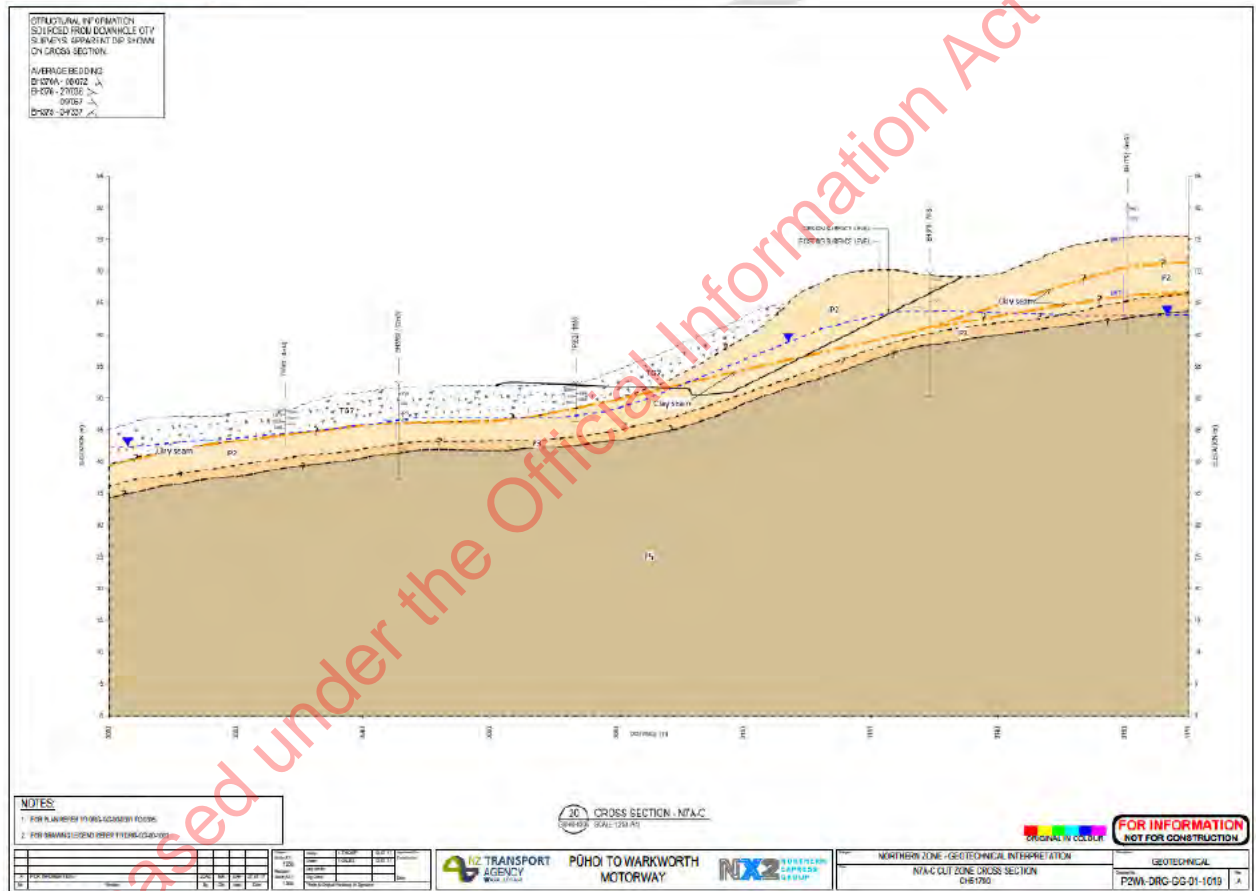
7.12 N7A – Landslide 2

Site & Design Description	<p><b>East (LHS):</b></p> <ul style="list-style-type: none"> <li>• 2H:1V slope, up to 2m high,</li> <li>• Ground surface dipping gently away behind cut slope at 6H~8H:1V.</li> </ul> <p><b>West (RHS):</b></p> <ul style="list-style-type: none"> <li>• 2H:1V slope up to 29m high.</li> <li>• Ground level above cut slope inclines at 3H~4H:1V.</li> <li>• Rock outcrops at lower slope,</li> <li>• Slope face re-shaped after slip, buttress fill with drainage installed.</li> </ul> <p><b>Note:</b></p> <ol style="list-style-type: none"> <li>1. Clay seams out slope, hummocky ground pre-construction</li> </ol>
Existing Landslide	Yes (No 2), N7A – West, Slip at Ch51,650 – Ch51,720
Cause of Landslide	<ul style="list-style-type: none"> <li>• Evidence of historic landslide activity within and above the excavation footprint.</li> <li>• A secondary softened shear planes orientated parallel to bedding fabric.</li> <li>• The presence of a saturated material above the soil/rock interface</li> </ul>

Date Landslide occurred	15/07/2020
Cut within area of historic landslide	Moderate risk identified. "Landslide debris up to about 5.5m deep is inferred to be present on the existing slope but is expected to be excavated with the cut."
Geotechnical Investigations	BH375, BH376, TP352, TP6152, TP6153
Site Geology	<p>Ch51,780 (N7A) drawing No P2Wk-DRG-GG-01-1019</p> <ol style="list-style-type: none"> <li>1. <b>Geology</b> - Pakiri Formation (Encountered/inferred stratigraphic thicknesses in order)             <ul style="list-style-type: none"> <li>• 4-5m - Firm to very stiff - Colluvium /landslide debris</li> <li>• 3-13m - Stiff residually weathered soil</li> <li>• 1.5m Very stiff to hard - Highly weathered rock</li> <li>• Slightly to unweathered rock encountered 11-15m below surface level</li> <li>• Discrete clay seams daylight out western cut slope at 12.5°, within stiff residual soil (6m above roadside swale at roadside cut)</li> </ul> </li> <li>2. <b>Structural Features &amp; Defects</b> <ul style="list-style-type: none"> <li>• Slightly to moderately weathered rock contact dips at 20° West to East</li> </ul> </li> </ol>

- Large rotational landslide feature through middle of site. Sliding occurring along clay seam.
- Groundwater recorded/inferred at contact between landslide deposits at underlying stiff residually weathered soils

Soil Rock Transition Zone	Up to 20° from West to East out of slope
Rock Cut	No rock cut or rock exposures at cut slope.
Remedial Works Design	DEI 0305 (Ch51710 – 51775, Slip Remediation). Remedial works are complete.
Remedial Works Details	<ul style="list-style-type: none"> <li>• 5x counterfort drains,</li> <li>• Buttress fill</li> <li>• Reshape to 3H:1V</li> </ul>
Peer Reviewed in PSM Report Rev 4	Refer to PSM Report PSM4203-029R Draft Rev 4 – Appendix B

<p>Groundwater Seepage Monitoring</p>	<p>Seepage monitoring of the western cut slope was undertaken on the 14/07/2021 within 48 hours of rainfall. Engineering geological site inspections were undertaken on the 2/11/2021 and 12/11/2021.</p> <p>Groundwater seepage and engineering geological observations are as follows:</p> <ul style="list-style-type: none"> <li>• Seepage recorded within lower slope</li> <li>• Multiple small slumps/slips have occurred within topsoil/mulch and upper soil layers, located at crest of toe buttress bench and toe of slope, above swale.</li> <li>• 1 subsoil drain outlet visible at northern end of cut/buttress. Subsoil drain is dry and does not exhibit signs of seepage.</li> </ul>
<p>Risk of Future Slope Failure</p>	<p><b>East (LHS):</b> The risk of future slope failure is considered <b>very low</b>.</p> <p><b>West (RHS):</b> The risk of future slope failure is considered <b>low to moderate</b>. It is unclear how the clay seams have been addressed in the analyses. Slope remain essentially at 2H:1V. Groundwater seepage at lower slope appears to be present. Design may rely on subsoil drains and maintained during the design life of the slope is required.</p> <p>The risk rating at the eastern side has been reduced from low risk to very low risk since the previous Revision D Report.</p>

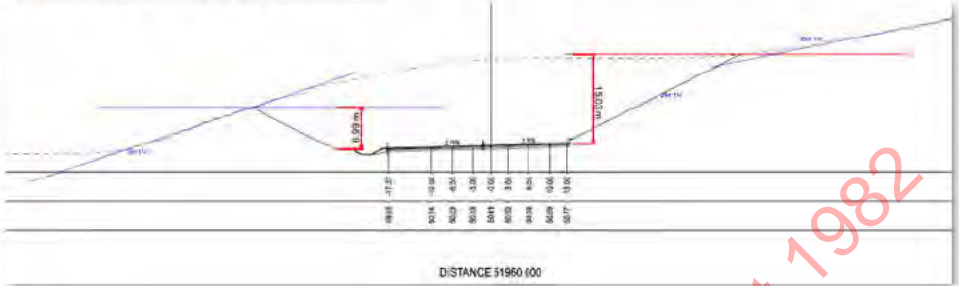
7.13 N7B

Chainage	Ch51,920 – Ch52,045
Typical Design Slope Geometry	<p>East: 2H:1V soil slope, up to 8m high            West: 2H:1V soil slope up to 18m high</p>

Site & Design Description	<p><b>East (LHS):</b></p> <ul style="list-style-type: none"> <li>• 2H:1V slope, up to 8m high,</li> <li>• Ground surface dipping away behind cut slope at 3H~5H:1V.</li> <li>• Low risk landslide mapped on Landslide Hazard Map P2Wk-DRG-GG-00-305 at lower slope with inferred headscarp extending under the pavement level. Cut N7B likely provides head unloading of the historic landslide. No construction records available which indicate mapping during construction.</li> </ul> <p><b>West (RHS):</b></p> <ul style="list-style-type: none"> <li>• 2H:1V slope, up to 16m high (based on alignment cross sections),</li> <li>• Rock outcrop encountered during construction. Details included in DEI 0432. The lower rock slope has been stabilised by 4m long rock bolts. Further details are unclear. Slope above rock cut is formed flatter than the design slope of 2H:1V.</li> <li>• Ground level above cut slope is generally flat, inclining up to 5H:1V</li> <li>• Cut slope at end of spur. Gullies to the North &amp; South of the spur. The southern spur is dipping towards a stream.</li> <li>• Soil-rock interface unclear.</li> <li>• Groundwater seepage unclear.</li> <li>• Cut slope near final level in June 2019</li> </ul> <p><b>Modified for rock cut</b>            From the Flyover videos, it appears the soil slope cutting was completed in February &amp; April 2020.</p>

Existing Landslide	None reported to s 9(2)(b)(ii) and 9(2)(ba)(i)
Cause of Landslide	Not applicable
Date Landslide occurred	Not applicable
Cut within area of historic landslide	Low to moderate risk at southern part.
Geotechnical Investigations	BH374, BH6023
Site Geology	No geological section provided in the report. Based on geotechnical investigations and the design report, firm to hard Pakiri Formation residual soils. It is noted that a rock cut was encountered during construction at the lower part of the slope.
Soil Rock Transition Zone	No records available. Based on topography, the soil -rock transition is dipping from West to East.

Rock Cut	Rock cut at lower slope (encountered during construction). The rock cut height is unclear but appears to be 5m high based on the aerial photos.
Remedial Works Design	None required. DEI 0432 (planning record) was prepared to inform of the rock cut below the soil cut slope.
Remedial Works Details	Not applicable
Peer Reviewed in PSM Report Rev 4	Not reviewed
Groundwater Seepage Monitoring	Seepage monitoring undertaken on the 14/07/2021 within 48 hours of rainfall.  Groundwater seepage observations are as follows: <ul style="list-style-type: none"> <li>• Cut slope was topsoil/mulched at time of inspection making observation of any seepages difficult</li> <li>• Installed subsoil drains functioning with minor seepage recorded</li> <li>• Seepage recorded at level of swale drains</li> </ul>
Risk of Future Slope Failure	<p>East (LHS):</p> <ul style="list-style-type: none"> <li>- The risk of future slope failure is considered <b>very low</b>.</li> </ul> <p>West (RHS):</p> <ul style="list-style-type: none"> <li>- The risk of future slope failure is considered <b>low</b>. <b>A topsoil slip has occurred at the slope during the January 2023 rainfall event.</b></li> </ul> <p>The risk rating at the eastern side has been reduced from low risk to very low risk since the previous Revision D Report.</p>

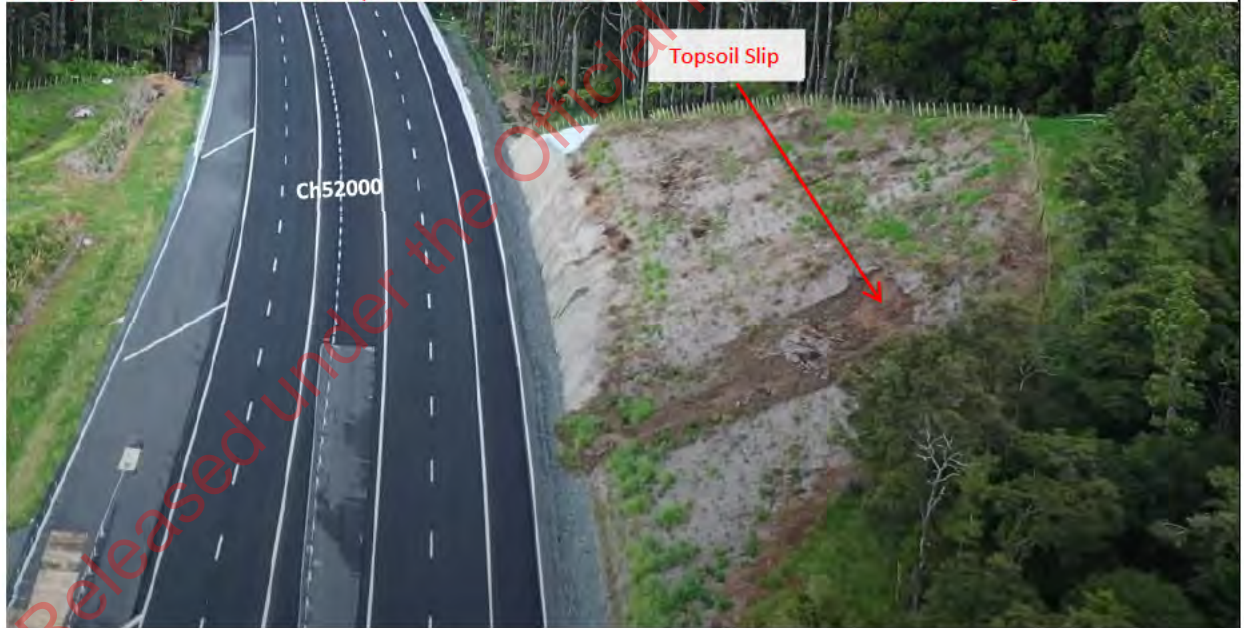
January 2023 (after to the rainfall event), Time 1:49 – View in southern direction: East = left-hand side; West = right-hand side

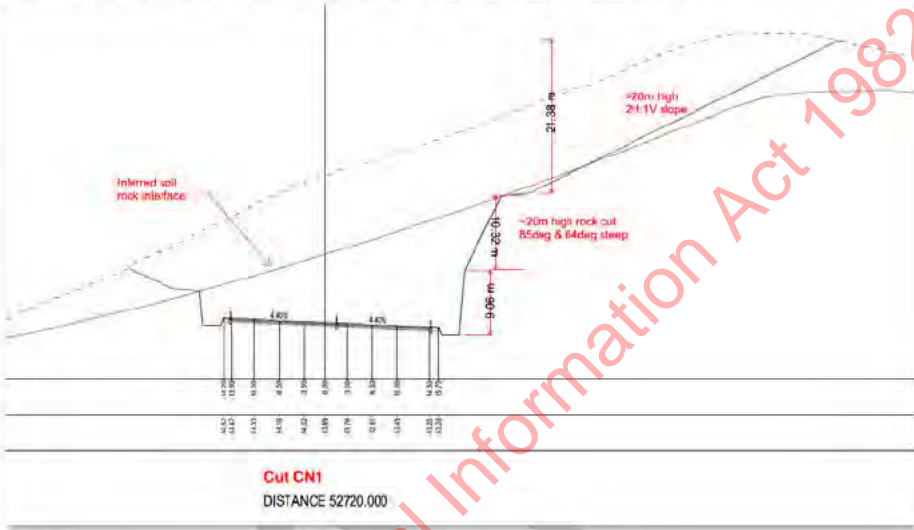
7.14 CN1

Chainage	Ch52,260 – Ch 52,930
<p>Typical Design Slope Geometry</p>	<p>East (LHS): 2H:1V up to 12m high soil slope above rock cut; 85° (lower 9m) and 64° steep up to 22m high rock cut slope (Ch52,400)</p> <p>West (RHS): 2H:1V up to 28m high soil slope above rock cut; 85° (lower 9m) and 64° steep up to 29m high rock cut slope (Ch52,740)</p> <p><u>We note that soil slope and rock height vary along the alignment at both sides. The above values are maximum values which may not be shown on the presented section.</u></p>

<p style="text-align: center;"><b>Cut CN1</b> DISTANCE 52720.000</p>
<p>Site &amp; Design Description</p>	<p><b>East (LHS):</b></p> <ul style="list-style-type: none"> <li>• 2H:1V slope, up to 12m high,</li> <li>• ground surface dipping away behind cut slope</li> <li>• 4m bench (inclined towards the rock cut) between rock cut and soil cut slope.</li> <li>• Rock cut up to 22m high, rock mesh drapery installed,</li> <li>• Ground level dipping towards the East away from the top of cut. Surface water run-off from cut slopes only.</li> <li>• No obvious groundwater seepage observed (based on drone footage). Based on geological section, the groundwater is within the rock and dipping towards the East away from the cut.</li> </ul> <p><b>West (RHS):</b></p> <ul style="list-style-type: none"> <li>• 2H:1V slope, up to 28m high,</li> <li>• ground surface dipping away behind cut slope</li> <li>• 4m bench (inclined towards the rock cut) between rock cut and soil cut slope.</li> <li>• Rock cut up to 22m high, rock mesh drapery installed,</li> <li>• Soil-rock transition dipping at 15 to 20degrees towards the slope,</li> <li>• Groundwater seepage unclear.</li> <li>• Cut slope near final level in June 2019 (Flyover time 1:22 - 1:30)</li> </ul>

Existing Landslide	None reported to s 9(2)(b)(ii) and 9(2)(ba)(i)
Cause of Landslide	Not applicable
Date Landslide occurred	Not applicable
Cut within area of historic landslide	High risk at western slopes, but sloping away from cut face; Moderate risk at the eastern slope, but sloping away from cut face.
Geotechnical Investigations	BH5201, BH395, BH370, BH220, BH366, BH365, BH6027, BH6028, BH6029, BH6030, BH218, BH219, BH6104,

Risk of Future Slope Failure	<p><b>East (LHS):</b> The risk of future slope failure is considered <b>low</b> for the soil slopes above the cut cutting. New slips were observed at the wetland at the eastern transition into the cut (approx. Ch52,330) in the September 2021 flyover footage (time 1:56). The slip debris has now been removed <b>and remedial works including counterfort drains were installed.</b></p> <p><b>West (RHS):</b> The risk of future slope failure is considered <b>low to moderate risk.</b></p>

- Rock cut slopes are up to 30m high with 2H:1V steep soil slope above rock cut. 15~20° steep inclined soil rock transition zone.
  - Potential rockfall risks from the upper 2H:1V exposed rock slopes have been reviewed as part of the CJV assessments. Refer to Section 4.2.
  - Seepage at rock slope may cause long-term maintenance issue.
  - The slip at the transition into rock cut which was observed in September 2021 has been repaired.
- The risk rating at the western side has been increased due to the consequence assessment since the previous Revision D Report.

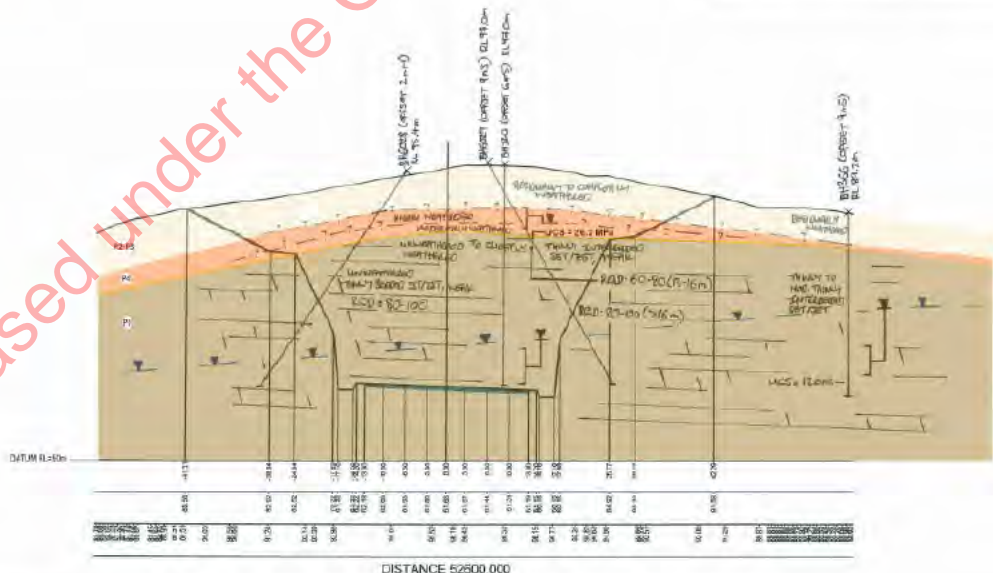
JOINTS VERY WIDELY SPACED  
 FEATHERING UNKNOWN  
 CROSS SECTION - CN1-C CH280

UCS TESTS  
 BH360 12.6m 26.2MPa E=4.4GPa  
 BH366 26.4m 12.0MPa E=3.6GPa

COMBINED BOREHOLE DATA ANALYSIS  
 AVERAGE BEDDING 2/227°  
 JOINT SET (S) 74/260°  
 INCLINED BOREHOLES - BOREHOLE B BOREHOLE C  
 CUT SURVEYS - BOREHOLE B BOREHOLE C & BOREHOLE D

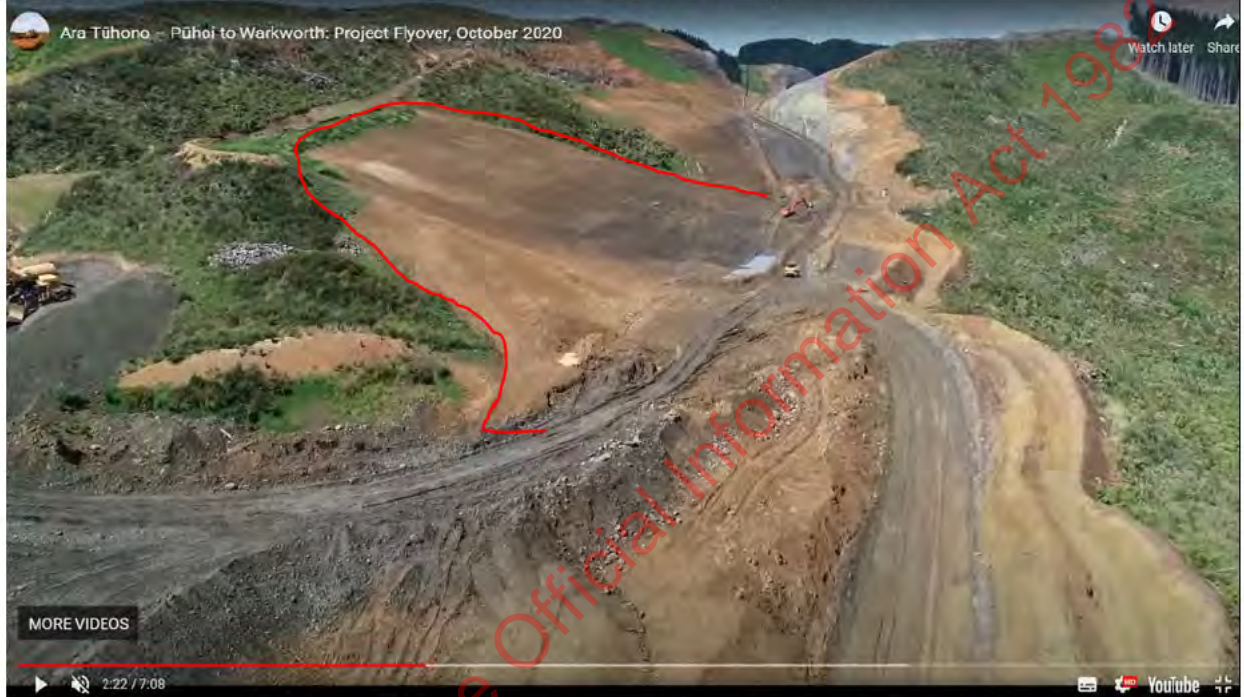
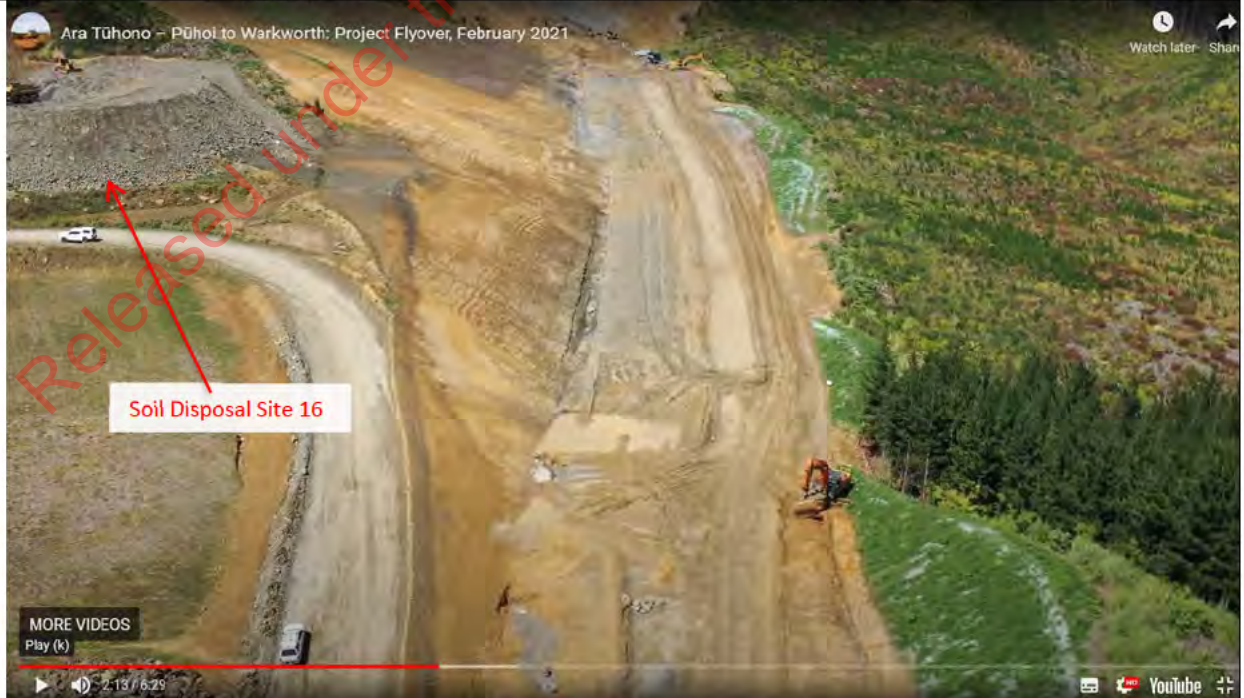
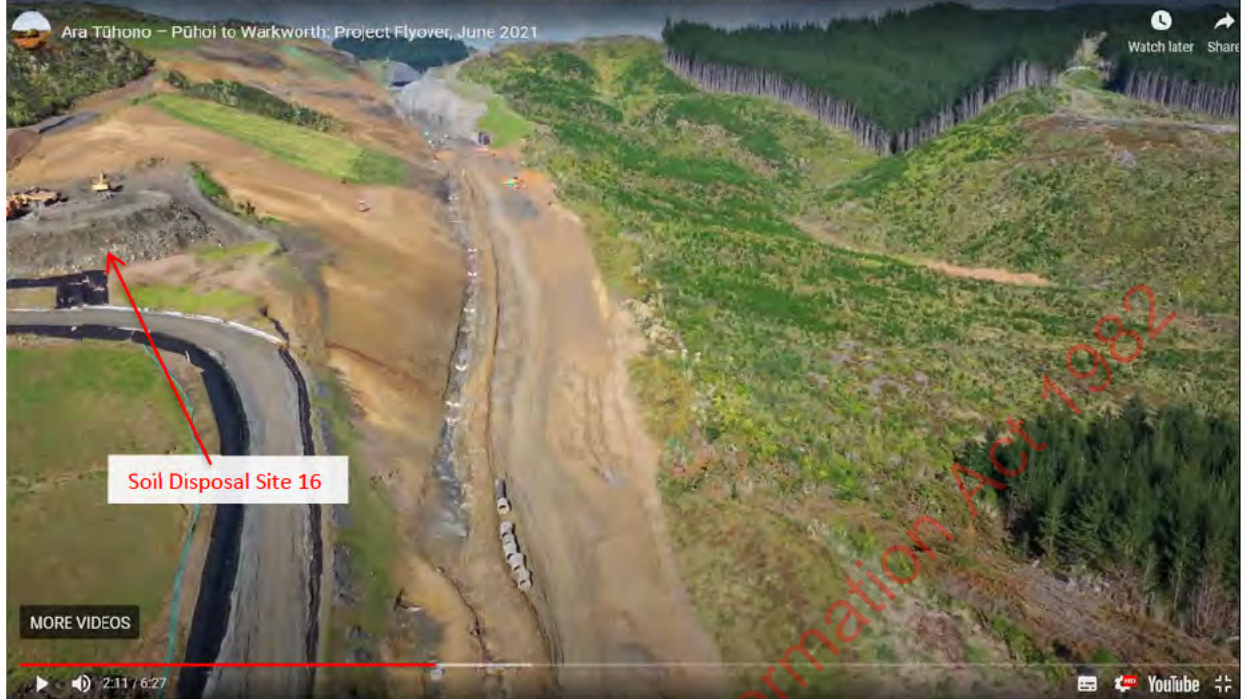
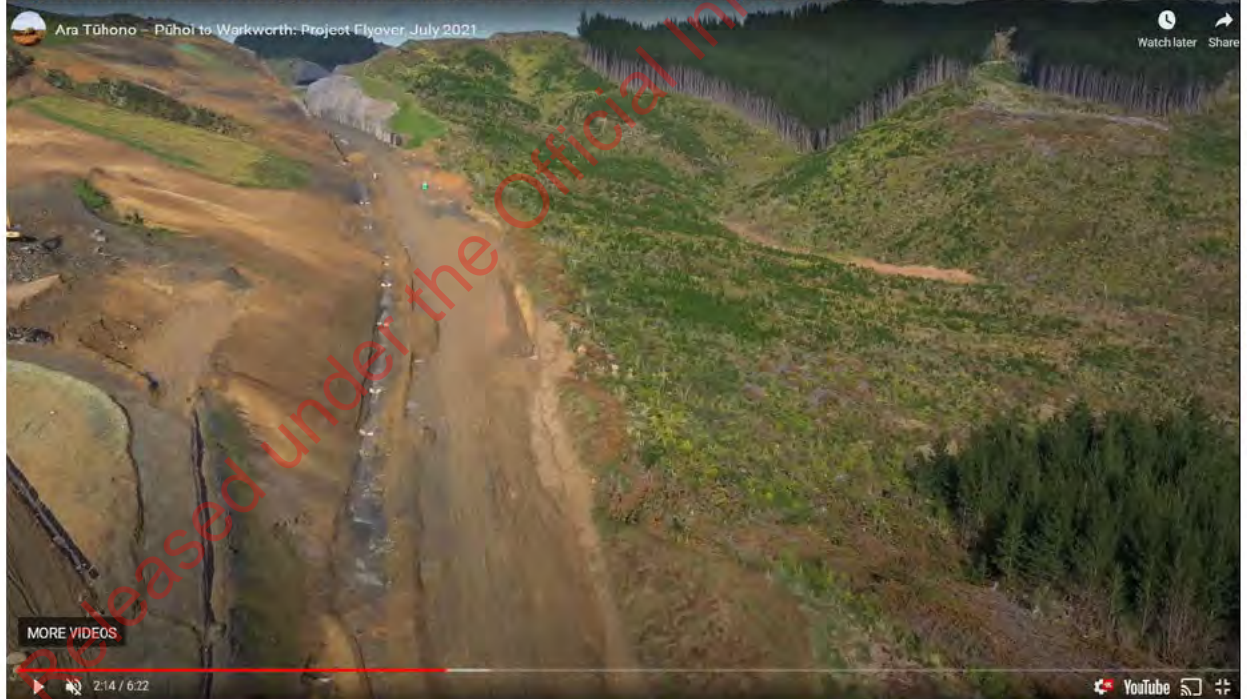
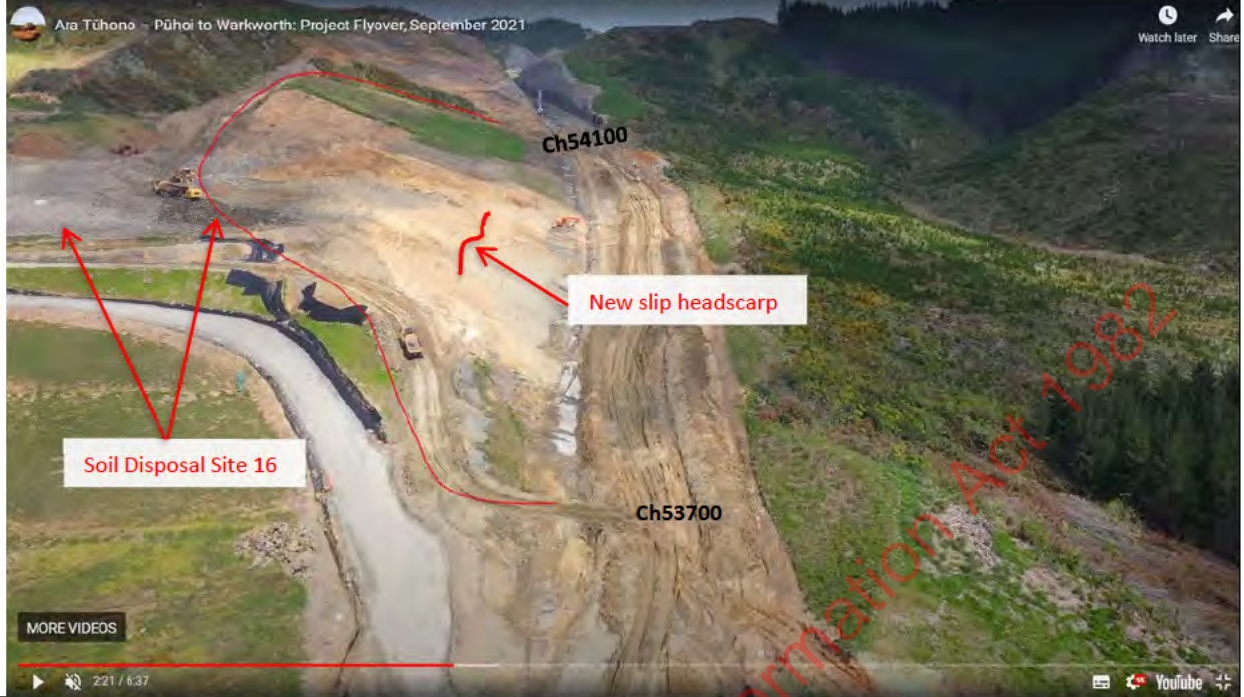
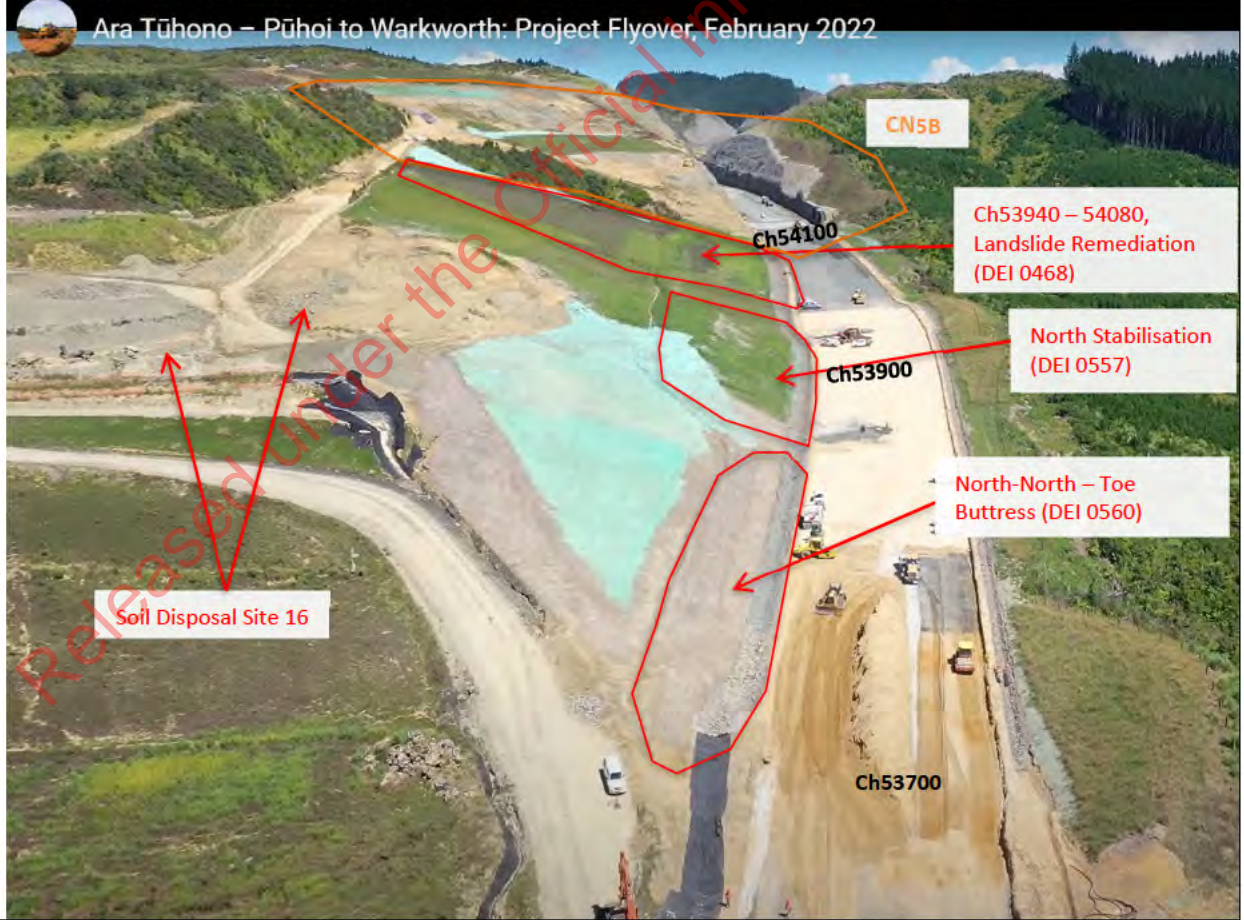
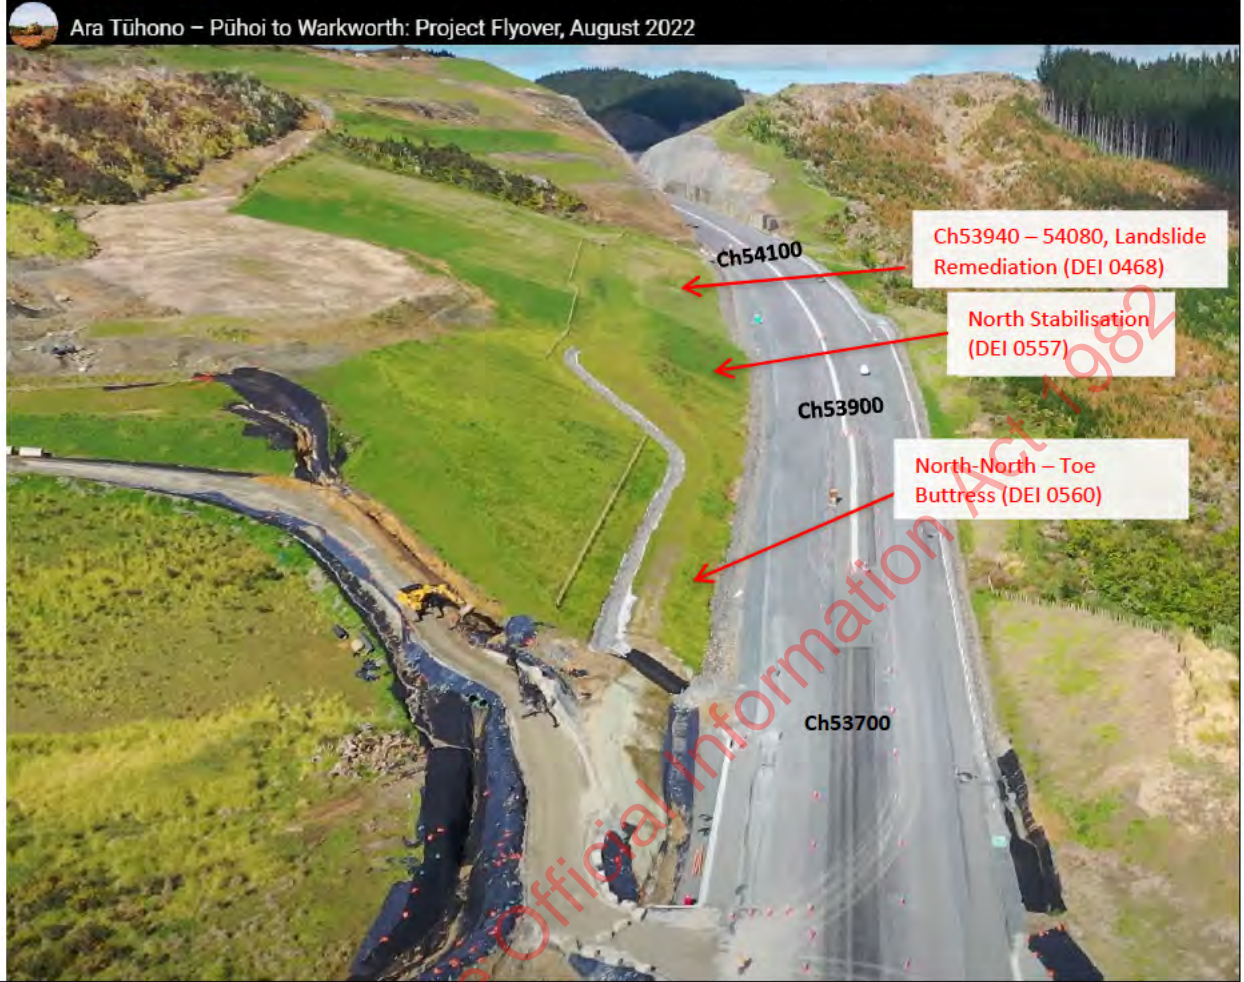
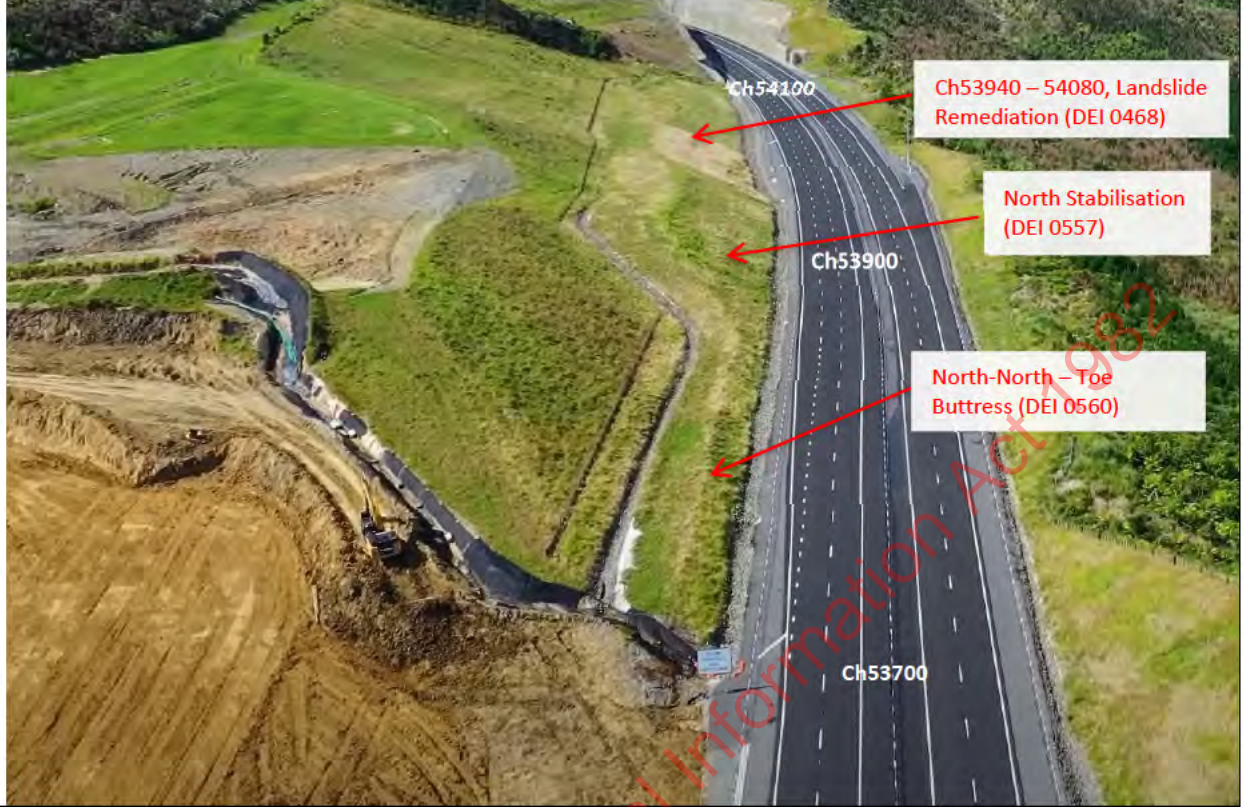
Risk of Future Slope Failure	<p><b>East (LHS):</b> The risk of future slope failure is considered <b>low to moderate risk</b> based on remediated design solution. During our site visit dated 2 November 2021, we observed new tension cracks and slip headscarps. This suggested that the design model is not sufficiently representative of the site conditions. New remedial works comprising buttress fills were placed at Ch53690-53750 (Refer to DEI 0560). <b>The construction works at soil disposal site 16 upslope of Cut CN5A have now been completed.</b></p> <p>In absence of <b>our independent</b> detailed geological assessment, it appears that remedial measures <b>may</b> not correctly or accurately address the underlying issue.</p>

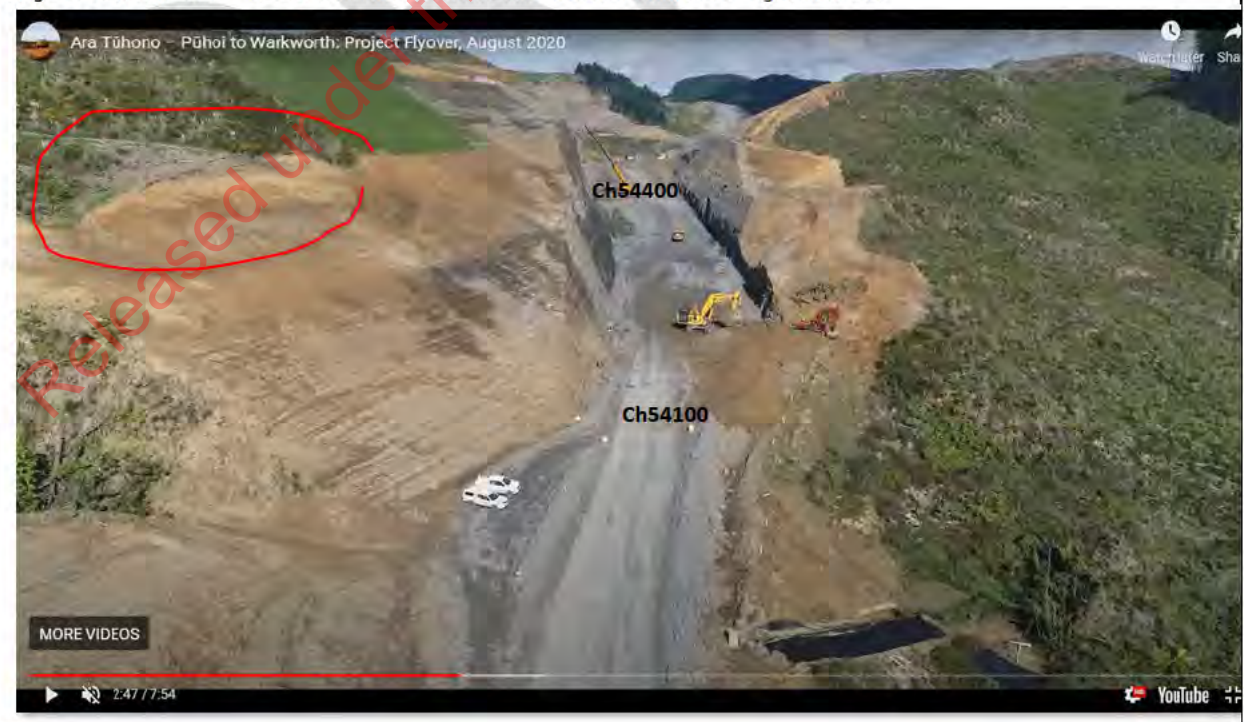
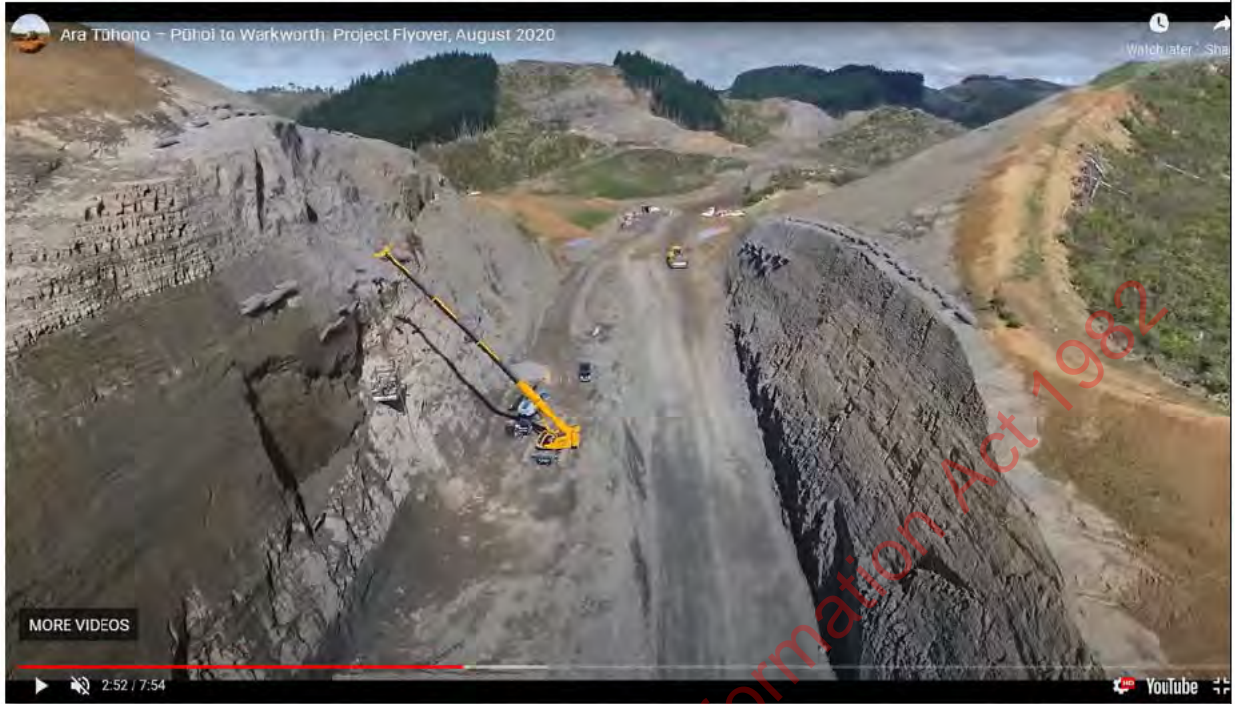
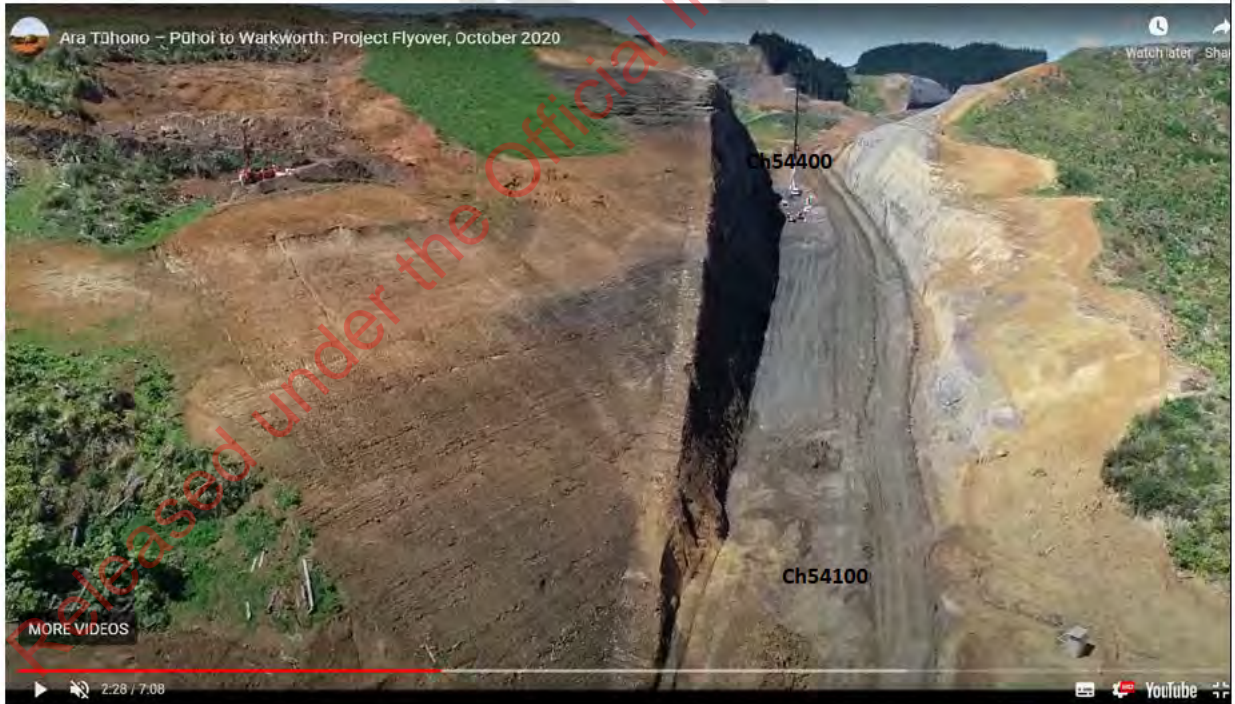
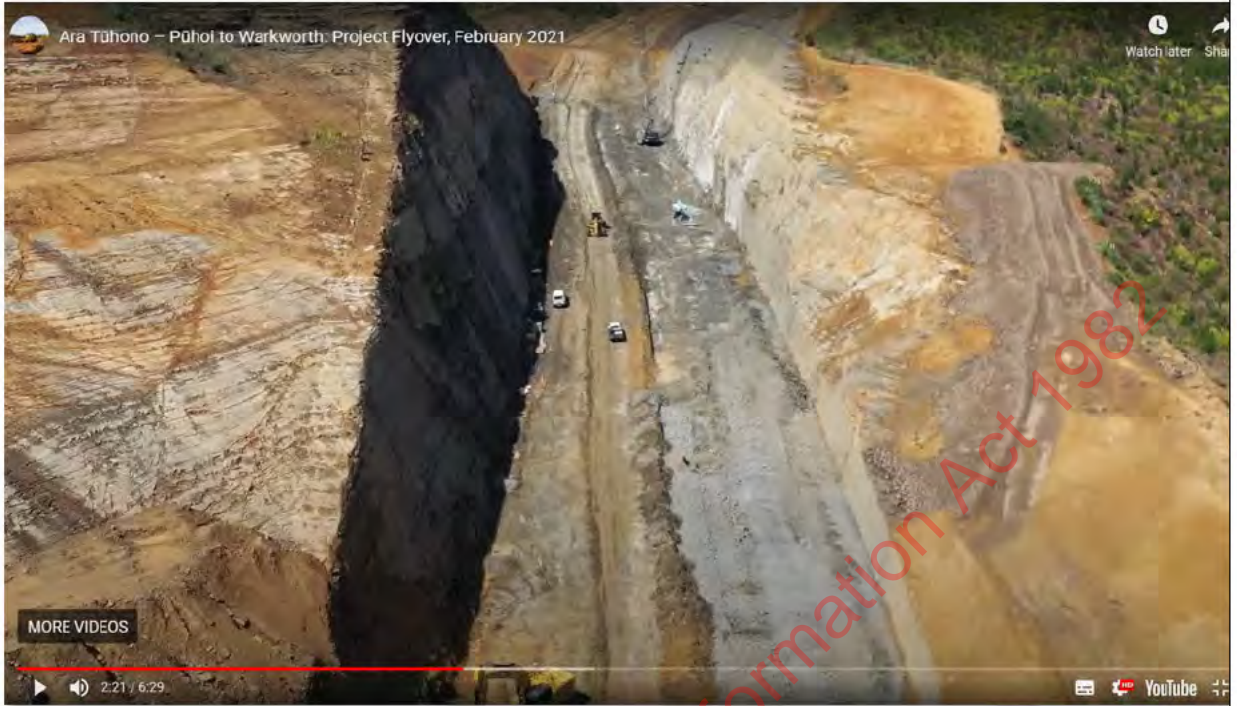
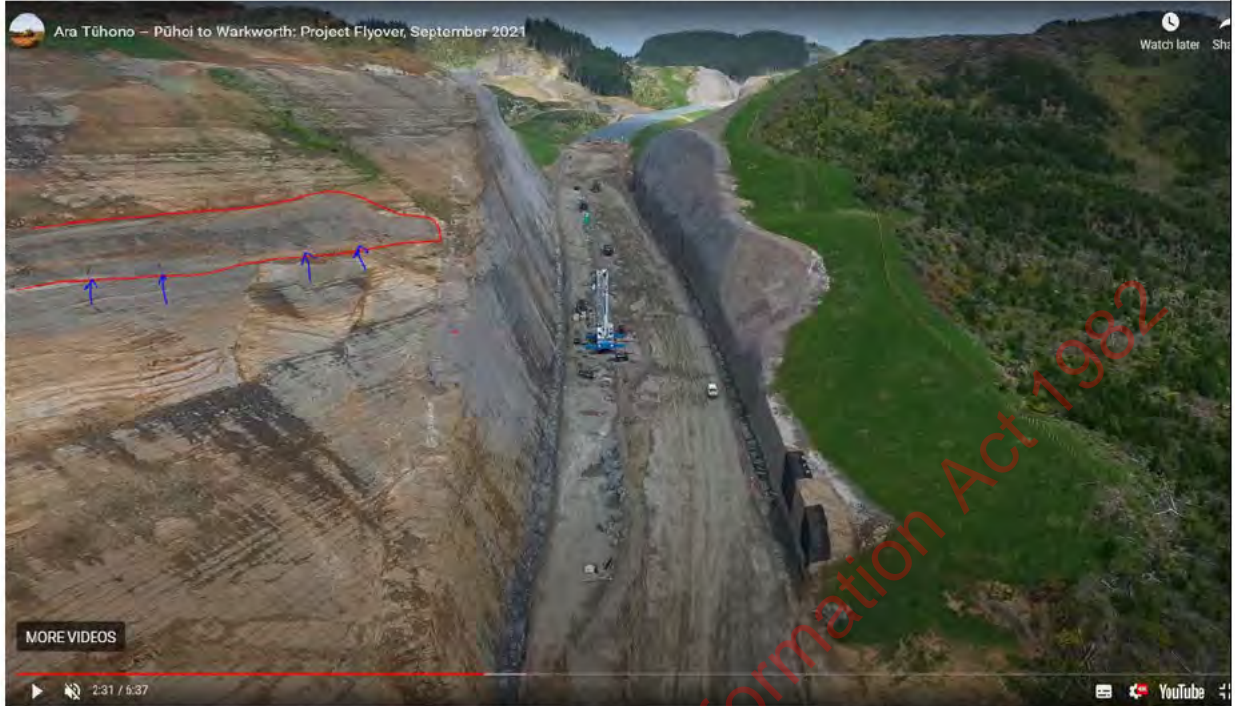
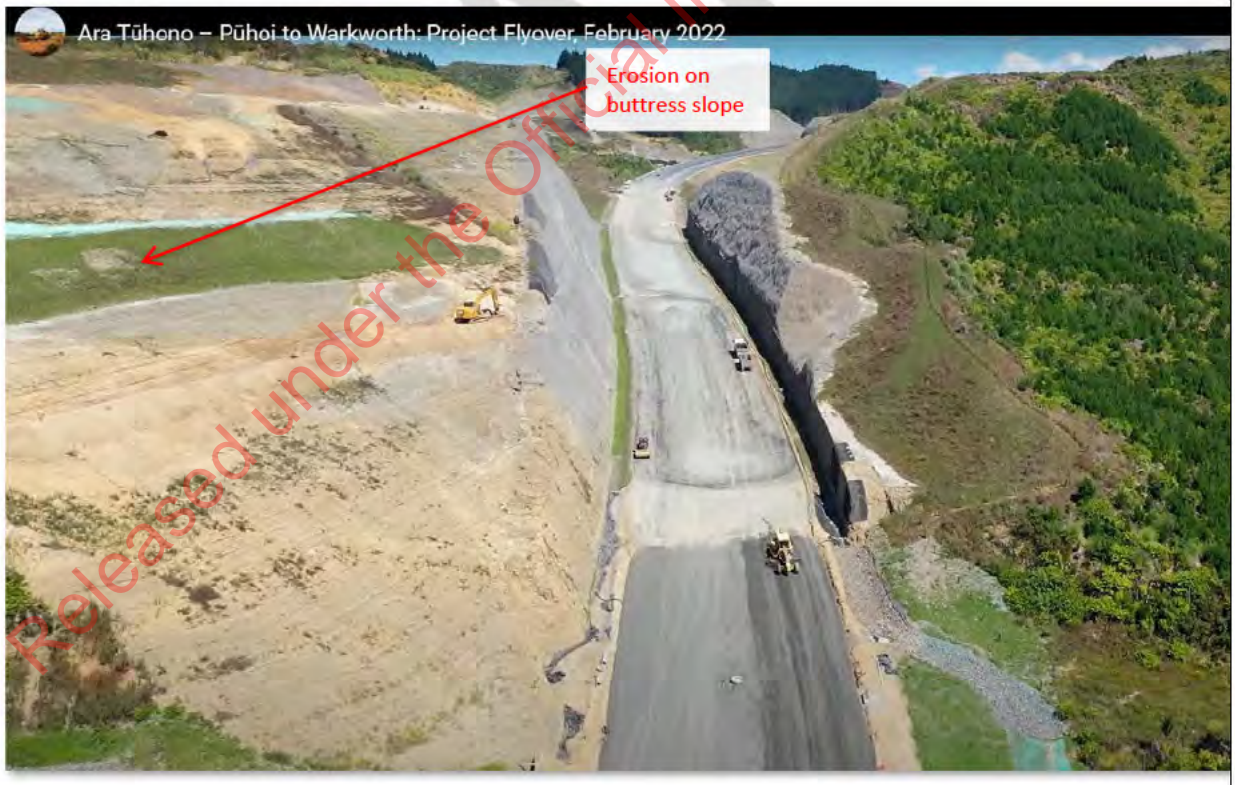
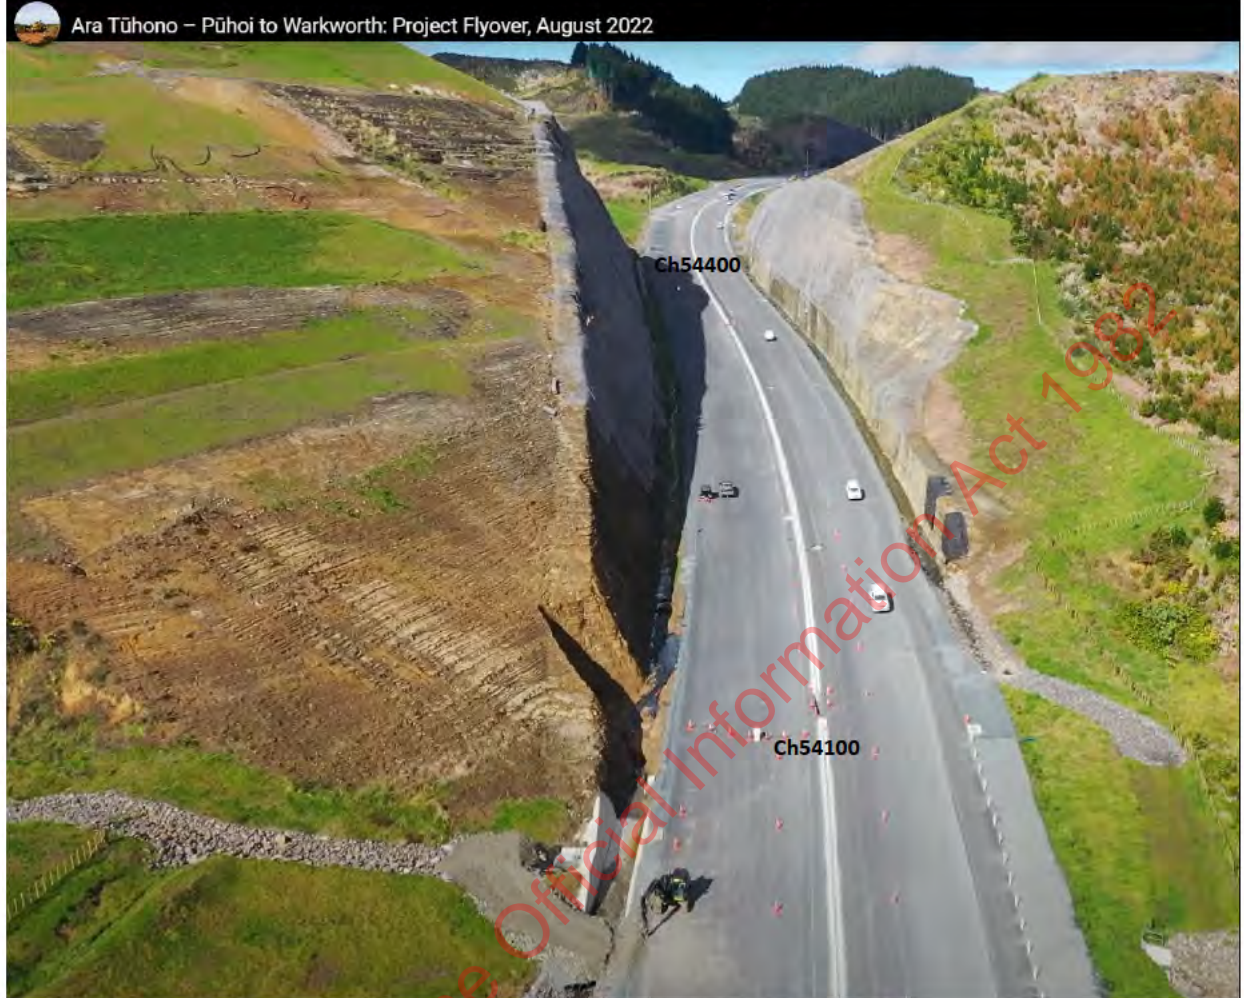
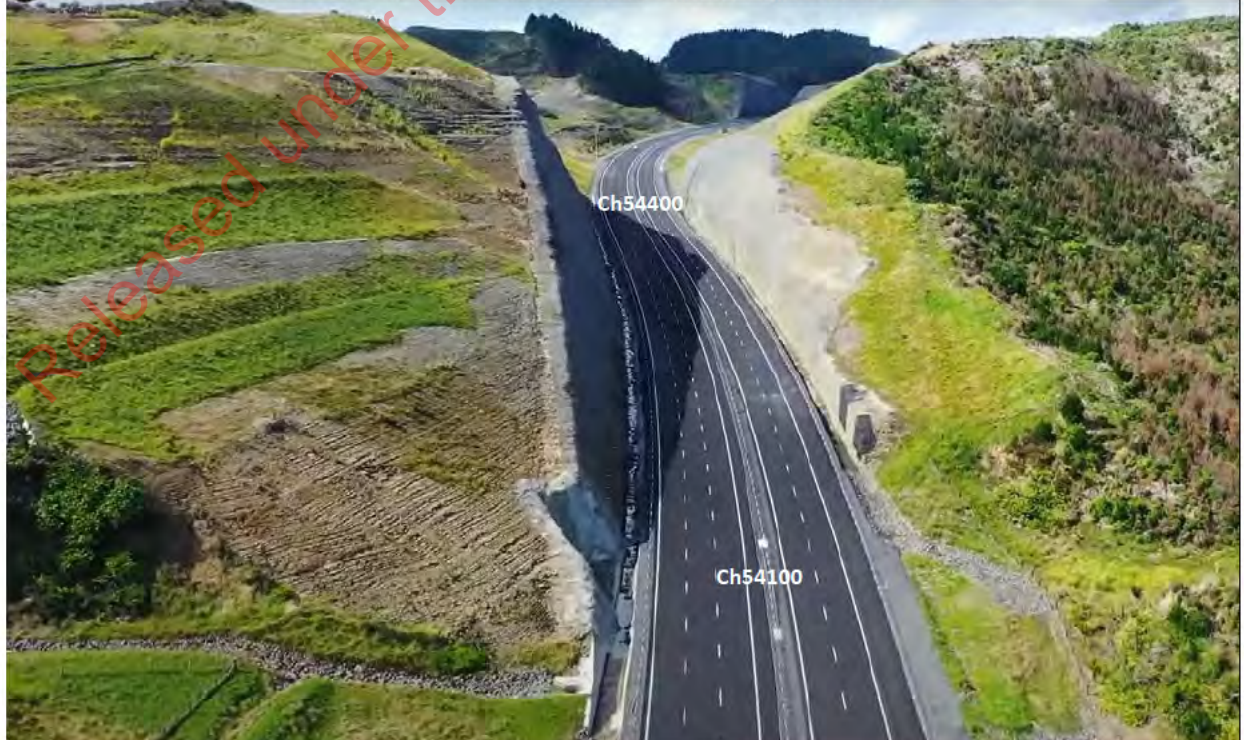
During our site visit dated 2 November 2021, we observed new tension cracks and slip headscarps. This suggests that the design model is not sufficiently representative of the site conditions.

In absence of detailed geological assessment, it appears that remedial measures do not correctly or accurately address the underlying issue. The weathering, geology and rock structure are highly unfavourable. The buttress fill quality appears not satisfactory based on our independent observations. Surficial failures within the buttress fill were present at the time of our site visit. The buttress slopes are now grassed, and no issues have been observed or reported at the July 2022 and the January 2023 rainfall events.

The risk of slope failure is generally considered low to moderate. The weighted risk level has been lowered since the previous assessment, although the individual risk for slope stability and sliding at soil-rock interface remains moderate.

Risk of wedge-type or rock slope failures cannot be determined based on the available information. However, large voids and overhanging rock albeit supported by rock bolts are present.
