Pūhoi To Warkworth (P2Wk)– Landslide Risk Assessment

# Geotechnical Review of Cut Slopes and Landslide Risks

Revision E

Date: 11 April 2023

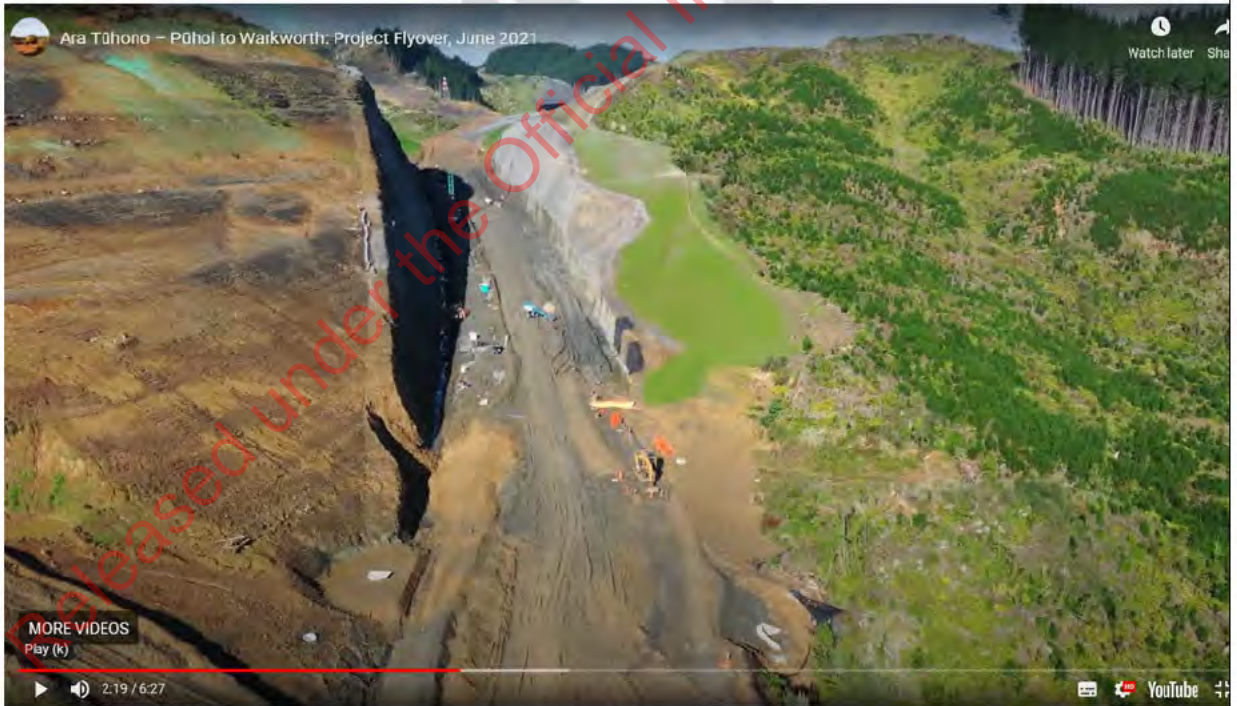
June 2021, Time 2:19 – View in southern direction: East = left-hand side; West = right-hand side

Large wedge failures on eastern side, wedge failure at start of CN5B (Ch54,100-54,200), (Flyover June 2021 time 2:19) appears overhanging at the end of CN5B.

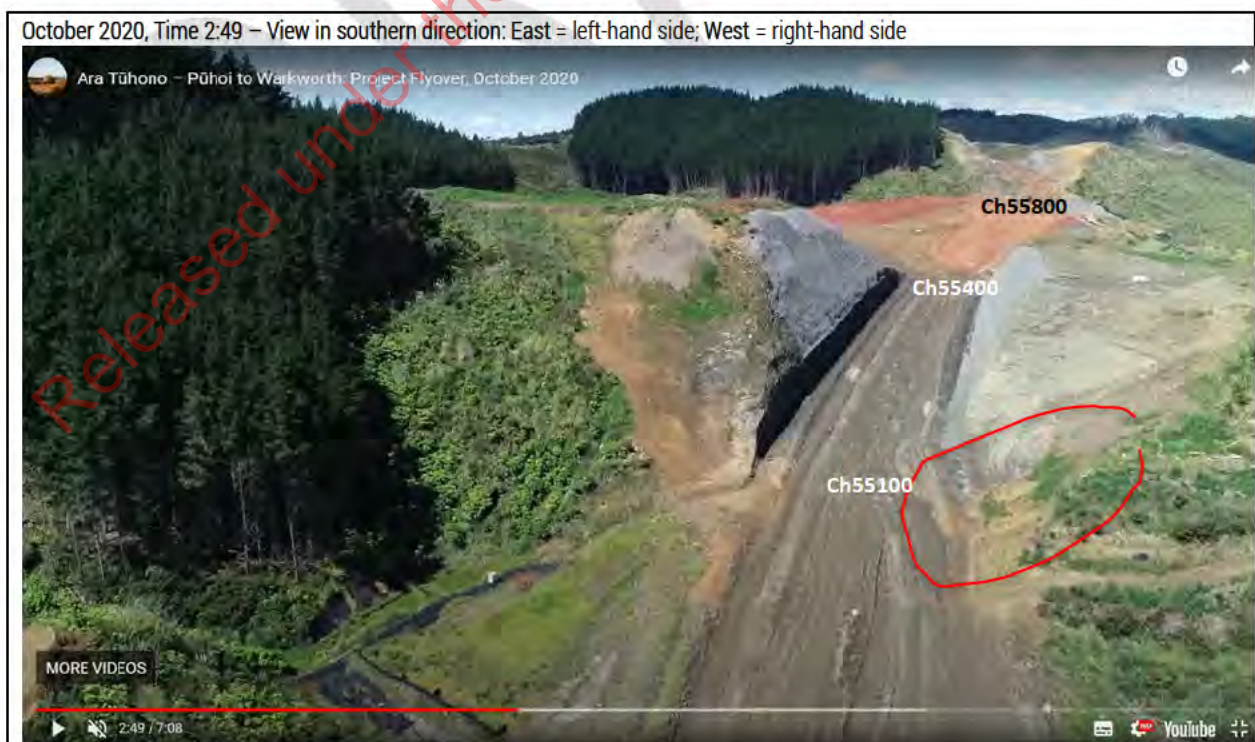
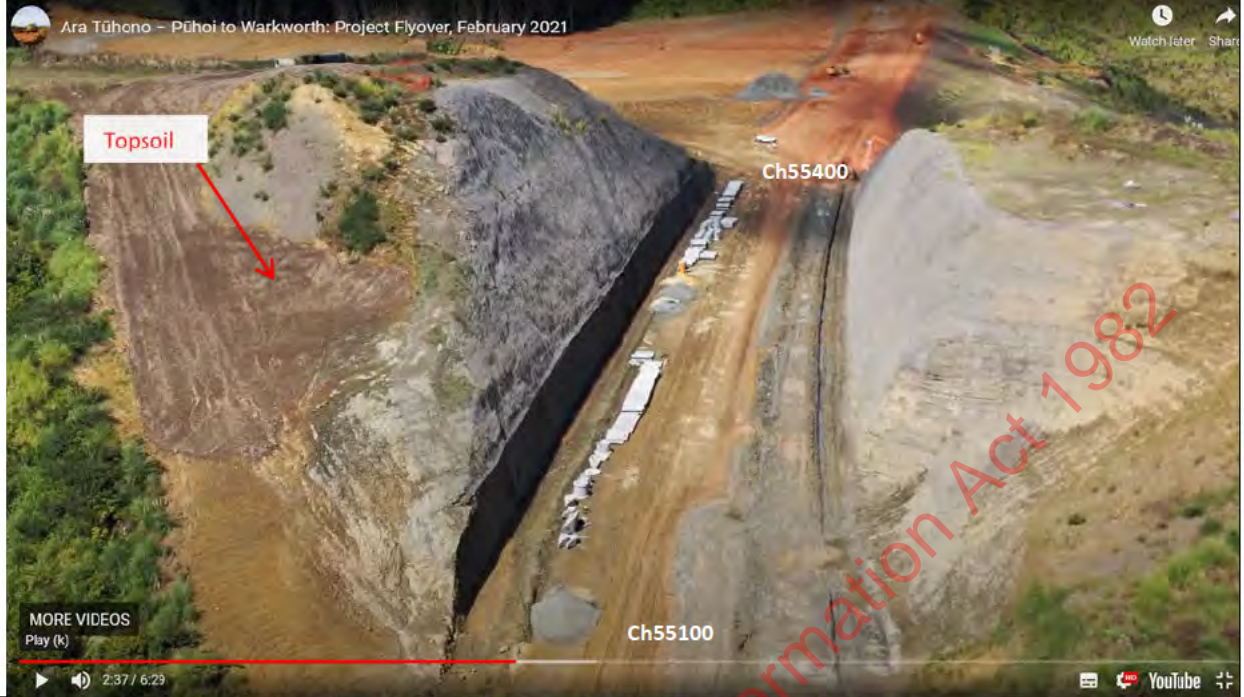
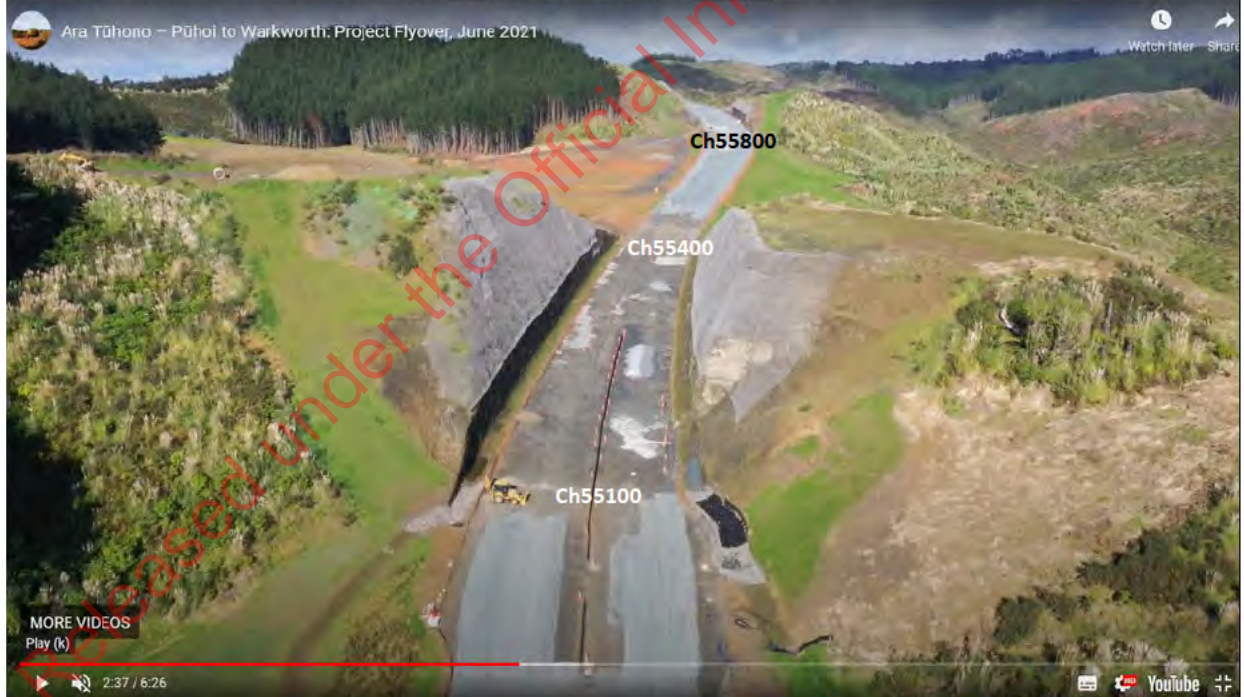
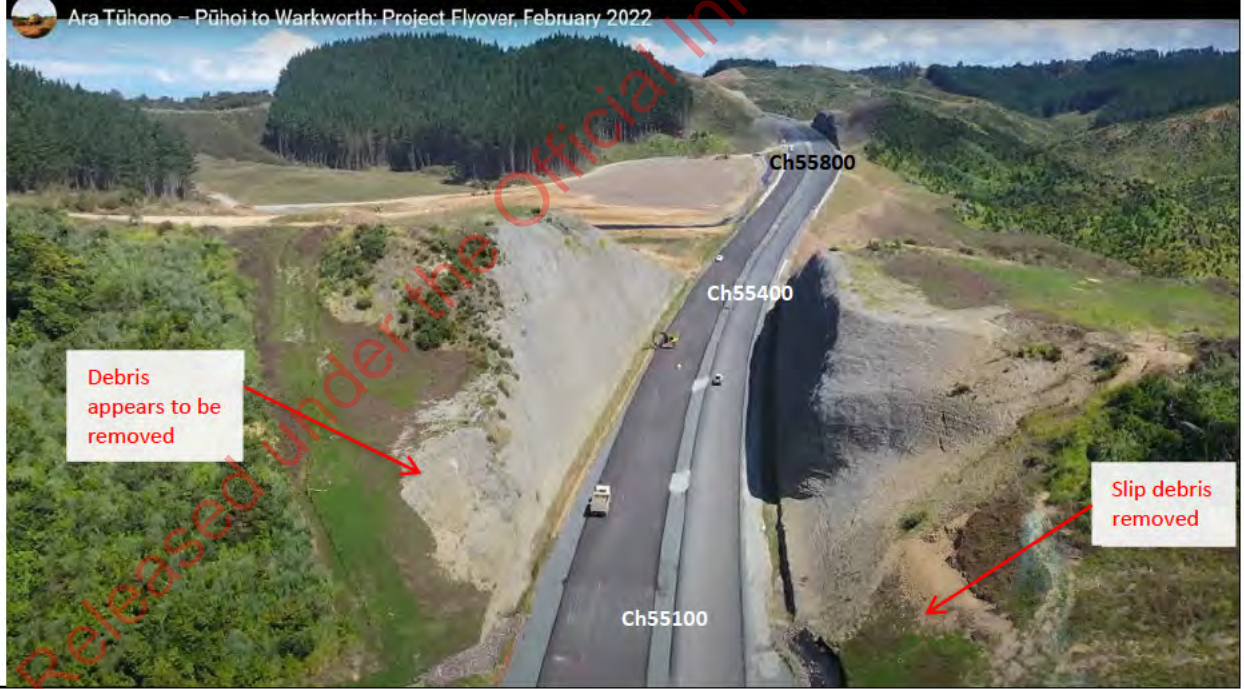
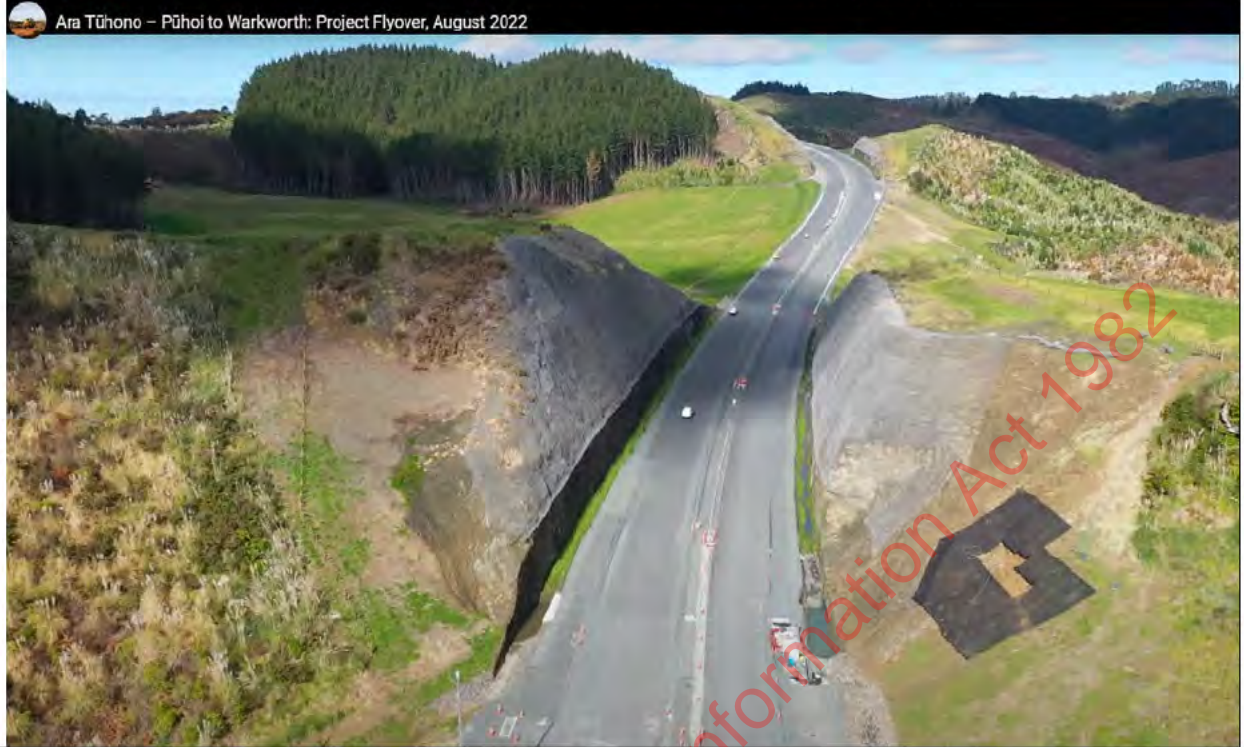
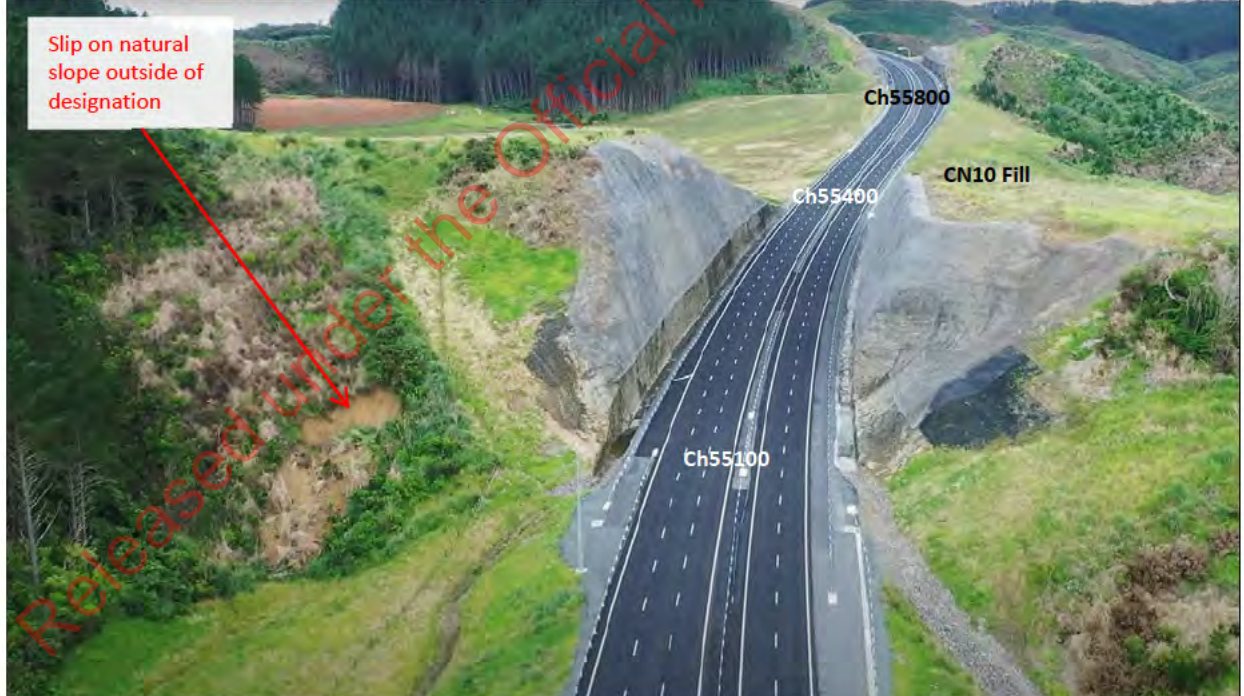
Risk of Future Slope Failure	<p><b>East (LHR)</b></p> <ul style="list-style-type: none"> <li>The risk of future slope failure at upper soil slopes perpendicular to the road alignment is considered low.</li> <li><u>Moderate risk at side slopes transition from the soil to rock slopes.</u></li> <li>Risk at rock slope difficult to determine.</li> </ul> <p><b>West (RHS)</b></p> <ul style="list-style-type: none"> <li>The risk of future slope failure at upper soil slopes perpendicular to the road alignment is considered low.</li> <li><u>Moderate risk at side slopes transition from the soil to rock slopes.</u></li> <li><u>Risk of wedge-type or rock slope failures cannot be determined based on the available information.</u></li> </ul> <p>The risk remains unchanged compared to the Revision D Report.</p>

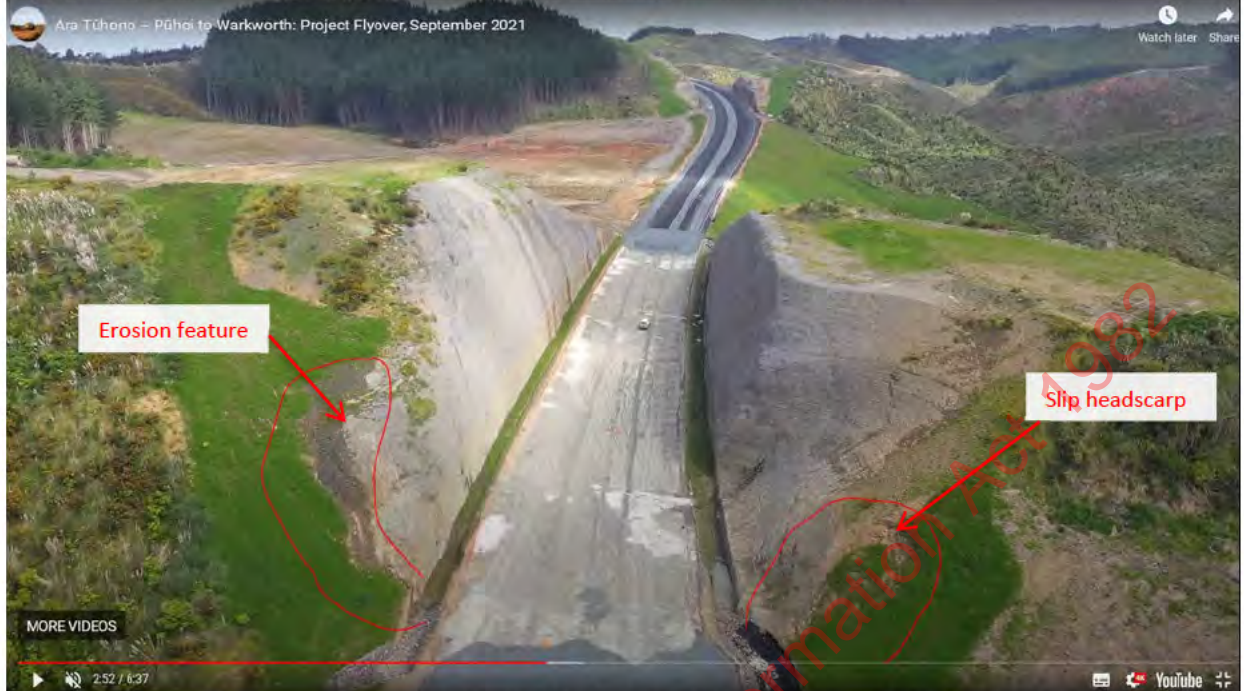
September 2021, Time 2:52 – View in southern direction: East = left-hand side; West = right-hand side

Existing Landslide	No landslide as part of the original report scheme. A new slip has been reported on 7 June 2021.
Cause of Landslide	Likely slip at soil rock transition zone at steep slope. Refer to September 2021 flyover footage.
Date Landslide occurred	June 2021. <b>A further landslide occurred on a natural slope outside of the designation at the NE side of the cut.</b>
Cut within area of historic landslide	Low risk at southern transition into fill CN10.
Geotechnical Investigations	BH216, BH3541, BH6108, BH4009, BH6044, BH6045
Site Geology	55,280 (CN7B), Drawing No P2Wk-DRG-GG-02-1007 1. Geology - Pakiri Formation (Encountered/inferred stratigraphic thicknesses in order) <ul style="list-style-type: none"> <li>• 2.5-11.5m -Stiff - Residually weathered CLAY &amp; SILT soil</li> </ul>

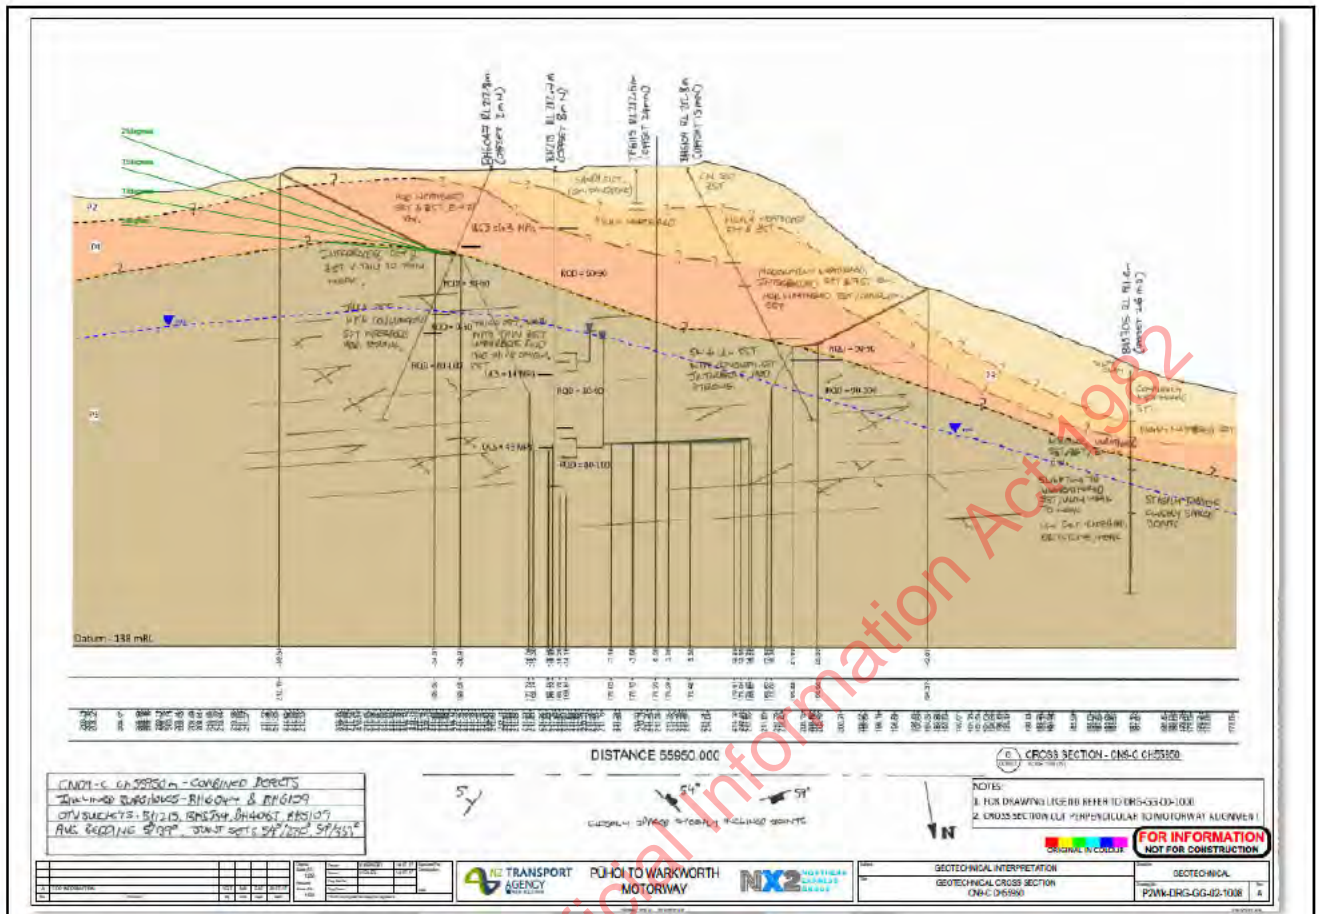
Soil Rock Transition Zone	<p><b>East (LHS):</b>          Ch55,750 – Ch55,940: transition zone dips away from the slope face,          Ch55,980 – Ch56,020: transition zone dips at 15~20° out of the slope face,</p> <p><b>West (RHS):</b>          Ch55,750 – Ch55,980: transition zone dips away from the slope face,          Ch55,980 – Ch56,020: transition zone dips away from the slope face, 5~10° out of the slope,</p>
Rock Cut	Up to 34m deep. 85° at lower 9m and 64° above 9m from excavation level.
Remedial Works Design	DEI 0470 (Ch55990 – 56030, Stabilisation south-eastern batter), DEI 0474 (Ch55840 – 55940, Western Batter Landslide Stabilisation)
Remedial Works Details	<p><b>Western side:</b></p> <ul style="list-style-type: none"> <li>9 nos. counterfort drains, at 10m centres, 8m long, 0.5m deep into rock,</li> <li>Slope reshaped to 3H:1V</li> <li>13m wide rock bench,</li> </ul>
Peer Reviewed in PSM Report Rev 4	Refer to PSM Report PSM4203-029R Draft Rev 4 – Appendix F

Groundwater Seepage Monitoring	Proposed at eastern slope. No seepage monitoring carried out to date.
Risk of Future Slope Failure	<p><b>East (LHR)</b></p> <ul style="list-style-type: none"> <li>Low risk at upper soil slopes perpendicular to the road alignment. Upper slope is covered by mesh drapery.</li> <li>Risk at rock slope difficult to determine as slope face is covered.</li> </ul>

- **Very low** risk at upper soil slopes perpendicular to the road alignment. All slipped debris has been removed. **This risk level has been reduced from the previous assessment in the Revision D Report.**
- Risk at rock slope difficult to determine. Upper part is covered by mesh drapery.

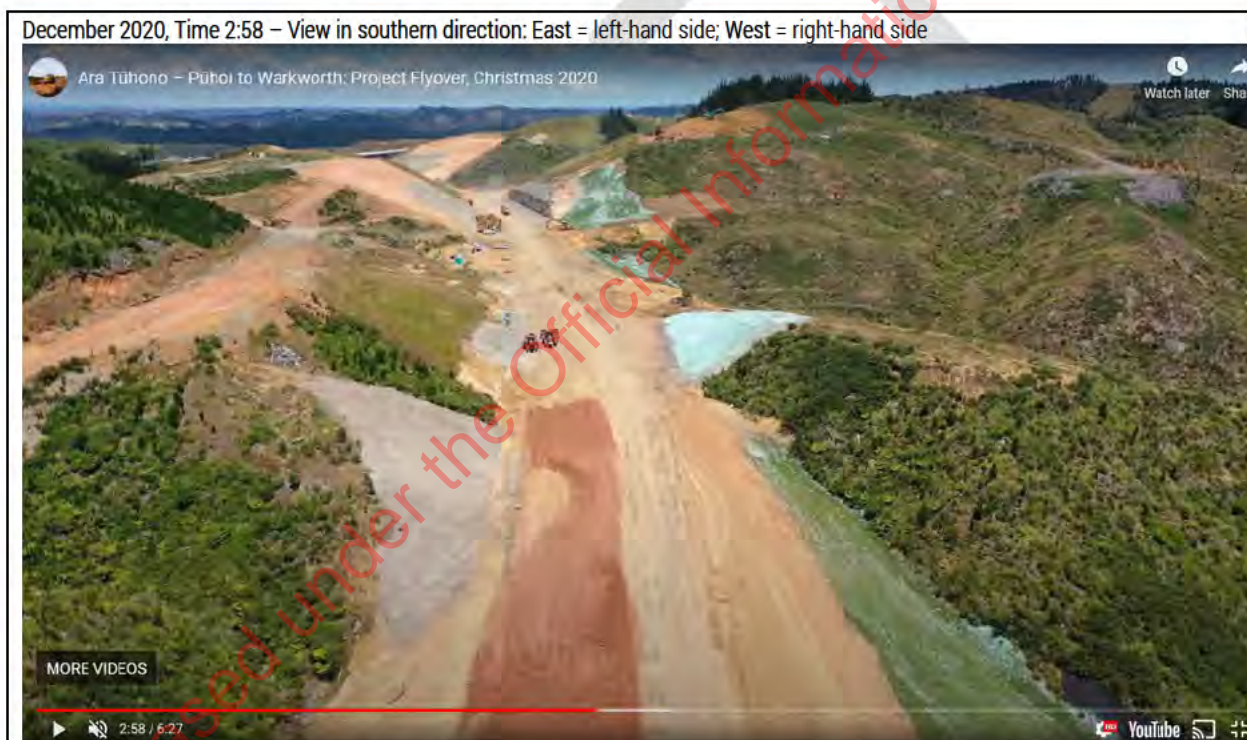
Site & Design Description	<p>Sidling cut through existing westerly trending spurs which are sloping in westerly direction.</p> <p><b>East (LHS)</b></p> <ul style="list-style-type: none"> <li>• 2H:1V soil cut slope, up to 10m high, grassed surface.</li> <li>• Northern part of CN12B is a sidling cut of existing East to West sloping ground. Soil rock interface slopes at 5-15 degrees. The rock cut at 2H:1V exposed at lower part in the southern section of CN12B.</li> </ul> <p><b>West (RHS)</b></p> <ul style="list-style-type: none"> <li>• 2H:1V soil cut slope, up to 10m high, grassed surface.</li> </ul>
Existing Landslide	Not part of the original landslide. A new landslide occurred in July 2022 following heavy rainfall event.

Cause of Landslide	Likely block sliding on soil-rock transition zone.
Date Landslide occurred	July 2022
Cut within area of historic landslide	Low risk in the centre of cut existing erosion gully.
Geotechnical Investigations	BH3532
Site Geology	No geological section provided in the report. Based on the design report and geotechnical investigations, it expected that the cuts are formed in Pakiri Formation soils.
Soil Rock Transition Zone	5~10° below cut level dipping in western direction.
Rock Cut	Minor rock cut outcrops at the lower part of the southern section were cut at 2H:1V.
Remedial Works Design	<ul style="list-style-type: none"> <li>• Removal of the slipped material and regrading of the slope to 4H:1V.</li> <li>• Shear key and toe buttress and counterfort drains.</li> </ul> <p>Discussions on addition ground improvements subject to further design and slope movement monitoring.</p>
Remedial Works Details	Details as above.

Peer Reviewed in PSM Report Rev 4	Not applicable. The landslide occurred after the report was issued.
Groundwater Seepage Monitoring	Proposed at eastern side, but no observations have been made.
Risk of Future Slope Failure	<p><b>East (LHS):</b> The risk of future slope failure is considered <b>low to moderate risk</b>. No significant groundwater seepage observed. Soil rock interface typically less than 10 degrees inclined.</p> <p>The overall weighted risk level has been raised to low moderate risk. The individual risk rating for slope failure and sliding at soil-rock interface is moderate. As the slope is now monitoring and remedial works are being carried out, the future risk level should decrease provided the geology and ground conditions are well understood, and a suitable remedial works design is prepared.</p> <p><b>West (RHS):</b> The risk of future slope failure is considered <b>very low</b>. Soil rock interface is dipping away from cut slope. The risk rating has been reduced from low to very low.</p>

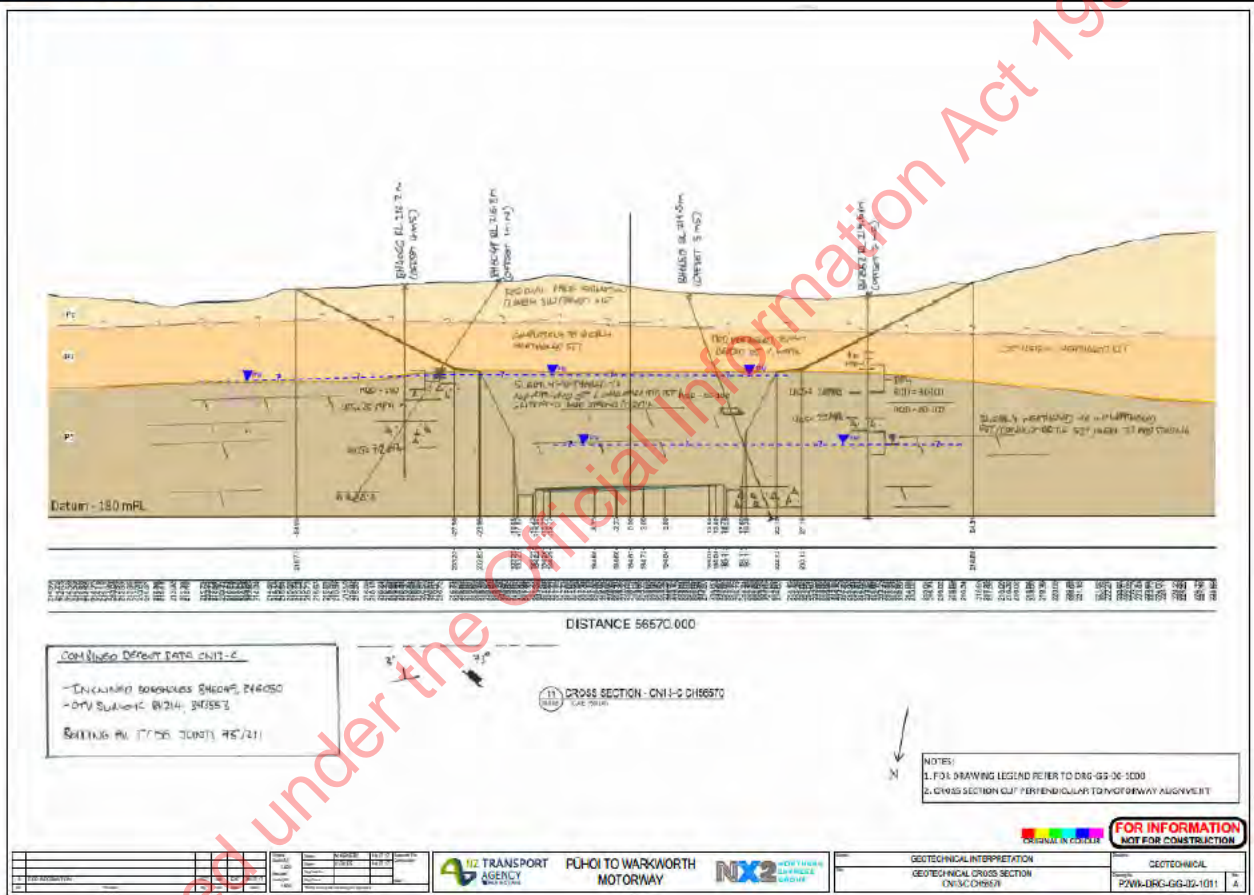
Soil Rock Transition Zone	East: Typically 5~10° towards slope face.
---------------------------	---

Rock Cut	<ul style="list-style-type: none"> <li>85° (at lower 9m) and 64° rock slopes with mesh draping</li> <li>bench above rock slope,</li> </ul>
Remedial Works Design	None required
Remedial Works Details	Not applicable
Peer Reviewed in PSM Report Rev 4	Not reviewed
Groundwater Seepage Monitoring	Proposed at eastern side, but no observations have been made.
Risk of Future Slope Failure	<p>East (LHS):</p> <p>The risk of future slope failure is considered <b>low</b>.</p> <ul style="list-style-type: none"> <li>No significant groundwater seepage observed.</li> </ul>

- Soil rock interface typically less than 10° inclined.  
Potential risk of topsoil slip where topsoil is placed on the rock surfaces.

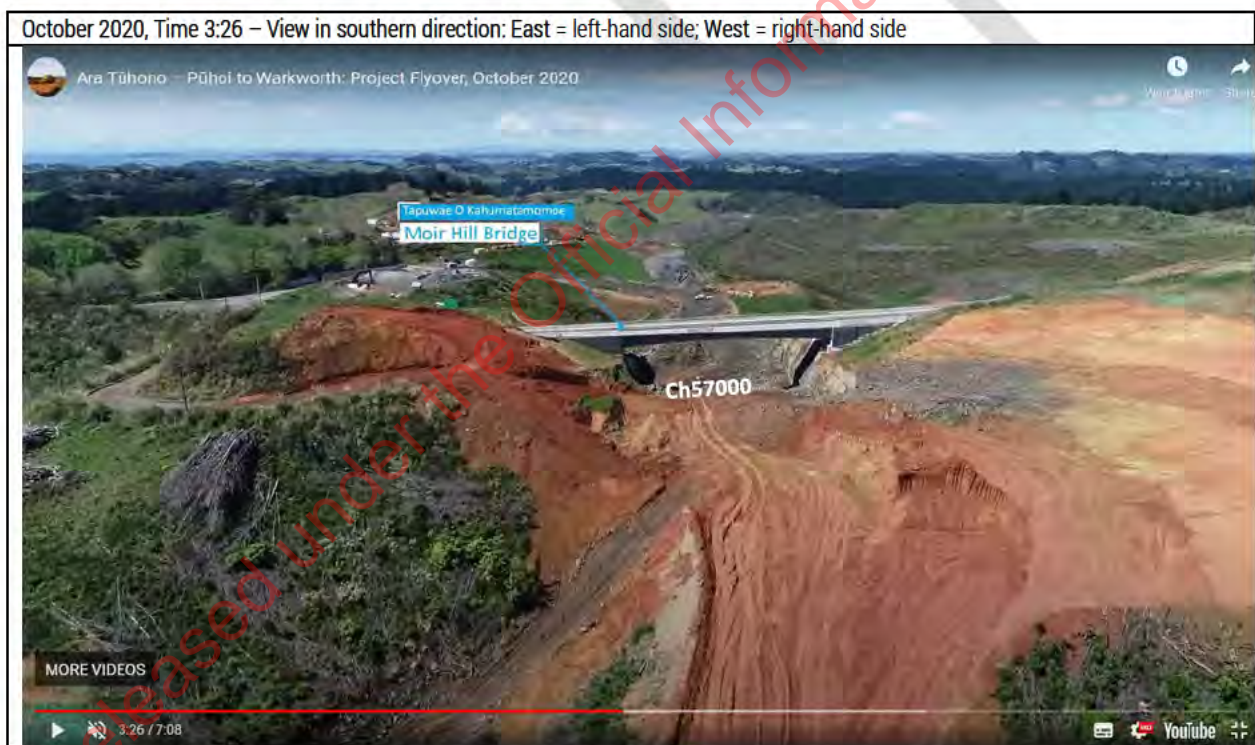
Soil Rock Transition Zone	<p><b>East (LHS):</b> Generally less than 5°~10°.</p> <p><b>West (RHS):</b> Dipping away from cut slope or horizontal</p>
Rock Cut	<ul style="list-style-type: none"> <li>• Rock cuts up to 21m deep supporting the Moir Hill Road Bridge,</li> <li>• 85° at lower 9m and 64° above 9m from excavation level.</li> </ul>
Ground Improvements	DEI 380 (confirmation of ground improvements as per design drawing P2Wk-DRG-GE-00-1007) 7x counterfort drains, 3m deep at 10m centres,
Remedial Works Design	DEI 0380 (Ch57025 – 57090, South West Counterfort Drain Line)
Remedial Works Details	Removal of slipped material and reshape slope (initial landslide). The second landslide at the NW slope comprised a toe buttress with shear keys and counterfort drains.
Peer Reviewed in PSM Report Rev 4	Not reviewed
Groundwater Seepage Monitoring	<p>Groundwater seepage and engineering geological site inspections were undertaken at CS1-C on the 2/11/2021. Observations included the following:</p> <ul style="list-style-type: none"> <li>• Bedding structure is sub-horizontal dipping towards the south</li> <li>• Rock mass structure ranges from massive/homogenous to interbedded widely spaced sandstone/siltstone</li> <li>• Wet/softened soil slope at Ch56850-west with minor erosional rilling</li> </ul>

<ul style="list-style-type: none"> <li>• Seepages at transition cut slope and from soil-rock contact at Ch 56950-East with wet and softened ground around seepage.</li> <li>• Seepages at bridge abutment contact with rock slope</li> <li>• Seepages from rock bedding structure</li> <li>• Seepages from soil-rock contact bench at Ch57500-west</li> <li>• Seepages from soil-rock contact with very wet and softened ground at Ch57100-west</li> <li>• Sediment at subsoil drain outlets at Ch57100-west</li> </ul>
<p>Risk of Future Slope Failure</p>	<p><u>Risk of wedge-type or rock slope failures cannot be determined based on the available information. A risk assessment with regards to the Moir Hill Bridge has not been made. Our assessment relates to the slopes outside of the bridge.</u></p> <p>East (LHS): The risk of future slope failure is considered <b>low</b>.</p> <ul style="list-style-type: none"> <li>• All slip debris at transition has been removed.</li> </ul> <p>West (RHS): The risk of future slope failure is considered <b>low</b>. Further remedial works at the soil cut to rock cut transition were completed.</p> <p><b>The overall weighted risk level remains low.</b></p>

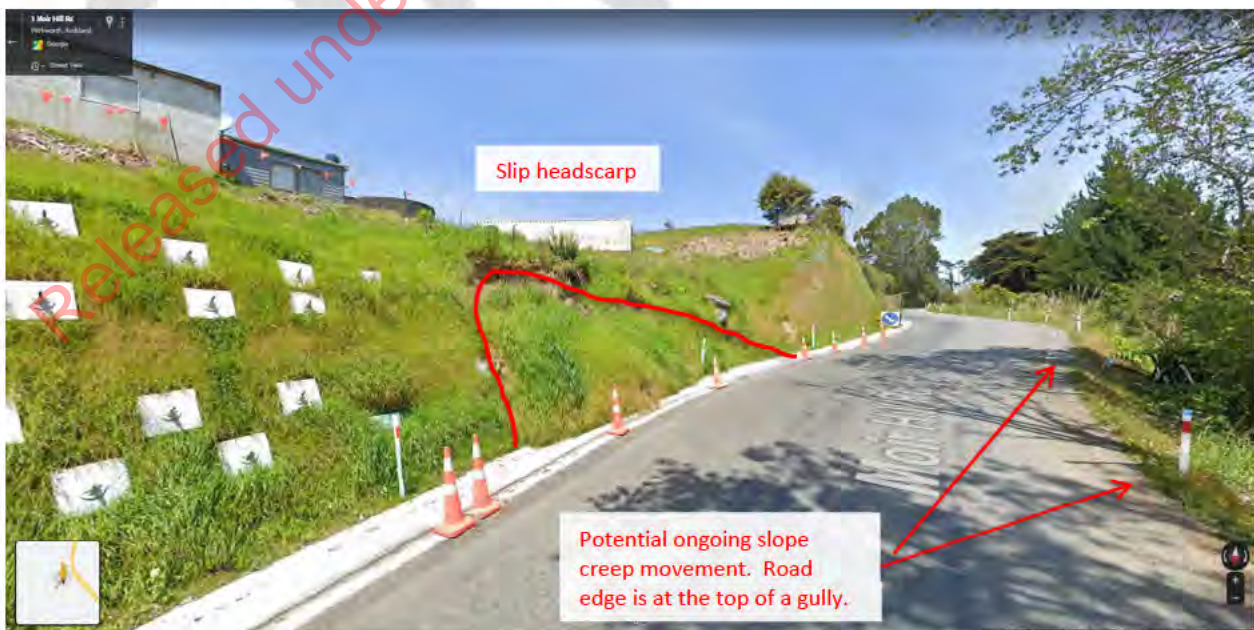
## 7.26 Moir Hill Road – Landslide 8

Chainage	MCM0 Ch140-170 The site is located approximately 1km East of the new alignment at approximately Ch57,000 near the existing SH1.
Typical <u>Design</u> Slope Geometry	LHS: 1H:3V cut slope at the south-eastern side of the alignment is stabilise with soil nails. RHS: Existing natural slope supporting Moir Hill Road.
Existing Landslide	<b>Yes South-East (No 8)</b>
Cause of Landslide	Shallow soil slope failure at the cut slope which was not improved with soil nails.
Date	14/08/2020
Remedial Works Design	DEI 0433 (Ch132 – 155, Retaining Wall incl. slope stability memorandum Rev C)
Remedial Works Details	Removal of slipped material and construction of Redi-Rock gravity retaining wall.
Independent Peer Review	Refer to PSM Report PSM4203-029R Draft Rev 4 – Appendix M.
Rock Cut Slope	No.
Groundwater Seepage Monitoring	No groundwater seepage monitoring <b>has been</b> undertaken.
Risk of Future Slope Failure	<p><b>South-East (LHS):</b> The risk of future slope failure is considered <b>very low</b>. Slope has been remediated with Redi-Rock retaining wall.</p> <p><b>North-West (RHS):</b> The risk of future slope failure is considered <b>low risk</b>. Ongoing downslope movement of existing slope supporting Moir Hill Road towards the existing gully in north-western direction <b>was expected in assessment of the Revision D Report. We understand some movement has occurred during the January 2023 rainfall event. Moir Hill Road was closed to the public.</b></p> <p><b>Nevertheless, the overall weighted risk rating is low, as potential slips do not affect the new SH1 main alignment and maintenance of this section understood not to be part of the NX2 scope.</b></p>

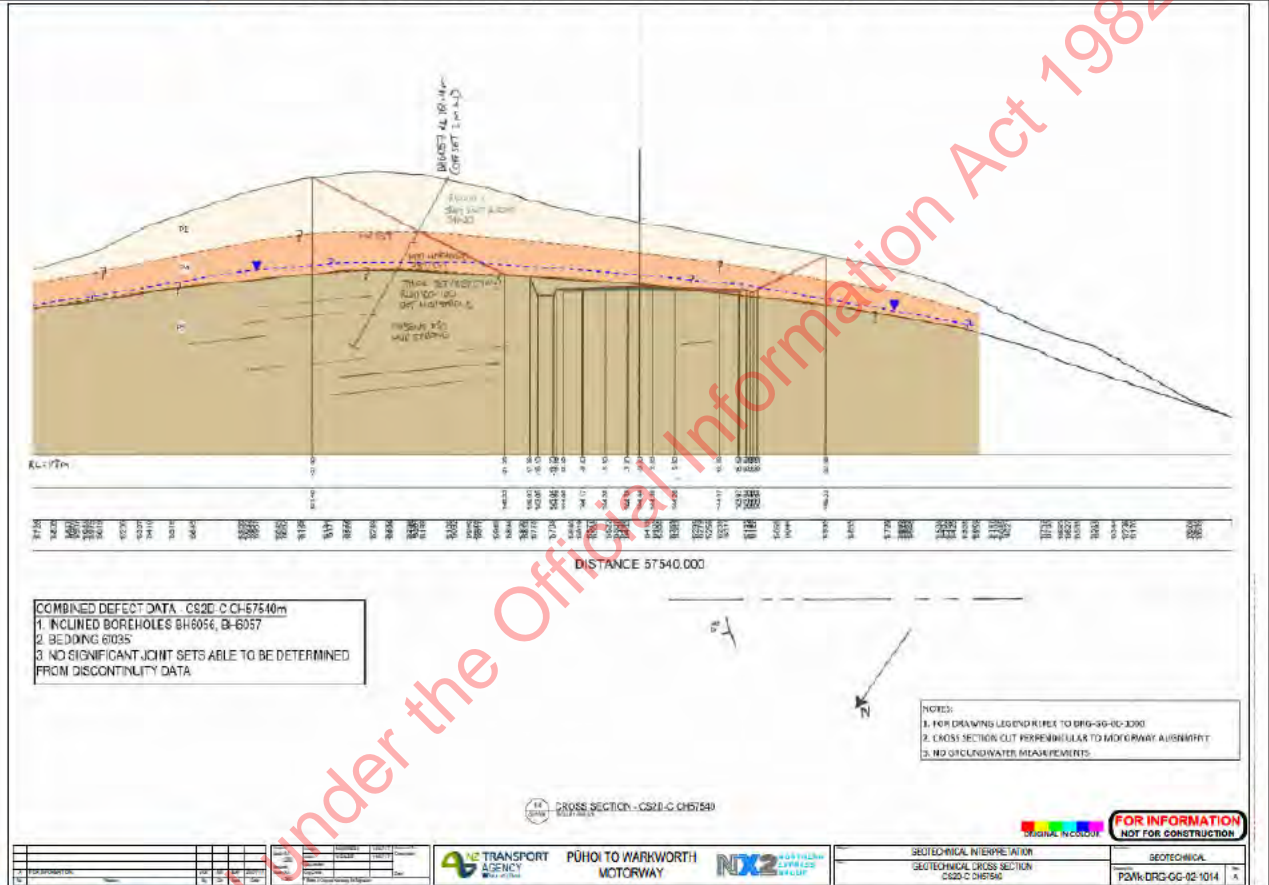
Existing Landslide	Yes (No 10) Slip Ch57,450 – Ch57,620
Cause of Landslide	<ul style="list-style-type: none"> <li>• Bedding fabric noted as being sub horizontal and dipping into the slope (06°/035°)</li> <li>• Softened shear planes orientated parallel to bedding fabric.</li> <li>• Evidence of potential historic landslide and fill material contained within the excavated slope.</li> </ul>
Date Landslide occurred	25/06/2020
Cut within area of historic landslide	Low risk at north-eastern side
Geotechnical Investigations	BH5216, TP3518, BH6056, BH6057 (inclined), TP6016
Site Geology	<p>Ch57,540 (CS2D), Drawing P2Wk-DRG-GG-02-1014</p> <p>1. Geology - Pakiri Formation (Encountered/inferred stratigraphic thicknesses in order)</p> <ul style="list-style-type: none"> <li>• 3-9m - Residually weathered to completely weathered soft SILT &amp; loose SAND</li> <li>• 4-6.5m - Highly weathered to moderately weathered siltstone/sandstone</li> <li>• Moderately strong, slightly to unweathered, thick sandstone &amp; thin siltstone</li> </ul>

- Groundwater recorded at/just above moderately to slightly weathered contacts

Soil Rock Transition Zone	<p><b>East (LHS):</b> Generally dipping away at up to 5~10°.</p> <p><b>West (RHS):</b> Transition zone is dipping away. Rock transition zone is below the cut level.</p>
Rock Cut	Less than 5m high at the eastern (LHS) side. The rock cut slope has been cut at 2H:1V.
Remedial Works Design	DEI 0412 (not provided s 9(2)(b)(ii) and 9(2)(ba) renced in PSM Report PSM4203-029)
Remedial Works Details	Reshape to of 2H:1V (not clear without DEI)
Peer Reviewed in PSM Report Rev 4	Refer to PSM Report PSM4203-029R Draft Rev 4 – Appendix G
Groundwater Seepage Monitoring	<p>Seepage monitoring was undertaken on the 30/06/2021 and an engineering geological site inspection on the 2/11/2021.</p> <p>Groundwater seepage and engineering geological observations are as follows:</p> <ul style="list-style-type: none"> <li>• Surficial topsoil washout and surface erosion observed at Ch57,450</li> </ul>

<ul style="list-style-type: none"> <li>• Toe buttressing to remediate slope "relaxation" between Ch57,425 to 57,600. Excavation of toe slope and buttressing</li> <li>• Sharp transition between completely and highly weathered soil/rock and underlying slightly weathered rock</li> <li>• Excavations relatively dry at time of inspection</li> <li>• Sediment at counterfort drain outlets</li> <li>• Sediment pond located directly above the cut slope at Ch57,500 is likely recharging groundwater to cut slope</li> <li>• Minor seepages recorded at soil-rock transition with wet and softened ground at location of seepage</li> </ul>
<p>Risk of Future Slope Failure</p>	<p><b>East (LHS):</b> The risk of future slope failure is considered <b>low to moderate risk</b>. The risk level has been increased from low.</p> <ul style="list-style-type: none"> <li>• The slope has been cut back to 2H:1V without lower rock slope. Buttress fill and counterfort drains were installed in October &amp; November 2021.</li> <li>• Cause of slip was daylighting of shear plane. Risk potential that the shear plane is re-activated.</li> </ul> <p><b>West (RHS):</b> The risk of future slope failure is considered <b>very low</b>. The risk rating at the western side has been reduced.</p>

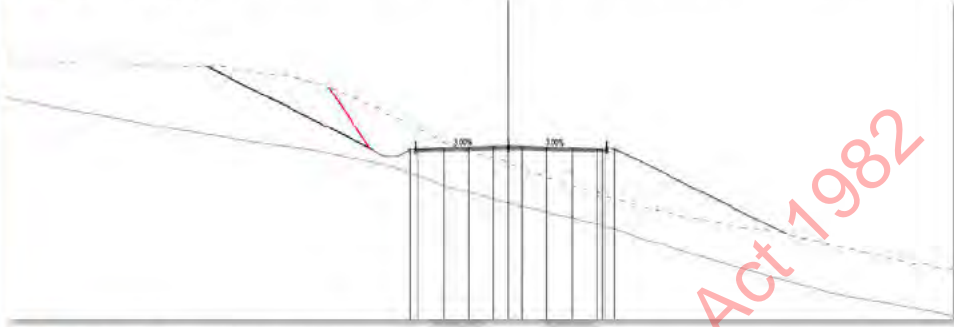
Chainage	Ch58,550 – Ch58,605
Typical Design Slope Geometry	<p>East (LHS): 2H:1V up to 12m high. Based on the drone footage, it appears that that this cut has been constructed steeper likely due to higher than expected rock levels (indicated by the red line in the sketch below).</p>

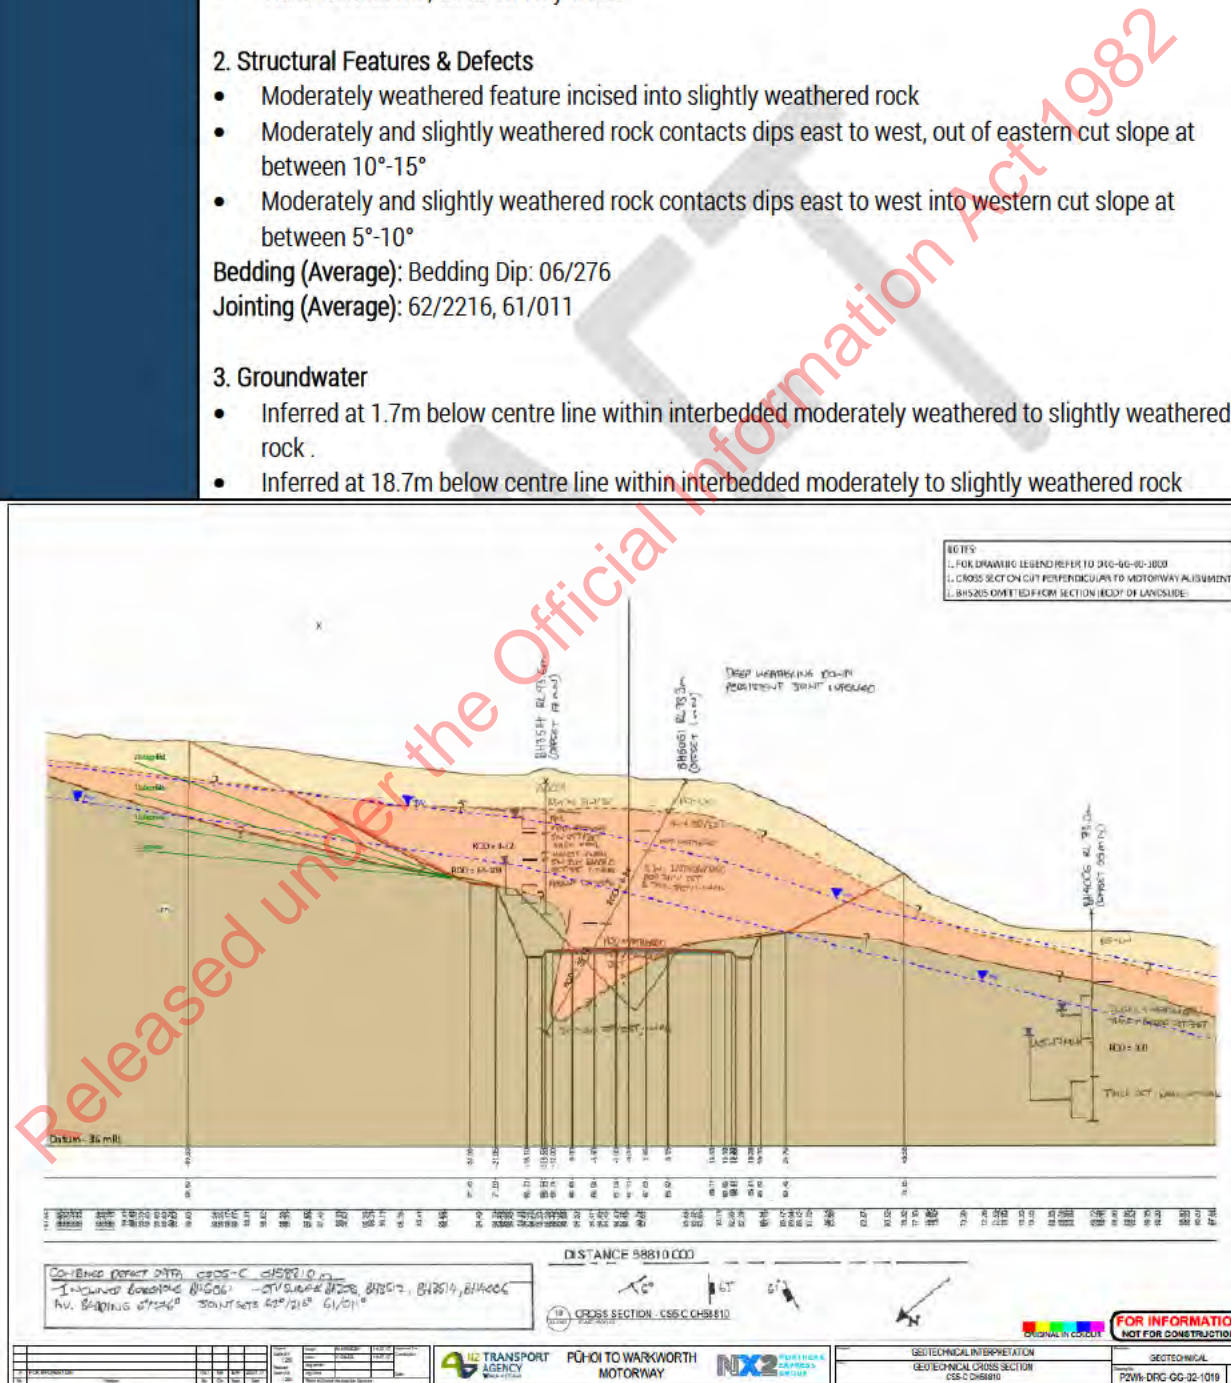
- Inferred at 1.7m below centre line within interbedded moderately weathered to slightly weathered rock .
- Inferred at 18.7m below centre line within interbedded moderately to slightly weathered rock

Soil Rock	East (LHS): Generally dipping out of the slope at up to 10~20° steep in western direction.
Transition Zone	West (RHS): Generally flat or dipping into the cut slope towards the western direction.
Rock Cut	Steep rock cut slope at eastern and western side

Remedial Works Design	DEI 0401 (Ch58715 – 58830, East Rock cut stabilisation), DEI 0414 (Ch58750 – 58800, Eastern Batter Soil Cut Stabilisation), DEI 0507 (Ch58715 – 58750, North East Rock Cut Stabilisation)
Remedial Works Details	<ul style="list-style-type: none"> <li>• 6 nos. counterfort drains at 10m centres,</li> <li>• 2m wide rock bench</li> <li>• Removal of debris and slope regraded to 4H:1V (initial landslide. The upper slope has further be regraded after the July 2022 landslide)</li> </ul>
Peer Reviewed in PSM Report Rev4	Refer to PSM Report PSM4203-029R Draft Rev 4 – Appendix J. It is noted that this report covered only the initial landslide.
Groundwater Seepage Monitoring	Seepage monitoring on site undertaken on the 9/06/2021. An engineering geological site inspection was undertaken on the 12/11/2021. Observations are as follows: <ul style="list-style-type: none"> <li>• Wet and softened ground at buttress-rock transition with wash out of rock and fill debris on to bench</li> <li>• Seepage observed at toe of counterfort drains</li> <li>• Moderately weathered extremely weak rock bench softened and eroded by seepage and surface water run off</li> <li>• Loose debris on bench and above rock slope.</li> </ul>
