Pūhoi To Warkworth (P2Wk)– Landslide Risk Assessment

# Geotechnical Review of Cut Slopes and Landslide Risks

Revision E

Date: 11 April 2023

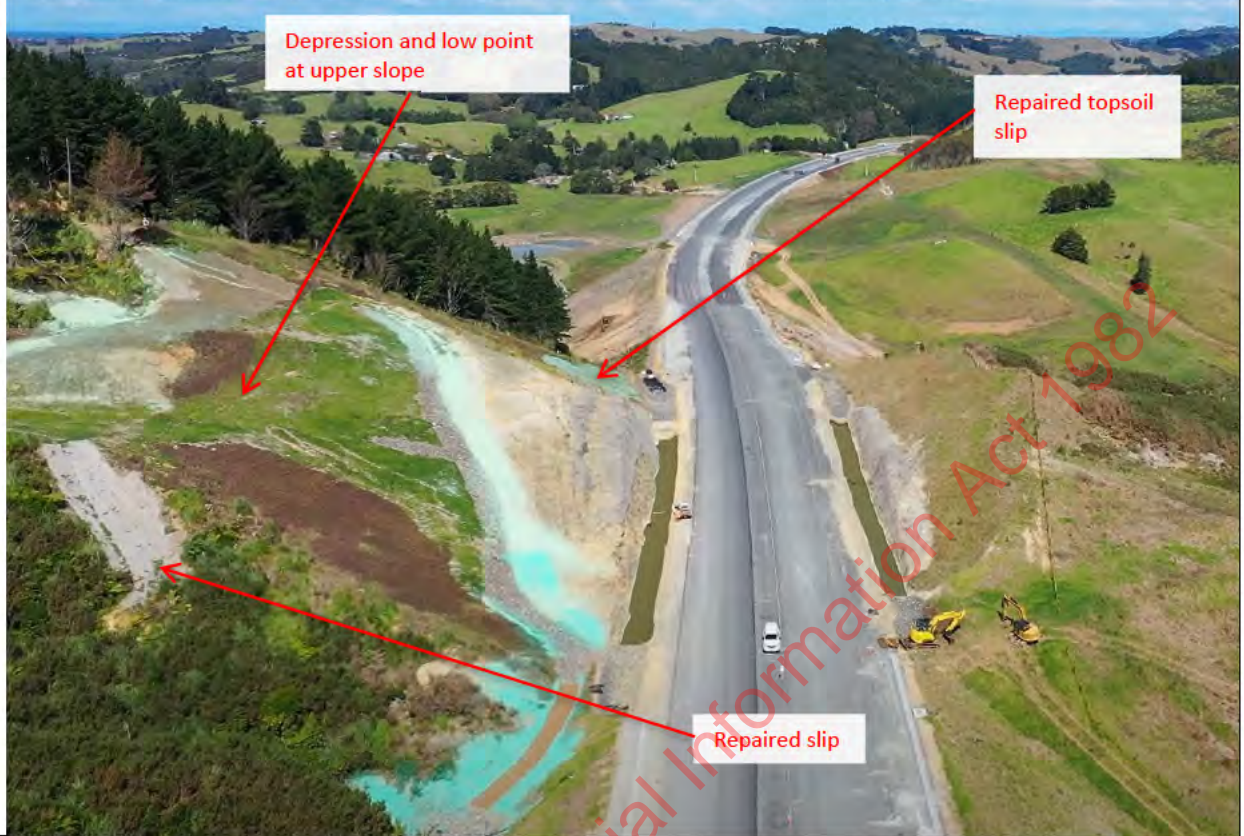
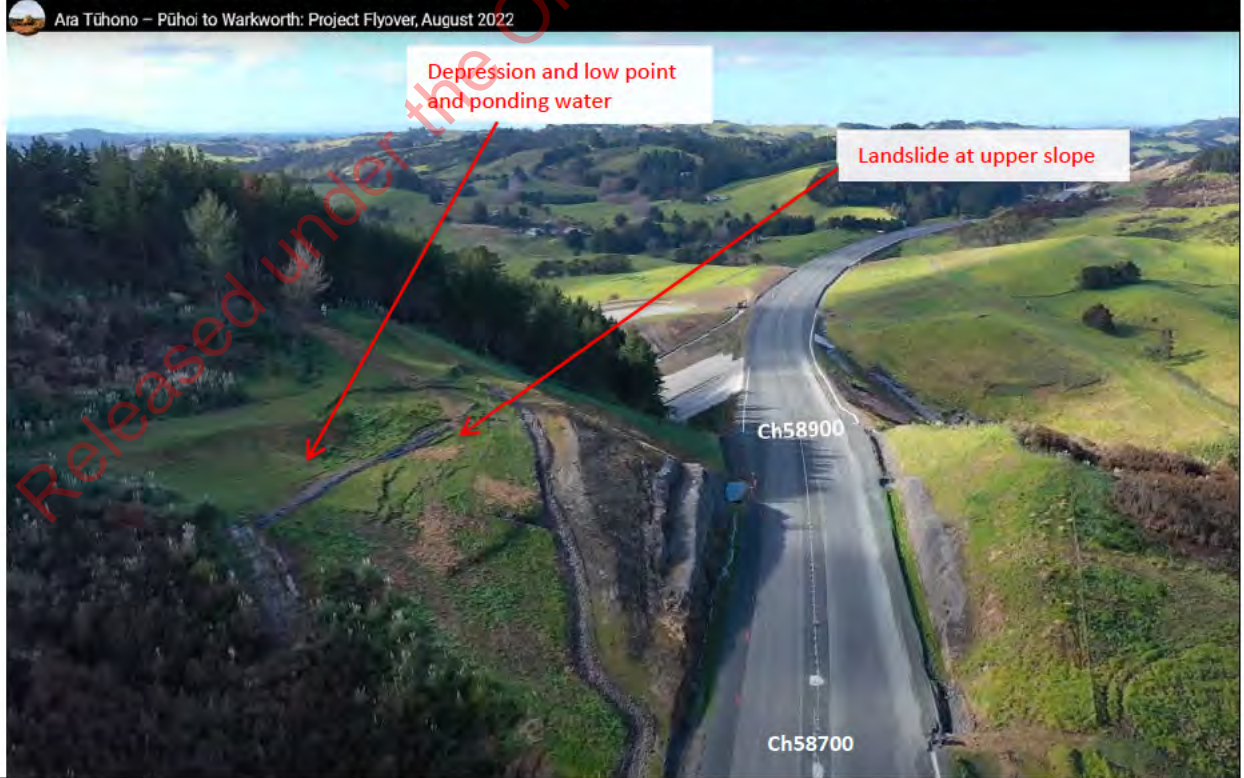
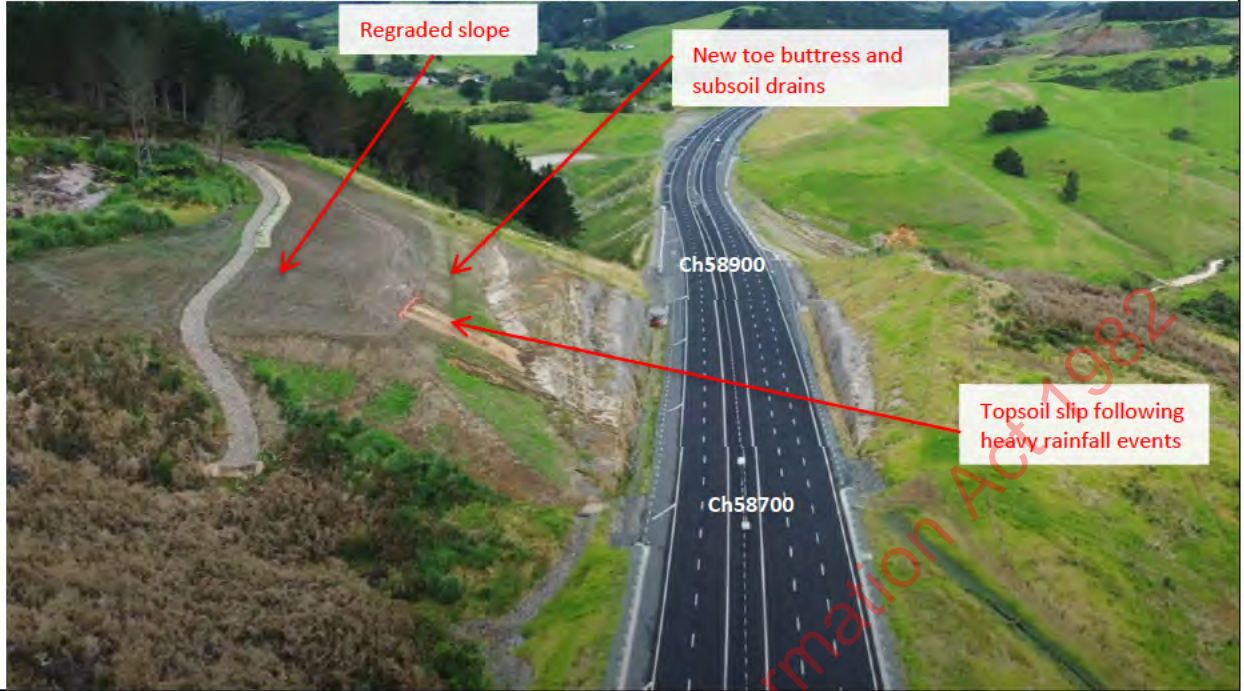
Existing Landslide	Yes (No 13) Slip Ch58,700 – Ch58,800 East
Cause of Landslide	<ul style="list-style-type: none"> <li>• Unfavourably orientated bedding fabric dipping out of the slope at approximately 6°/276°.</li> <li>• Two sets of moderately to steeply inclined joints</li> <li>• Evidence of historic shallow landslide activity within the cut.</li> <li>• Softened shear planes orientated parallel to bedding fabric.</li> <li>• The presence of a perched groundwater table about the soil/rock interface</li> </ul>
Date Landslide occurred	2/06/2020
Cut within area of historic landslide	Low risk at north-eastern side. Moderate risk at western side but sloping in western direction.
Geotechnical Investigations	BH208, BH3514, BH3515, BH3516, BH4006
Site Geology	<p>Ch58,810 (CS5), Drawing P2Wk-DRG-GG-02-1019</p> <p>1. Geology - Pakiri Formation (Encountered/inferred stratigraphic thicknesses in order)</p> <ul style="list-style-type: none"> <li>• 4.5-6.5m Stiff - Residual to completely weathered SILT/Sandstone</li> <li>• Highly weathered sandstone</li> </ul>

Risk of Future Slope Failure	<p><b>East (LHS):</b> The risk of future slope failure is considered <b>low to moderate</b>, increased from previous assessment despite additional remedial works.</p> <ul style="list-style-type: none"> <li>• Remedial works completed (buttress fill with subsoil drains). However, there is an increased risk if the design relies on maintenance of subsoil drains.</li> <li>• Soil removed above rock transition zone. Where topsoil is present, there could be a risk of topsoil and surface erosion</li> <li>• Potential rockfall risks from the upper 2H:1V exposed rock slopes have been reviewed as part of the CJV assessments. Refer to Section 4.2.</li> </ul> <p><b>West (RHS):</b> The risk of future slope failure is considered <b>very low</b>, reduced from the previous assessment.</p> <ul style="list-style-type: none"> <li>• Cut slope less than 10m high,</li> <li>• Topography sloping in western direction and soil rock transition zone is dipping into cut slope,</li> <li>• No/insignificant groundwater recharge/ seepage,</li> </ul>

Remedial Works Design	DEI 0401 (Ch58715 – 58830, East Rock cut stabilisation), DEI 0414 (Ch58750 – 58800, Eastern Batter Soil Cut Stabilisation), DEI 0507 (Ch58715 – 58750, North East Rock Cut Stabilisation)
Remedial Works Details	<ul style="list-style-type: none"> <li>• 6 nos. counterfort drains at 10m centres,</li> <li>• 2m wide rock bench</li> <li>• Removal of debris and slope regraded to 4H:1V (initial landslide. The upper slope has further be regraded after the July 2022 landslide)</li> </ul>
Peer Reviewed in PSM Report Rev4	Refer to PSM Report PSM4203-029R Draft Rev 4 – Appendix J. It is noted that this report covered only the initial landslide.
Groundwater Seepage Monitoring	Seepage monitoring on site undertaken on the 9/06/2021. An engineering geological site inspection was undertaken on the 12/11/2021. Observations are as follows: <ul style="list-style-type: none"> <li>• Wet and softened ground at buttress-rock transition with wash out of rock and fill debris on to bench</li> <li>• Seepage observed at toe of counterfort drains</li> <li>• Moderately weathered extremely weak rock bench softened and eroded by seepage and surface water run off</li> <li>• Loose debris on bench and above rock slope.</li> </ul>

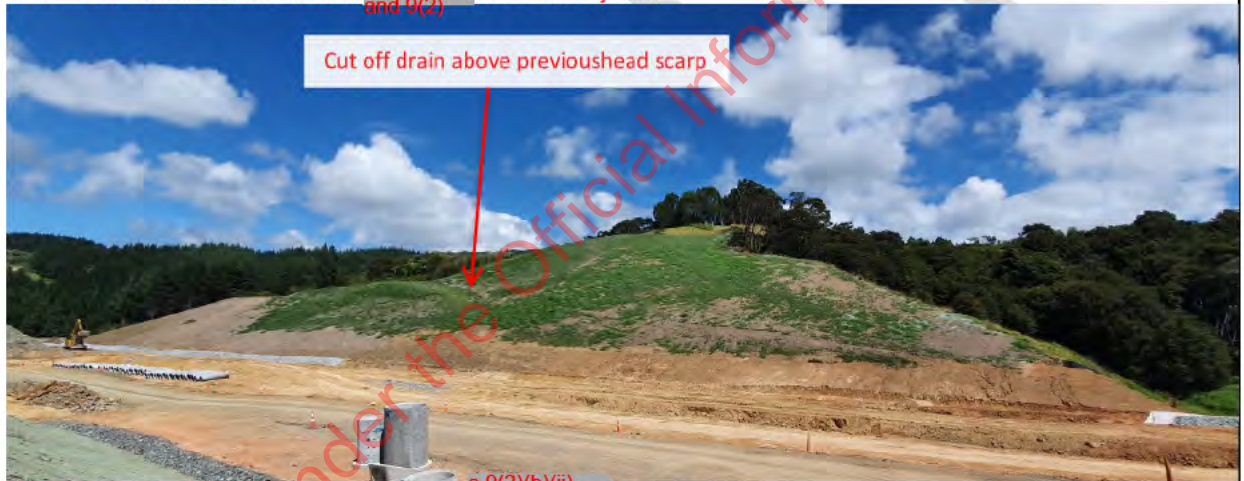
CS8D – View from in southern direction s 9(2)(b)(ii) and 9(2) sit 24 February 2021

<ul style="list-style-type: none"> <li>Obscured drainage outlets</li> <li>Subsoil drains typically dry but with evidence of previous seepage via sediment at location of drain outlets</li> </ul>
Risk of Future Slope Failure	<p><b>East (LHS):</b> The risk of future slope failure is considered <b>very low, reduced from previous assessment</b>.</p> <ul style="list-style-type: none"> <li>Cut depth less than 6m and topography is sloping down beyond the cut towards existing SH1.</li> </ul> <p><b>West (RHS):</b> The risk of future slope failure is considered <b>low, as per previous assessment</b>.</p> <ul style="list-style-type: none"> <li>Substantial remedial works design completed.</li> <li>It is noted that the remedial works were not constructed in accordance with DEI 411 as per non-conformance report NCR 1156. However, an independent DJV assessments (DC547) concludes that the as-built can remain in place.</li> </ul>

Soil Rock Transition Zone	<p><b>East (LHS):</b> Generally dipping out of the slope at up to 15~20°.</p> <p><b>West (RHS):</b> Soil rock transition zone below excavation level and dipping into the slope below the cut level in eastern direction.</p>
Rock Cut	Geological section indicates steep rock cut at lower part of western slope, which was not encountered during construction (refer photos).
Remedial Works Design	DEI 411
Remedial Works Details	<p>Based on PSM Report PSM4203-029R Appendix K Table 7:</p> <ul style="list-style-type: none"> <li>Reshape slope to 3H:1V</li> <li>Counterfort drains: <ul style="list-style-type: none"> <li>to extend to below sheared surface or a depth of 4 m, 8m centre-to-centre spacing.</li> <li>to extend 12m from the back face of the toe buttress.</li> </ul> </li> <li>Surface water cut-off drain to be installed upslope of the head scarp.</li> </ul> <p><u>Shear Key/Buttress at south eastern part only:</u></p> <ul style="list-style-type: none"> <li>Minimum 6 m wide toe buttress base.</li> <li>Base of toe buttress to be extended minimum 0.5m into UW Pakiri Formation Rock.</li> <li>Buttress to be extended minimum 4m in vertical height above the sheared surface.</li> <li>Base of the toe buttress to comprise of compacted Class 1 Rockfill and Structural 120 Fill above the Class 1 Rockfill.</li> <li>Cut slope behind the toe buttress to be re-graded to maximum 3H:1V.</li> </ul>

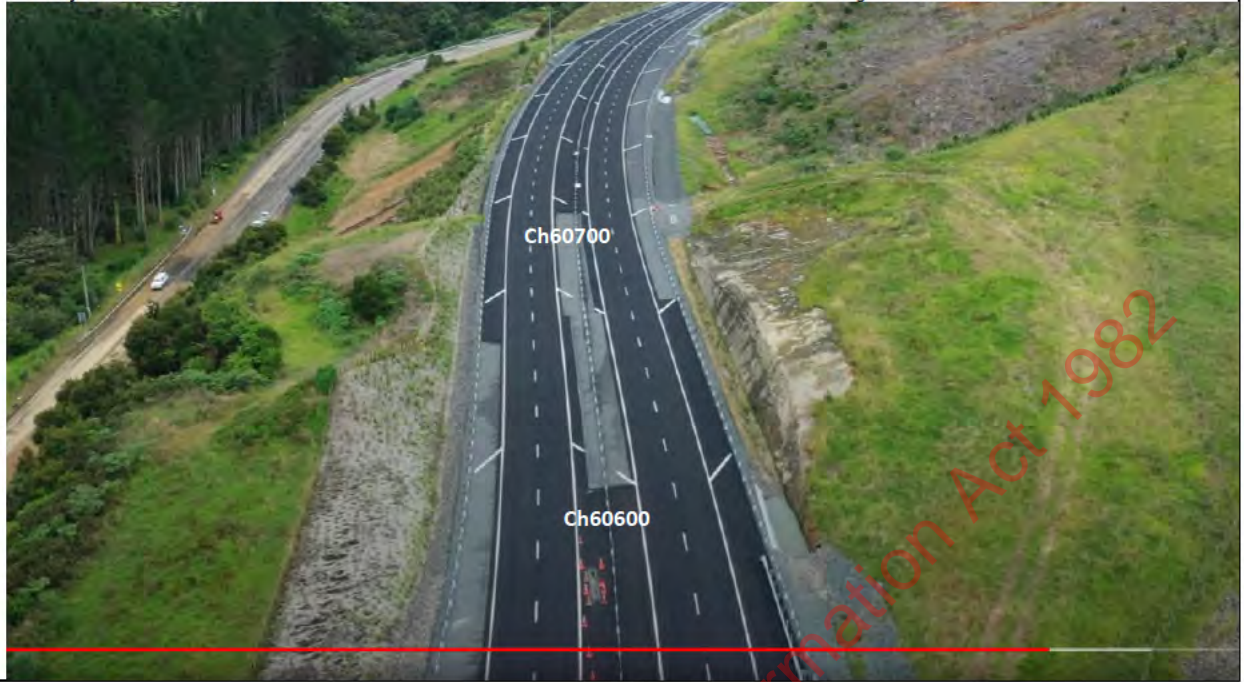
Risk of Future Slope Failure	<p><b>East (LHS):</b> The risk of future slope failure is considered <b>very low, reduced compared to the previous assessment.</b></p> <p><b>West (RHS):</b> The risk of future slope failure is considered <b>low to moderate (as per previous assessment),</b> Seepage and possible softened ground observed at north-western transition into the slope.</p>

January 2023, Time 5:00 – View in southern direction, Ch60600: East = left-hand side; West = right-hand side

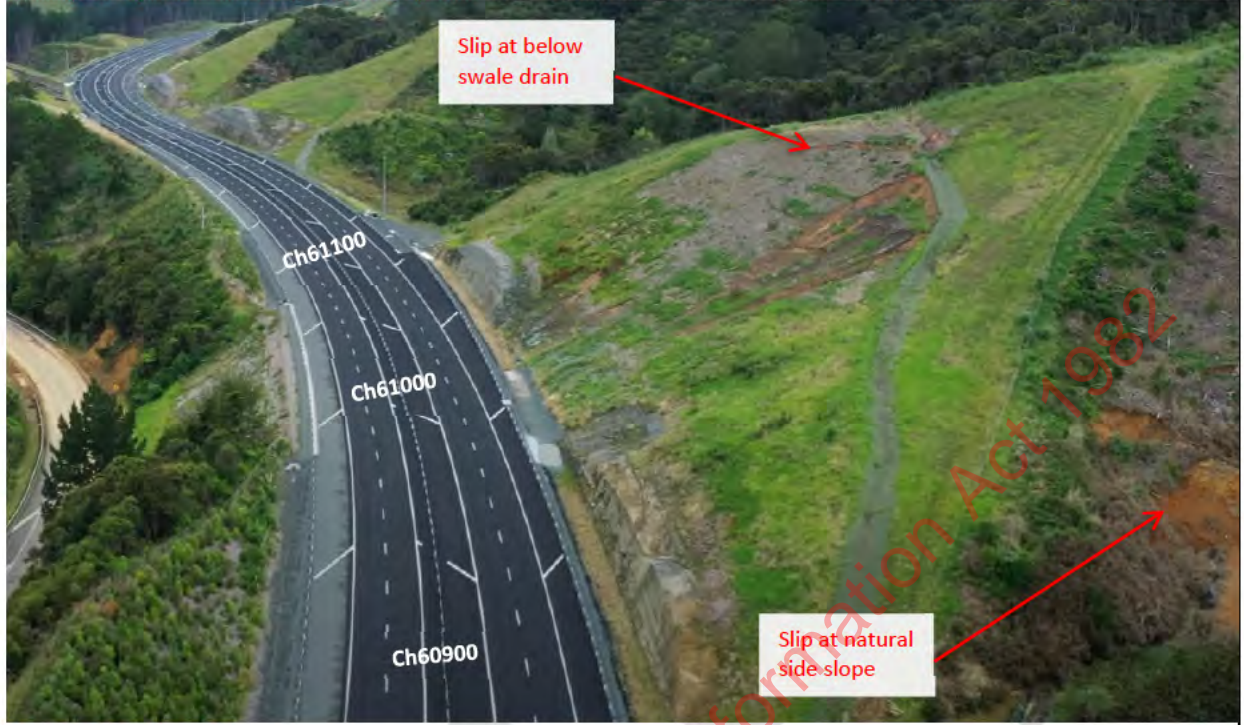
January 2023 (after rainfall event 28/01/2023), Time 5:11 – View in southern direction: East = left-hand side; West = right-hand side

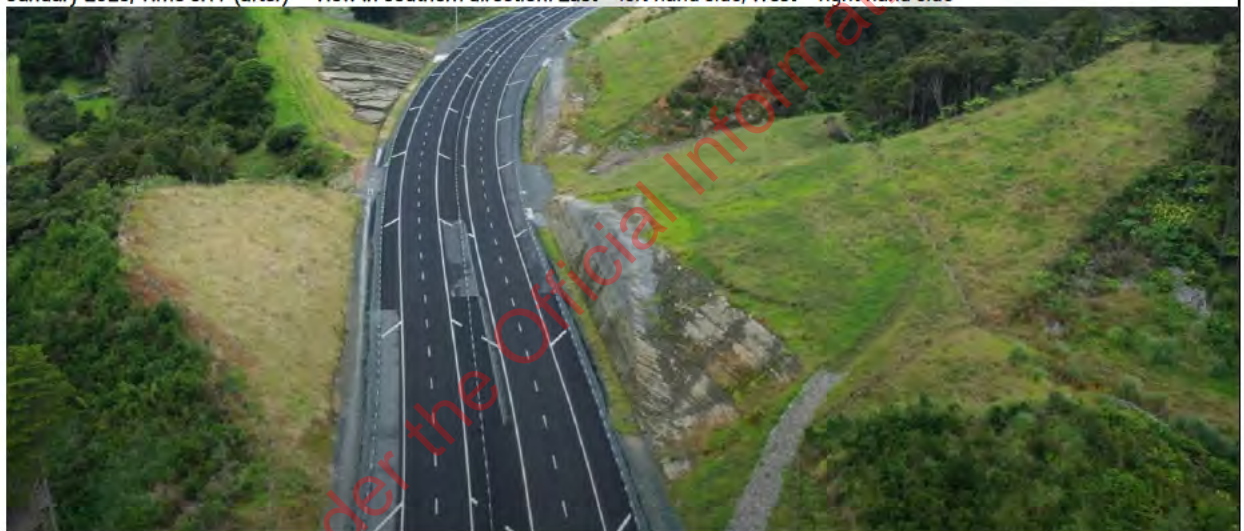
January 2023, Time 5:17 (after) – View in southern direction: East = left-hand side; West = right-hand side

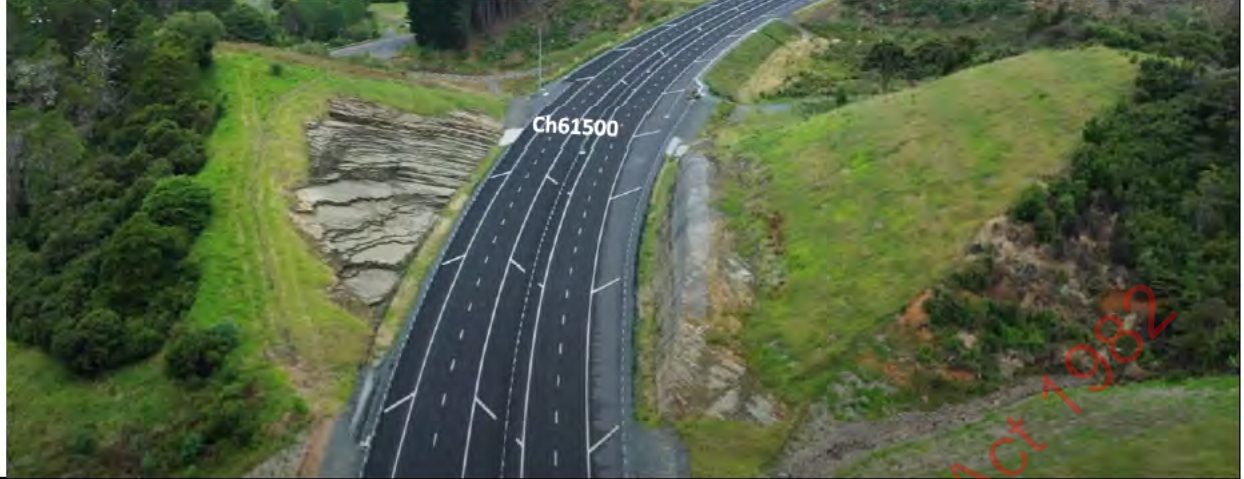
January 2023, Time 5:20 (after rainfall events 28/01/2023) – View in southern direction: East = left-hand side; West = right-hand side

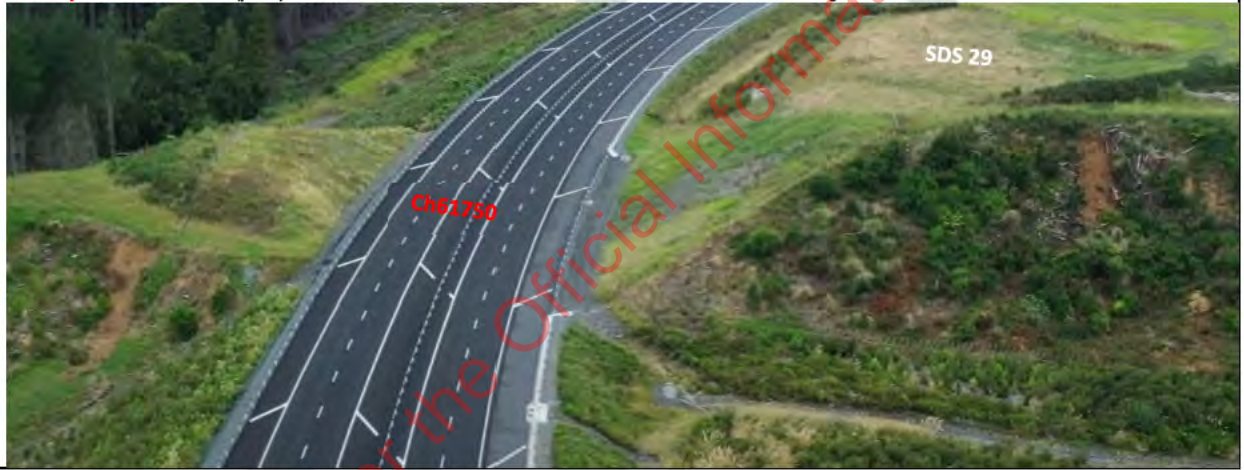
January 2023, Time 5:25 (post) – View in southern direction: East = left-hand side; West = right-hand side

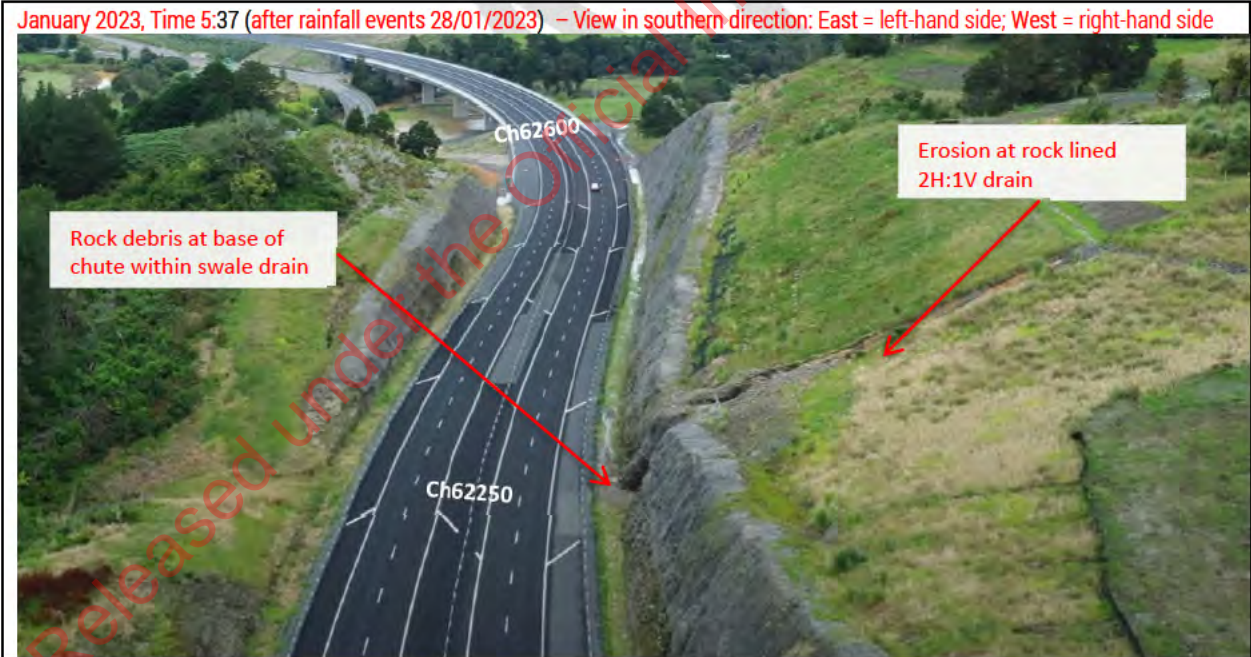
January 2023, Time 5:37 (after rainfall events 28/01/2023) – View in southern direction: East = left-hand side; West = right-hand side

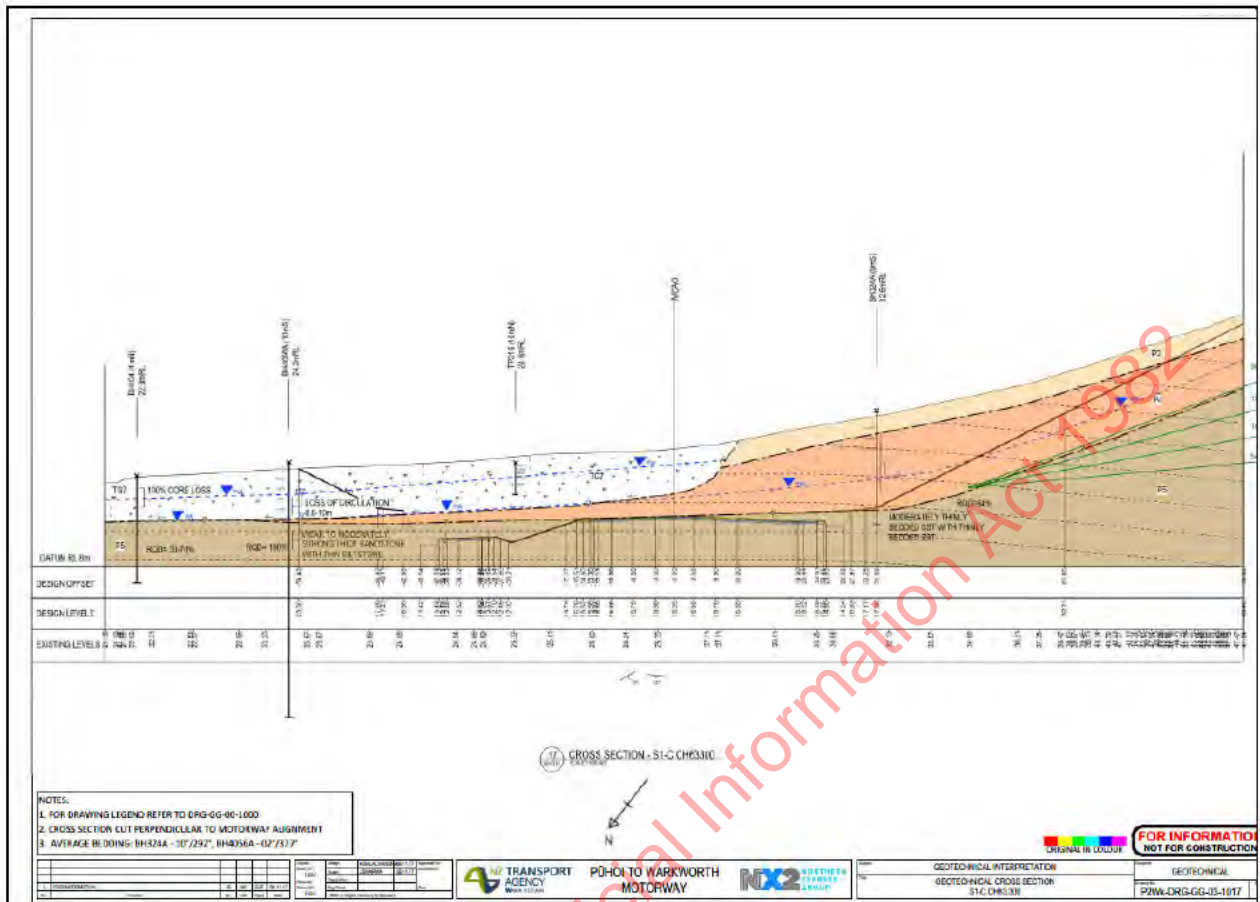
Geotechnical Investigations	BH103, BH104, BH323, BH324A, BH325, BH6079, BH6080, BH4056A
Site Geology	<p>Ch63,300 (S1-C), drawing P2Wk-DRG-DD-03-1017</p> <p>1. Geology-Pakiri Formation (Encountered &amp; inferred thicknesses in stratigraphic order)</p> <ul style="list-style-type: none"> <li>• 8-8.5m - Soft to firm - Colluvium/landslide debris (SPT N= 1-5)</li> <li>• 3-4m - Stiff - Residually weathered soil</li> <li>• Up to 12m - Highly to moderately weathered rock</li> <li>• Slightly to unweathered rock encountered between 8.5 and 15m below existing ground level.</li> <li>• Colluvium/landslide debris encountered directly above moderately and slightly weathered rock at location of road cut</li> <li>• Slightly to unweathered rock comprises weak to moderately strong, thick sandstone and thin siltstone to moderately thick bedded sandstone with thinly bedded siltstone</li> </ul> <p>2. Structural Features &amp; Defects</p> <ul style="list-style-type: none"> <li>• Slightly to unweathered rock contact with moderately weathered rock dips out western cut at 15°-20°</li> <li>• Apparent dip of bedding with reference to section at approx. 5° towards West - Southwest in to cut slope</li> </ul> <p>Bedding Average: 10/292, 02/327</p> <p>3. Groundwater</p> <ul style="list-style-type: none"> <li>• Groundwater recorded within landslide debris at 3-4m below surface level</li> <li>• Groundwater recorded 10.5m below surface level within moderately weathered rock at up slope western cut side</li> <li>• Inferred at 8m below surface level at centre line of road cut and at contact of landslide debris and moderately to slightly weathered and unweathered rock</li> </ul> <p>4. Geomorphological Features</p> <p>Large translational landslide feature through alignment</p>

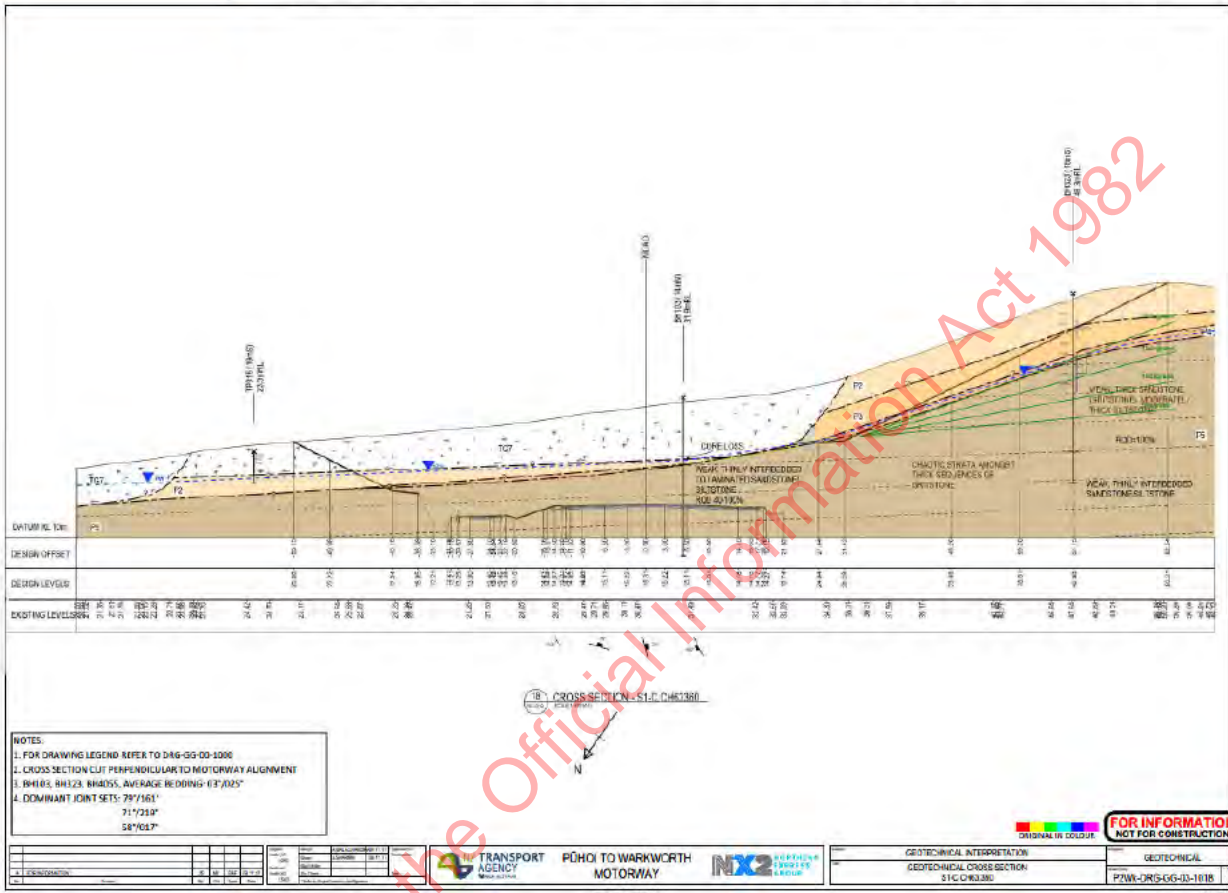
- Groundwater recorded between 9.5-10m below surface level, within thin layer of moderately weathered rock and directly above slightly to unweathered rock contact

- Groundwater inferred at boundary of landslide debris and residual to slightly weathered rock
- 4. Geomorphological Features**
- Large west to east translational landslide feature 100-120m long.
  - Landslide debris/colluvium directly contacts with underlying slightly to unweathered rock

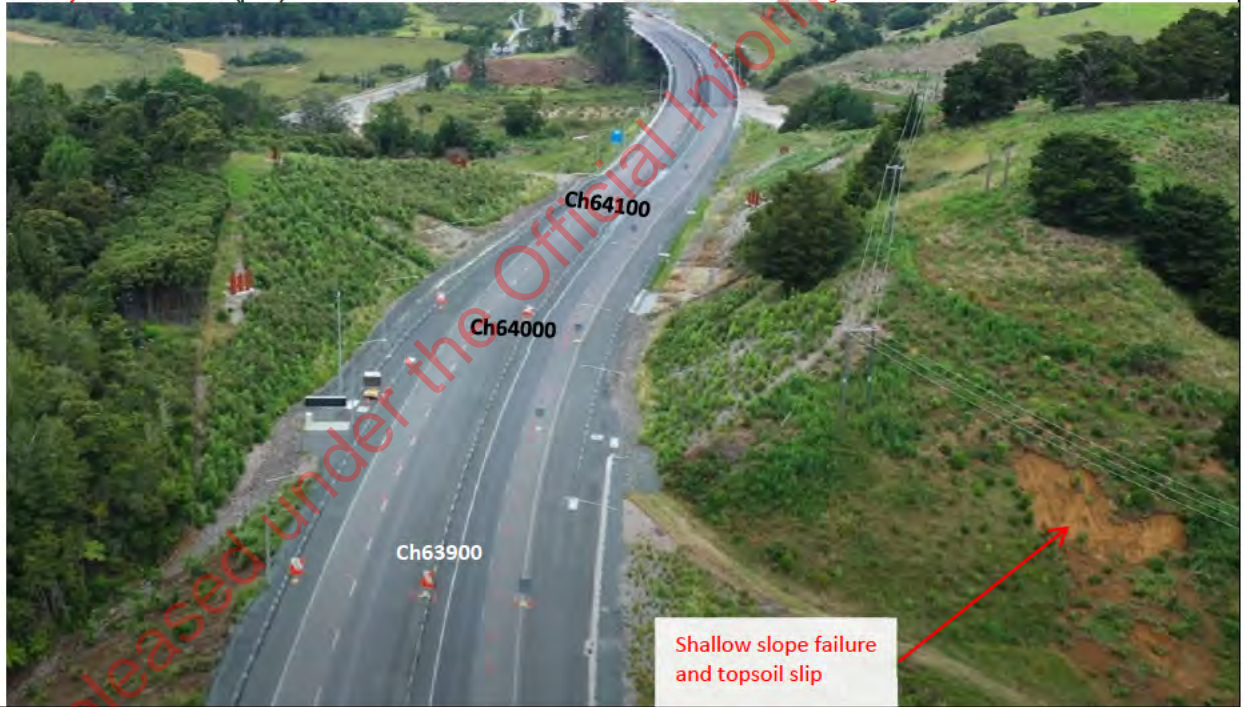
January 2023, Time 6:10 (post) – View in southern direction: East = left-hand side; West = right-hand side

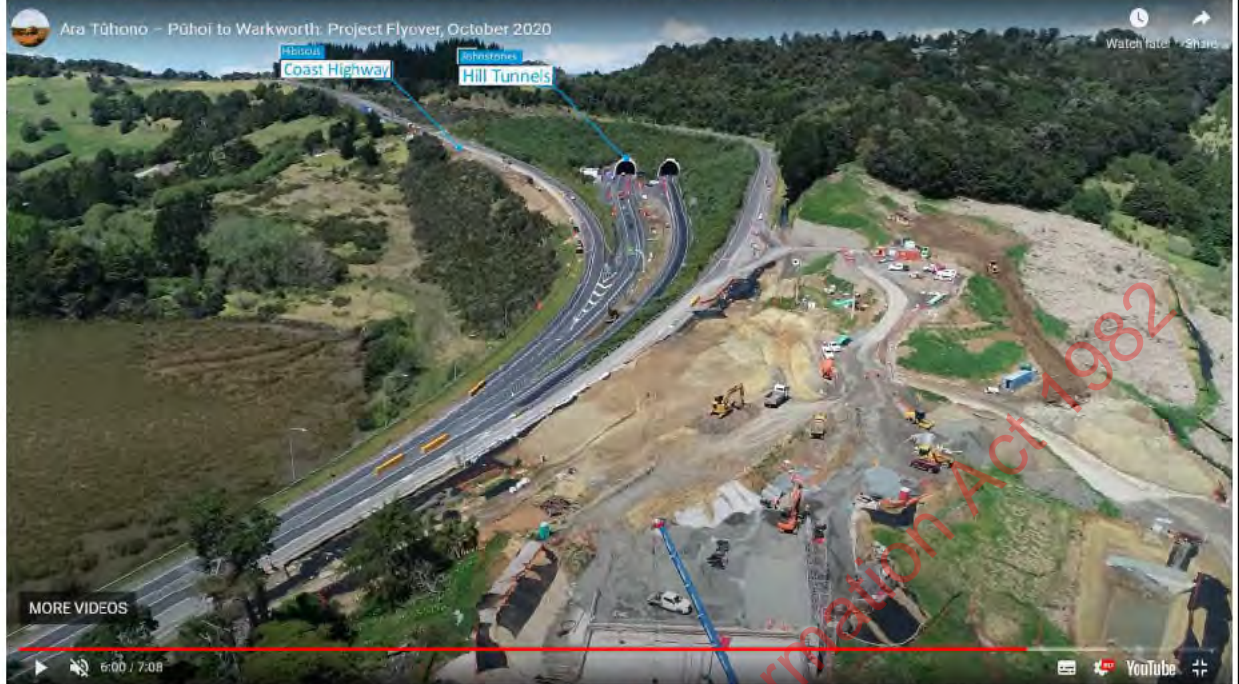
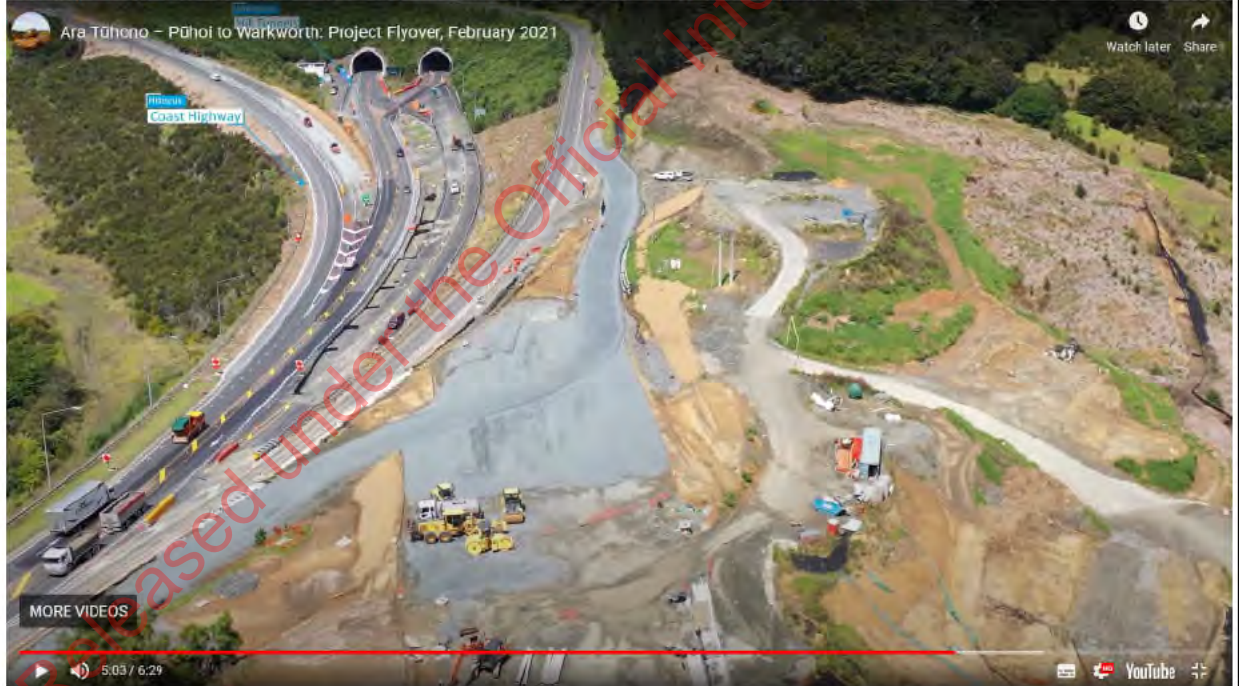
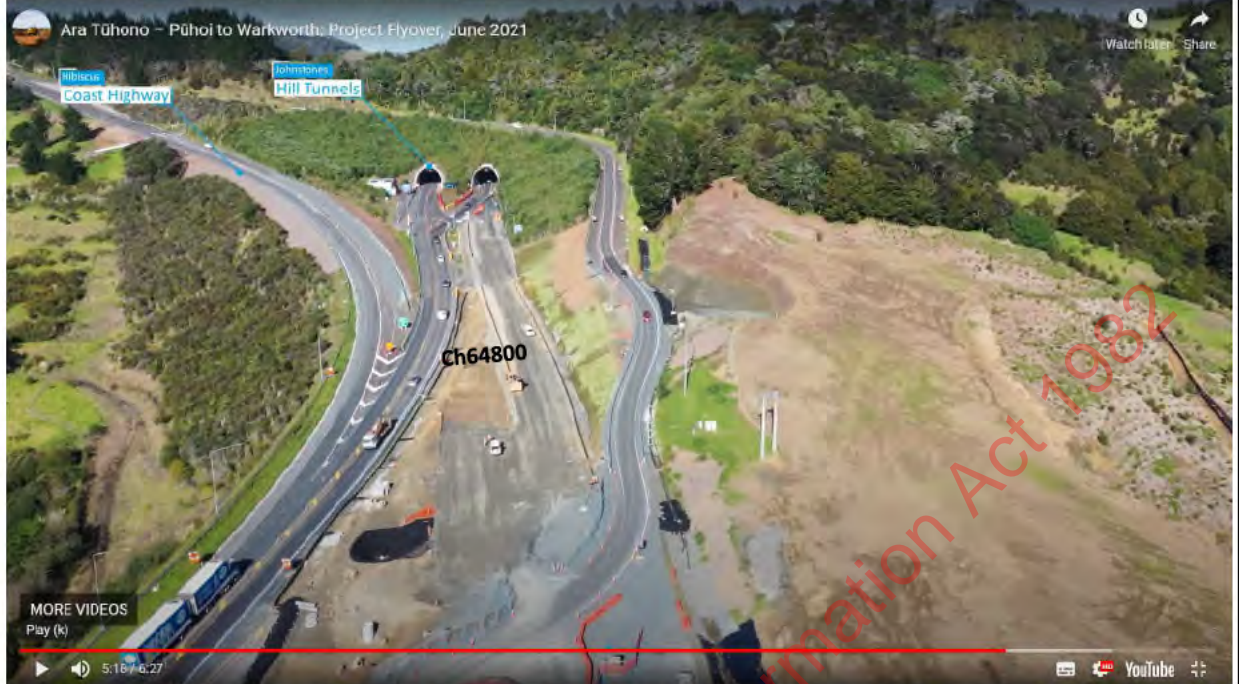
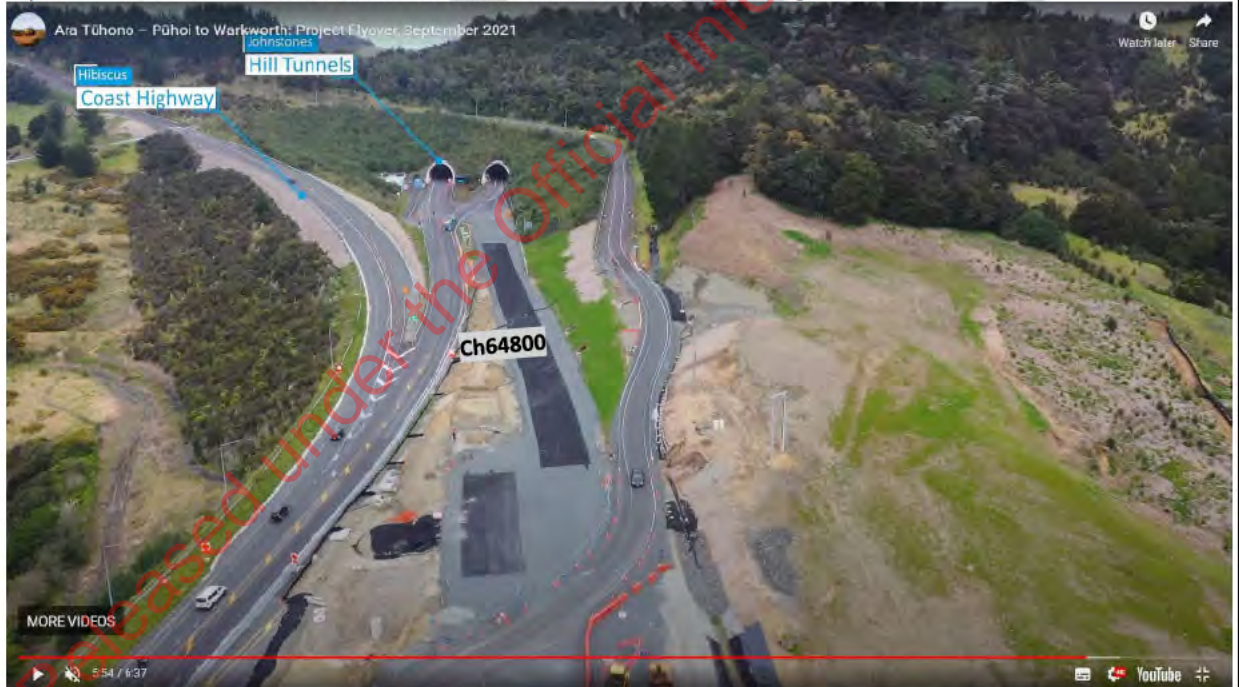
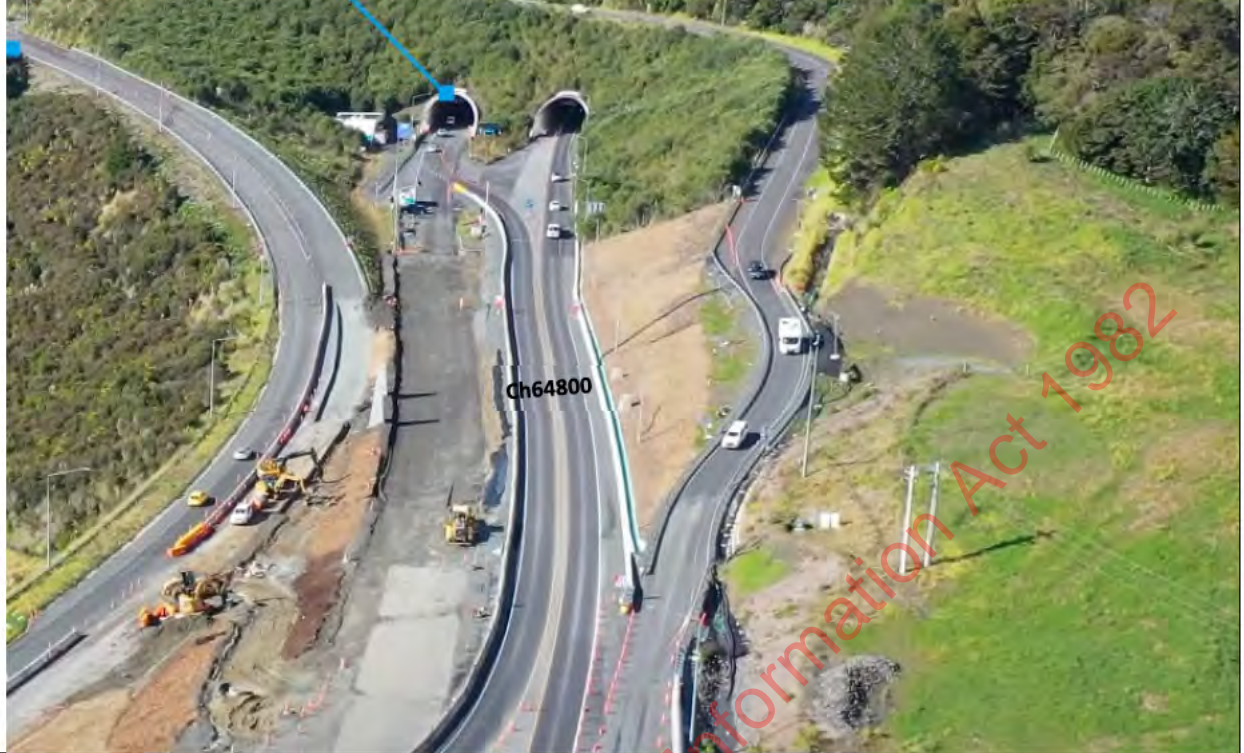
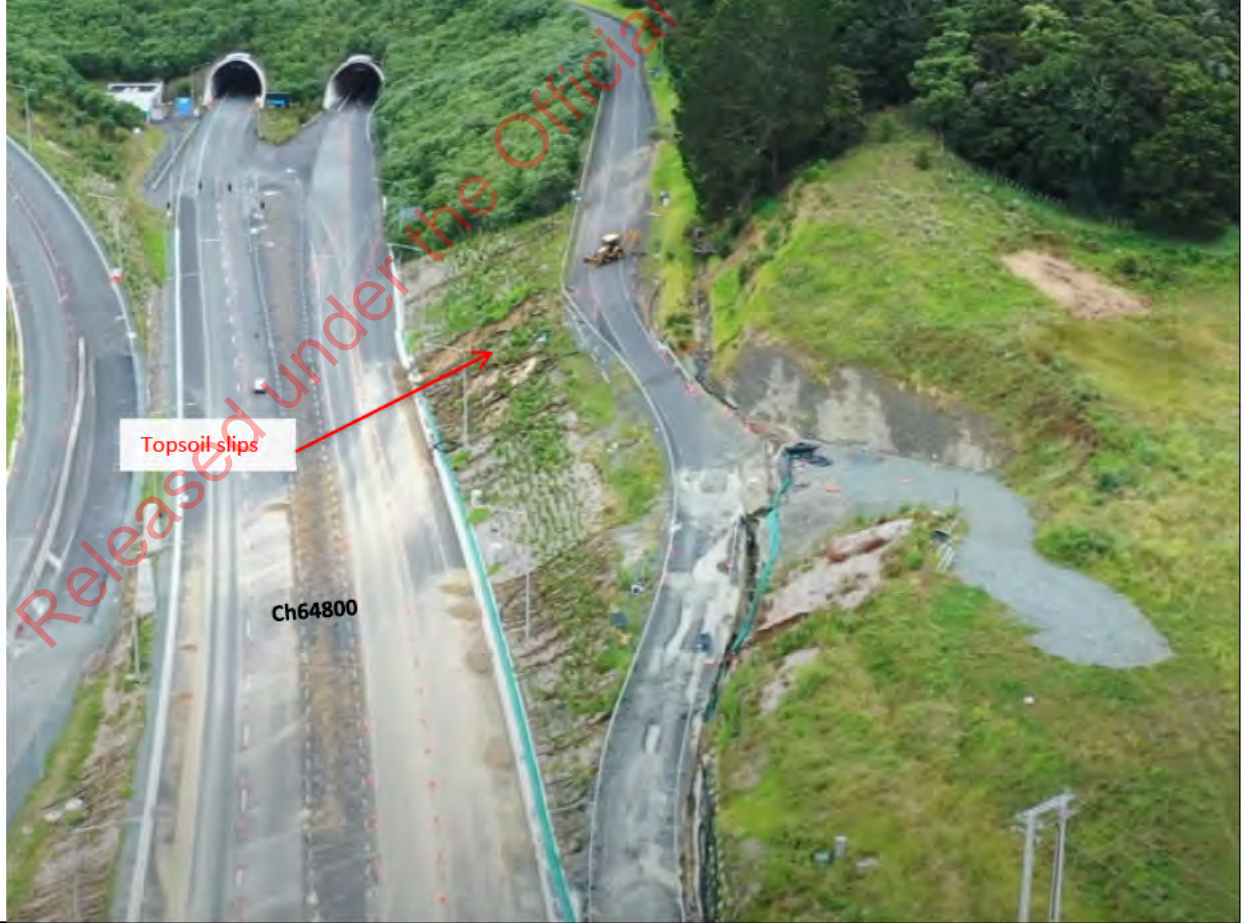
7.48 S7

Chainage	Ch64,660 – Ch65,070
Typical Design Slope Geometry	East (LHS): no slope, transition into existing SH1 West (RHS): no rock cut, up to 10m high 2H:1V soil slope between new SH1 and existing SH1 northbound onramp (to be removed, future maintenance access only).
Site & Design Description	Tie-in of existing SH1 into new SH1 alignment.
Existing Landslide	No
Cause of Landslide	Not applicable
Date Landslide occurred	Not applicable
Cut within area of historic landslide	Low risk. Dipping in north-western direction towards the back of the cut slope.
Geotechnical Investigations	BH302, BH303, BH304, BH305, BH6086
Site Geology	No geological section provided. Expected ground conditions are Pakiri Formation residual soils.
Soil Rock Transition Zone	Dipping in eastern direction at 5~10° unfavourable out of slope
Rock Cut	85° and 64° (1H:2V) up to 30m high at the western side
Remedial Works Design	No DEI provided

Remedial Works Details	Not applicable
Peer Reviewed in PSM Report Rev 4	Not reviewed
Groundwater Seepage Monitoring	No groundwater seepage monitoring proposed
Risk of Future Slope Failure	<p>East (LHS): The risk of future slope failure is considered <b>very low</b>. No cut slope at this location.</p> <p>West (RHS): The risk of future slope failure is considered <b>very low</b>.</p> <ul style="list-style-type: none"> <li>Generally sidling cut. Earthworks were completed February 2023 and but minor works at this location are still outstanding.</li> </ul>
