# Auckland Harbour Bridge Alliance

## Principal Structural Inspection Concrete Piers Above Water (Boat)

2020/2021

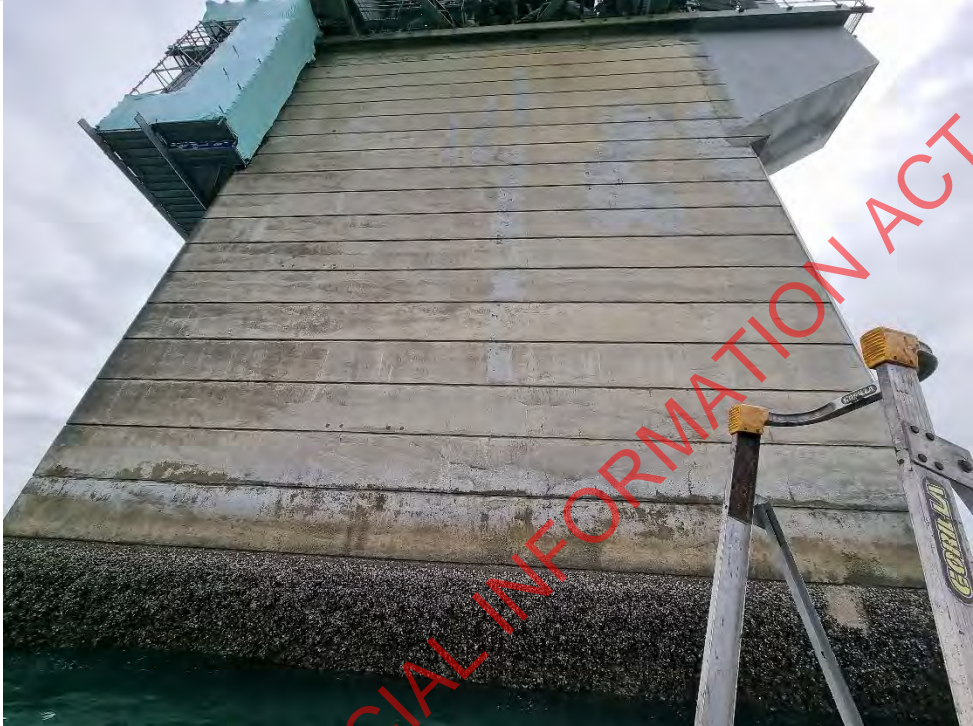
Pier 2. South face. General view.	N/A	N/A
P2-8.	S	 		
		Pier 2. South face. Section 6. Old fixing hole.	Concrete repair.	L 2+ Years

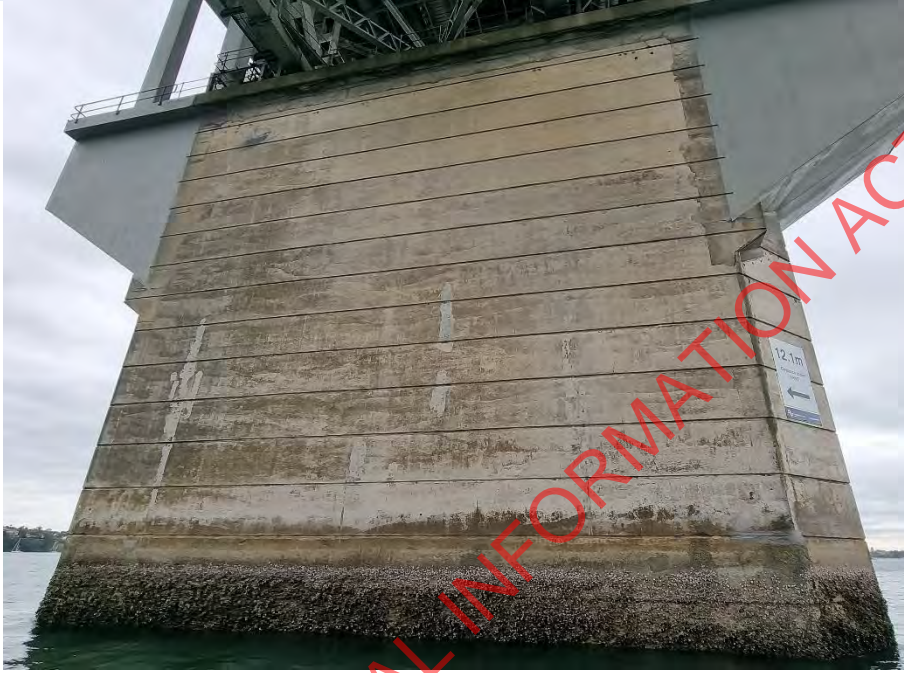
<p>Pier 3. South face. General view.</p>	N/A	N/A
P3-8.	2

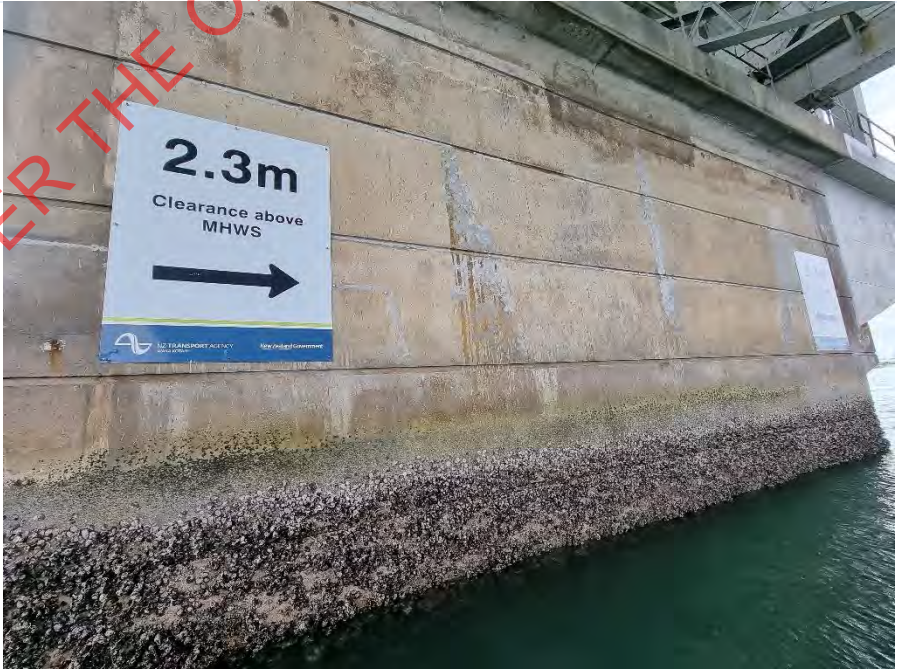
Photo ID	Marking Code	Description of Defects	Maintenance/ Repairs Recommendations	Maintenance/ Repairs Priority & Timeframe
P6-1.	N	  <p>Pier 6. North face. General view.</p>	N/A	N/A
P6-2.	N

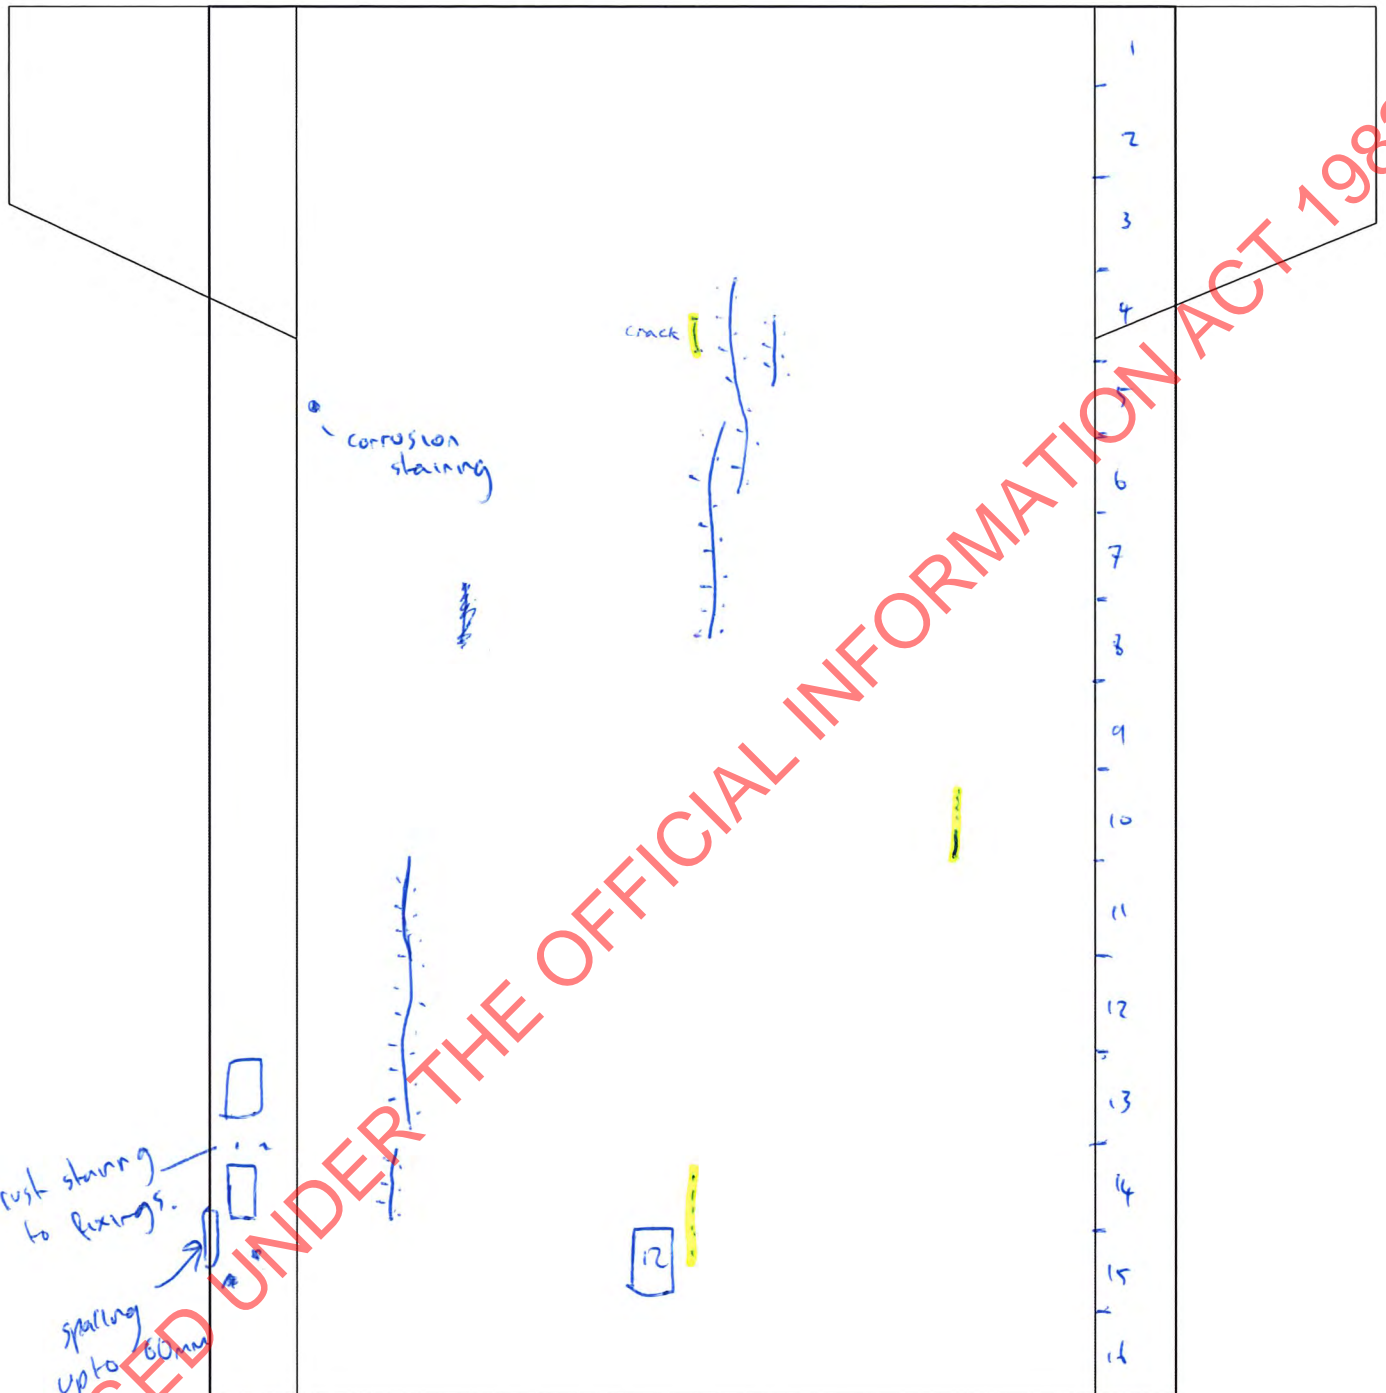
# pier 2 North face

cores

cores  
rust staining.
