Attention: Greg Haldane, Programme & Standards, Manager Assurance
RE: External review panel – soil contamination, Te Onewa / Stokes Point
Our Reference: 2063

Summary

Site inspection

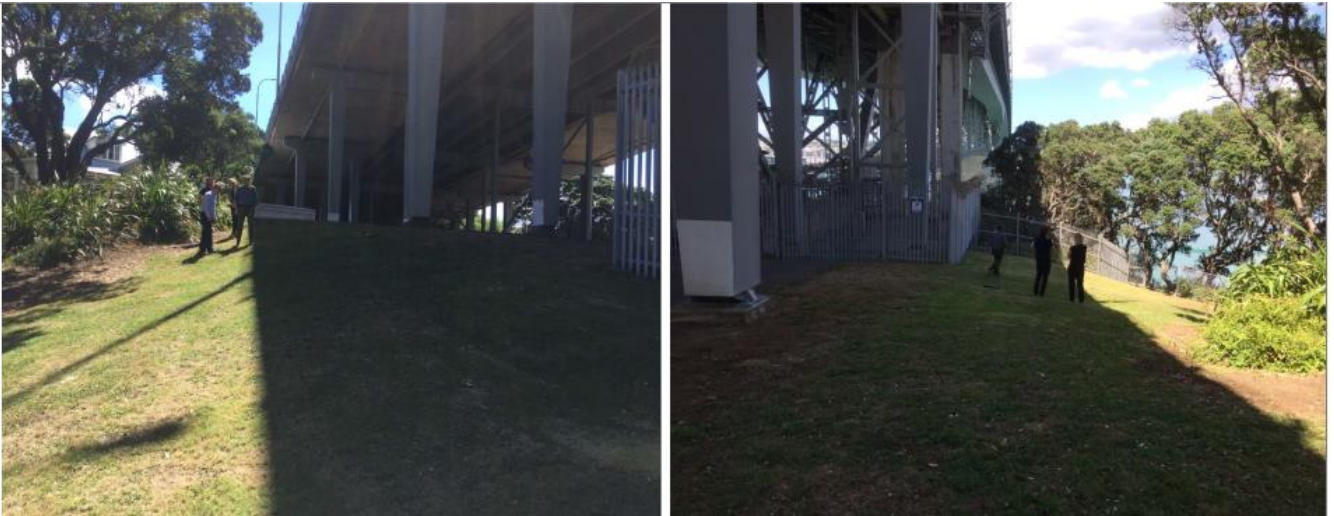
2 February 2021. Western Park; LHS – view to north towards #1 Queen Street from North Anchorage; RHS – view to south showing North Anchorage.

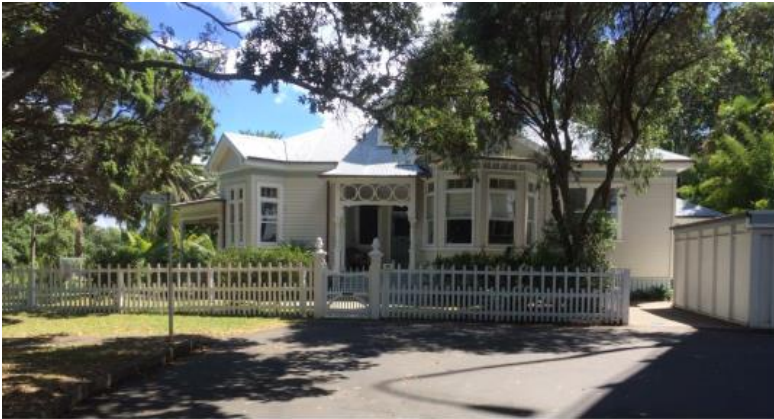
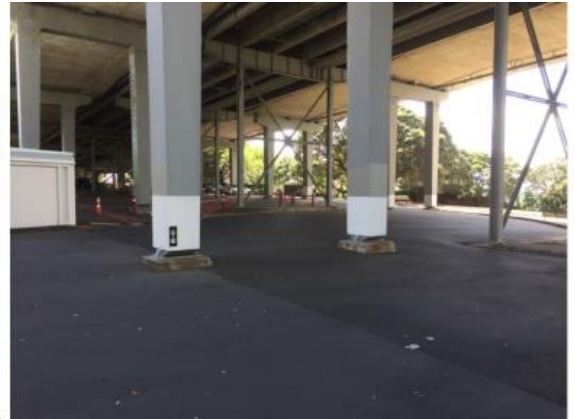
2 February 2021. LHS – residential property #1 Queen Street; RHS – view to north east of hard stand area below AHB between eastern and western parks.

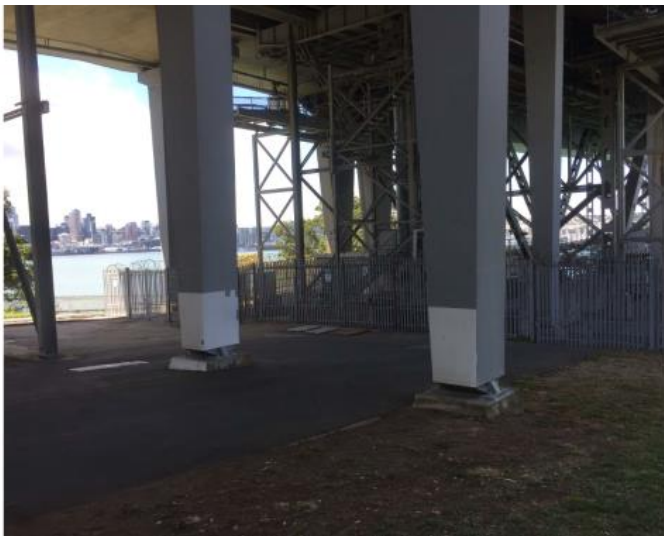
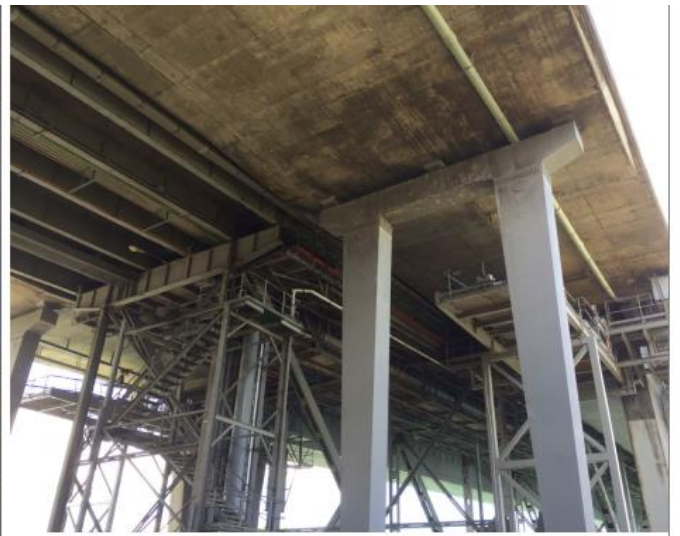
2 February 2021. LHS – view to south east showing North Anchorage; RHS – view to south of bridge under-structure.

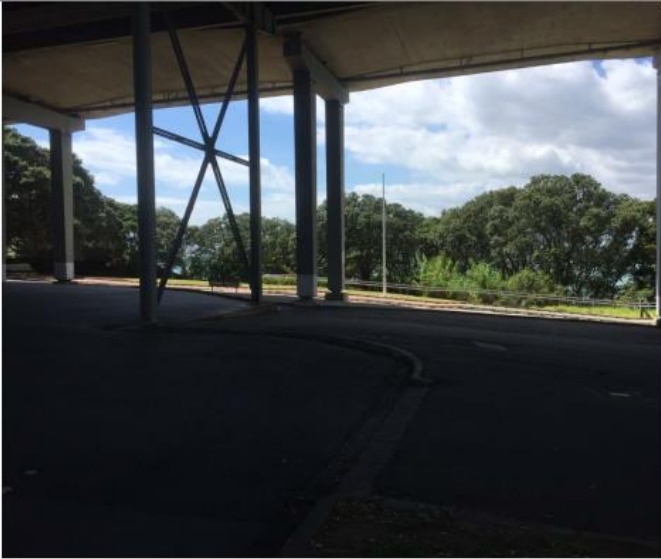
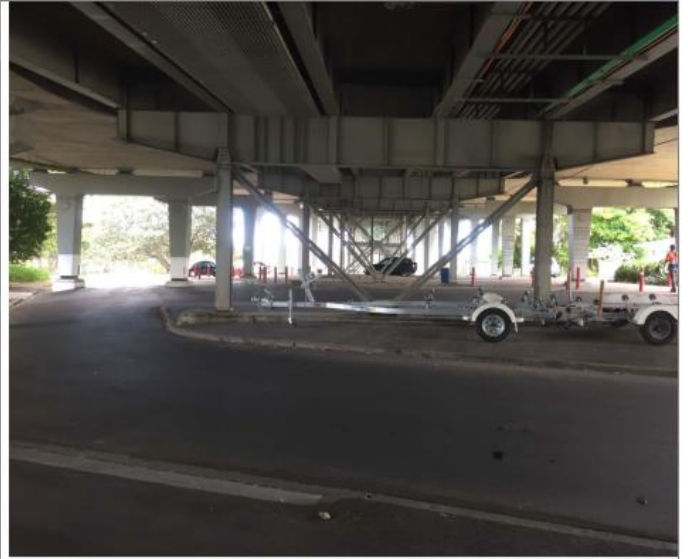
2 February 2021. LHS – view to east along Princes Street towards eastern park (Stokes Point Reserve); RHS – view to north of bridge under-structure and hard stand area.

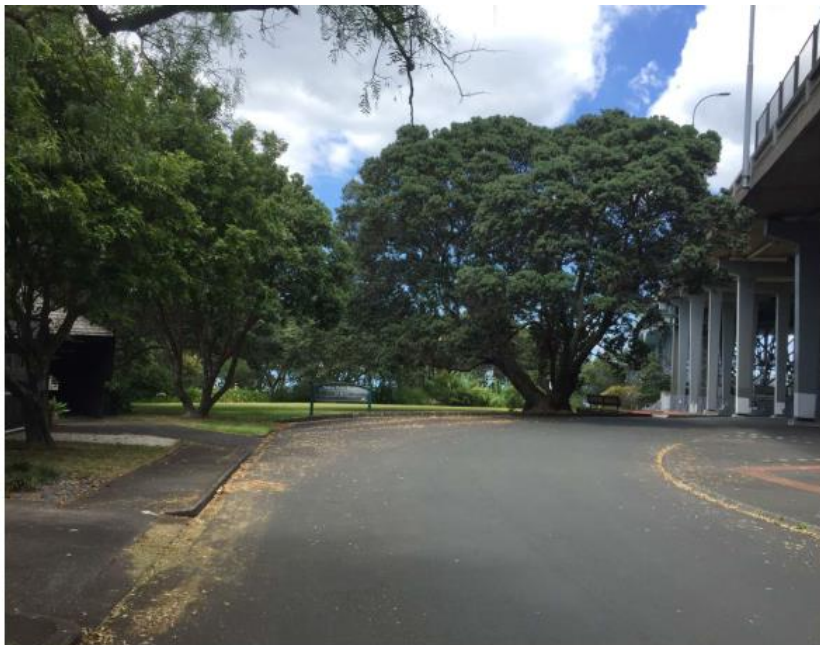
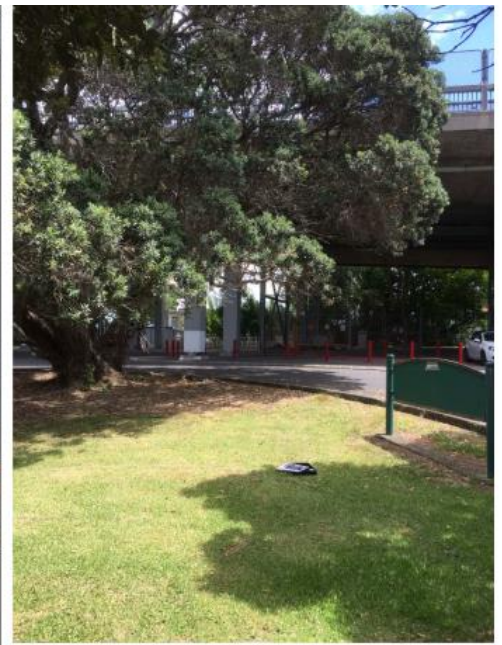
2 February 2021. LHS – view to south along Princes Street towards eastern park (Stokes Point Reserve); RHS – view to west from Stokes Point Reserve.

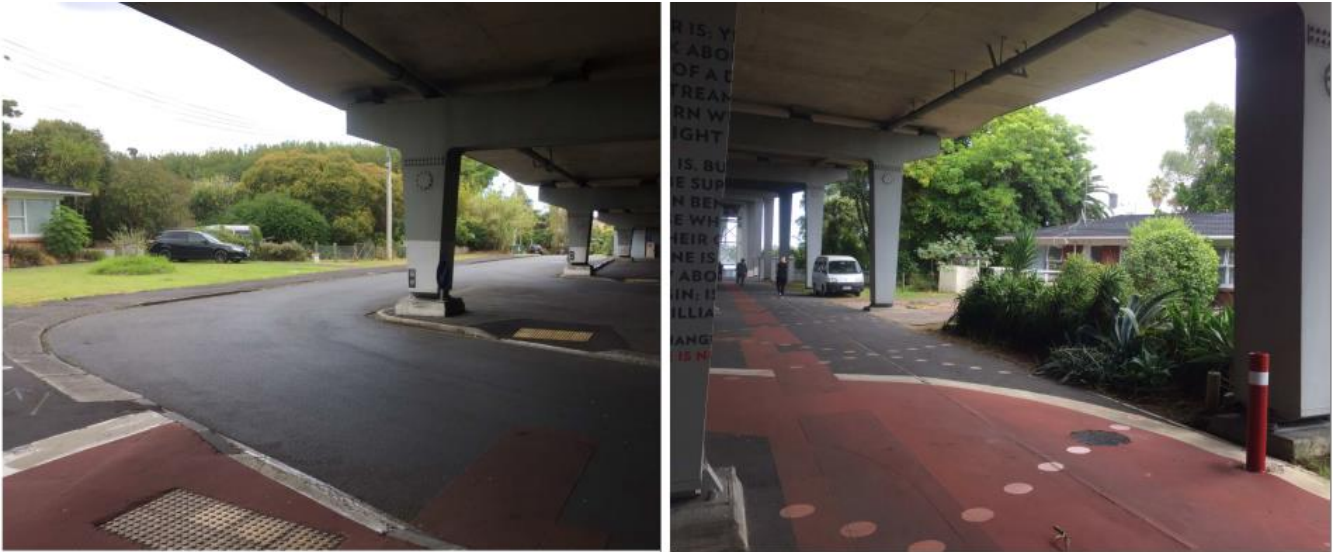
2 February 2021. LHS – view to north along Princes Street towards residential property at #6 Princes Street; RHS – view to south showing residential property at #6 Princes Street.
