OTAKI TO NORTH OF LEVIN RONS: INTERIM SAFETY IMPROVEMENTS

Prepared for the NZ Transport Agency

25 September 2017

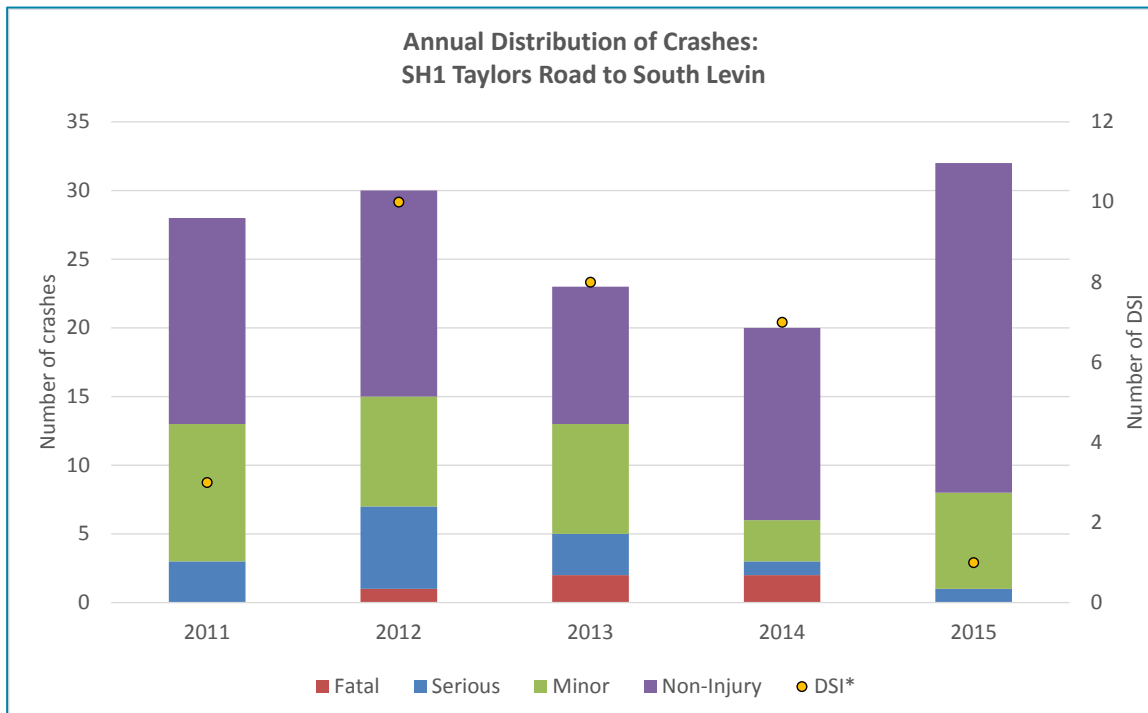
Figure 2-1: Annual Distribution of Crashes

A review of NZ Transport Agency’s CAS database over the five-year period 2011 to 2015, summarised in Figure 2-1 below, revealed a total of 133 crashes (19 high severity crashes resulting in 29 DSI³) along the approximately 16 km project length, from Taylors Road (RP 995/3.30) to the southern urban boundary of Levin (RP 967/16.0). Collision diagrams along with the crash listing are contained within Appendix A.

The five year crash history shows a general reduction in high severity crashes since 2012. However, the total number of crashes ranges from 20 to over 30 per year, reflecting the random nature of crashes.

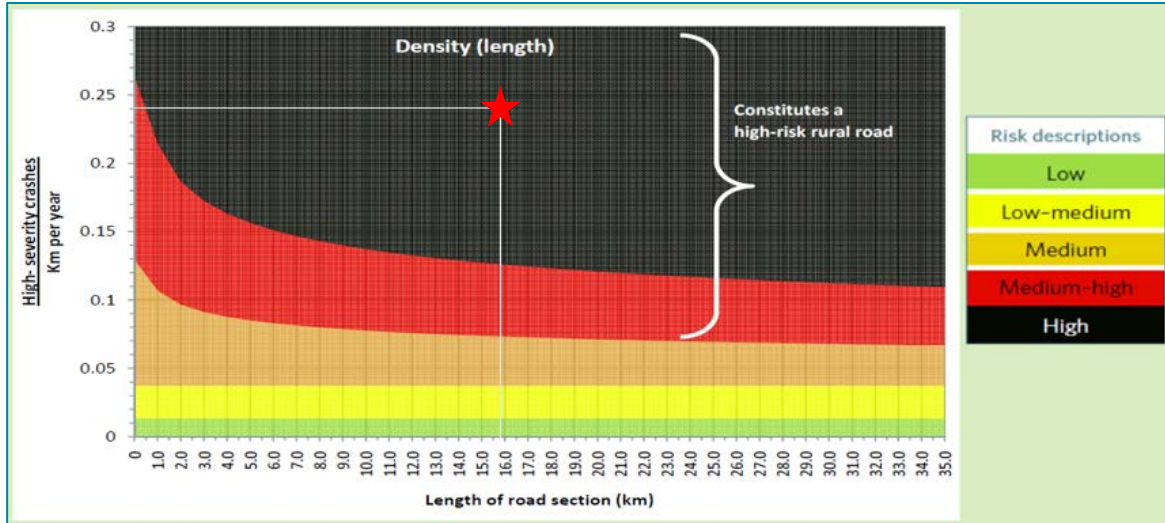
Figure 2-2: Collective Risk Graph showing the section of SH1 from Taylors Rd to south of Levin

This section of SH1 has a high collective risk with 1.2 high severity crashes per kilometre within a five year period (or 0.24 high severity crashes per kilometre per year). This high collective risk classifies this section as a High Risk Rural Road⁴, as shown in Figure 2-2 below. Figure 2-2 also shows that this route has a collective risk that is at least three times higher than a road that would not be classified as high risk.

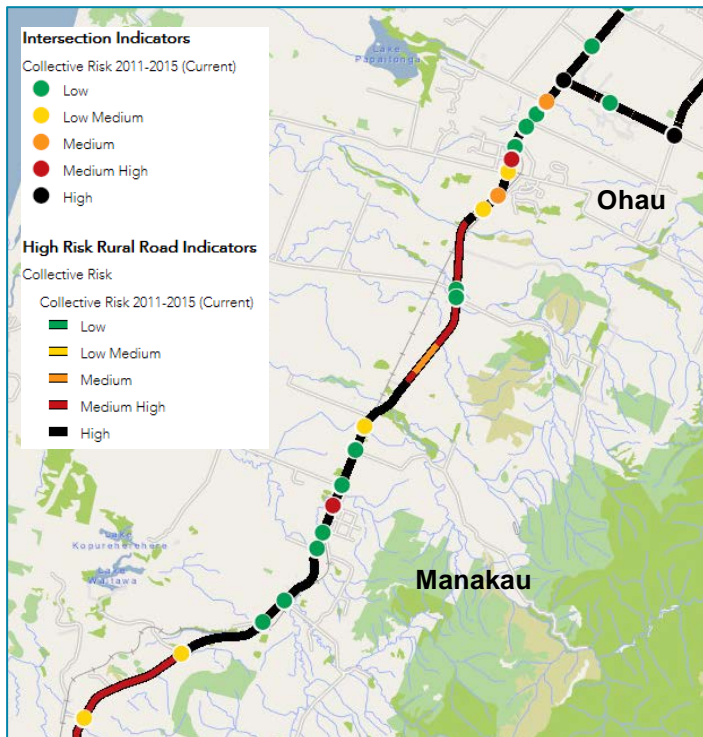
Figure 2-3: Collective Risk and Intersection Risk (Source: NZTA SafetyNET)

In addition to collective risk, Figure 2-3 below, identifies a number of medium and high risk intersections⁵. The one high risk intersection on this route is located where SH1 meets SH57.

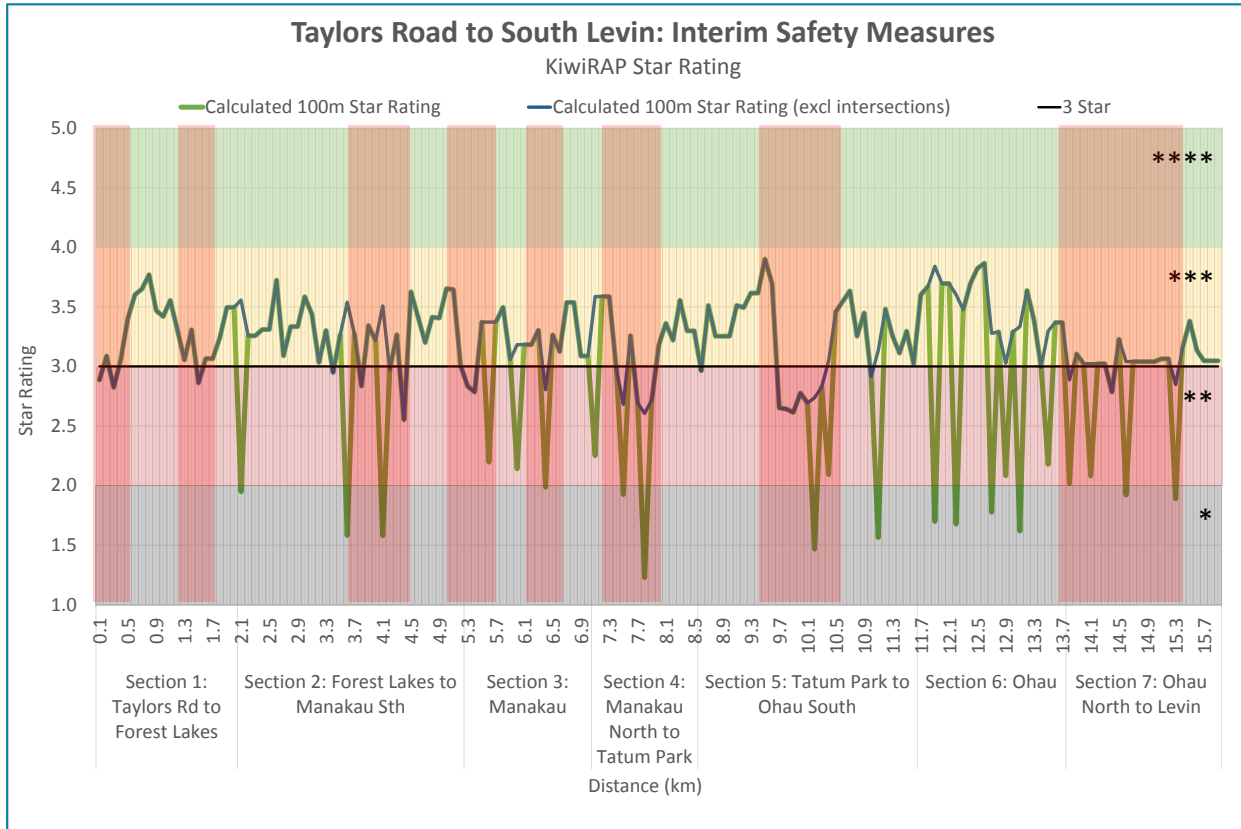
Figure 2-4: KiwiRAP Star Rating

The calculated KiwiRAP star rating for this section is 3.1, below the KiwiRAP 4-star One Network Road Classification (ONRC) Safety Customer Level of Service target for a National (High Volume) route. However, as outlined in Section 1.2, the interim objective is to ensure a minimum KiwiRAP 3-star rating is maintained. Figure 2-4 below presents the existing KiwiRAP star rating, both with and without the effect of intersections, highlighting key sections where the 100m star rating drops below 3 stars.

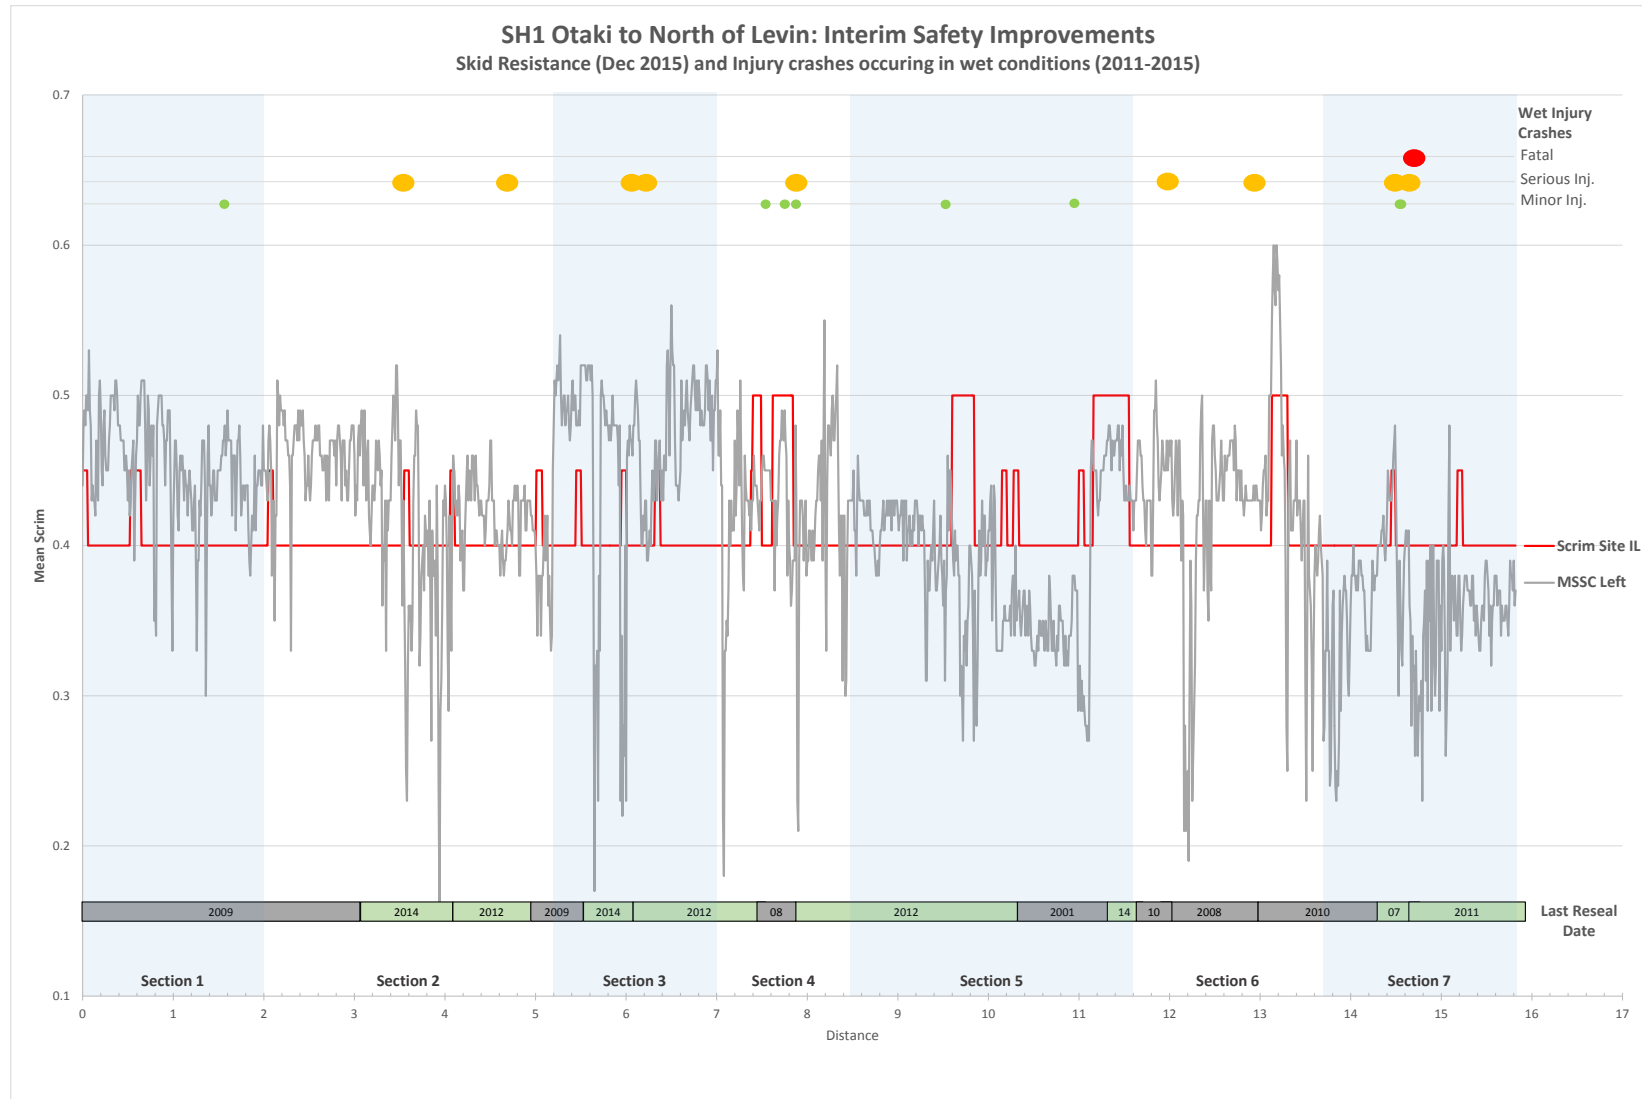
Appendix B Skid Resistance vs Wet Injury Crashes

Due to the high percentage of high severity crashes occurring during wet and icy conditions, MWH have undertaken a brief review of latest skid resistance information compared to injury crashes that occurred in wet or icy conditions (refer Appendix B for comparison graph). While lengths of highway fall between the SCRIM Investigatory Level (IL) and Threshold level (IL) along the route, there only appeared to be correlation with wet injury crashes in Section 7 (Buller Road to Levin urban boundary). This section is the highest risk section along the route (refer Figure 2-6) and hence further investigation should be undertaken into whether improved skid resistance is required.

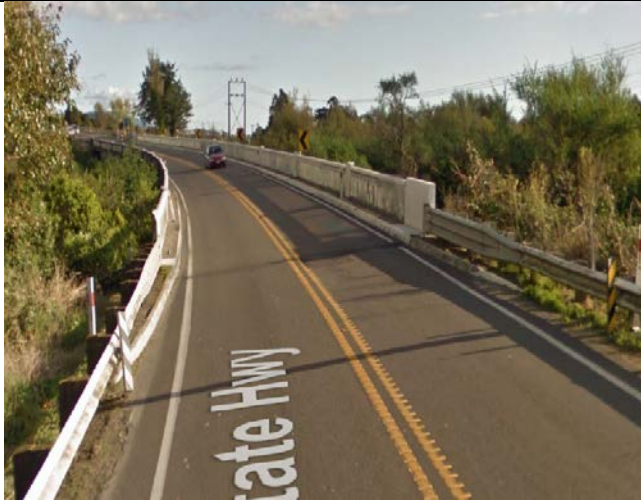
8. Section 5 – Ohau River Bridge – Kuku Beach Road
8.1. Shoulder too narrow or unsealed on both sides – consider sealing min 1.5m.
