Factors influencing the decision to rehabilitate a pavement

June 2012

Patrick, JE and H Aramoorthy (2012) Factors influencing the decision to rehabilitate a pavement. NZ Transport Agency research report 491. 108pp.

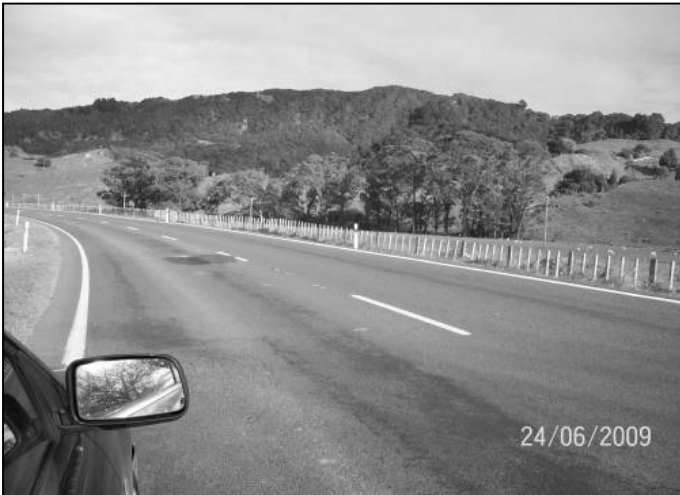
Figure 4.4 View of site B1, showing an extended area of flushing

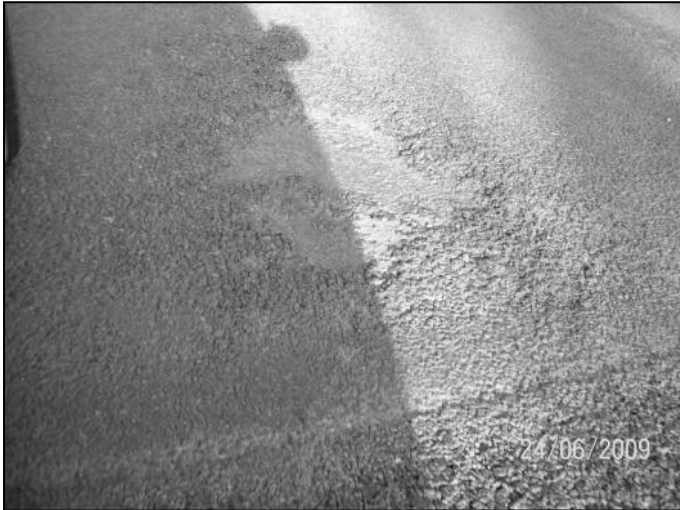
Figure 4.6 View of site B2, showing a close-up view of scabbing/chip loss

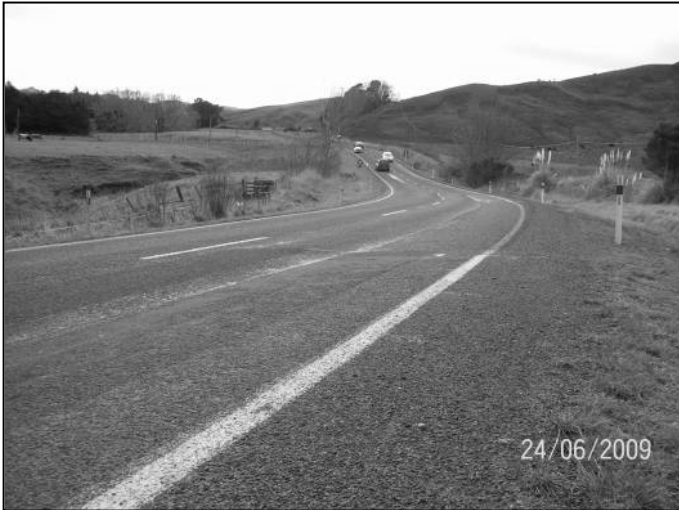
Figure 4.16 View of site B7, showing extensive rutting

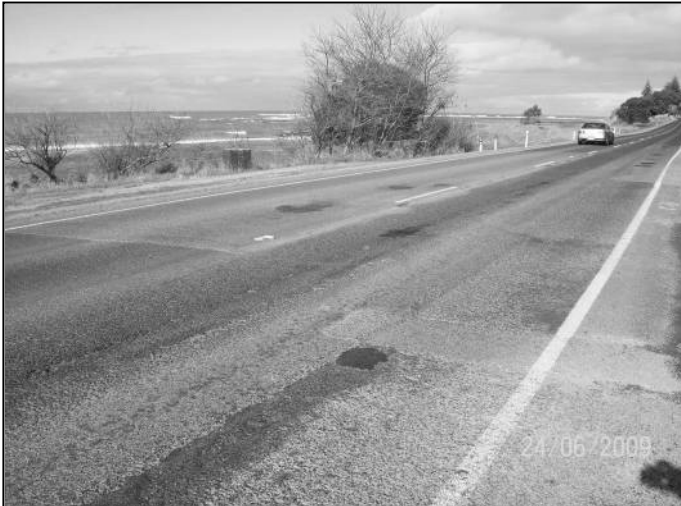
Figure 4.18 View of site B8, showing a range of problems contributing to pavement roughness

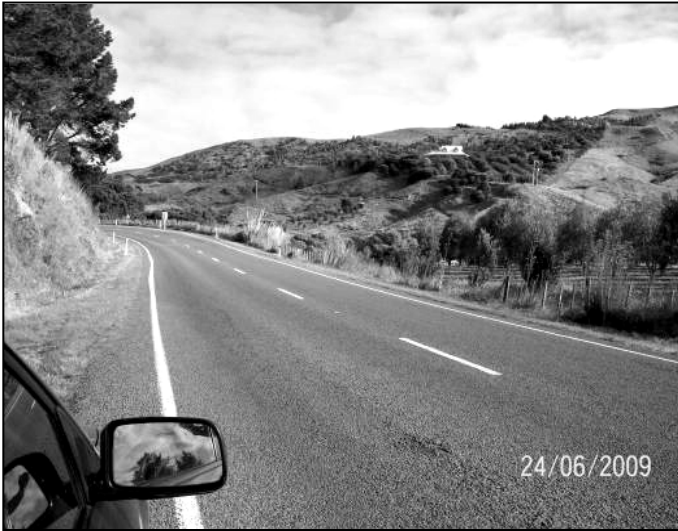
Figure 4.20 View of site B9, showing scabbing

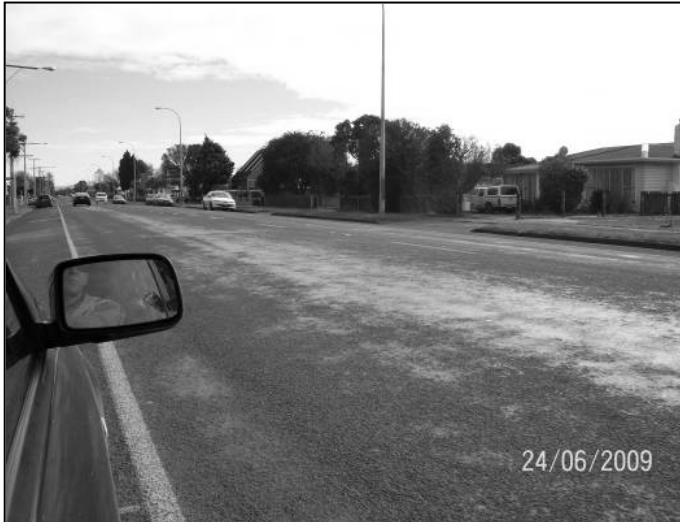
Figure 4.22 View of site B10, showing flushing

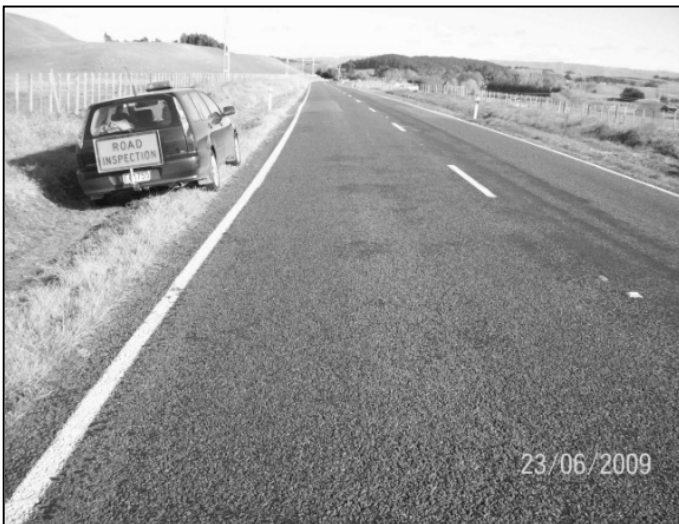
Figure 4.24 View of site C1, showing minor flushing

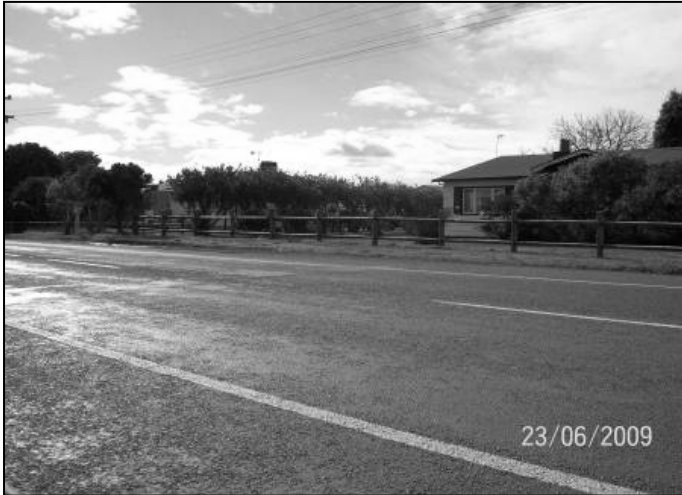
Figure 4.33 View of site C6, showing more flushing

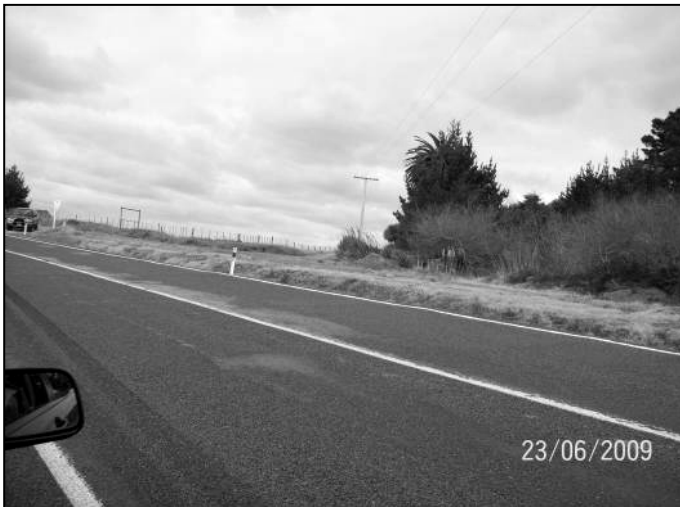
Figure 4.39 View of site C10, showing another area of flushing

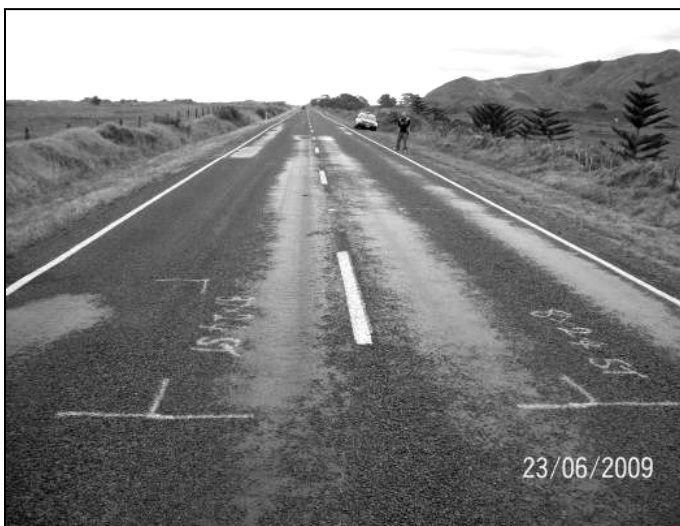
Figure 4.43 View of site C13, showing extensive flushing and potholing

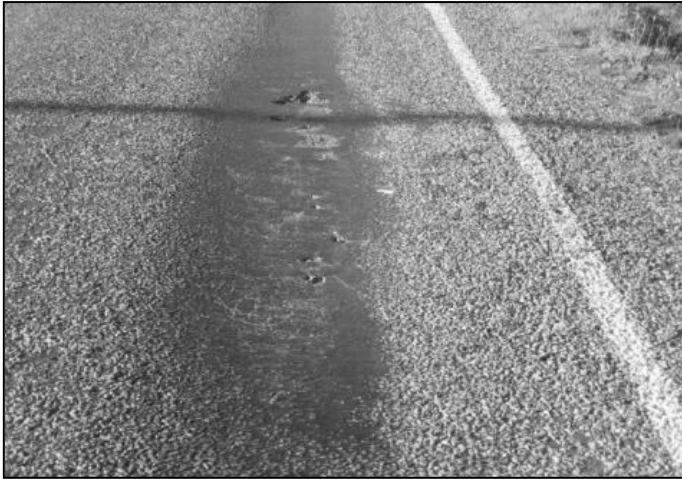
Figure 4.65 View of site D7, showing more detail of the flushing

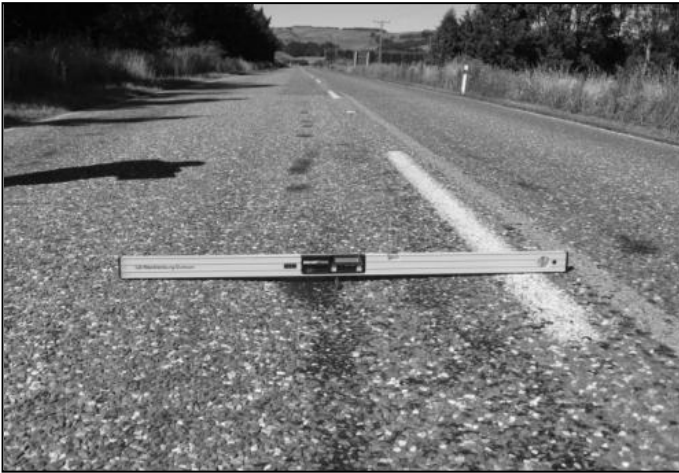
Figure 4.67 View of site D8, showing the depth of the rutting

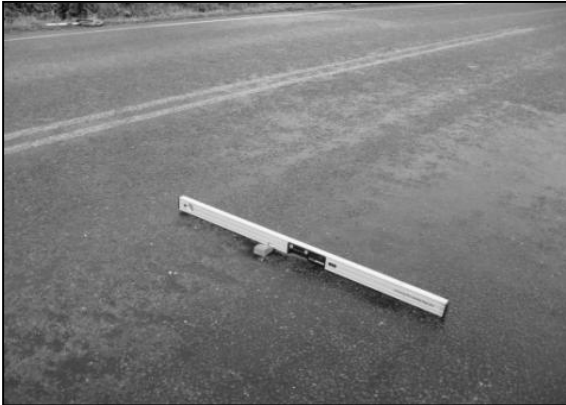
Figure 4.71 View of site D10, showing the depth of the rutting

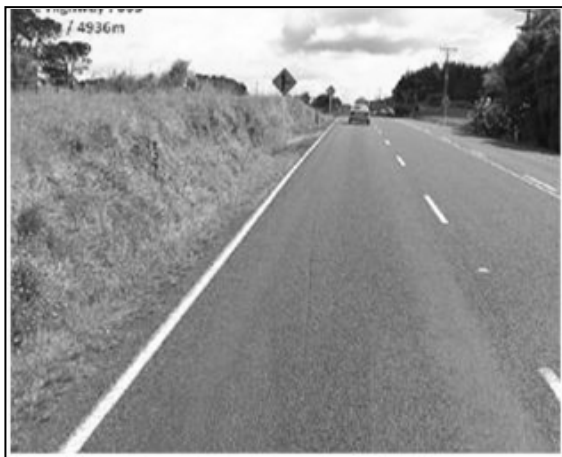
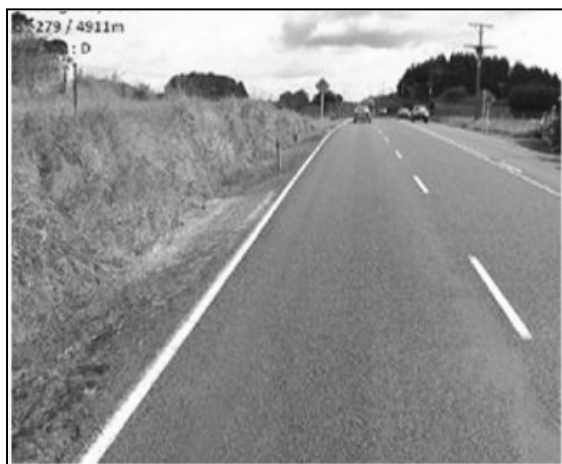
Inspection length 1 for this site was RP 279/4900– 4950 (figure 5.6 and 5.7).

Figure 5.6 Inspection length 1 for site A1: RP 279/4936 decreasing

Figure 5.7 Inspection length 1 for site A1: RP 279/4908 increasing

The inspection section **does not** represent the full rehabilitation section very well.

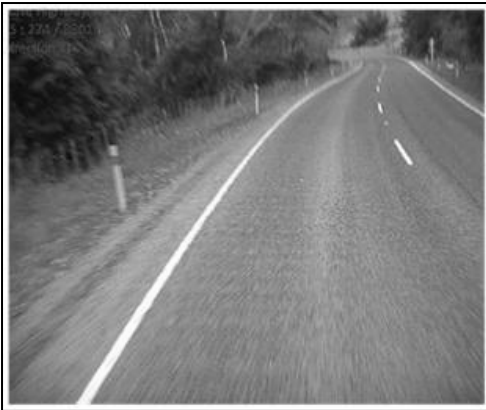
Figure 5.11 Typical distress in site B2 (RP 8801), showing evidence of corrugation

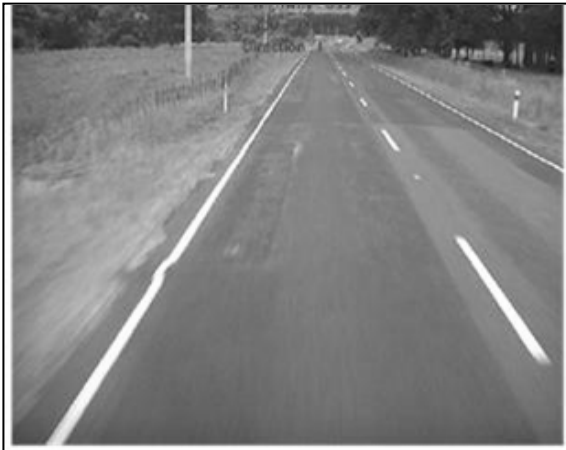
Figure 5.20 Site B6 inspection length 1: RP 3350-3400

Figure 5.21 Inspection length 2: RP 3840-3884

The inspection section **closely** reflects the full rehabilitation section.

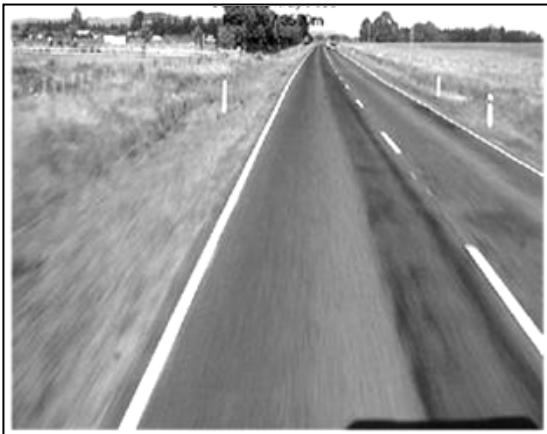
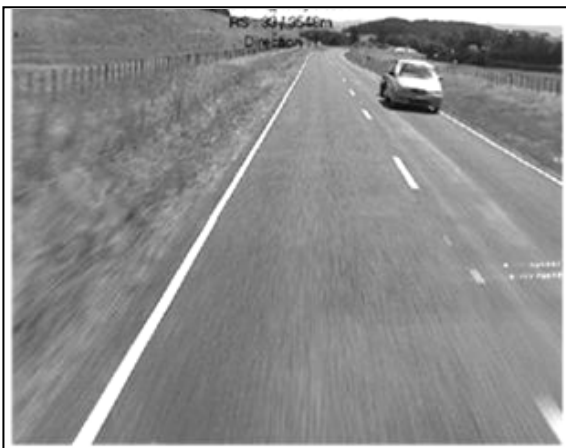
Figure .5.27 Inspection length of site C1: RP 33/3570 decreasing

Figure 5.28 Inspection length of site C1: RP 33/3548 increasing

The inspection section **does not** represent the full rehabilitation section very well.

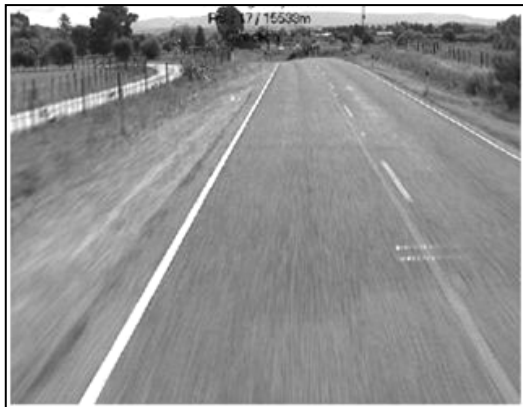
Figure 5.32 Inspection length in site C4: RP 15,533 increasing

Figure 5.33 Inspection length in site C4: RP 15,546 decreasing

The inspection section **closely** reflects the full rehabilitation section.

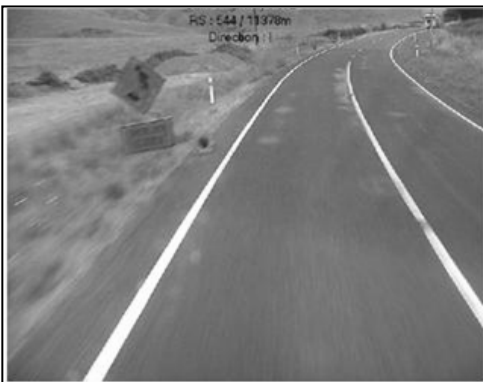
Figure 5.35 Typical section of site C10 (RP 544/11,378 increasing), showing flushing

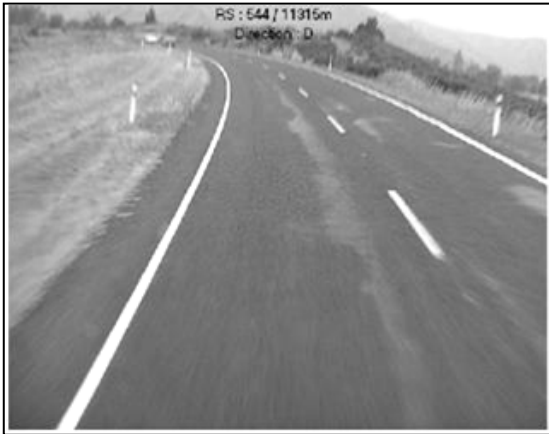
Figure 5.36 Typical section of site C10 (RP 544/11,315 decreasing), again showing some areas of flushing

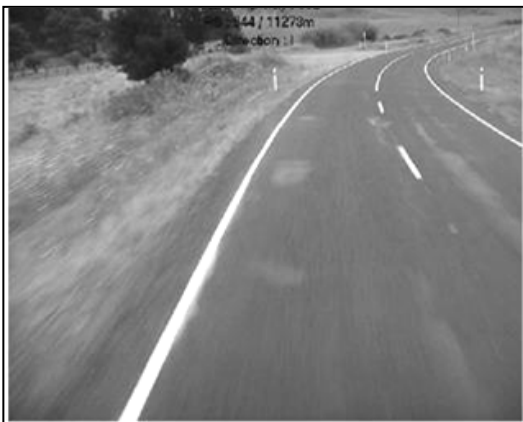
Figure 5.37 Inspection length in site C10: RP 444/11,270 decreasing

Figure 5.38 Inspection length in site C10: RP 544/11,273 increasing

The inspection section **closely** reflects the full rehabilitation section.

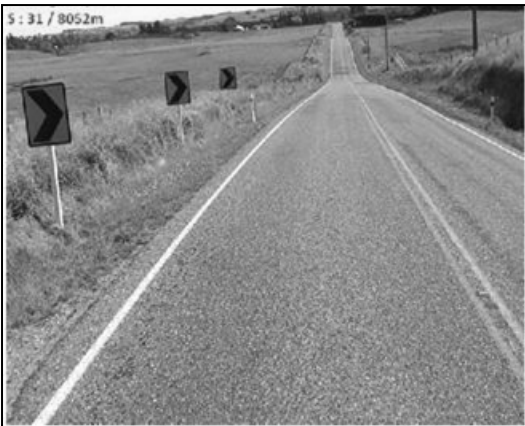
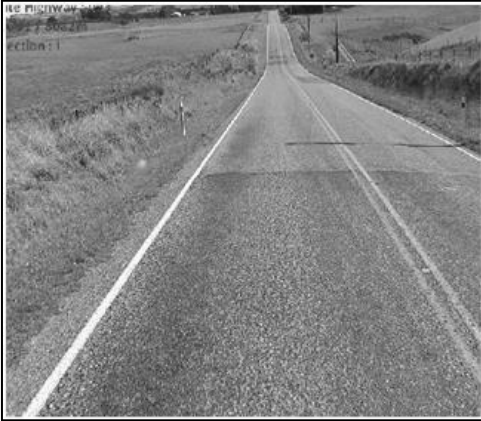
Figure 5.48 Inspection length 1 from site D6: RP 8052

Figure 5.49 Another view of inspection length 1 from site D6: RP 8082

Figure 5.50 Inspection length 2 from site D6: RP 8814

Figure 5.51 Another view of inspection length 2 from site D6: RP 8849

The inspection section **does not** represent the full rehabilitation section very well.

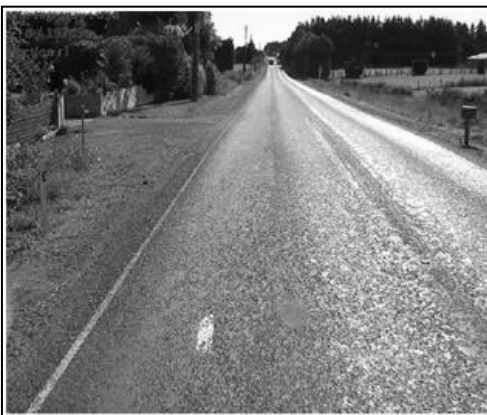
Figure 5.57 View of the inspection in site D10 (RP 0/19,747)

Figure 5.58 Alternate view of the inspection length in site D10 (RP 0/19,807)

The inspection section **does not** correctly reflect the full rehabilitation section.

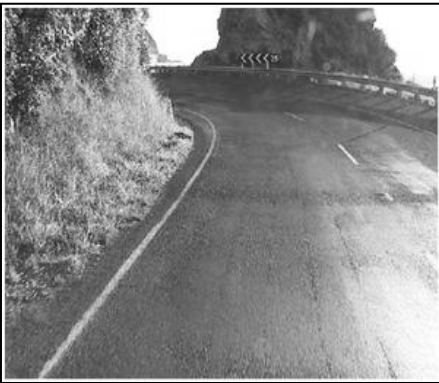
Figure 6.52 Another view of the inspection length in site E1 (RP 15,531 decreasing), showing flushing

The inspection section **closely** reflects the full rehabilitation section.
