Analysis and interpretation of New Zealand long-term pavement performance data December 2017

KL Neaylon, R Davies, L Harrow and R Henderson
Opus Research, Opus International Consultants

NZ Transport Agency research report 633
Contracted research organisation – Opus International Consultants

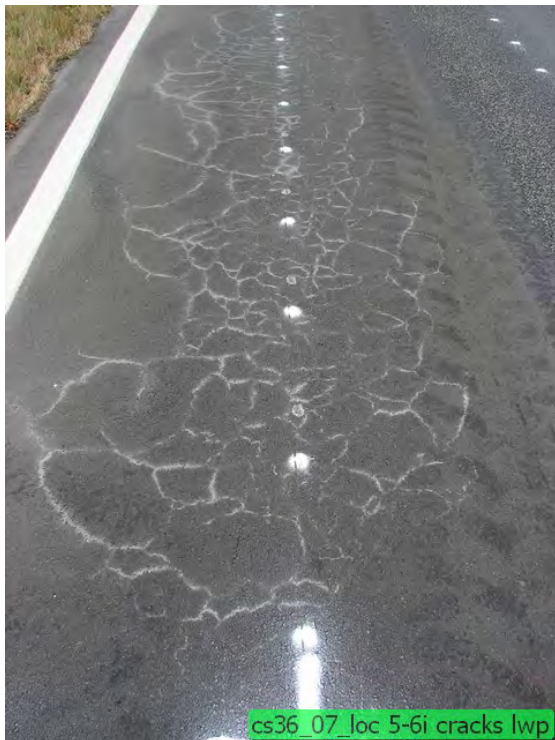
Figure 5.1 CS- 36 SH2 RP 858/9.00 – 9.30 increasing direction

- Thin in-situ cement stabilised repairs that fail again often within months of completion. Time of year, cement application rates, depth of the repair and moisture in the pavement can all contribute to early failure. This type of pavement repair failure is quite evident in the survey contractor's notes and site photographs.
- Thin asphalt surfaces. This repair method appears to be used without first knowing the strength of the pavement on which it is being constructed. The result is that an area of cracking larger than existed just prior to the completion of the repair often develops quite quickly and statistically shows an increase in cracking even though a maintenance repair has been completed. Again this type of pavement repair failure is quite evident in the survey contractor's notes and site photographs.

Figure 5.1 shows an example of a pavement repair surfaced with a thin asphalt surface that has extensively cracked. The repair is not recorded in the RAMM maintenance cost table but appears to have been completed in 2005 and is showing significant cracking in the December 2007 photograph.
