Progressive Underslip Stabilisation Using Gravel Columns

Transfund New Zealand Research Report No. 208

GHD Ltd

Transfund NZ commissioned GHD Ltd to monitor the performance of an innovative stabilisation method designed and implemented by GHD's Geotechnical Team. The stabilisation method consisted of the construction of deep *graded gravel columns* to provide positive subsurface drainage to the failure planes within a slip site. This monitoring was undertaken as a part of the stabilisation of a road embankment slip at Snake Hill (SH1 RP 144/11.34).

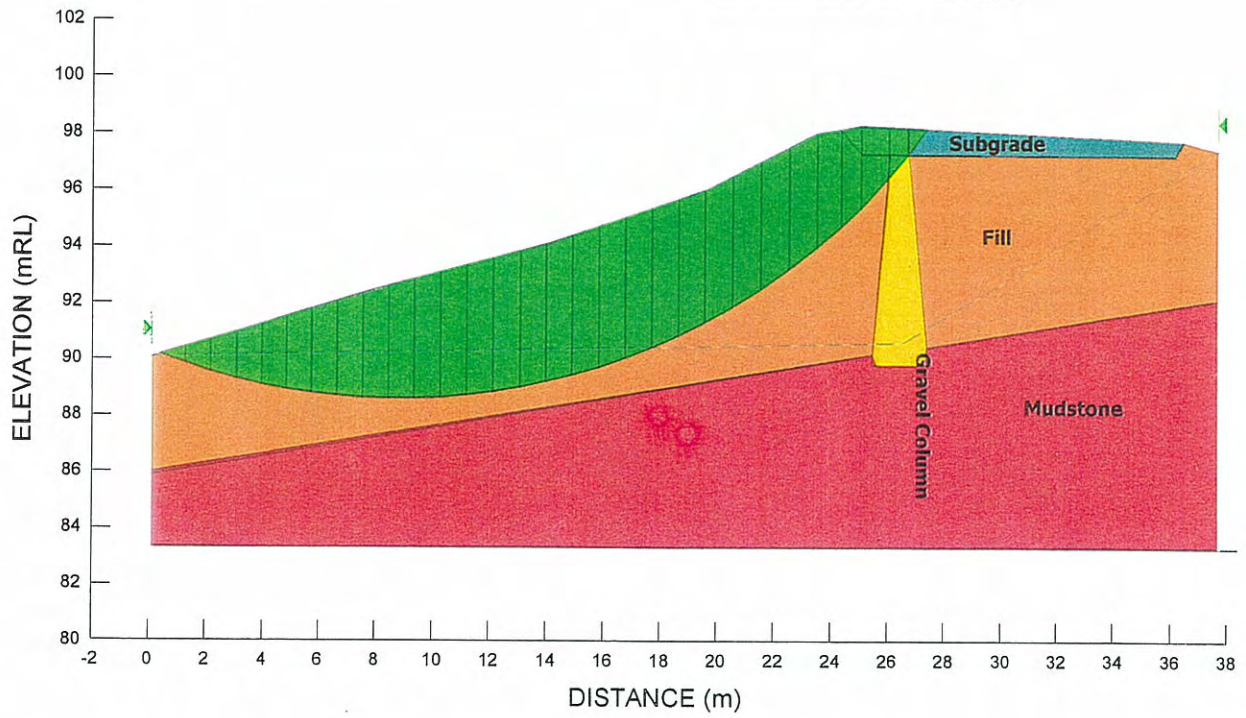
SNAKE HILL STABILITY ANALYSIS LOWER BOUND CASE

SOIL TYPE	C'	ϕ	γ
Subgrade	0	34	18
Fill	1	27	17
Gravel	0	31	17
Mudstone	5	33	23

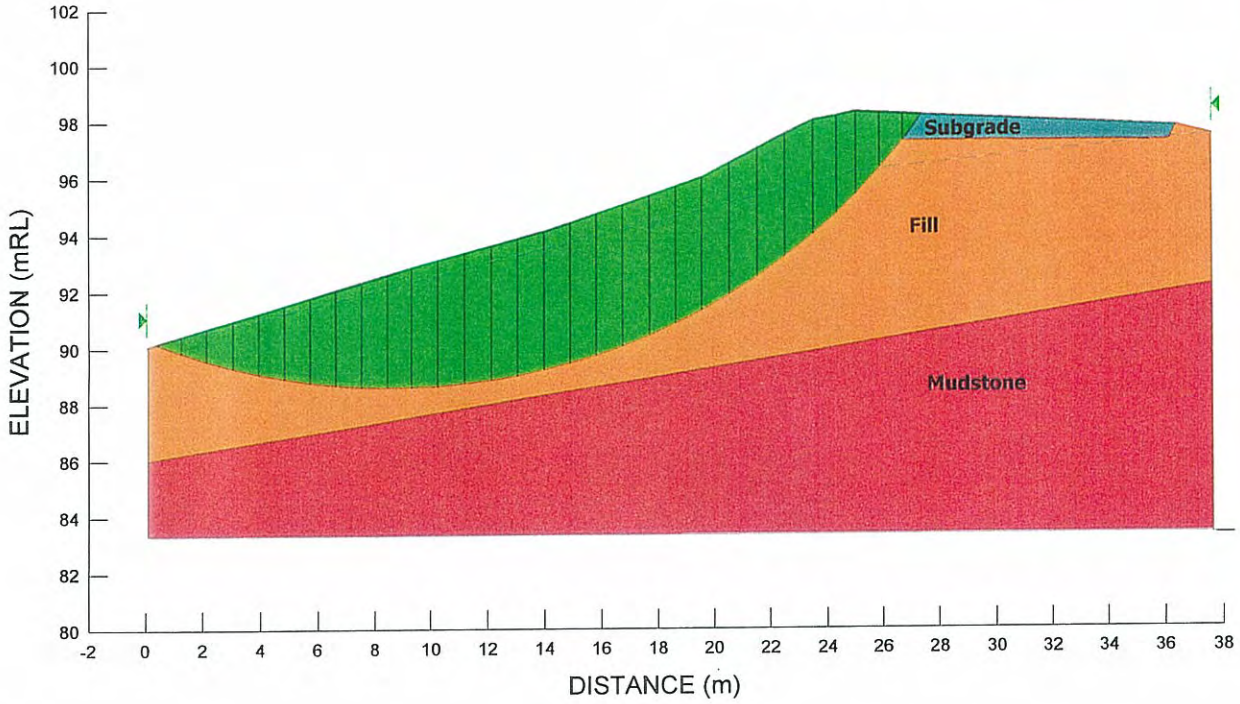
SNAKE HILL STABILITY ANALYSIS UPPER BOUND CASE

SOIL TYPE	C'	ϕ	γ
Subgrade	0	34	18
Fill	1	27	17
Mudstone	5	33	23
