ASM – AHB STRUCTURAL INSPECTION

Pier Bracket External Principal (Pier 6)

SOLOCI EXE SOLO TO DECEMBER 2021 REVISION

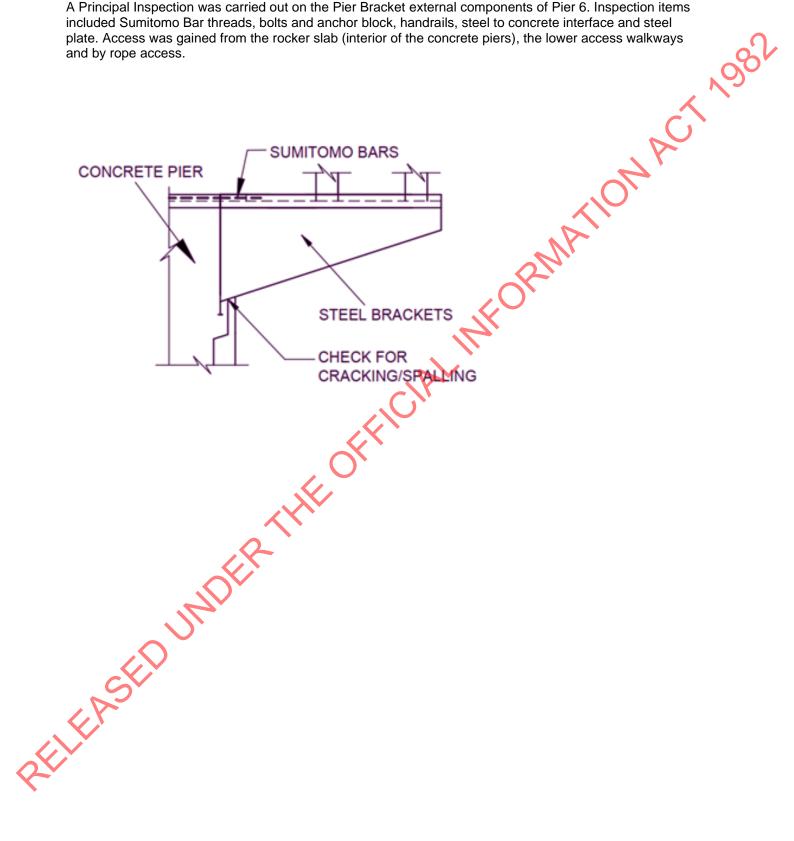
A Principal Inspection was carried out on the Pier Bracket external components of Pier 6. Inspection items included Sumitomo Bar threads, bolts and anchor block, handrails, steel to concrete interface and steel plate. Access was gained from the rocker slab (interior of the concrete piers), the lower access walkways and by rope access.
