Examples of emergency works and improvement activities

Overview

Introduction Here are some examples of Emergency and Improvements activities.

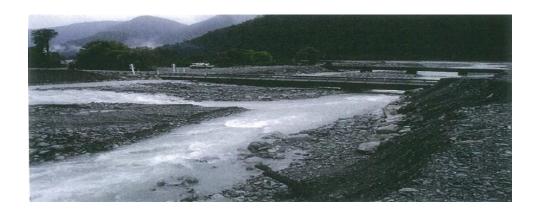
Event image

Heavy rainfall caused the river to rise and debris to flow in Kelly's Creek.

The aggradation filled the river bed and banked up under the state highway bridge.

Stream clearing work was required to prevent the bridge blocking and the river overtopping the road.

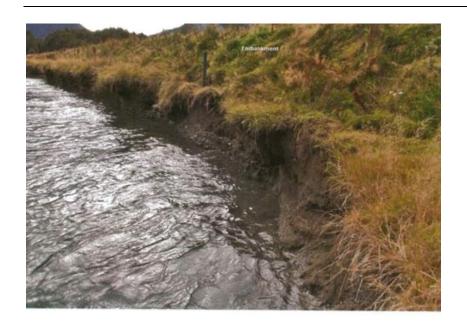
Event image

Embankment erosion in the area of SH94 Eglinton Flat / Eglinton River.
