# Transport noise Transparency

## **NOISE BARRIER CASE STUDY 14**

# **Victoria Park Tunnel**

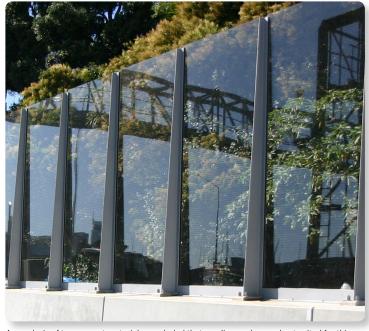
An analysis of transparent materials concluded that acrylic panels were best suited for this location, based upon the enhanced optical clarity of acrylic.

The project team undertook an analysis of transparent materials and concluded that just two materials, polycarbonate and acrylic, were suitable for use within the VPT project. Glass was not considered appropriate because local and offshore experience suggested that while it has excellent optical qualities, it is too easily damaged. A comparison between acrylic and polycarbonate was undertaken, and while neither is an ideal solution, on balance acrylic panels were recommended for this specific location. This was based primarily on the enhanced optical clarity of acrylic – a key requirement of the VPT noise barrier was to maintain views over its design life. The greater stiffness of acrylic also reduces the thickness of material required, leading to a small cost saving.

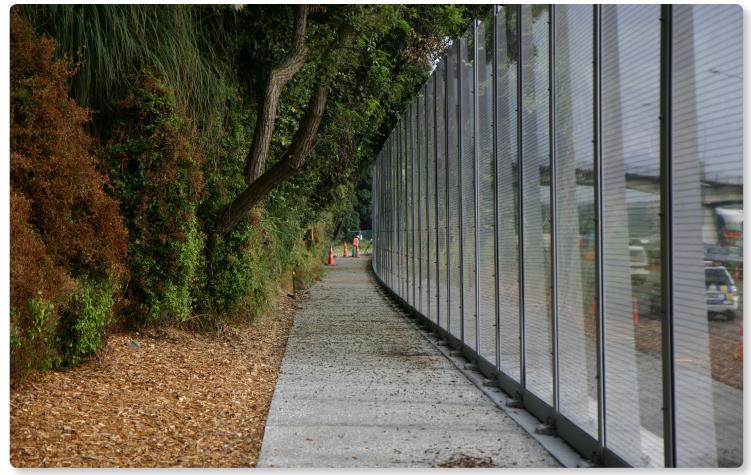
The close proximity of pedestrian access to the noise barriers meant anti-etch film has been used. A special film with black stripes has also been applied to panels to provide a visual cue to help prevent bird-strike.

Based on overseas studies the best option for avoiding bird-strike was considered to be the use of bold longitudinal striping visible on the transparent panels. Thus providing a sufficient visual cue to prevent bird-strike in the majority of instances, while at the same time maintaining the transparency of the panels. As such a special film with black longitudinal striping was applied to the acrylic panels (motorway facing side) by the manufacturer.

Graffiti and vandalism are inevitable to a transparent wall of this magnitude. In regards to acrylic, the principal risk is etching of the panels, as it cannot be easily repaired. While spray-on solutions exist to mitigate the effects of tagging, replaceable adhesive films are the only viable solution to mitigate the effects of etching. Research found few products available that had been used with acrylic. Eventually, an adhesive film for glass, was found to be suitable for acrylic. The product is applied as a film to the panels (non-motorway side), and provides etching protection and a degree of shatter control. The ends of the noise barrier are situated some distance from easy pedestrian access, and as such etching protection has only been applied to the lower 2 metres of the noise barrier where there is pedestrian access.

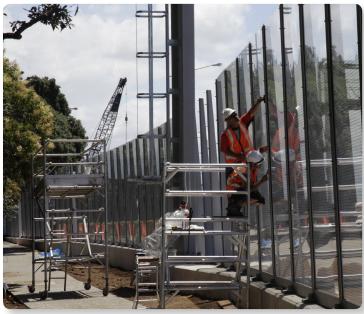
Ongoing maintenance costs will be higher for transparent panels and relates to cleaning and replacement of anti-etch film.

The overall cost of the transparent barriers was approximately  $$1,200/m^2$  (eg in the order of \$6,000 per linear metre at 5 metres high). A substantial proportion of the cost relates to the foundations to accommodate the wind and traffic impact loadings. The barrier is more expensive than conventional barriers using opaque materials such as timber or concrete. The ongoing maintenance cost for the transparent barriers is also expected to be much higher. This includes ongoing costs associated with regular cleaning to remove dirt and motorway grime from the panels, along with the replacement of anti-etch film (after vandalism has occurred).

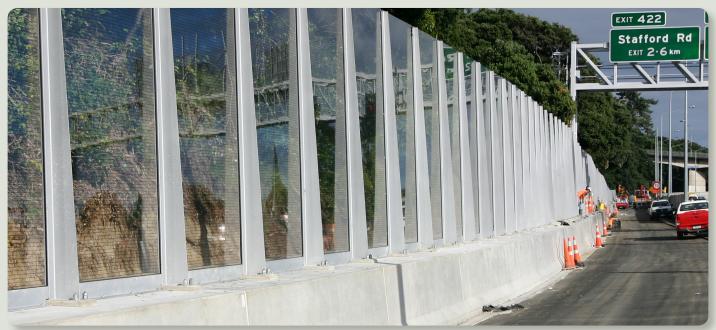
The projecting tees of the noise barrier support post were rotated to face the motorway side as a solution to help reduce the incidence of sunstrike.

A solution to rotate panels by 5 degrees away from the driver was not compatible with the aesthetics of the tapered steel tee support posts. However, this structure allowed a partial solution. The posts were originally conceived with the flanges facing the motorway. By reversing the flanges to face the St Marys Bay Reserve, the projecting tees interrupt reflected light by up to 10 degrees on the motorway side, which slightly reduces the extent of sunstrike. The re-positioning of the posts also allowed more straightforward installation of the acrylic panels, as these could be presented from the motorway side, thereby avoiding constraints of the pohutukawa trees. In the event that sunstrike presents a serious safety concern in the future, retrofitted mitigation is available through attaching deeper fins to posts at affected sites, or sandblasting acrylic panels.

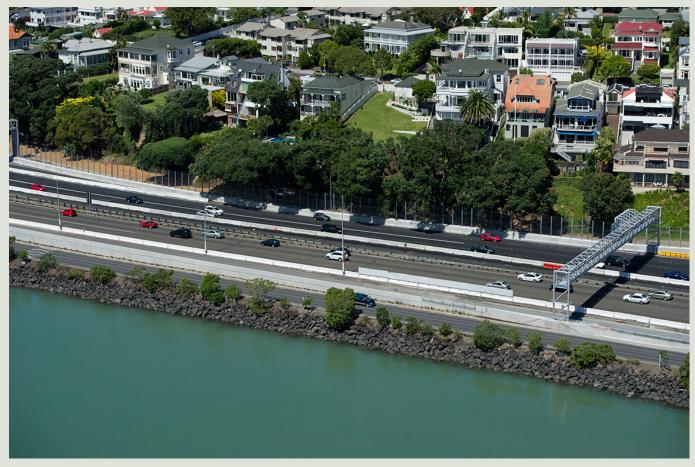
Noise barriers were designed to meet specific designation conditions and included the use of transparent materials to ensure views were maintained.

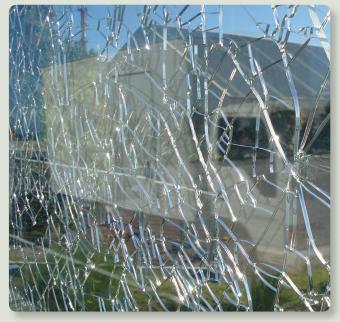
There is no perfect material available for transparent barriers, and strengths and weaknesses should be considered for each specific location. For example glass is too easily damaged, especially where there is close pedestrian access.
