SH1 Centennial Highway median barrier project

Flexible median barriers are a part of the Safe System approach to road safety

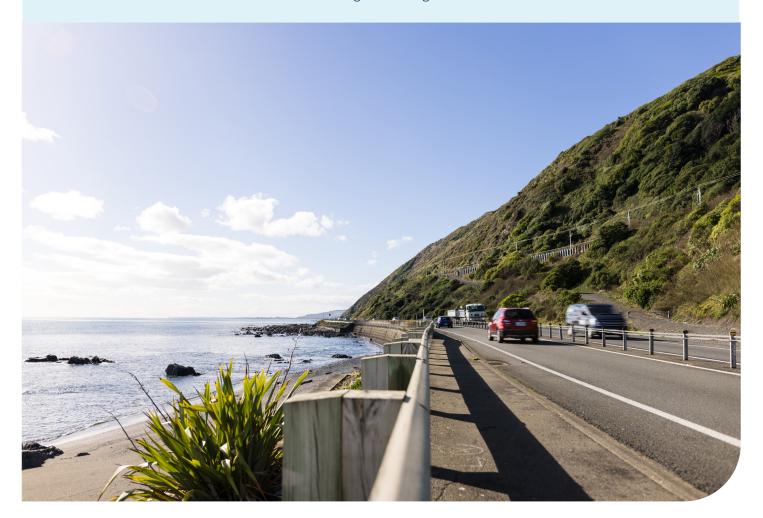
Comparison of footage from before and after the median barrier installation showed that drivers tended to travel more centrally within their lane with the median barrier in place. However, on the inside of a left hand bend, the proportion of drivers tracking to the left of their lane was generally higher, with a small increase in the number of vehicles cutting the left edgeline.
