Auckland Harbour Bridge  
Contract PSMC003

Annual Report 2010 - Maintenance Works  
Resource Consents 23954, 23955, 23956  
Discharge of Contaminants

April 2010

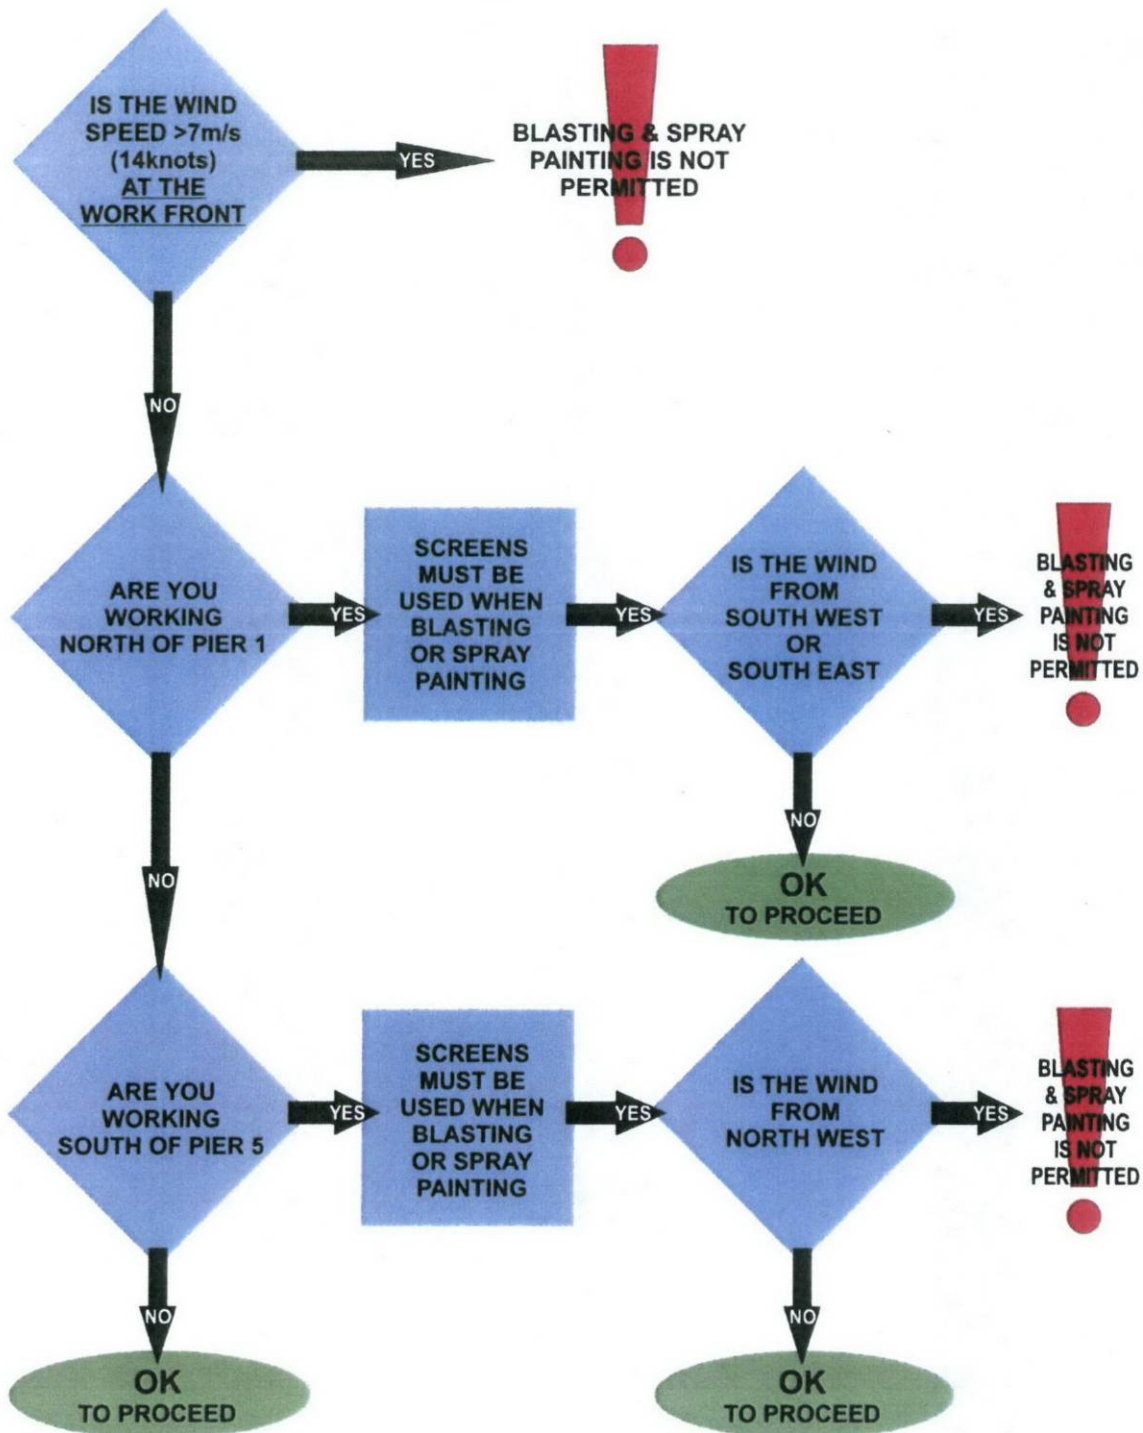
### Dry blasting and Spraypainting Commencement Flowchart

**NOTE:**  
WIND SPEED & DIR  
MUST BE RECORDED  
ON THE DAILY RECORD SHEET
