Final Report

Peka Peka to Ōtaki - Phase 1 Contaminated Land Assessment

Prepared for
New Zealand Transport Agency

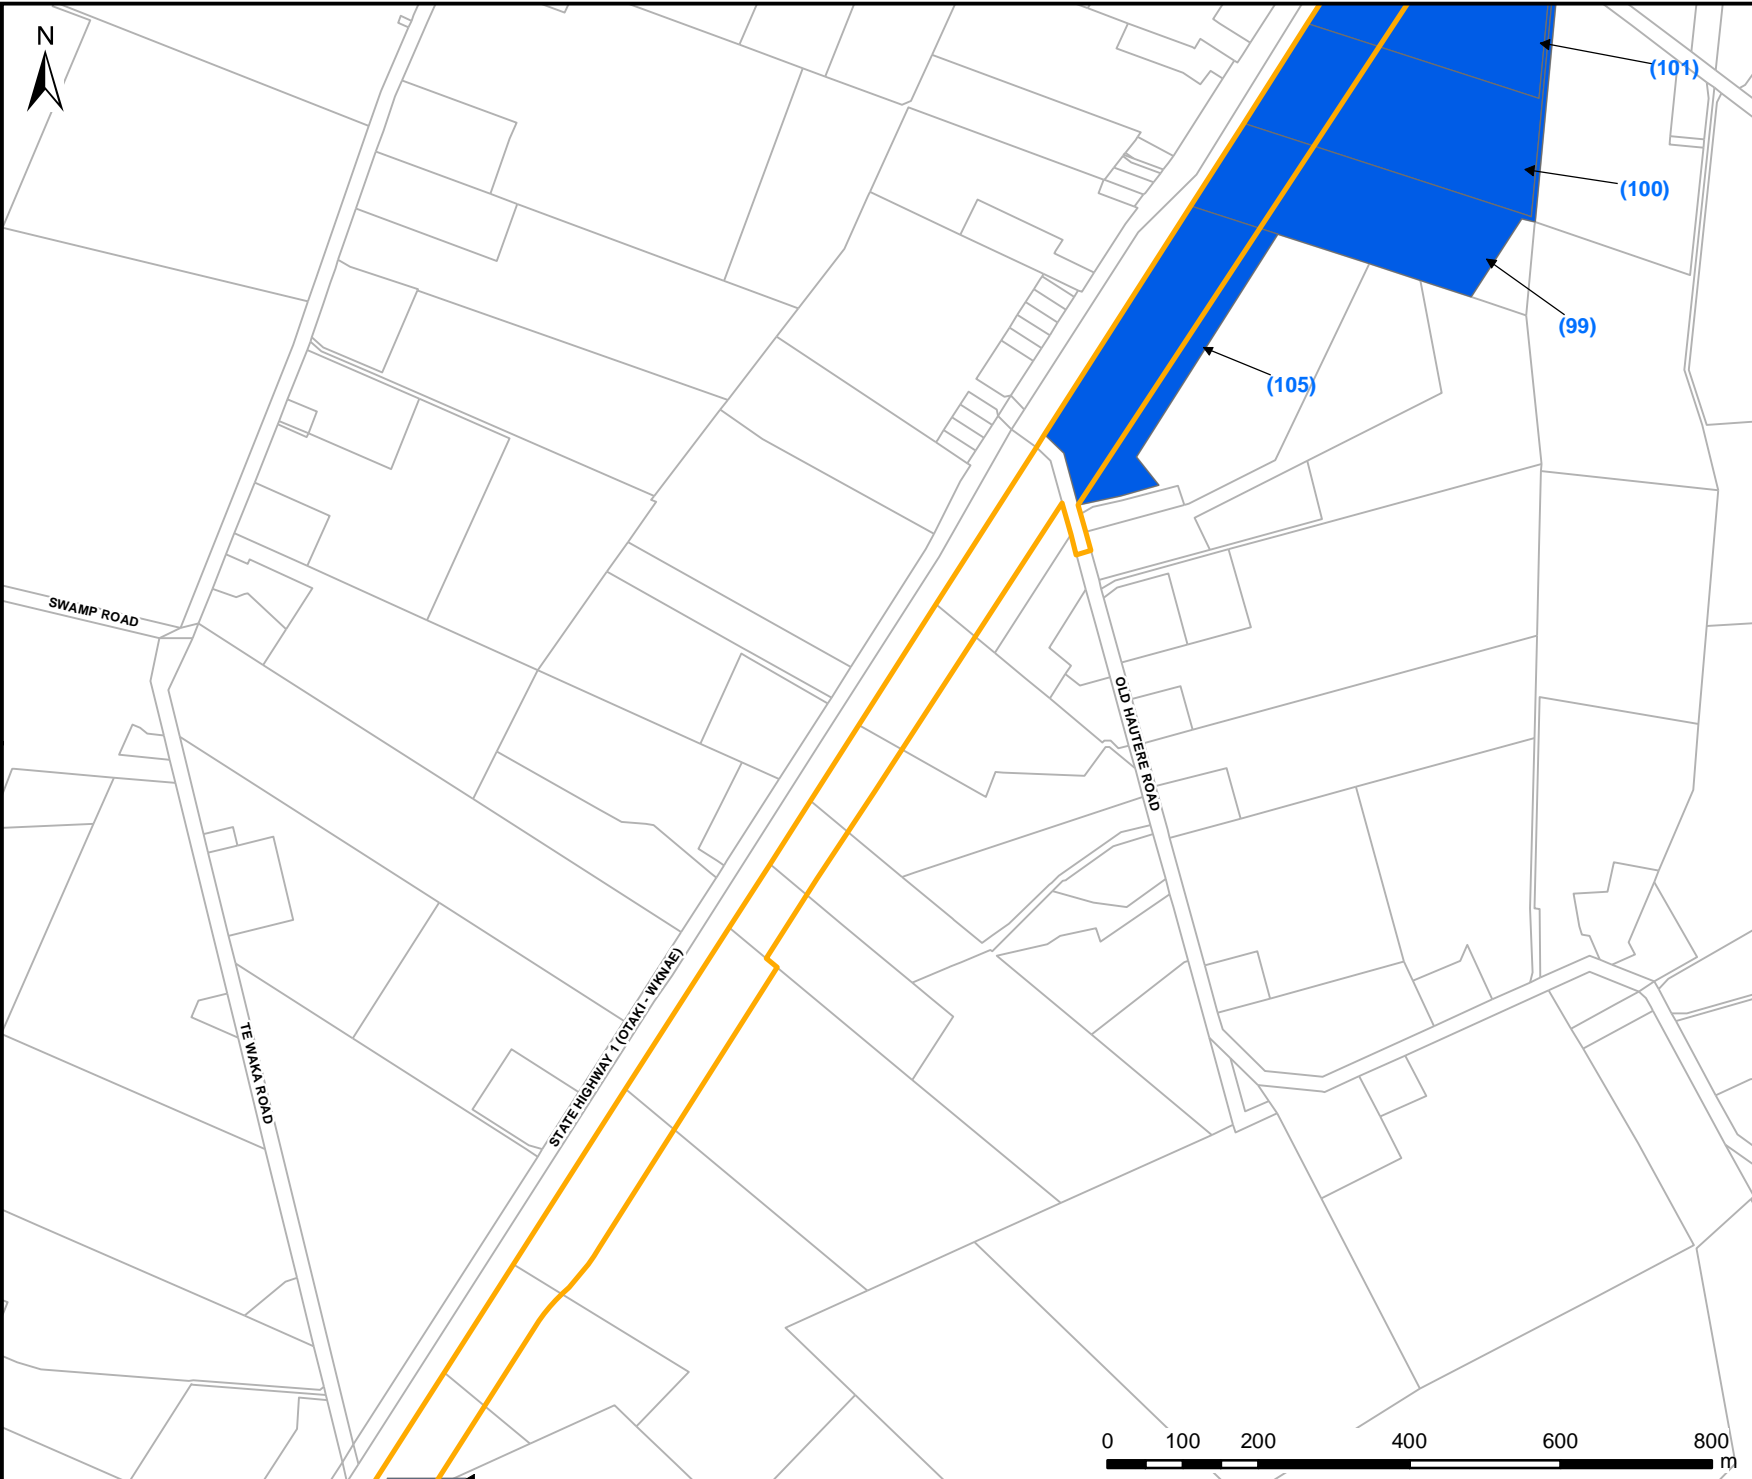
Drawing Number	Status	Rev.
Figure 2-3	DRAFT	A
Date: 31/01/2013	Designed: SS	
Scale: 1:10,000	Drawn: SS	
Original Size: A4	Checked: SL	
Status: DRAFT	Approved: SL

MapTitle: Sites of Interest

The Overview Phase 1 findings for the designated Project corridor are provided in **Table 2-2**. Refer to **Figure 2-1** through **Figure 2-6** for the locations of these sites and the designated Project corridor.
