# Petone to Grenada Link Road Preliminary Geotechnical Appraisal

September 2013

Date: September 2013 Reference: GER 2013-24

The Petone to Grenada (P2G) project is an approximately 6 km long new route between the Hutt Valley and northern Wellington districts. The project area lies between western Petone and the Tawa interchange on State Highway 1 at Grenada North. The project area and the alignment proposed in the Petone to Grenada project feasibility report (identified as the PFR P2G route) (SKM, 2010), is shown below in Illustration 1.

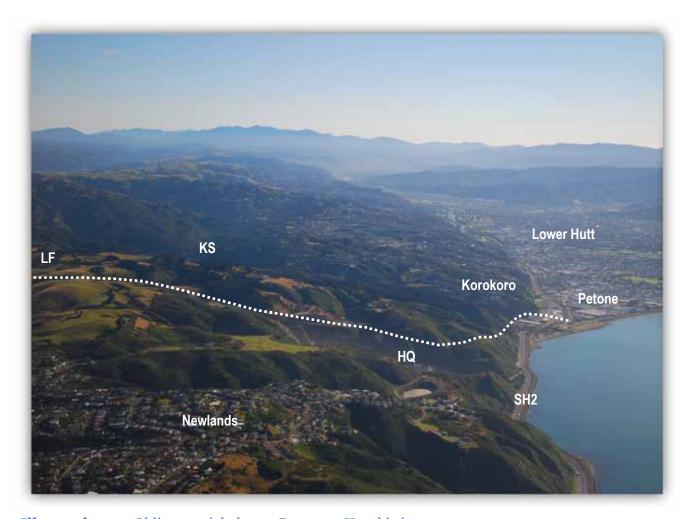
Illustration 2 Oblique aerial photo - Petone to Horokiwi

Key geomorphic features to note are the low-lying coastal flats at Petone, the steep hillslopes of the Wellington Fault scarp above State Highway 2 (SH2), incised gullies around Korokoro Stream (KS) and Horokiwi Quarry (HQ), and the broad, undulating hilltop plateaux at Lincolnshire Farm (LF). The approximate PFR P2G alignment is indicated by the dotted line.

Immediately adjacent to this area, on the western side of State Highway 2, are steep hillslopes and deeply incised gullies of the uplifted block to the northwest of the Wellington Fault (Illustration 2). The slope angles are typically 30° to 45°, and in places are steeper than 50°, which reflect the ongoing uplift and subsequent incision of land on the northwestern side of the Wellington Fault scarp (Dellow, 1988). The hills rise from sea level at the SH2 Petone Interchange up to 290 m elevation on the hilltops near Horokiwi. This area consists of bush-covered hillslopes, the active cut slopes of Horokiwi Quarry, and rural-residential land on the ridge tops.

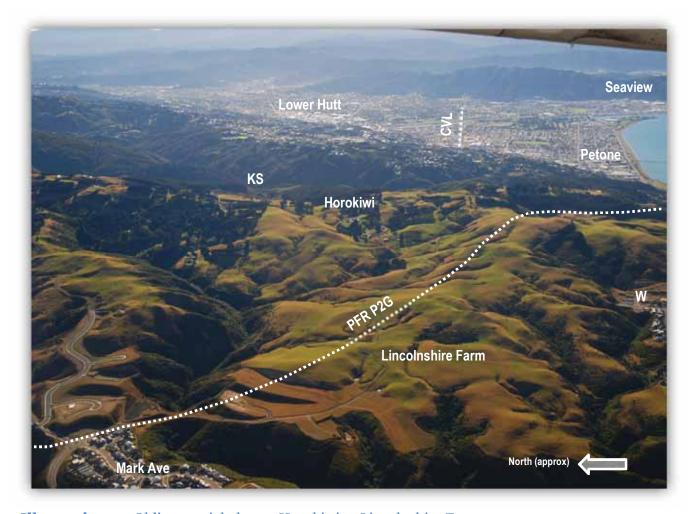
**Illustration 3** Oblique aerial photo - Horokiwi to Lincolnshire Farm

The PFR P2G route crosses a K-surface remnant that forms the undulating hilltop in the Lincolnshire Farm area. The approximate route alignments are indicated by dotted lines. Other features shown include Korokoro Stream (KS) and Woodridge (W).

The PFR P2G route crosses a prominent K-Surface remnant in the Linconshire Farm area (Illustration 3). The geomorphology here is characterised by broad, undulating hilltops that gently dip to the northwest towards State Highway 1. This K-Surface remnant is generally of moderate relief, and has been incised by streams which are bounded by steeply sloping gully sides.

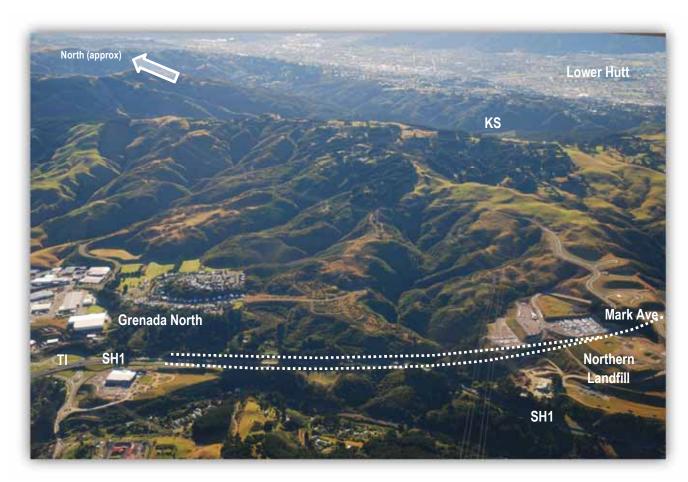
Illustration 4 Oblique aerial photo - Grenada

Key geomorphic features to note include the now-closed Northern Landfill, and the incised gullies and steep hillslopes above State Highway 1 (SH1). The approximate location of the PFR P2G alignment is indicated by the dotted lines. Other features shown include Korokoro Stream (KS) and the Tawa Interchange (TI).

The northwestern end of the PFR P2G area crosses the area of the former Northern Landfill, between Mark Avenue and State Highway 1 (Illustration 4). The geomorphology in this area consists of deeply incised hillslopes and gullies with moderate to steep slope angles. The Northern Landfill area is marked by flat terraces with steep slopes between the terrace surfaces.

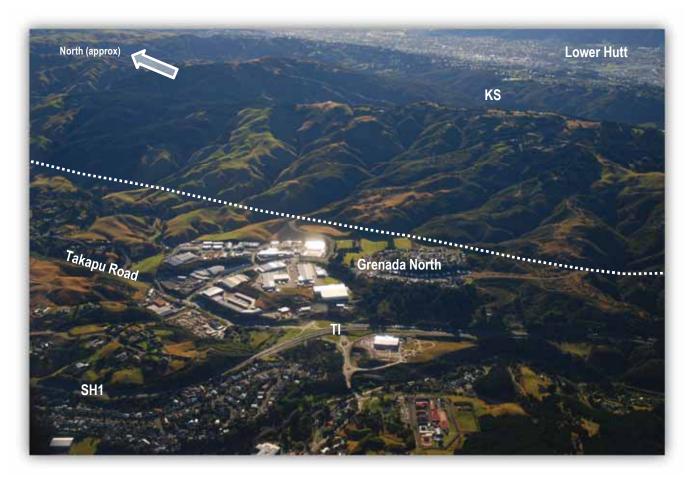
**Illustration 5** Oblique aerial photo – Takapu Road

Key geomorphic features to note include the steep greywacke hillslopes east of Grenada North and Takapu Road, with deeply incised, steep gullies. The approximate location of the route connecting to Transmission Gully near Takapu Substation is shown by the dotted line. Other features shown include Korokoro Stream (KS) and the Tawa Interchange (TI).

There is an option to connect the P2G route with the proposed Transmission Gully highway in the vicinity of Takapu Substation, at the northern end of Takapu Road (Illustration 5). This section of the route passes across steep greywacke hillslopes and deeply incised gullies to the north of the Northern Landfill. This route traverses across the hillslopes before sidling down to the floor of the valley to follow Takapu Road north to the Transmission Gully route. The geomorphology of the valley is characterised by a narrow, winding valley floor, with steep side slopes and incised tributary gullies.

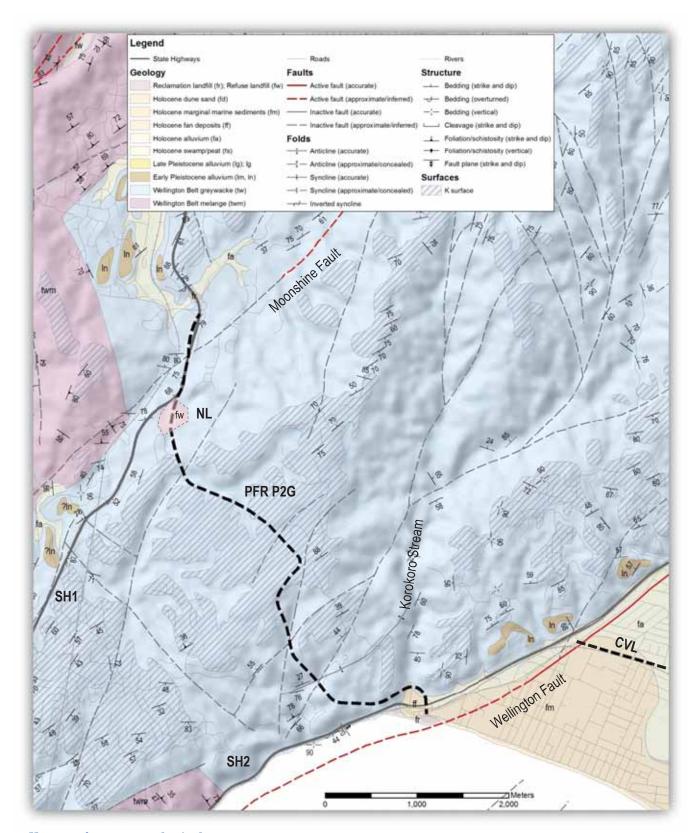
Illustration 6 Geological map

This map shows the geology of the study area (after IGNS, 1996); the PFR P2G and CVL alignments are indicated by the dotted lines. The indicative area of the Northern Landfill (NL) is shown.

The Wellington Fault is located in close proximity to the proposed PFR P2G route in the vicinity of the interchange at Petone (Illustration 6). The fault has a recurrence interval of 610 to 1,100 years and ruptures in large earthquakes of magnitude 7.5 with typical coseismic displacements of the ground surface of 5 m horizontally and 1 m vertically (Little *et al.*, 2010).

The route also crosses the Moonshine Fault trace near the proposed interchange with State Highway 1 at Grenada North (Illustration 6). The location, width, characteristics and form of the fault zone are poorly defined. This fault has a very long recurrence interval (>11,000 years) and accordingly has a very low probability of rupture. Therefore this fault is of lesser importance than the Wellington Fault to the selection of the P2G route and conceptual designs.

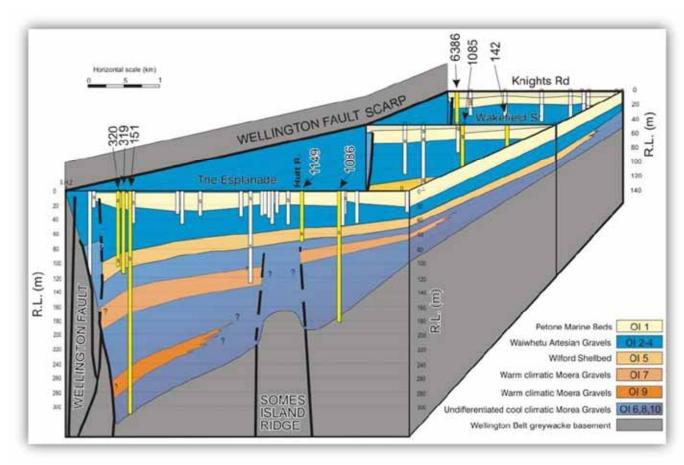
**Illustration 7** 3D block model of the Wellington Fault scarp and Lower Hutt basin

This diagram shows the relationship of the Wellington Fault to the alluvial and marine deposits in the Lower Hutt basin. The alluvial deposits are in excess of 300 m thick at the western end of the Esplanade in Petone (Begg *et al.*, 2008).

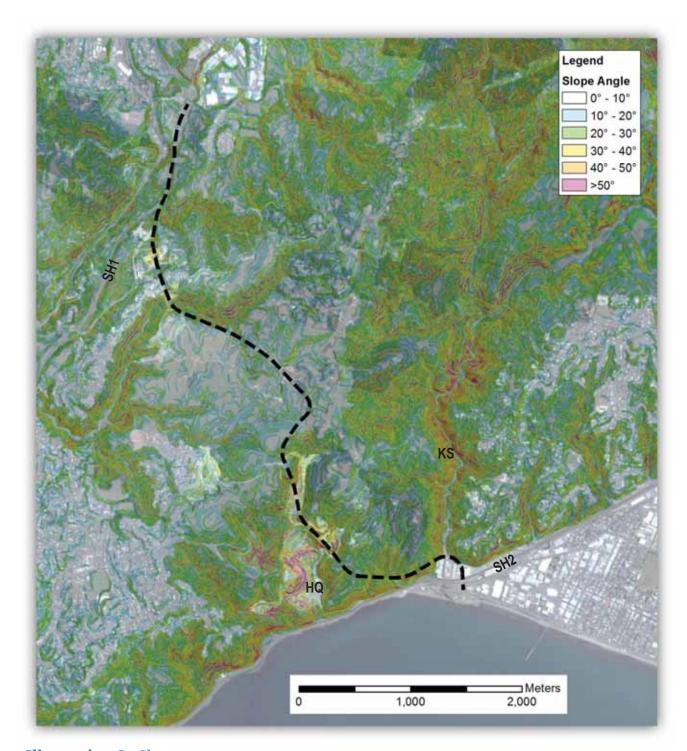
**Illustration 8** Slope map

This map shows the slope angles in the project area; the PFR P2G alignment is indicated by the dotted line. Very steep slope angles (>50°) are present around Horokiwi Quarry (HQ) and the Korokoro Stream (KS) valley.

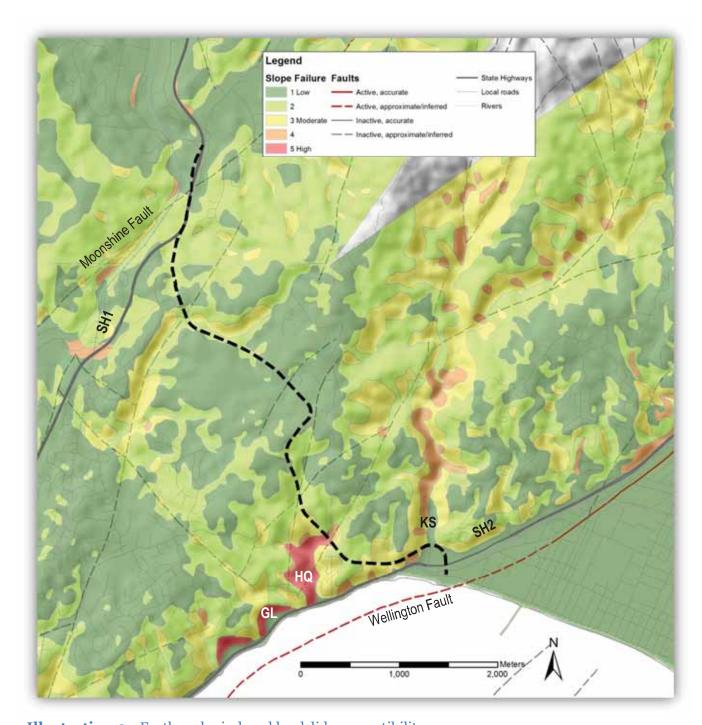
**Illustration 9** Earthquake-induced landslide susceptibility map

This map shows the earthquake-induced slope instability of the PFR P2G route (after IGNS, 1996); the PFR alignment is indicated by the dotted line. The principal area of slope hazard is at the southern end of the route, where the alignment crosses steep hillslopes associated with the western side of the lower Korokoro Stream valley and the Wellington Fault scarp (Dellow, 1988). KS – Korokoro Stream; HQ – Horokiwi Quarry; GL - Gold's Landslide.

Moderate to large earthquakes can lead to slope failures in steep to very steep slopes, including cuttings which are generally steeper than the natural hillslopes. The PFR P2G route crosses steep, hilly terrain at its eastern end, between Petone and the hilltops at Horokiwi. The hillslopes in this area have been mapped as high susceptibility to earthquake induced landslides (Illustration 9).

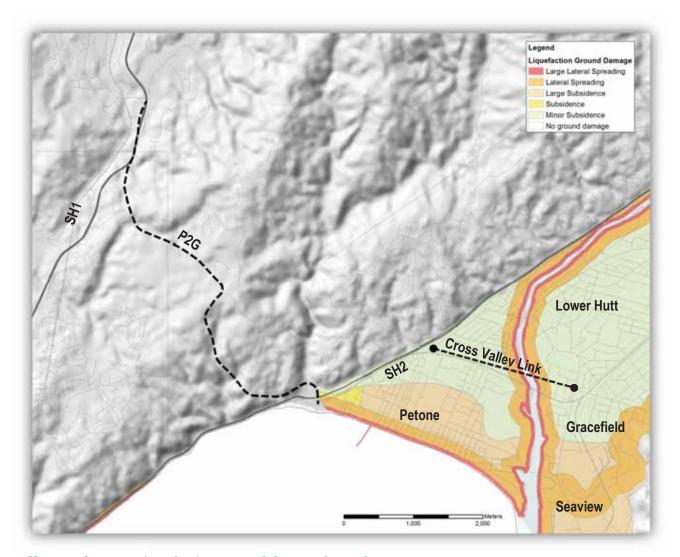
**Illustration 10** Liquefaction ground damage hazard map

The liquefaction-induced ground damage hazard map (Illustration 10) indicates potential for lateral spreading along the Petone foreshore and Seaview areas, and along the banks of Hutt River. Site investigations are required to quantify this hazard and the consequences to the project, and to develop mitigation measures.

A liquefaction hazard study for the Wellington Region was carried out by Works Consultancy Services (now Opus) in 1992 and the results of the study were published by the Wellington Regional Council (WRC, 1993). This study indicates a variable liquefaction potential across the site, from low to high, which reflects the variable compositions of the alluvial, marine and fan deposits. The liquefaction-induced ground damage hazard mapping is shown in Illustration 10.

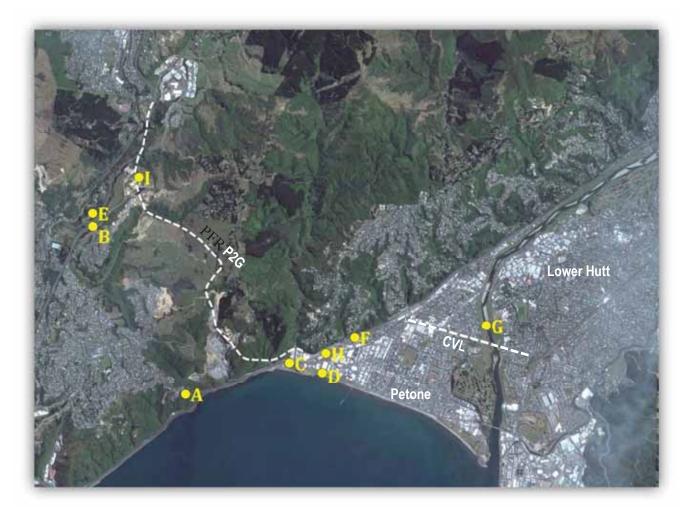
**Illustration 12** Locations of previous geotechnical investigations and studies

- A. Earthquake generated landslides in Wellington (Dellow, 1988)
- B. SH1 Grenada Interchange (Works Consultancy Services, 1992a)
- C. SH2 Petone Overbridge (Works Consultancy Services, 1992b)
- D. Korokoro valve chamber (Works Consultancy Services, 1996a)
- E. Grenada mobile cell site (Works Consultancy Services, 1996b)
- F. SH2 Melling to Petone (Beca, 1998)
- G. Earthquake vulnerability of Flood Protection Assets (Opus, 2005)
- H. SH2 Dowse to Petone (Beca, 2003)
- I. Northern Landfill (MWH, 2003)

Limited geotechnical information is available from previous investigations in the project area. Previous geotechnical investigations and studies relevant to the project are indicated on the map below (Illustration 12).

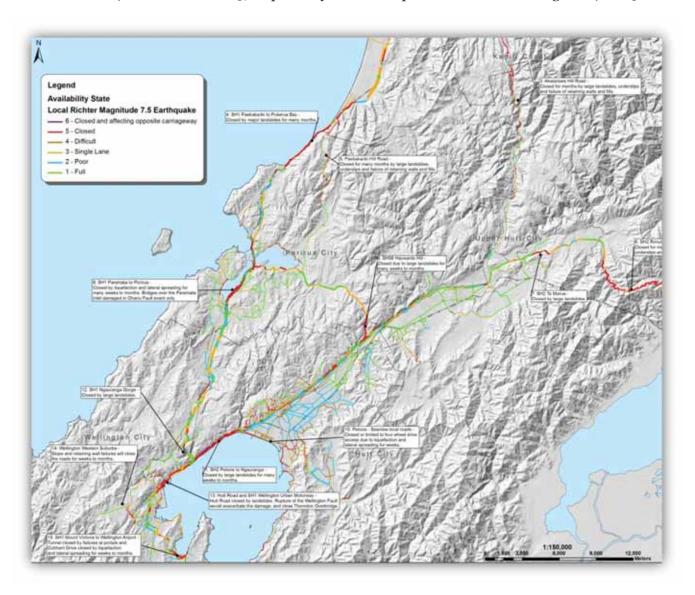
**Illustration 14** Resilience of Wellington Region: Availability state after large local earthquake (after Opus, 2012)

The maps show that in the aftermath of a large magnitude 7.5 earthquake in the region, land access to the Greater Wellington area comprising Wellington, Hutt Valley and Porirua will be cut off for many months – four to six months or more. This is due to the vulnerability of SH1 and SH2 to

The study by Opus (2012) indicates the poor resilience of access into the region in the aftermath of hazard events such as a large earthquake. The resilience of the road networks in the region is illustrated in the resilience state maps of "availability state" and "outage state" presented in Illustration 14 and Illustration 15, respectively. These maps are also shown on Figures 4 and 5.

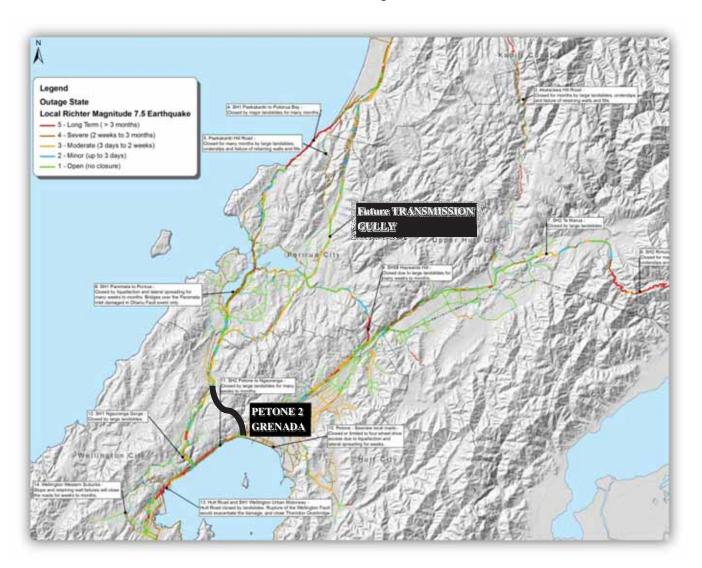
Illustration 16 Resilience context of Petone to Grenada Link

Projects such as Transmission Gully expressway and the Peka Peka to Otaki expressway will help enhance resilience of access into the region and will enable quicker restoration of access into Porirua and Wellington, see Illustration 16. However, the Hutt Valley will remain isolated because SH2 will be cut off between Wellington and Petone, and Upper Hutt and Featherston (Rimutaka Hills), and SH58 will be cut off between Paremata and Pauatahanui, and Judgeford and Manor Park (Haywards Hill).
