Summary Engineering Geology Along the Route

Project: Transmission Gully

Notice of Requirement and Consents Scale: Figure: Date:

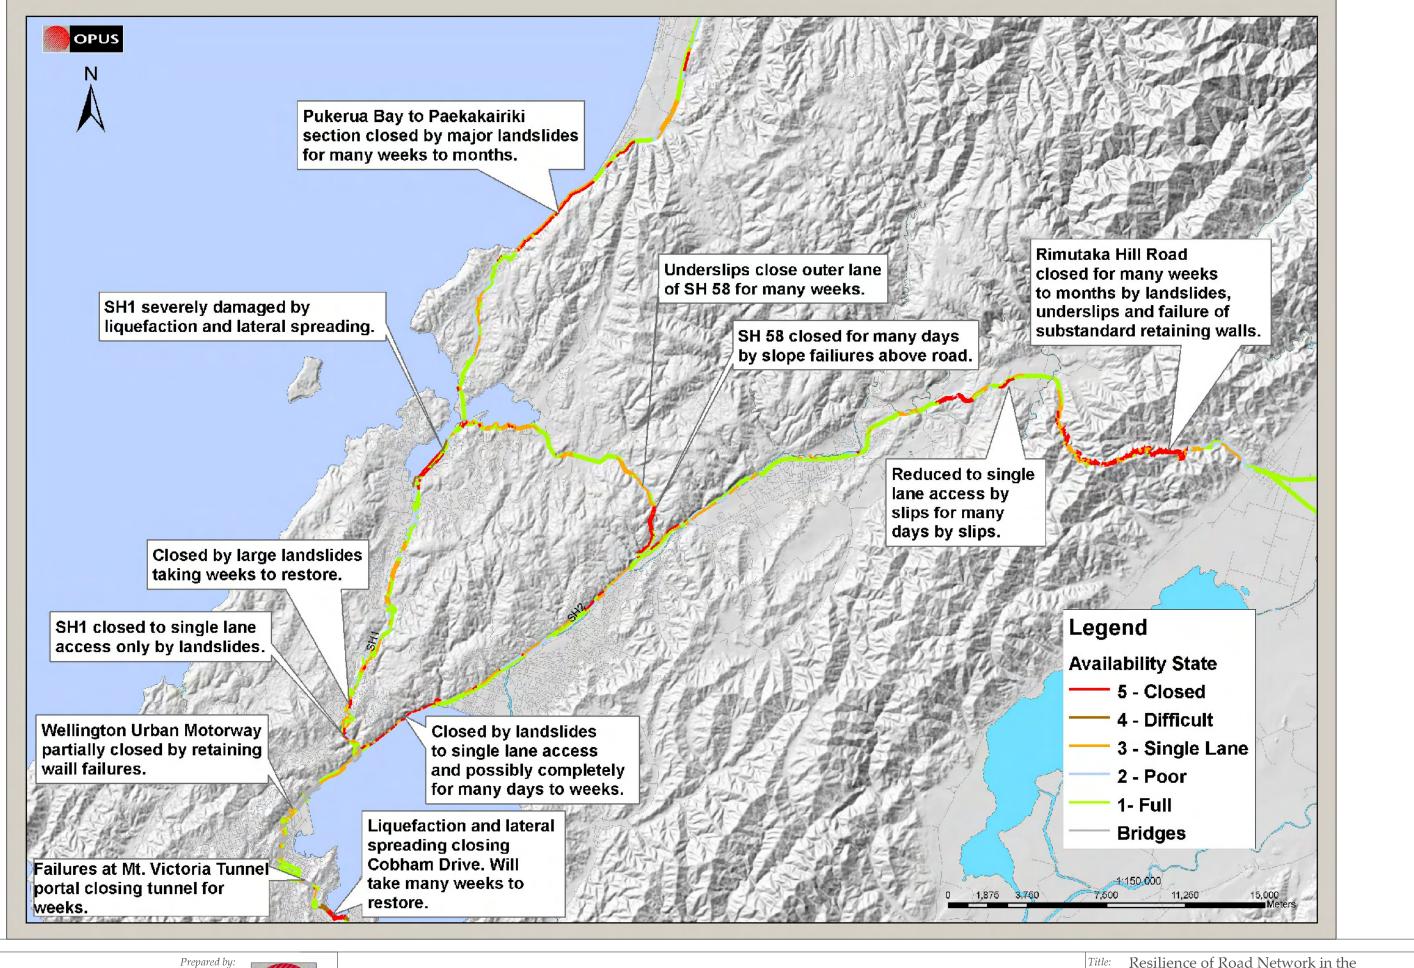
Figure E - Resilience and Availability and Outage States

Title: Resilience of Road Network in the Wellington Region - Availability State

Illustration 1 - Resilience of Network Time

Resilience States

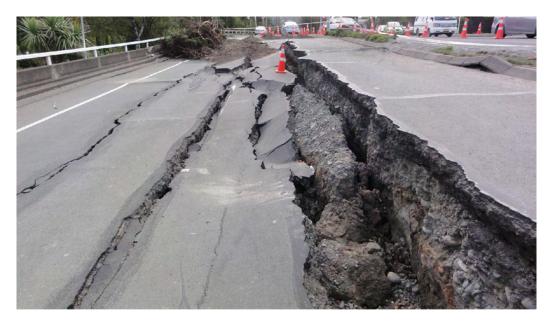
FAILURE OF ROAD DUE TO LIQUEFACTION AND LATERAL SPREADING IN THE 2011 CHRISTCHURCH EARTHQUAKE

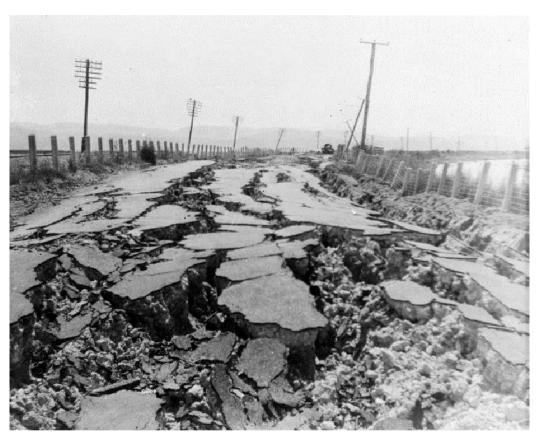
FAILURE OF ROAD EMBANKMENTS DUE TO LIQUEFACTION IN THE 1931 HAWKES BAY EARTHQUAKE

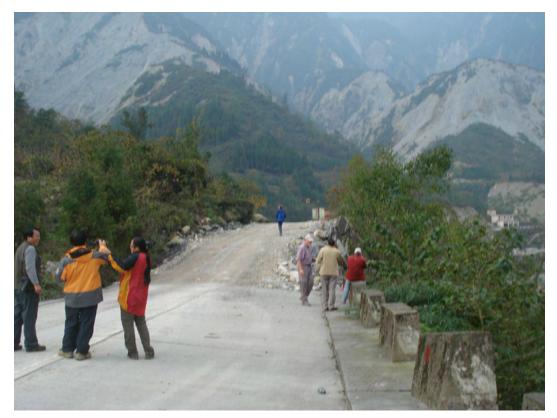
FAULT RUPTURE ACROSS EMBANKMENT, ACCESS RESTORED WITHIN DAYS AFTER THE 2008 WENCHUAN EARTHQUAKE, CHINA

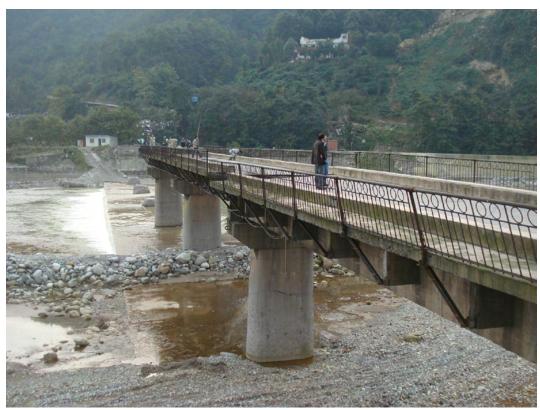
FAULT RUPTURE CAUSING BRIDGE COLLAPSE, ACCESS NOT RESTORED 6 MONTHS AFTER THE 2008 WENCHUAN EARTHQUAKE, CHINA

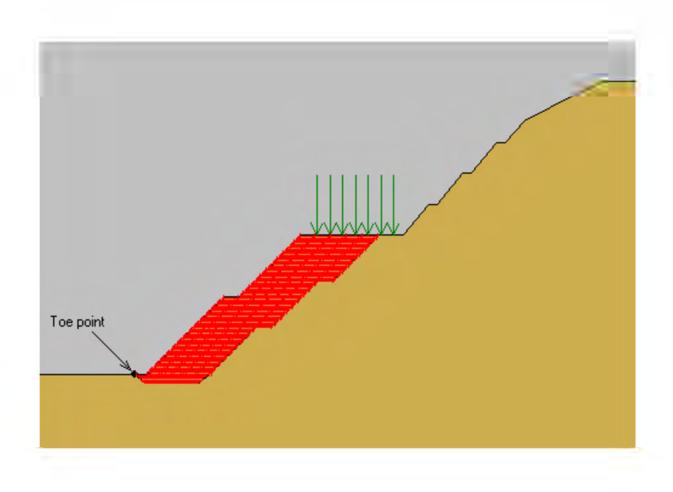
Title: Reinforced Soil Embankments

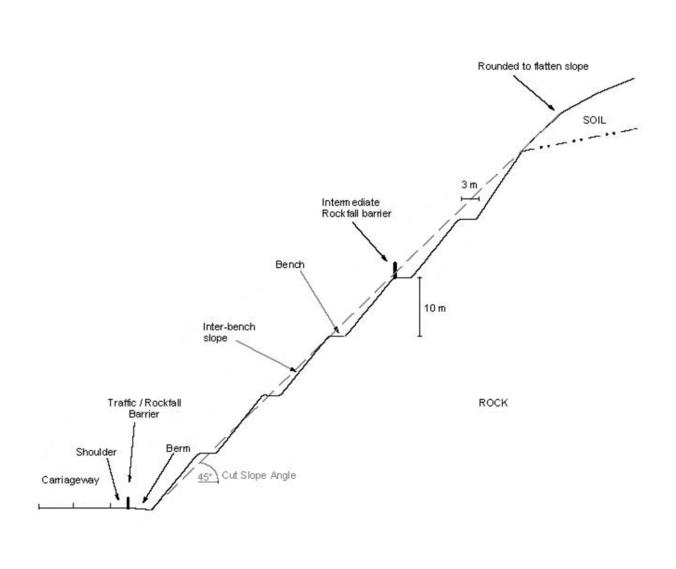
Title: Rock Slope Configuration and Rock Fall Protection
