**TRANSMISSION GULLY PROJECT
ASSESSMENT OF ENVIRONMENTAL EFFECTS**

**TECHNICAL REPORT No. 3
GEOTECHNICAL ENGINEERING REPORT**

**Technical Report No.3
Geotechnical Engineering Report
July 2011**

Report No GER 2010 / 23

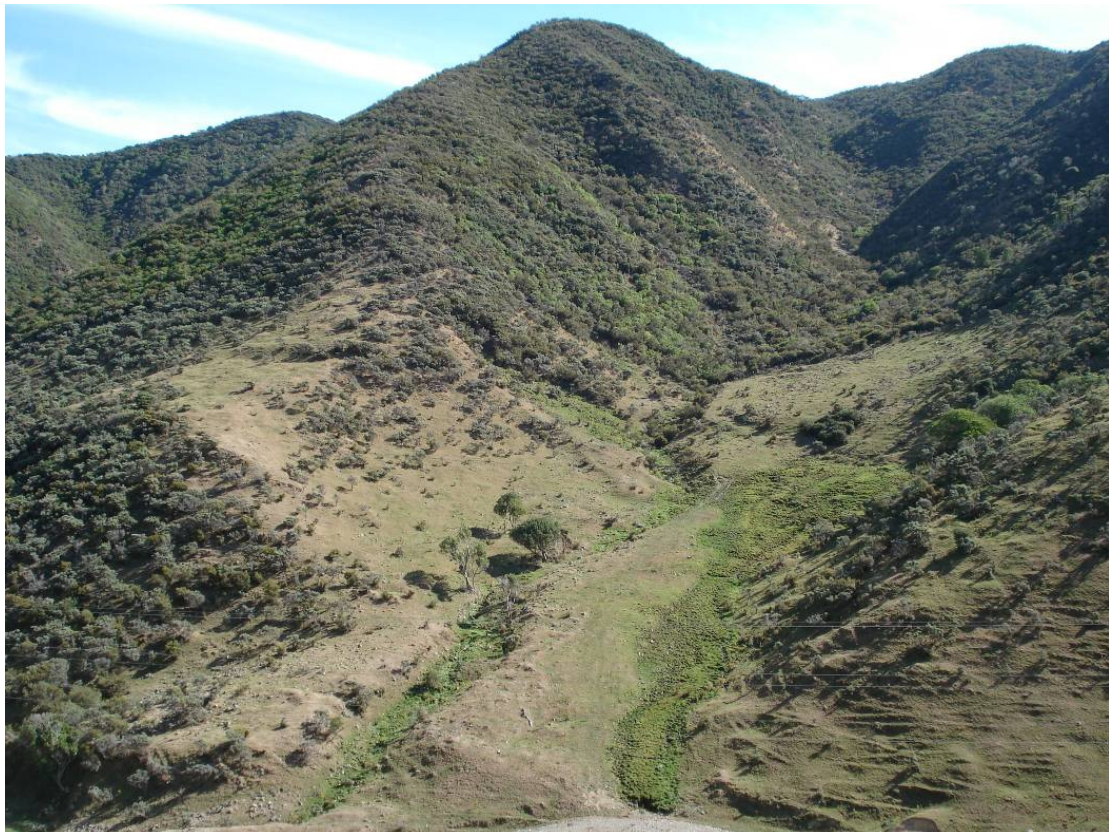
Illustration 3.3 - Seepages from Active Splinter Fault on Western Flank South of Wainui Saddle

Springs are evident along the Ohariu Fault and the active splinter of the Ohariu Fault discovered by the investigations on the western flank of Horokiri Stream, south of the Wainui Saddle in Sector 4. These springs and the wet ground associated with this fault were readily apparent during the dry 2008 summer as a contrast with the dry surrounding vegetation, see Illustration 3.3. These springs were still flowing in the dry summer months, and this is not unexpected given that these are inferred to be fed up through the shattered rocks associated with the fault zone from deeper groundwater flow.

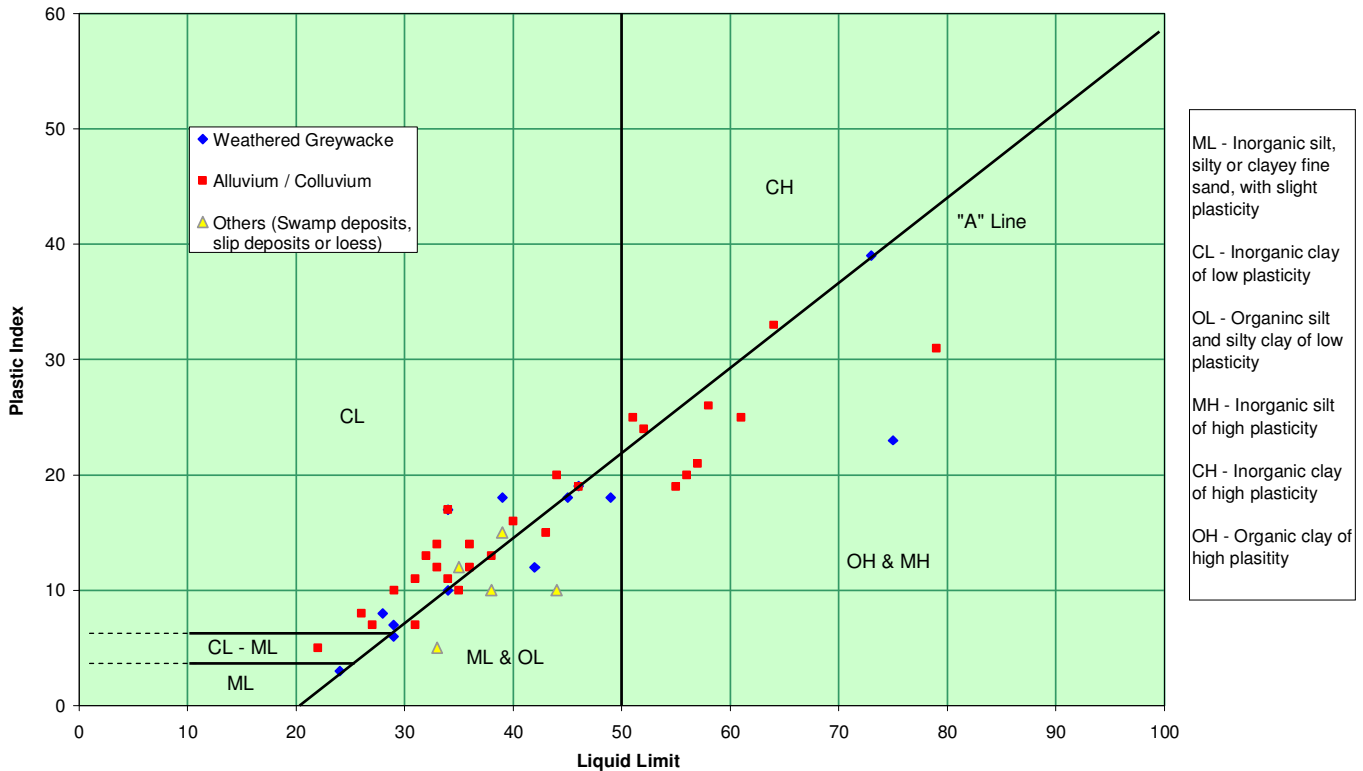
Illustration 3.5 - Classification of Soils from Transmission Gully

The soil classification tests results are plotted on the Casagrande Chart to show the distribution of the soils relative to the A-line, and are shown on Illustration 3.5.

The chart shows that the majority of the soils recovered and tested from the Transmission Gully corridor are of low to medium plasticity and fall close to the A-line.

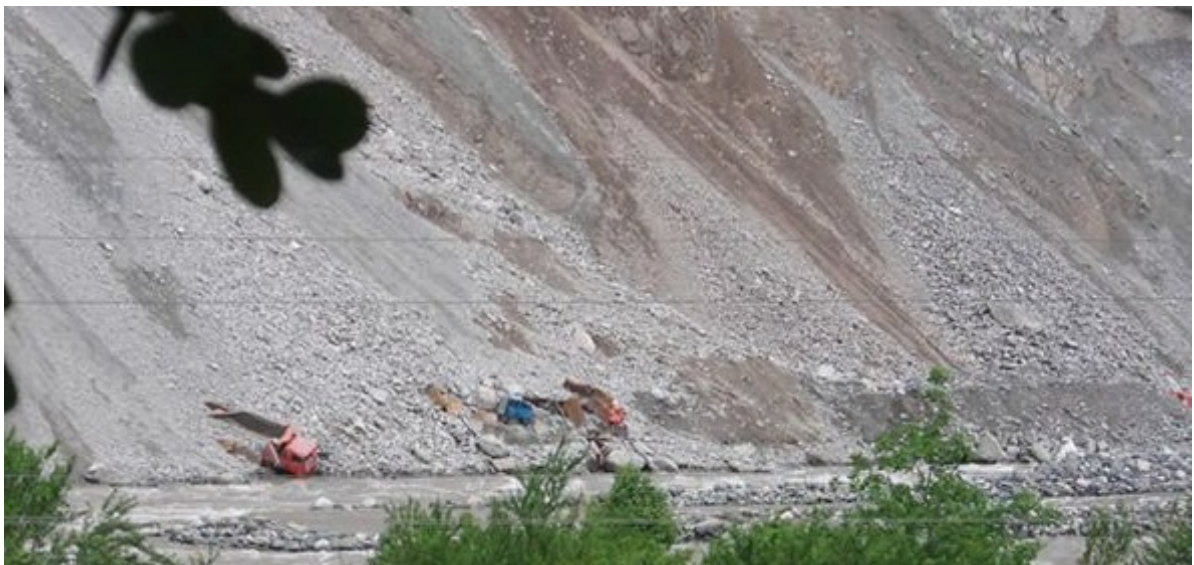
Illustration 3.8 - Highway destroyed by landslides in the 2008 Wenchuan Earthquake, China

The author of this report (P Brabhakaran) was part of a New Zealand Society for Earthquake Engineering (NZSEE) Learning from Earthquakes team which visited the earthquake damaged areas of China in November 2008, following the May 12, 2008 Magnitude 8 Wenchuan Earthquake that devastated areas of the Sichuan Province of China. Observations of landslides and the effect on transportation lifelines are documented by Brabhakaran in the reconnaissance report (Yu et al, 2010). Extensive landslides, in somewhat similar steep terrain to the Te Puka Valley, were observed to have led to closures of many highways in Sichuan, see Illustration 3.8.

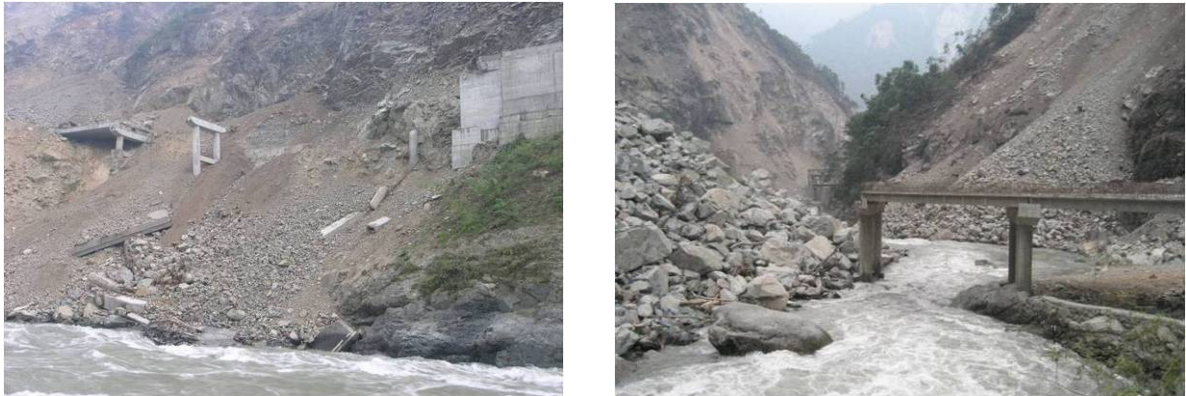
Illustration 3.9 - Viaduct / bridges in steep terrain destroyed by landslides in the Wenchuan Earthquake

The author also observed and obtained records of many highway bridges and viaducts that had been destroyed or damaged by landslides where they are located in steep terrain prone to landslides, see photographs on Illustration 3.9.

Observations from the 2008 Wenchuan Earthquake illustrate that structures along steep hillsides are prone to damage and destruction from the large forces associated with earthquake induced landslides, or can be undermined by the failure of steep slopes.

Viaducts were proposed in the Te Puka Valley in the 2008 SAR preferred alignment (1B) between Stations 3,800 m and 4,800 m (as well as previously in the 2004 Costed Viaduct Option). These viaducts could be vulnerable to severe damage or destruction by large landslides as they are located on steep slopes. These viaducts will also be located alongside the proposed high cuttings which will be steeper than the natural hillsides, and earthquakes induced slope failures are likely as discussed in Section 12.6. In addition, these viaducts are located very close to the active Ohariu Fault and hence are vulnerable to local shaking and ground displacements in the proximity of a fault rupture zone. These structures would therefore not meet the route security philosophy for the project.

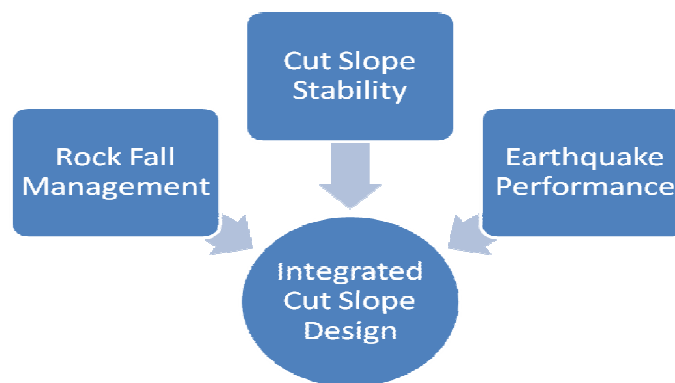
Illustration 3.10 - Important Issues Influencing Design of Cut Slopes

Three important issues influence the selection of cut slopes in rock, see Illustration 3.:

- stability under normal conditions
- stability and route security under large hazard events, e.g. earthquake and storm
- rock fall hazard mitigation.

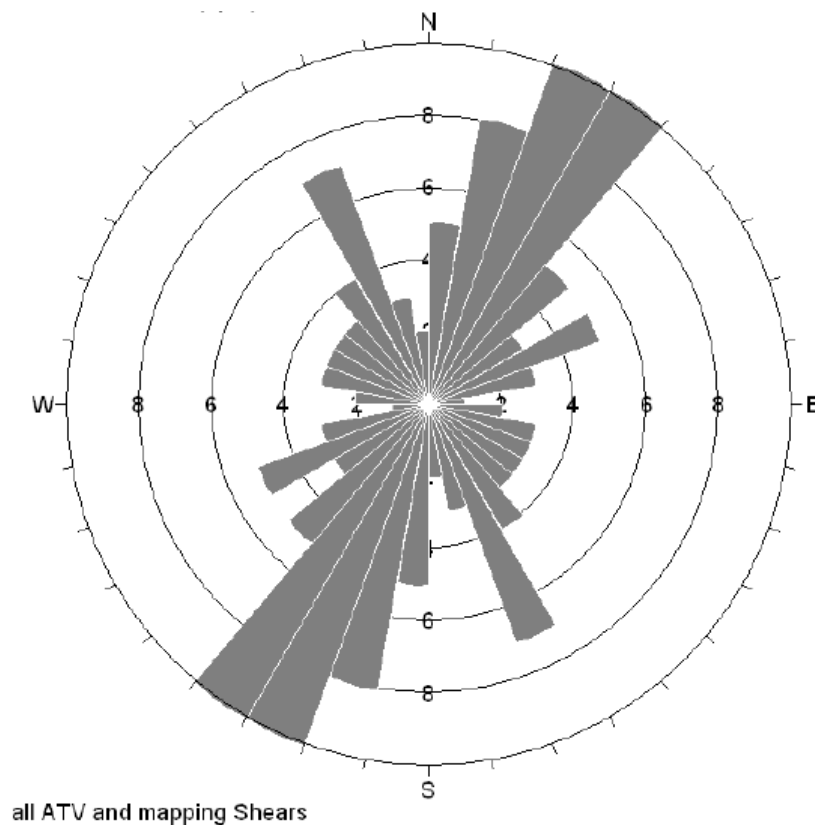
Illustration 3.12 - Rosette Plot showing Strike of Shear Surfaces

These shear surfaces, faults and crush zones have a dominant dip direction of 110° to 150°, and 290° to 310°. This corresponds to a strike of SSW to NNE as clearly shown in the Rosette plot in Illustration 3.12.

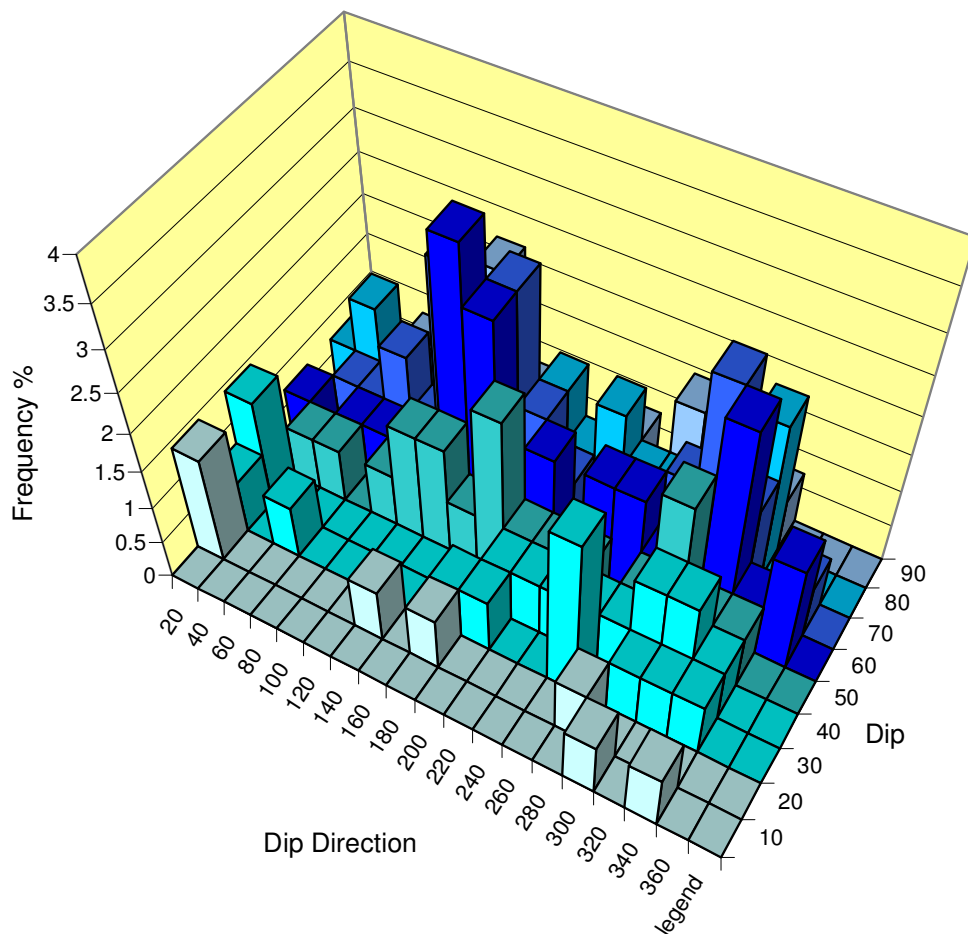
Illustration 3.13 - Frequency Plot showing Dip and Dip Directions of Shear Surfaces in Rock

The dip and directions of the shear surfaces mapped from the acoustic televiewer and field defect mapping surveys is presented in Illustration 3.13. This three-dimensional plot clearly shows the concentration of dominant defects with dips of 45° to 80° and dip directions of 110° to 140°, and 300° to 330°. Also shows some low angle defects dipping 20° to 30°.

Overall formation of the cuttings at a cut slope of about 45° to 50° will minimise the potential for planar failures due to the dominant shear surfaces that are steeper than about 45° to 50° (80%), see Illustration 3.13. Some 15% of shear zones that dip at between 20° to 45° , and in particular the significant proportion of those that dip towards the west-northwest (see Illustration 3.13) could give rise to some failures for the west-northwest facing cut slopes on the eastern flank of the Te Puka and Horokiri Valleys (for *In-designation Alignment 1A*), depending on the shear strength on the shear surfaces and crush zones.

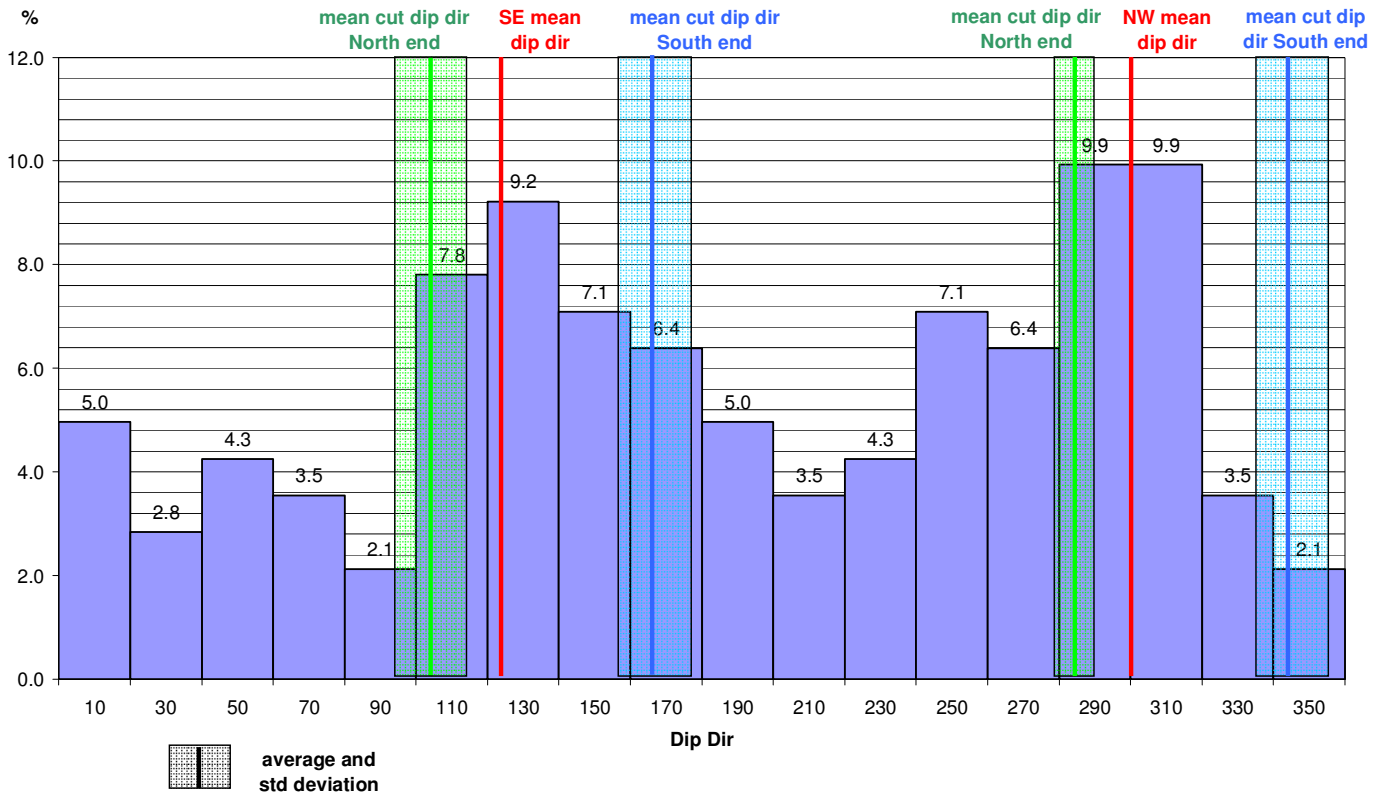
Illustration 3.14 - Comparison of Dip Direction of Cuttings and Shear Surfaces

These shear surfaces have a strike that is generally sub-parallel to the strike of the proposed cuttings along the Transmission Gully alignment in Sectors 2 to 8, as shown in Illustration 3.14.

The parallel nature of the strike of the shear zones to the strike of the proposed cuttings, ie the presence of widespread shear surfaces that dip perpendicular to the plane of the cut slopes, has the potential to cause large planar failures where the cuts are formed steeper than the shear surfaces. Such failures have been observed in cuttings for the State Highway 58 realignment (Hancox & Brabhakaran, 1995)¹⁷, and the Newlands Interchange cutting prior to the late 1990s construction of an interchange (Brabhakaran, 1998)¹⁸.

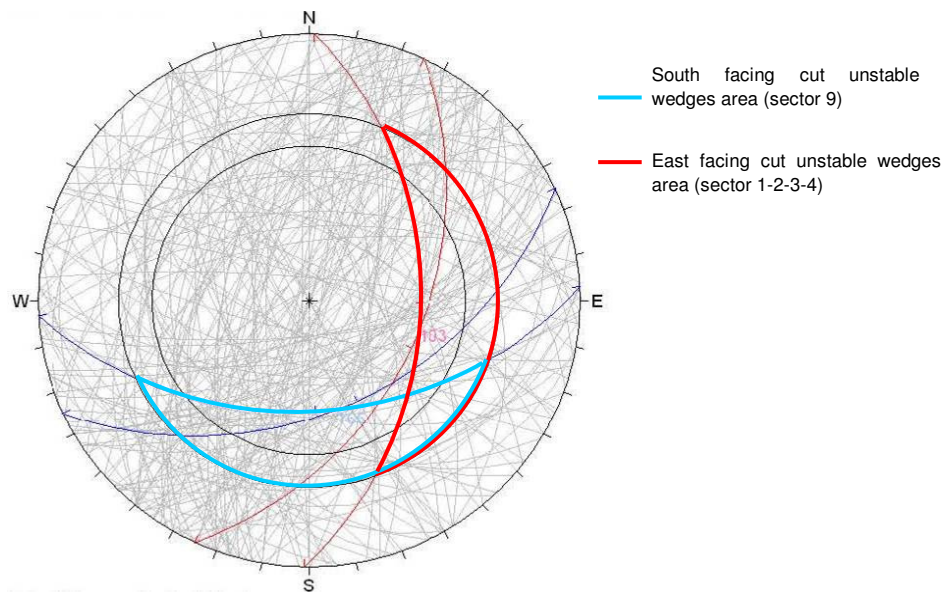
Illustration 3.15 - Stereonet for Wedge and Planar Failures on S & SE Dipping Cuts

The stereonet on Illustration 3.15 shows the E and SE dipping cuts in Sectors 2,3,4 & 8 (red great circles) for the alignment on the western side of the valley in sectors 3 and 4 (*Preferred Alignment 1B*), and S dipping cut slopes in box cuts in Sector 9 (blue great circles) (both *In-designation 1A* and *Preferred 1B Alignments*) in relation to the great circles for the shear zones (grey).

The cuts shown are assumed to be 45°. The friction circles (20° and 30°) in black show that there is some potential for wedge failures, but these are relatively less if the cut is formed at a slope of about 45°. There will also be some potential for toppling failures given the presence of very steep shear surfaces and faults.

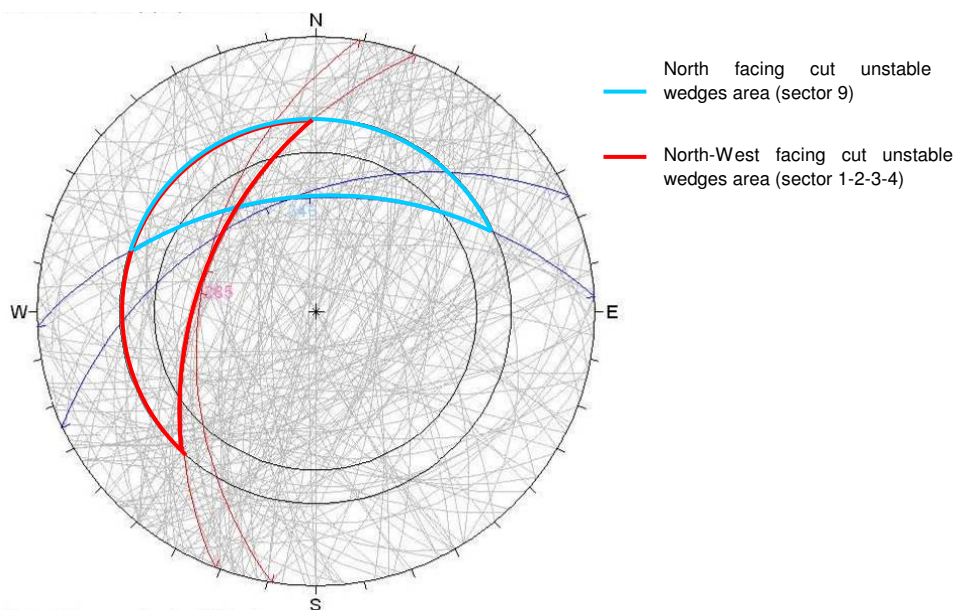
Illustration 3.16 - Stereonet for Wedge and Planar Failures on N & NW Dipping Cuts

The stereonet on Illustration 3.16 shows a similar plot for NW dipping cuts in Sectors 2,3 and 4 (red great circles) for the alignment on the eastern side of the valley (*In-designation Alignment 1A*), and the dominant north facing cuts in Sector 9 (both *In-designation Alignment 1A* and *Preferred Alignment 1B*). The more frequent intersections of the great circles of shear surfaces (grey) between the great circles of cut slopes (red / blue) and the friction circles (black) indicate the greater potential for wedge and some planar failures in this case.

The NW facing cuts will apply only for the *In-designation Alignment 1A* on the eastern flanks of the Te Puka and Horokiri Valleys, but the N facing cuts (blue) in Sector 9 will apply for both alignments. The reliability of the assessment for Sector 9 is low given the very limited data on dip and orientation of shear surfaces currently available for Sector 9 (No acoustic televiewer data available for Sector 9). These will need to be considered further in design, potential wedges stabilised and managed during and after construction.

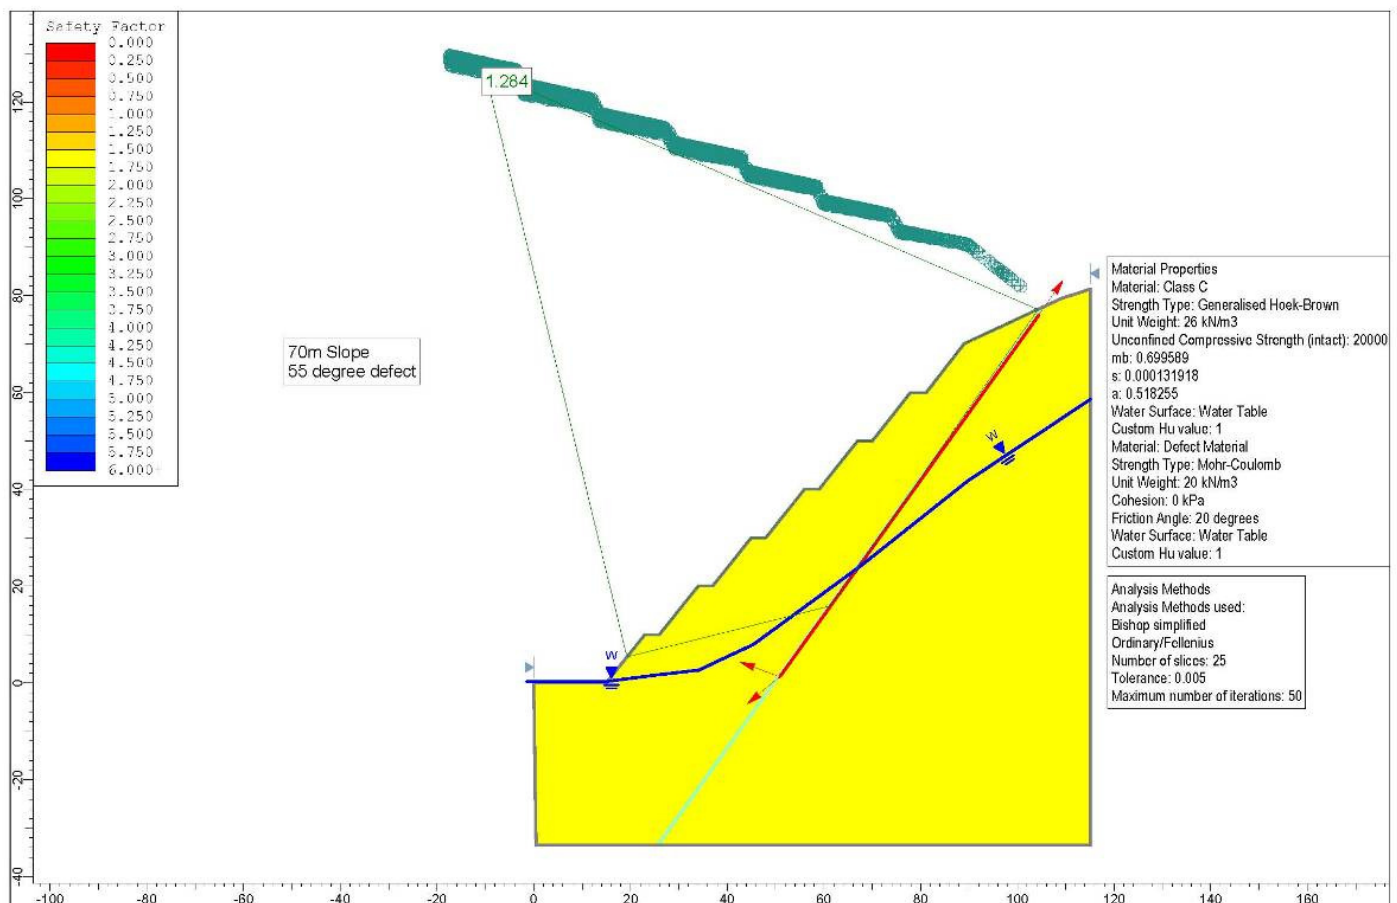
Illustration 3.17 - Typical Analysis of Combined Defect and Rock Mass Failures in Rock

Stability analyses using SLIDE indicate that the presence of dominant defects that do not daylight in the proposed cuttings can still reduce the stability of the high cuttings in rock, see Illustration 3.17. The analysis indicates that dominant defects closely behind cut faces could lead to failure during construction or under static conditions, particularly if high groundwater pressures exist in the slope. The risk of such failures can be reduced by drainage measures, such as sub-horizontal drainage holes, and in some cases rock anchors. The sizes of failures from defects close to the face are expected to be small. The influence of combined failures and the associated risks would be further considered on a site specific basis for the large cuttings in rock.

Defects further back from the slope may not lead to failure during construction or under static conditions unless they are located close to the cut face. However, they could lead to failure under strong earthquake shaking, which would reduce the stability of such slopes. This confirms the precedent based assessment in Section 12.6.2 that some earthquake induced failures can still be expected.

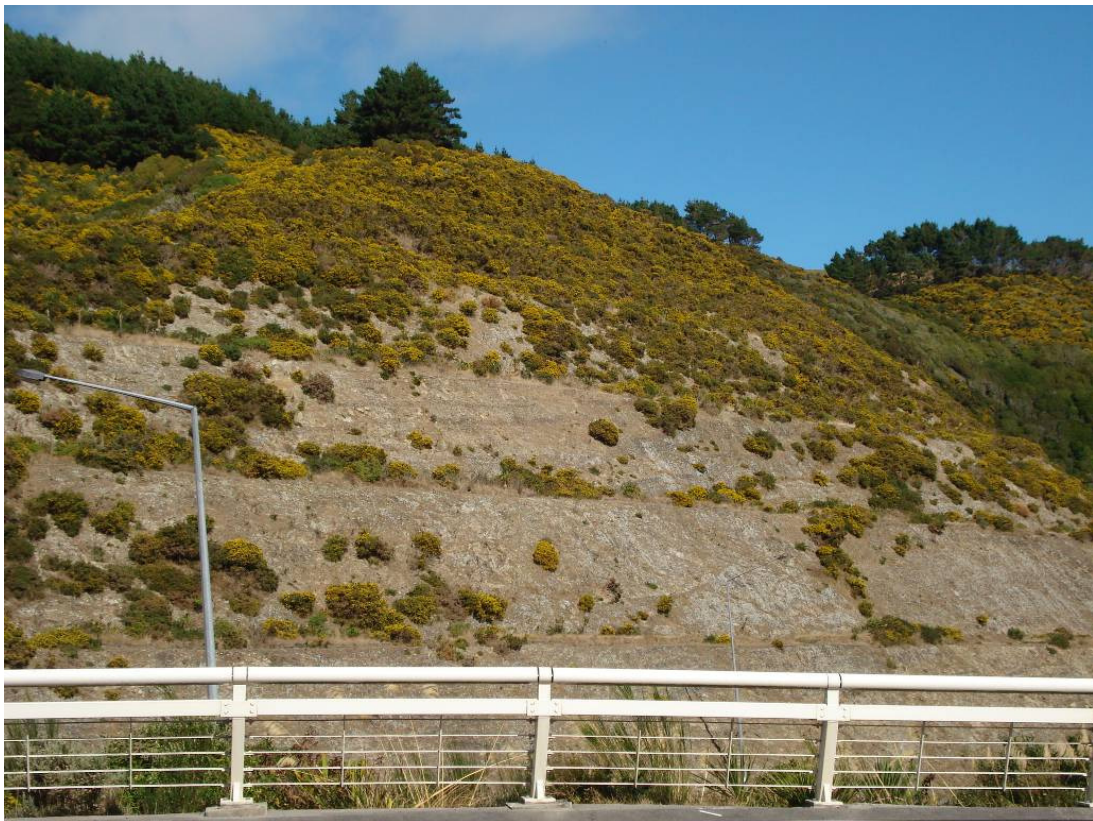
Illustration 3.19 - Benched Cut Slope in Wellington Greywacke at SH 1 Newlands Interchange

The cut slope configuration widely adopted in the Wellington Greywacke rocks in the region is to use 3 m wide benches at about 10 m height intervals, for example at SH1 Newlands Interchange, see Illustration 3.19. The photograph shows a benched cut slope in Wellington Greywacke rock similar to that likely to be encountered at Transmission Gully, 10 years after construction, showing excellent performance. The 50 m high cut slope was formed at a slope of about 50°, with 3 m wide benches at 10 m height intervals, giving an overall slope angle of 45°. The benches had a slight outward fall to ensure that the benches are drained and do not lead to accumulation of surface water.

This has provided excellent performance of cut slopes and has helped manage rock fall hazards, minimise erosion, and helped establish vegetation on the slopes to provide an attractive landscape in the medium to long term.

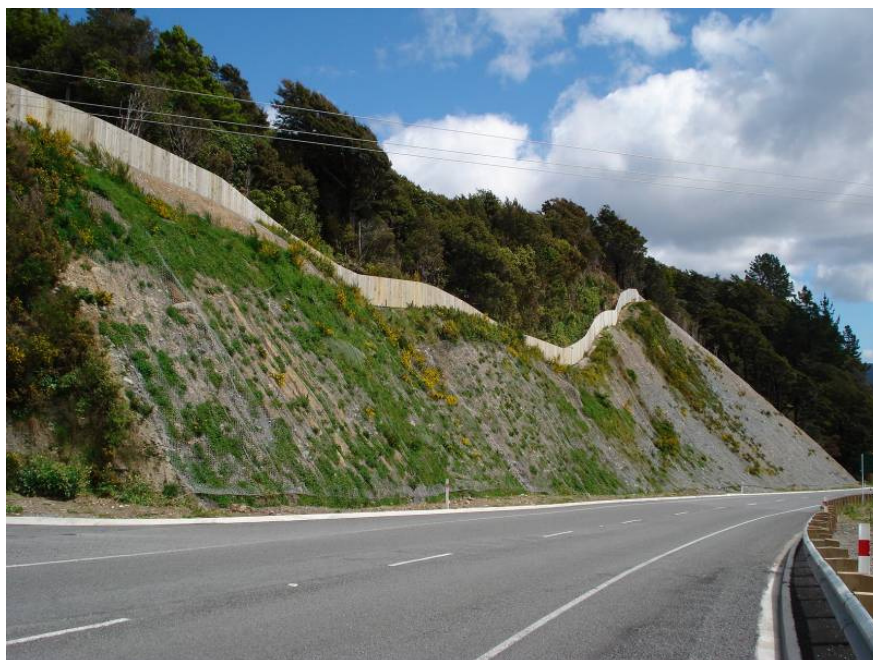
A slightly higher (moderate) level of hazard has been caused by steep cuttings in older alluvial gravel deposits (eg Kaitoke Gravels) which comprise coarse gravel, cobble and occasional gravel boulders in a sandy silt matrix. In some instances, rock fall protection netting has been installed to mitigate this hazard (eg SH 2 Kaitoke to Te Marua realignment).

Illustration 3.21 - Rock Fall Protection Netting at SH 2 Kaitoke to Te Marua

This would be relevant to cuttings formed in the dense gravels at the northern end of Te Puka Stream valley in Sector 2.

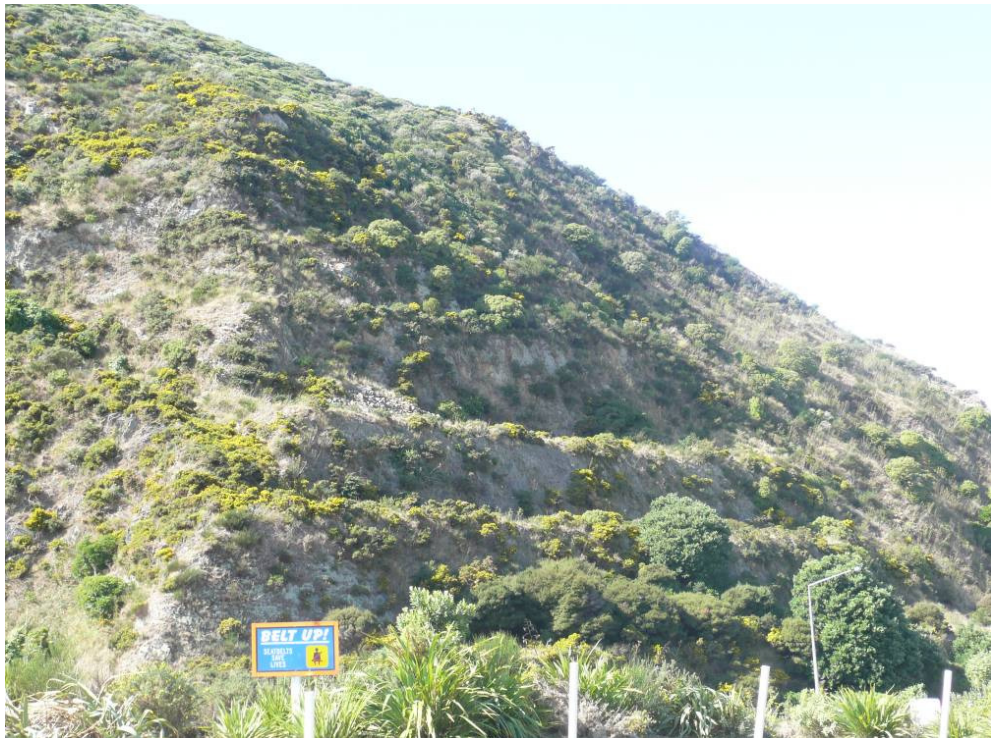
A disadvantage of this approach is that the benches are narrow and difficult to access after a period of time, for maintenance. However, the long experience of the use of benches in the Wellington Region, shows that this has not been a major issue. For example Illustration 3.23 shows a 1950's cutting over 50 years old and over 50 m high showing bench configuration with only significant rock accumulation at one location, and which is fully contained by the benches. Note that lower benches will provide additional capacity even if a bench overflows.

Illustration 3.23 - 1950's Cut Slope in Ngauranga Gorge, Wellington

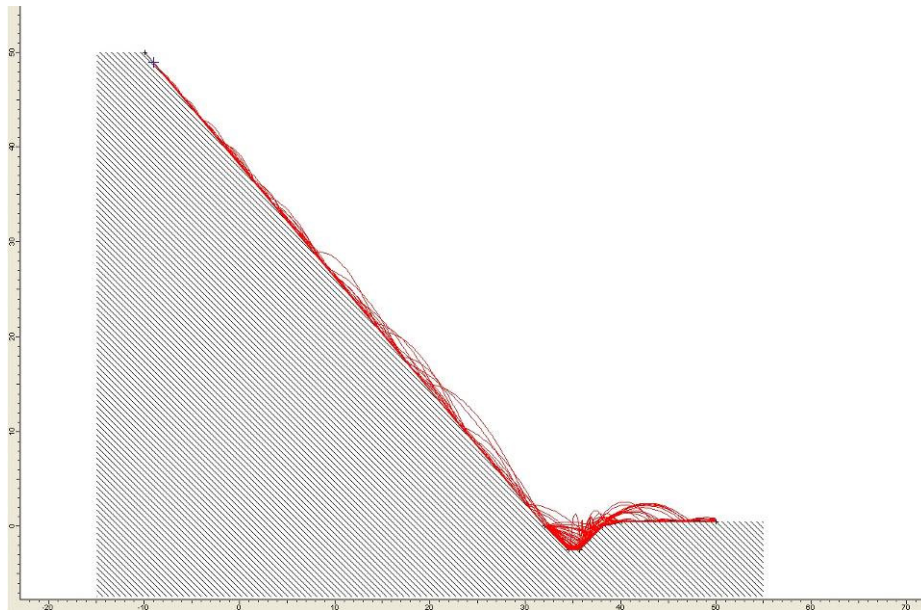
For comparison, a uniform cutting based of the North-American approach has also been analysed and indicates that even with the wide ditch at the base, it still leads to some residual rock fall hazard, and requires a rock fall fence at the base to make it effective. This is illustrated in Illustration 3.26.

Even with weathering in the long term, the uniform slope configuration is indicated to require a rock fall barrier at the base in the long term. Given that the ditch at the base will be maintained it has been assumed to not be vegetated in the long term.

Illustration 3.26 - Rock Fall Analysis with a Uniform Cutting with No Benches

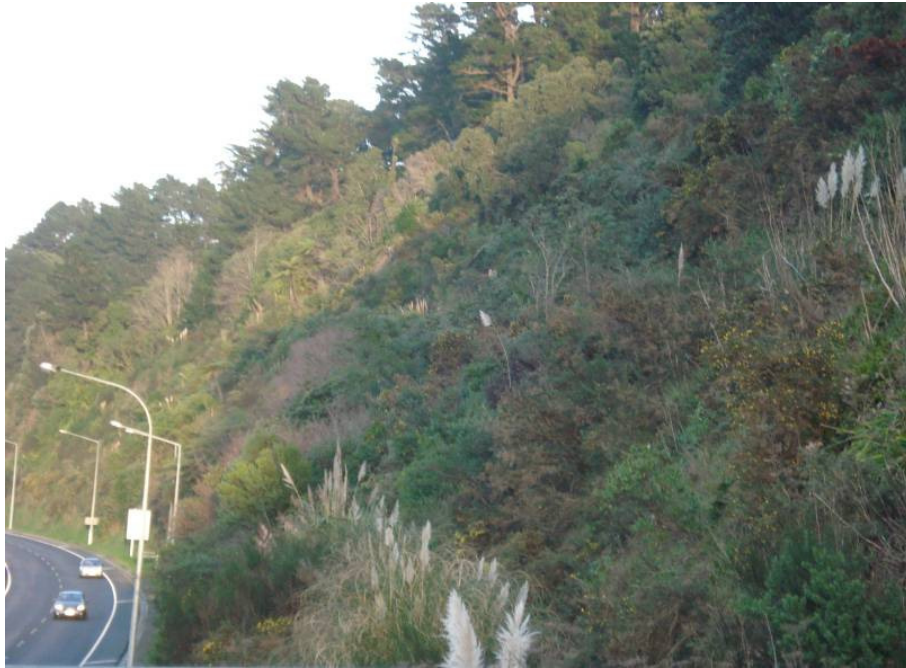
Illustration 3.27 shows a cutting in Wellington Greywacke rock, with intermediate benches, more than 40 years after construction. The cutting is well vegetated and there is no evidence of rock fall hazards. It shows that in practice, accessing the benches for frequent maintenance in the Wellington environment would not only be required, but would affect the beneficial established vegetation and has the potential to remove vegetation and hence initiate rock fall.

Illustration 3.27 - Rock Cutting with Benches along State Highway 2, after 50 Years

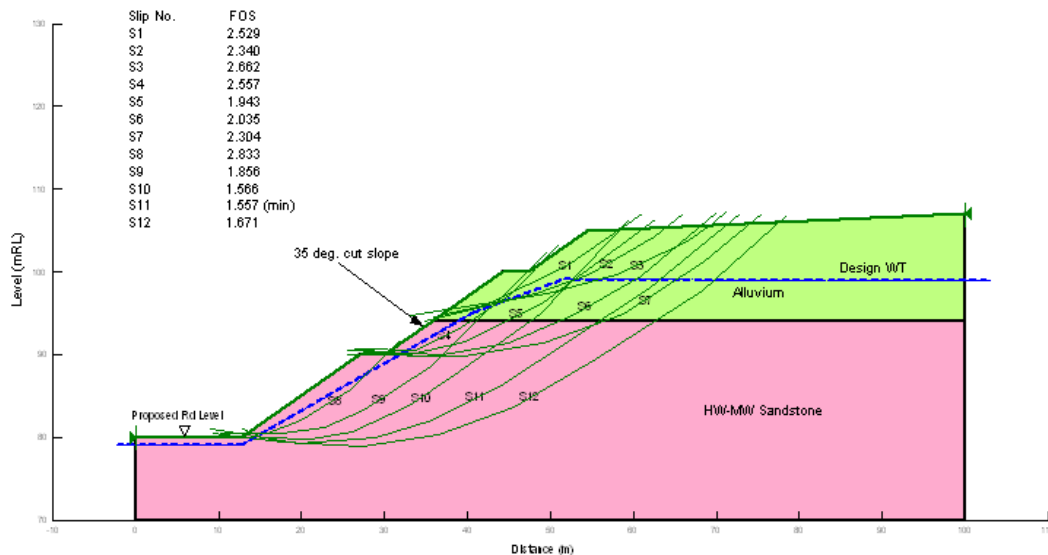
Stability analyses have been carried out assuming 15 m to 30 m high slopes formed at 35° slope with 3 m wide benches at 10 m height intervals in the Pre-Holocene alluvium in Sectors 5 and 6, and completely weathered greywacke in Sector 8. Groundwater level profile was at 5 m to 10 m depth based on observations. Representative soil parameters were chosen based on the laboratory test results. The analyses indicated that the commonly accepted factor of safety of 1.5 would be achieved under normal static conditions.

Illustration 3.28 shows results from a typical slope stability analysis in Pre-Holocene alluvium.

Illustration 3.28 - Typical Slope Stability Analysis of Cut Slopes in Soil

Should the groundwater level rise to 3 m depth reflecting wet or storm conditions, the factor of safety is indicated to drop to slightly less than 1.5 for the most critical surfaces, which is acceptable based on the design philosophy adopted, see Section 9.4. Existing landslides in Sector 6 confirm the potential for failure of slopes, which are likely to have been triggered by high groundwater conditions. Incorporation of sub-horizontal drainage holes and sub-soil drains at the toe of slopes, and in some cases at intermediate levels, is therefore considered to be important to maintain stability where high groundwater levels are present. Counterfort trench drains may also be appropriate in some cases with very high groundwater levels and weak soils. It may be necessary to form sections of the cuttings to a shallower 25° slope where weaker soils are encountered as can be expected from the variability of some of the alluvium units, or where higher cut slopes greater than 30 m height are proposed.

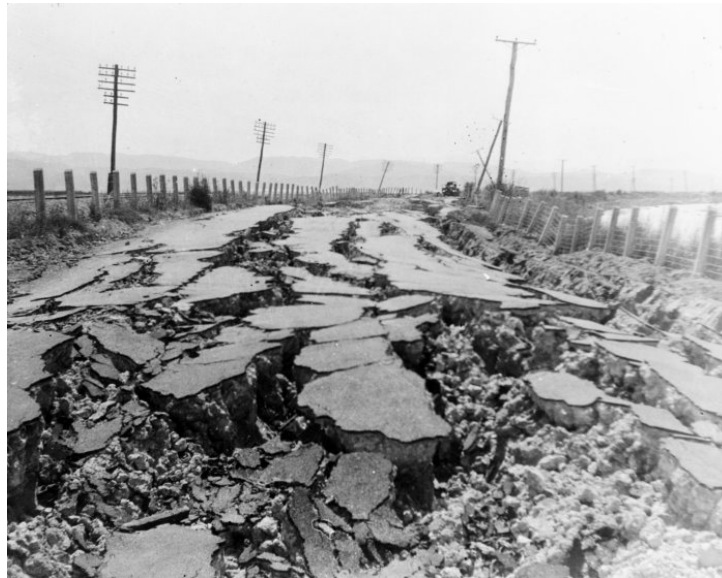
There is no precedent information on the earthquake performance of embankment slopes in the Wellington Region. There is also no readily available New Zealand evidence of failure of well engineered road embankments in earthquakes, except where they are constructed on liquefiable soils. Road embankments on liquefiable soils failed extensively through lateral spreading in the 1931 Hawkes Bay Earthquake, see Illustration 3.29.

Illustration 3.29 - Failure of Road Embankments due to Liquefaction in 1931 Hawkes Bay Earthquake
