5 TIMBER

5.1 GENERAL

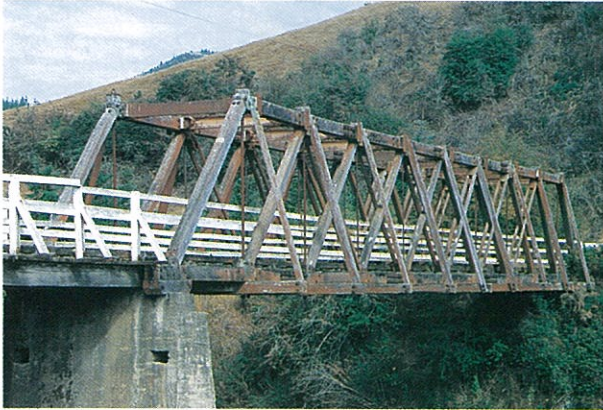
Figure 5.1: Timber truss bridge comprises timber members bolted together.

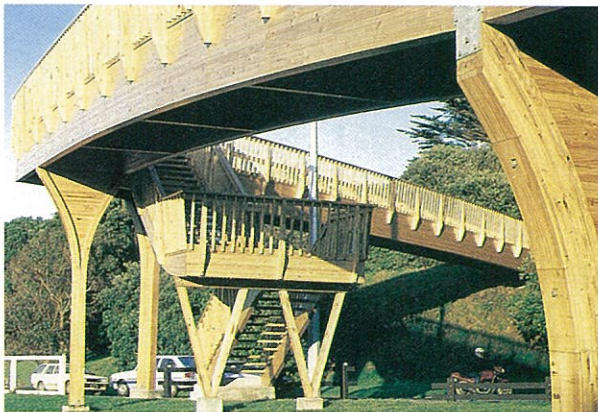
Figure 5.2: Laminated timber bridge has many small parts glued together.

Manufacture of large structural timber members by glue lamination from many smaller pieces has generated the resurgence of timber as a structural material for many types of construction including bridging. The process gives benefits of better penetration and treatment for durability, multimember load sharing for improved strength, elimination of physical defects, better drying and elimination of shrinkage defects, higher strength to weight ratio, lower temperature movements, versatility and enhancement of sizes and shapes, and enhanced natural appearance.

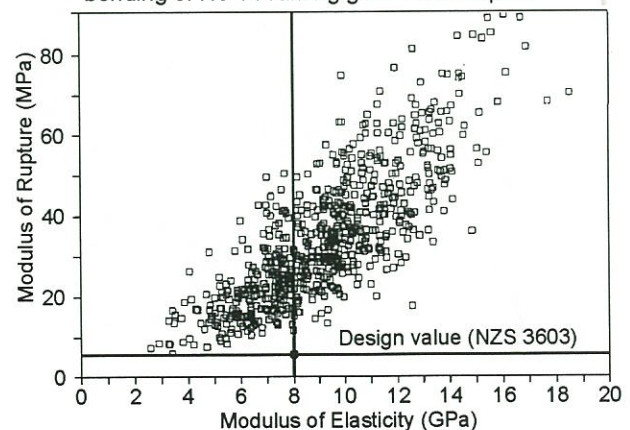
Relationship between strength and stiffness from in-grade bending of No 1 Framing grade radiata pine

Figure 5.5: The strength for one species of timber can vary by a factor of 10.

The strength of timber is very variable, and is influenced by orientation of cell structure, size of member and presence of defects. A strong piece may have up to ten times the strength and five times the stiffness of a weaker piece. Allowable code design stresses are based on the strength of the weakest pieces, and allowable stiffness is based on the average modulus of elasticity value.

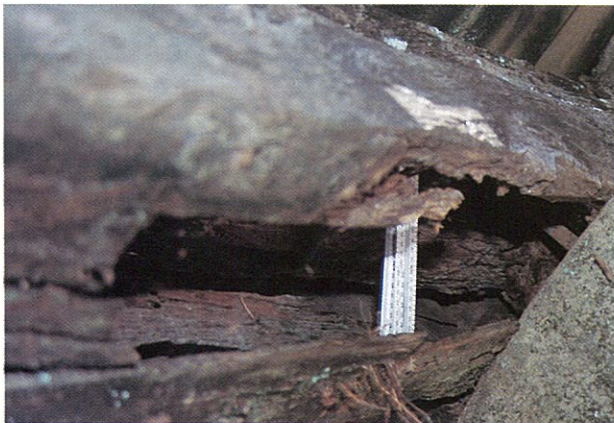
Figure 5.6: Decay is the most serious timber defect.

Decay is the most serious timber defect and is the main cause of timber bridge replacements. Decay is the rotting of timber as a result of fungal attack. The cellulose materials or wood sugars, the main constituent of timber, are a food source for a variety of fungi.

Advancement of decay requires the presence of fungal spores, oxygen, temperatures in the range 20°C to 30°C, moisture content greater than 20% and a non-durable timber food source. Durability depends on a number of factors including species, age and source. Treatment of softwood such as radiata pine to the appropriate hazard class (MP 3640:1992) is the best assurance of good durability for new timber.

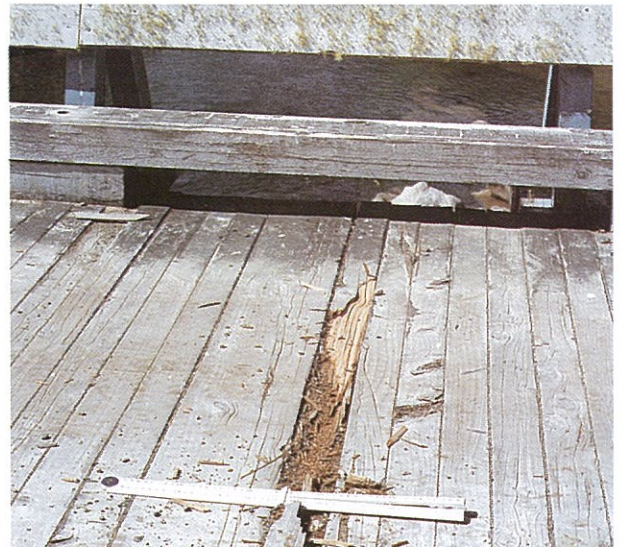
Figure 5.7: Decay in laminated macrocarpa deck after 10 years.

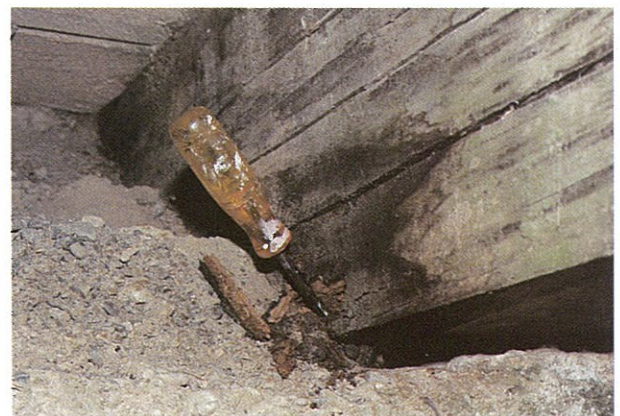
Figure 5.8: Accumulation of gravel, splits and advancement of decay at bearing area of timber beam.

Splits, (separations along the grain extending right through the member), checks (surface cracks on one side of a member), and shakes (cracks between annual growth rings), result from the weakness of timber to tension across the grain and differential shrinkage during drying.

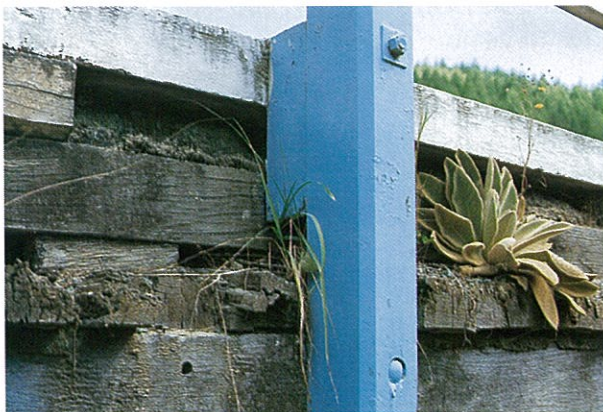
Figure 5.9: Drill hole, accumulation of road gravel, vegetation growth, and decay in deck planks.

Any holes, either from boring insects, nails, spikes, bolts, or drilling investigation, provide the means of access for the natural elements that cause deterioration of the surrounding timber cell structure.

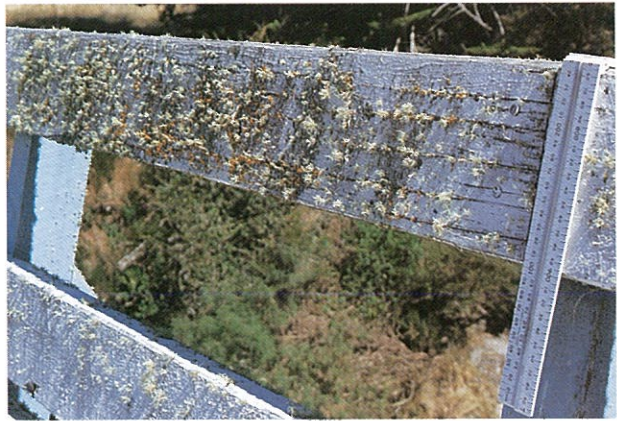
Figure 5.10: Splits in painted macrocarpa rail and moss growth after 10 years.

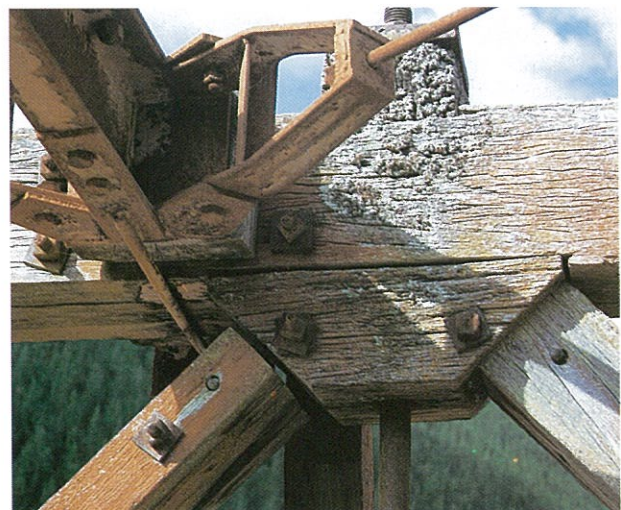
Figure 5.11: Joint defects: movement from compression, looseness of tension member, open holes from investigation drilling, corrosion of steel fixings, moss growth and decay.

Timber structures depend on members effectively connected together. Connections may involve holes, foreign materials such as bolts, and concentration of loads and stresses. They are a likely location of defects from crushing of the timber grain, chemical attack of the timber cell structure, corrosion of steel fixings, splitting of the timber member from the wedge action of nails and spikes, and decay from the access of moisture and oxygen into the joint.

Looseness, usually associated with movement in a joint or failure of spikes to hold members firmly, can lead to progressive deterioration of the structure and be hazardous to users.

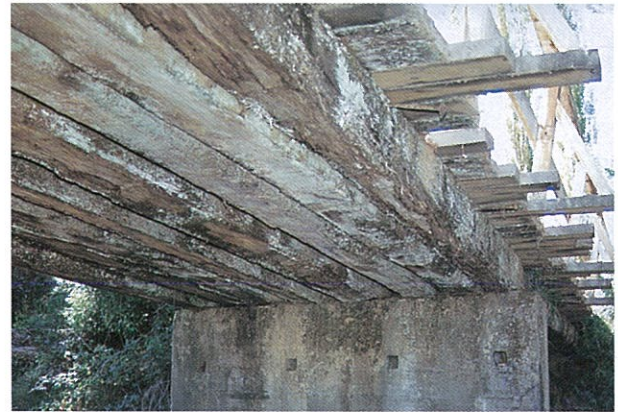
Figure 5.12: Old timber superstructure with an assemblage of beams.

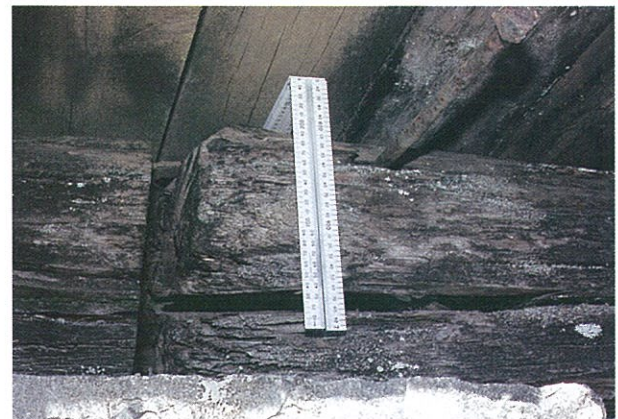
Figure 5.13: Large split at bearing area of beam greatly reducing load capacity in shear.

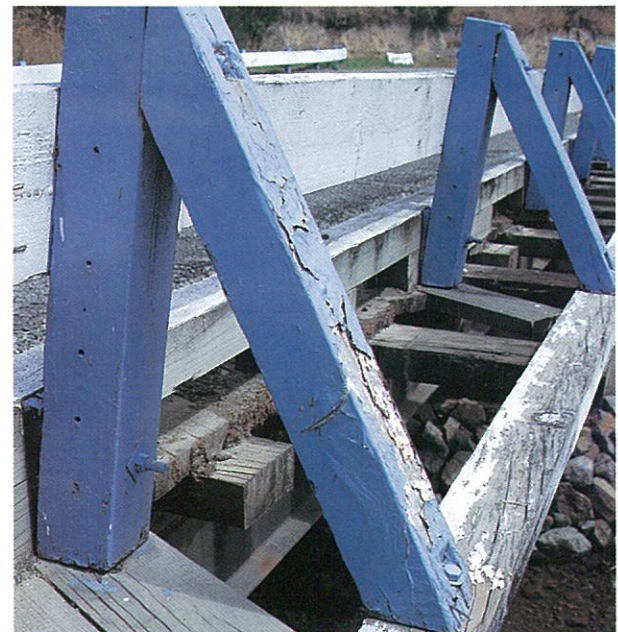
Figure 5.14: Maintaining a sound painted coating is a problem on old timber rails.

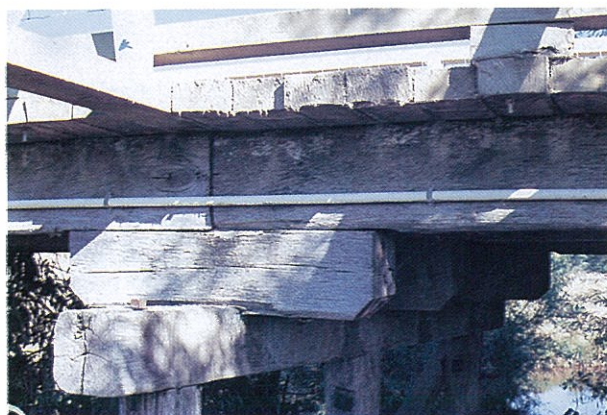
Figure 5.16: Old timber bridge with relatively new treated radiata pine decking.

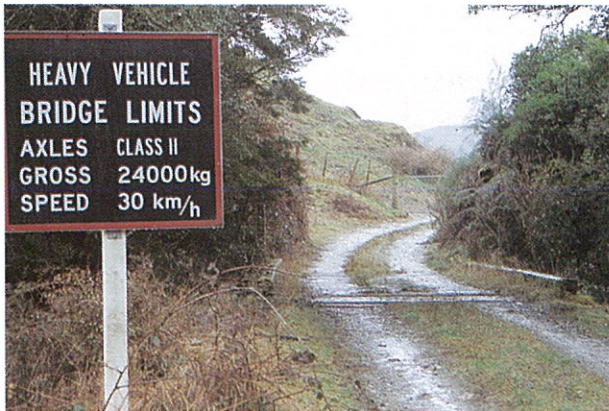
Figure 5.17: Old bridge with load restriction.

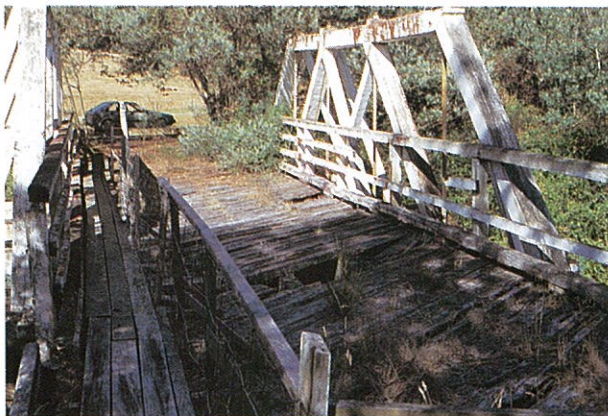
Figure 5.18: Old truss bridge beyond its life limit for vehicles. Some old bridges have a heritage value and deserve preservation, possibly for pedestrian use.

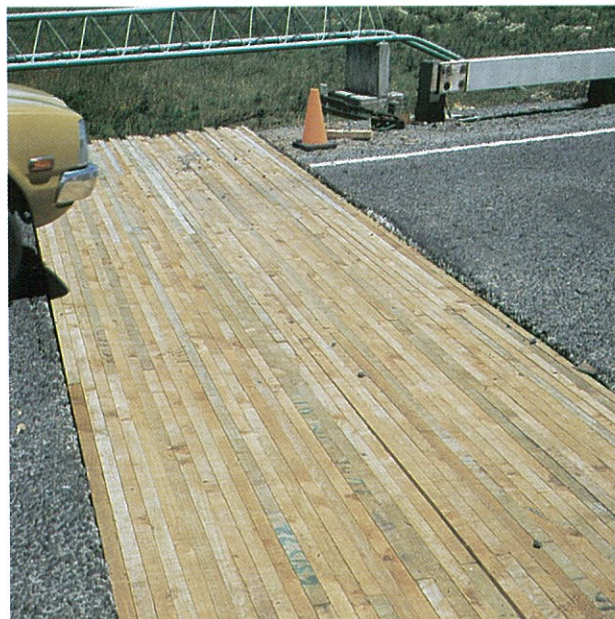
Figure 5.19: Replacement sections of radiata pine nail-laminated deck.

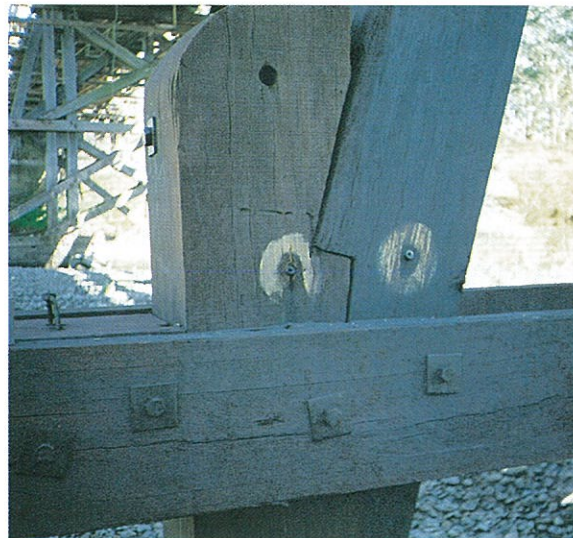
Figure 5.21: Repair to base of raking pier member.

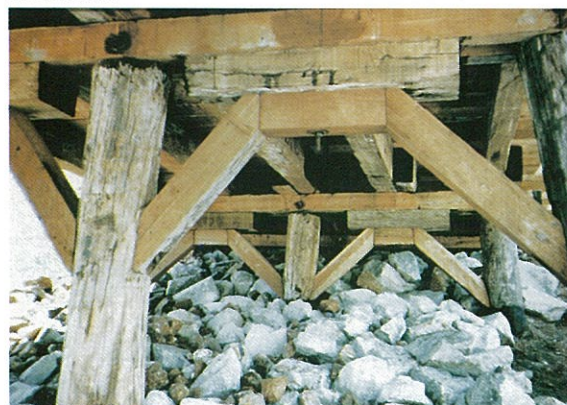
Figure 5.22: New bracing provides additional support to an old hardwood superstructure.

Occasionally it may be impractical to replace decayed members because of their location in the existing structure, but reinforcement with a parallel member or other bracing may be feasible. Because infection can spread from one member to another, untreated naturally durable hardwoods should not be used as reinforcement in close proximity to decayed members unless decay eradication procedures have been applied to the original member. Steel, preservative-treated softwoods, or concrete are preferred alternatives.

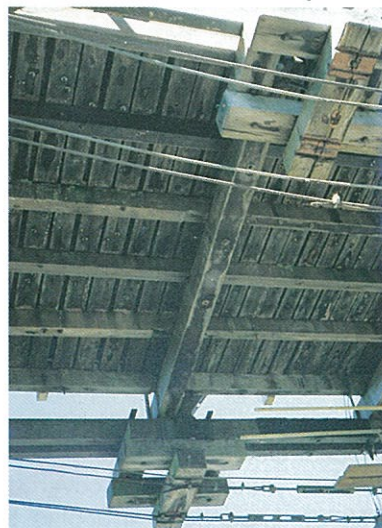
Figure 5.23: Reinforcement of truss with tensioned wire rope.

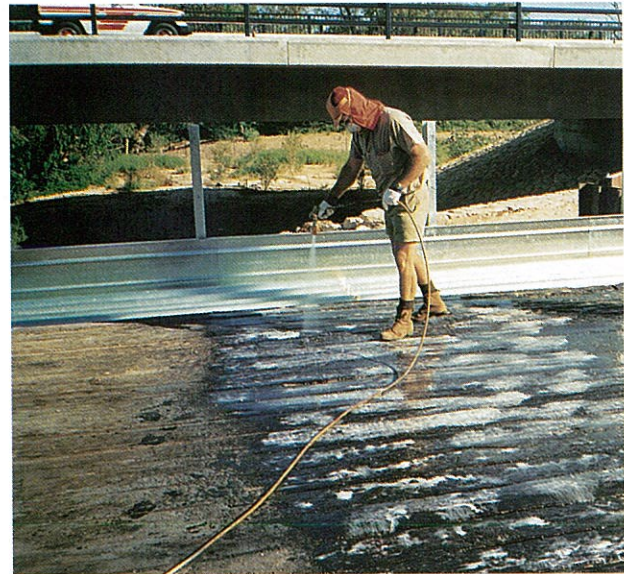
Figure 5.24: Application of diffusible fungicide (Boracol) prior to installing concrete overlay.

Several proprietary formulations are available. These are either gels or thick liquids based on fluorine, copper and boron salts, or fused rods of borate salts. Gels and liquids are applied to timber surfaces which are then covered for 5-6 weeks with an impervious wrapping to allow the chemicals to diffuse into the wood. Boron rods are inserted into holes drilled into the affected member and the holes are then sealed.

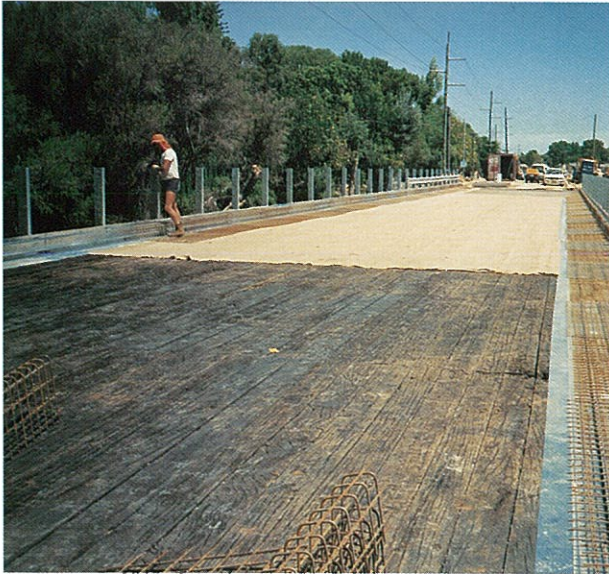
Figure 5.25: Preparation for concrete overlay.

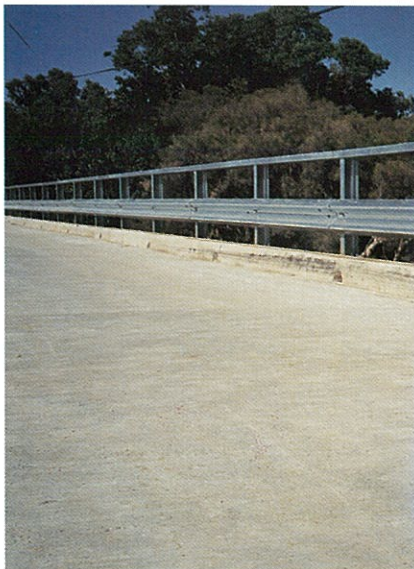
Figure 5.26: Concrete overlay complete.
