8 HARDWARE

8.1 DEFINITION

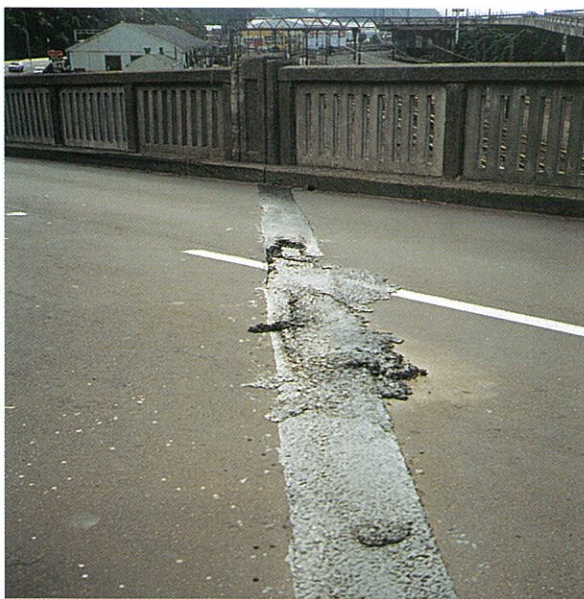
Figure 8.5: Asphaltic plug joint skewed to the traffic flow showing flow of joint material out of recess due to traction forces.

- Excessive depression in the wheel paths, generally caused by incorrect proportioning of aggregate to matrix or by using a matrix unable to cope with high ambient temperatures. In joints skewed to the direction of traffic flow, these deficiencies may also result in “flow” of the joint material along the joint under the traction forces exerted (Figure 8.5);
