Rockfall Protection Structures Maintenance Guideline

Waka Kotahi

June 2023

Rockfall Protection Structures Maintenance Guideline for Waka Kotahi Infrastructure

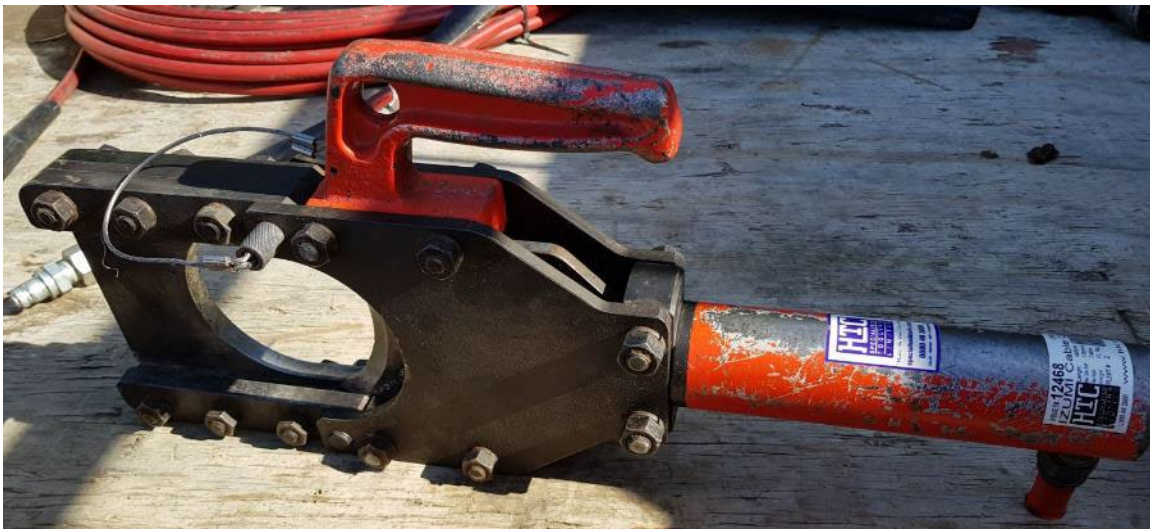
Image 2: An example of a remotely operated hydraulic wire rope cutter.

need to be cut in order to release the material - a remote cutter (see Image 2, page 14) should be used as the mesh may be under tension, and the material may release suddenly.

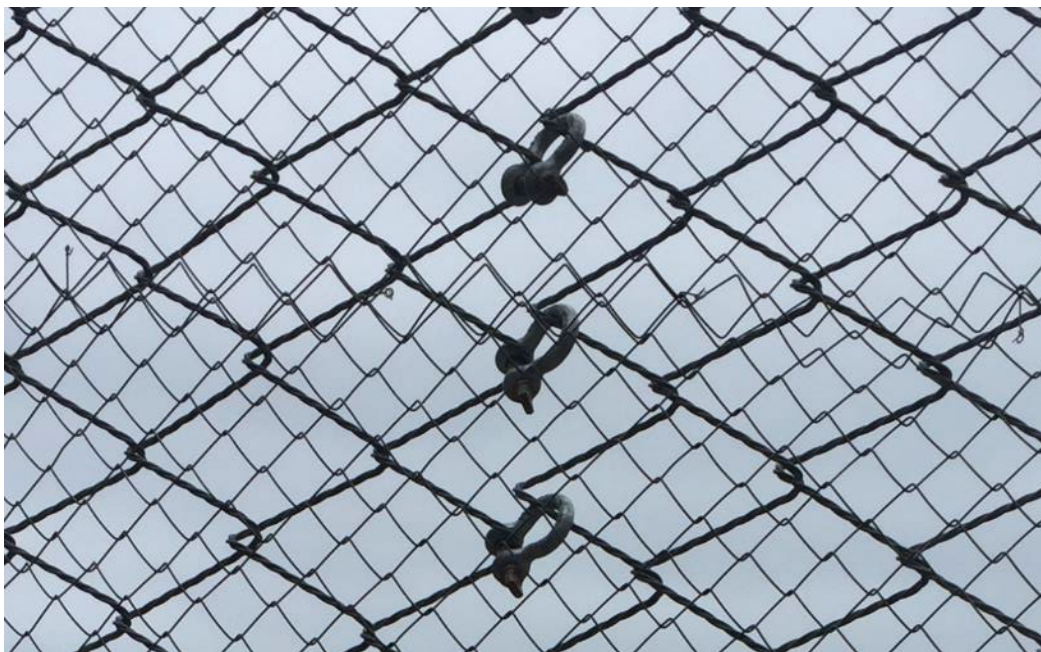
Image 5: Shackles used to connect two mesh panels.

Shackles are used on several systems for attaching critical components, such as mesh to mesh, see Image 5, or mesh to wire ropes. The critical aspects of the shackles that should be checked include:

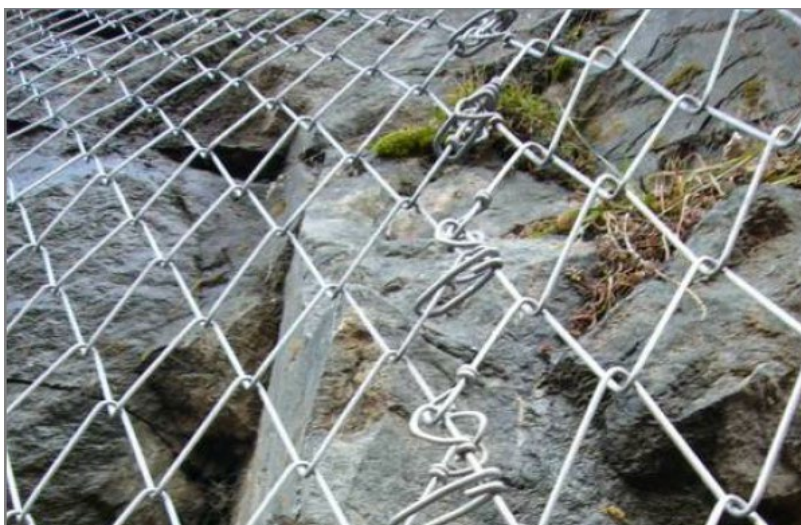
Image 6: Diamond Mesh, for example Geobruugg Tecco (Geobruugg, 2009)

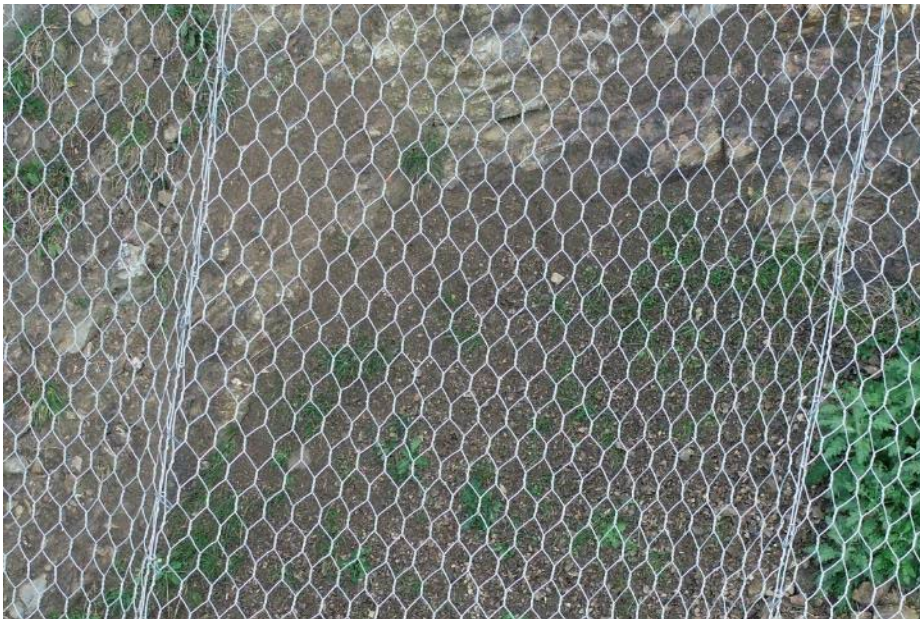
Image 7: Double Twist Mesh, for example Maccaferri DT Mesh

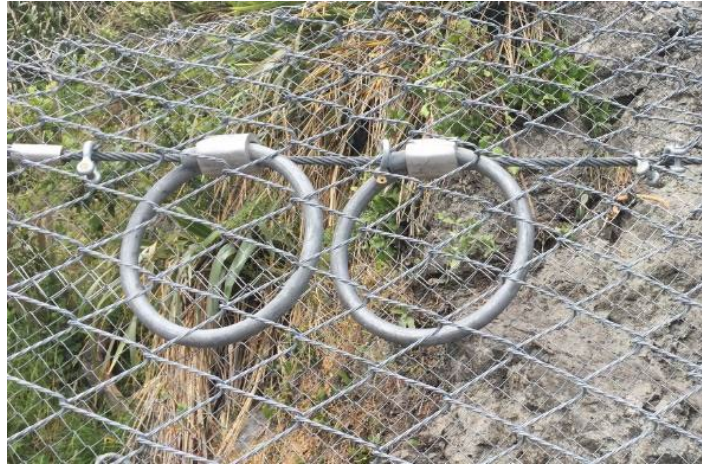
Image 8: Ring Brake

The maintenance criteria for ring-brakes is required if the elongation of the energy dissipaters exceeds a lengthening of 40cm or has greater than 50% elongation, or the height is reduced below the required design height, the brake element should be replaced.

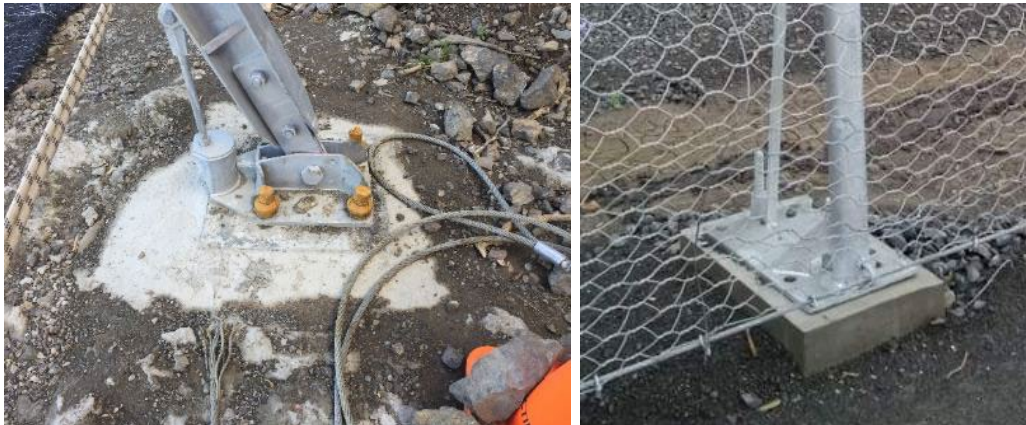
Image 9: A hinged post (left), a fixed post (right)

The steel posts form the supporting element of the rockfall barrier systems, posts generally come as fixed base posts or hinged flexible posts, see image below.

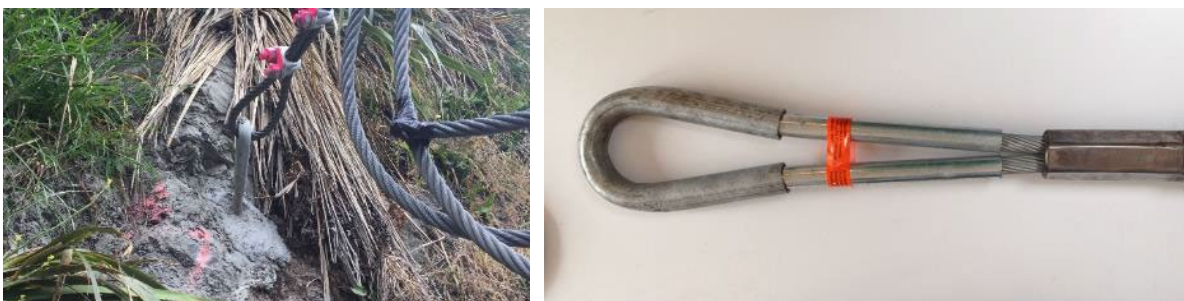
Image 10: An installed flexible anchor head (left), an example of a Geobrigg FLEXHead (right)

Additional to the bar anchors, head attachments are used within the high-energy rockfall barrier systems to provide connection for the support ropes to the anchorages.

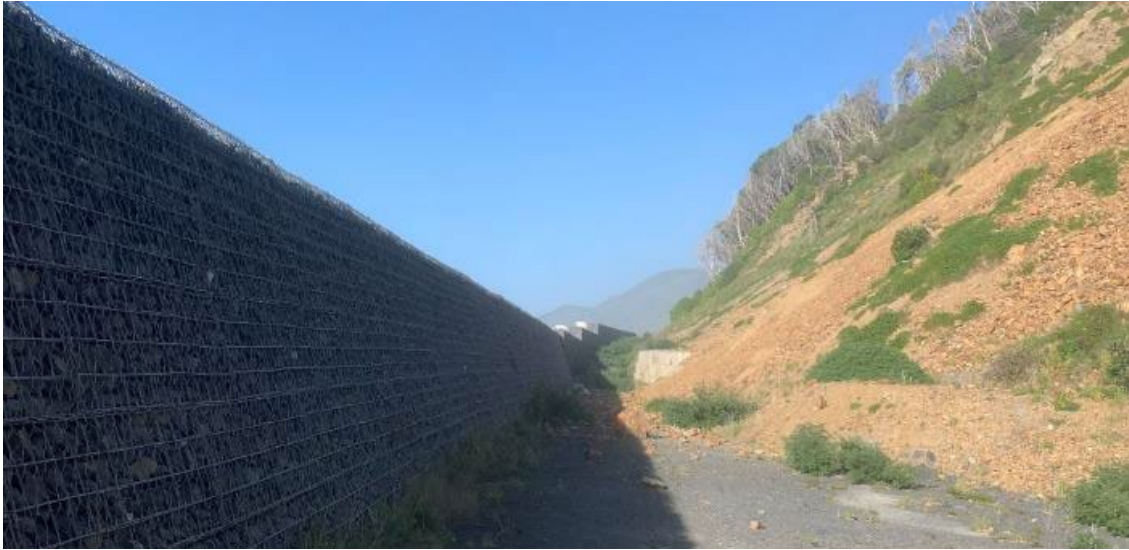
Image 11: A reinforced bund at the base of a slope

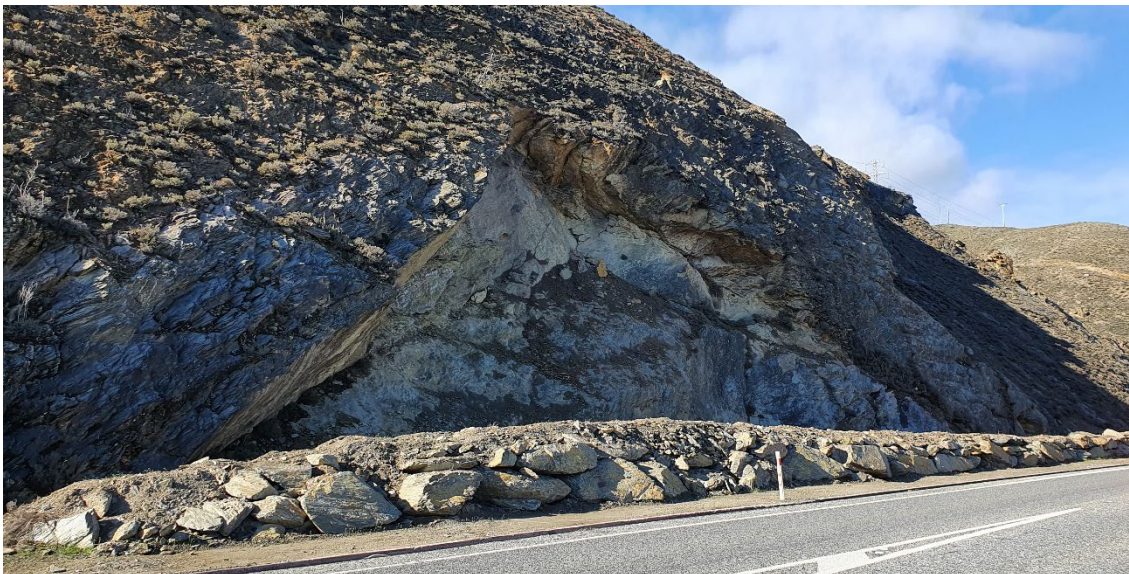
Image 12: An earth bund constructed from site won material

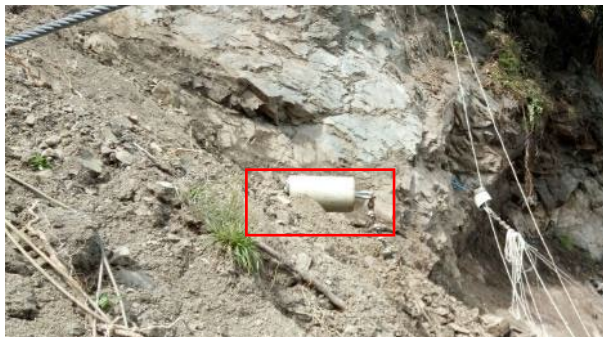
Component	Damage / Action	Reference Photo
Anchors		
Anchor	<p><i>Obvious damage to anchor head, however bending appears less than 15°</i></p> <p>Inspect anchor for pull-out and visible breaks in the corrosion protection. Undertake additional acceptance testing in accordance with BS EN 1537 to check load-bearing capacity is sufficient.</p>

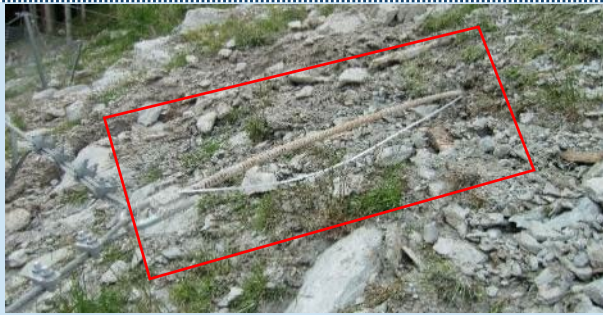
Anchor	<p><i>Anchor has pulled out a distance greater than 30mm (in this case almost 1m).</i></p> <p>Replace anchor – consideration will need to be given to the new location to avoid influence of the surrounding damaged ground. Consult geo-professional.</p>

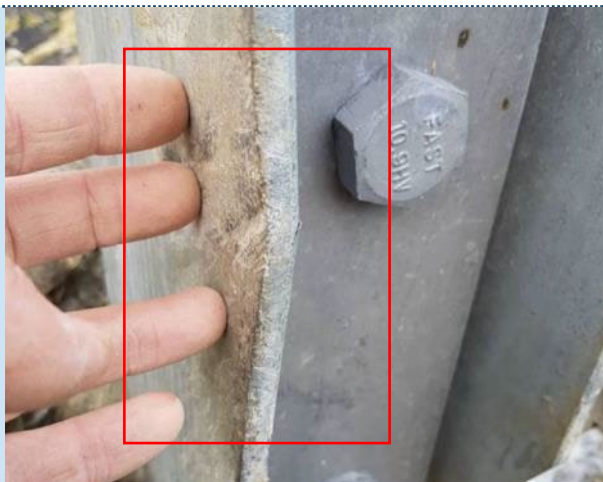
Posts		
Post	<p><i>Post has been impacted by debris causing a bend in the flange of the post, and cracking of the galvanising / corrosion protection.</i></p> <p>Bending of post is less than 15°, and damage is localised to the post flange – check with manufacturers guidance and use wire brush to remove flaked galvanising, re-paint area with zinc-epoxy anti-corrosion coating in accordance with AS/NZ 2312.</p>

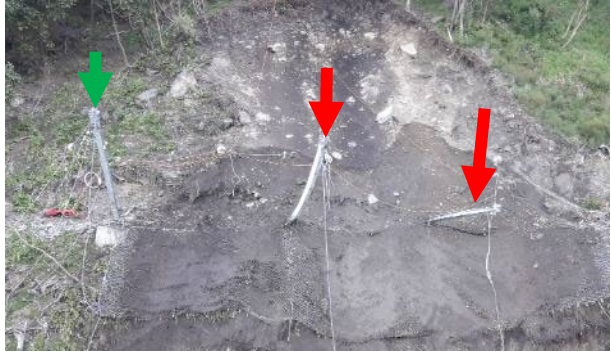
Component	Damage / Action	Reference Photo
Post	<p><i>Posts have been damaged following impact. Furthest left post has not sustained rotation or bending. Middle post is bent greater than 15° near the base. The right most post has lateral rotation in excess of 10°.</i></p> <p>Replace the middle and right posts with new posts, check anchors and foundations. Check the left most post for damage to corrosion protection – re-paint/repair as required.</p>

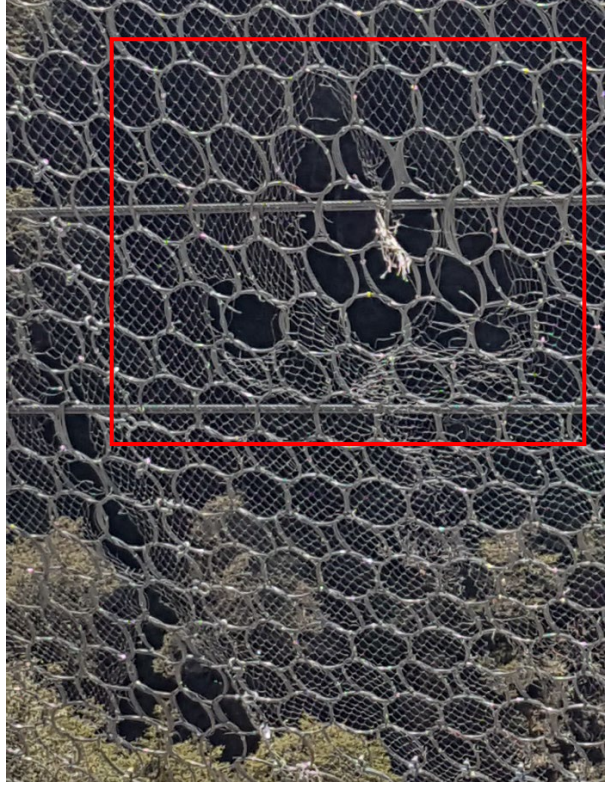
Mesh		
Secondary Mesh	<p><i>Isolated sections of damage and tearing of the secondary mesh due to impact from boulders.</i></p> <p>Sections of damage are relatively small. The areas can be patched. Secondary mesh patches can be laid over the damaged area and fastened to the mesh with steel wire ties in accordance with manufacturers guidance. Care should be taken to fasten the patch to intact mesh, ensuring it is aligned and each boundary diamond is connected.</p>

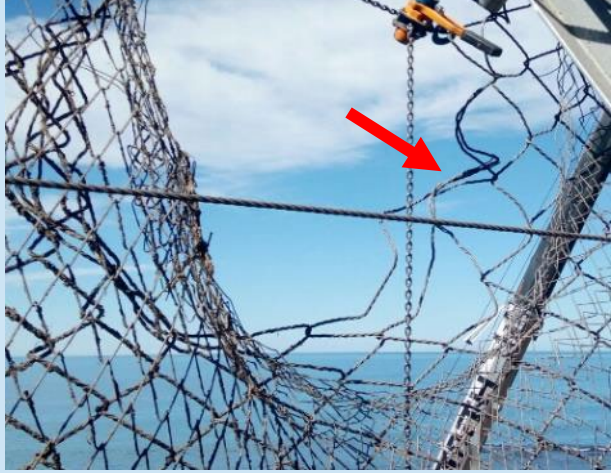
Diamond Mesh	<p><i>Isolated section of diamond mesh has been distorted out of shape, due to either impact or material loading.</i></p> <p>As section of distorted mesh is relatively small, the panel can be repaired. A corresponding sized section of diamond mesh can be laid over the damaged area and fastened to the intact mesh diamonds using shackles in accordance with manufacturers guidance.</p>

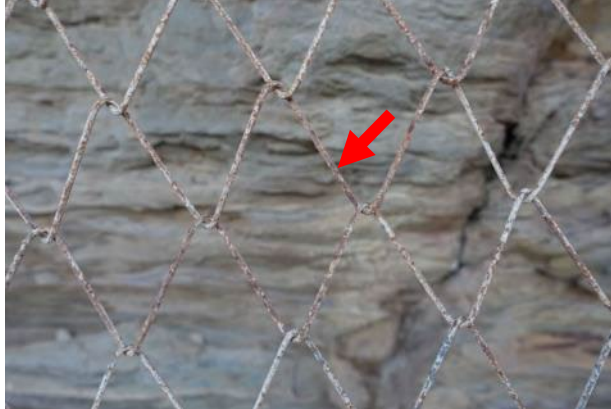
Component	Damage / Action	Reference Photo
Diamond Mesh	<p><i>Corrosion observed to be developing on the diamond mesh.</i></p> <p>As greater than 10% of the total surface area is visibly corroded, the diamond mesh will need to be replaced. As the corrosion is isolated to a single panel. Replace the single mesh panel in accordance with the manufacturers' documentation.</p>

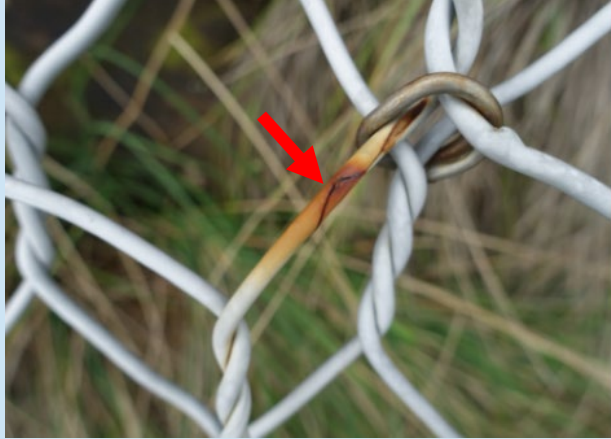
Double Twist Mesh	<p><i>Corrosion observed to be developing behind the PVC coating on double twist mesh.</i></p> <p>As less than 10% of the total surface area is visibly corroded, the mesh does not require replacement, but should be monitored for change.</p>

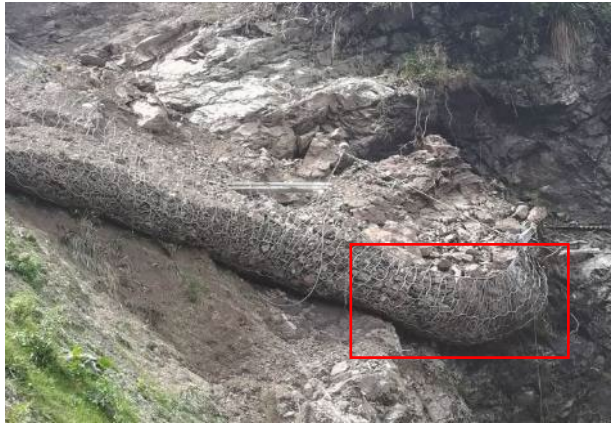
Ring-Net	<p><i>Panel of ring-net is heavily distorted by fence being fully loaded following large impact event.</i></p> <p>Once debris is released, inspect the ring-net. If non-plastic deformation only and no breaking of rings, the panel does not need repairing.</p> <p>If damage to 1 – 8 rings the ring-net panel can be patched. If greater than 8 rings damaged, then the entire panel should be replaced.</p> <p>Note: In this case the ring-net was only distorted with no breaks – therefore it was re-used in the reinstated fence following debris removal.</p>

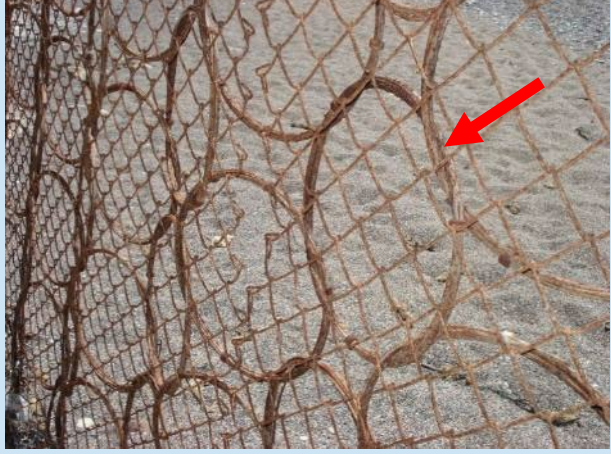
Component	Damage / Action	Reference Photo
Ring Net and Secondary Mesh	<p><i>Significant corrosion visible on both ring-net and secondary mesh.</i></p> <p>Both the ring-net and secondary mesh panels will require replacement. Consideration should be given to using a higher-level of corrosion protection as the corrosive environment may be more severe than anticipated.</p>

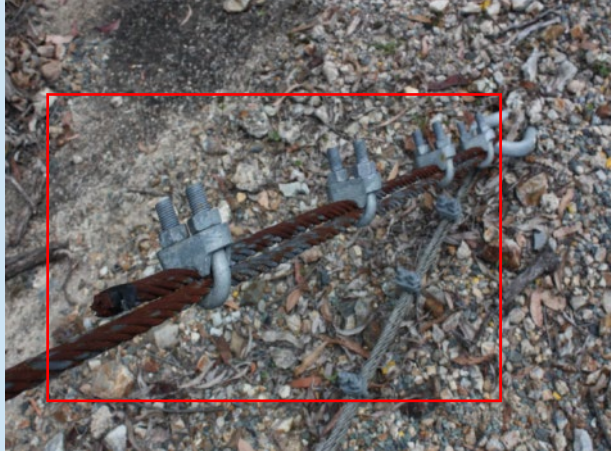
Steel Rope		
Steel Rope	<p><i>Steel rope is visibly rusted and covers a significant area. Steel rope is likely to be the most prone to corrosion. In addition, the wire rope grips have been installed incorrectly.</i></p> <p>As greater than 10% of the cross-sectional area and total surface area appears to be visibly corroded, the steel rope will need to be replaced. (Note: if the section of corrosion is very isolated <10% of the total length, it can be patched/spliced.) Repair or replace the rope in accordance with the manufacturers' documentation. Install wire rope grips in correct orientation.</p>

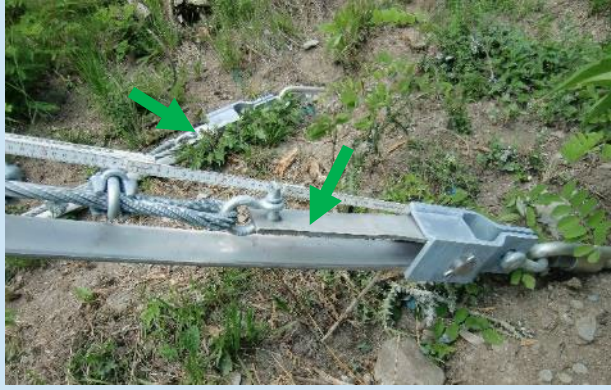
Brake Elements		
U-Brake	<p><i>The U-brake in the background has not moved. However, the U-brake in the foreground has moved and been activated roughly 300mm.</i></p> <p>The energy dissipating U-brakes can be activated up to 600mm before requiring replacement. Therefore, no action is required other than to monitor the fence for further impacts.</p>

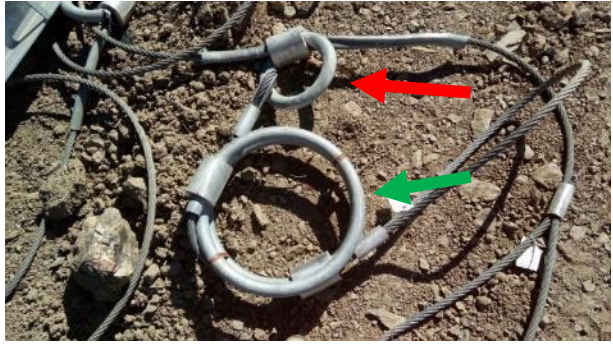
Component	Damage / Action	Reference Photo
<p>Brake Ring</p>	<p><i>Brake rings following an impact on the fence. The brake ring at the bottom of the photos has not been activated, while the brake ring at the top of the photo has been activated.</i></p> <p>The activated brake ring exceeds the acceptable limits of 50% lengthening (~400mm elongation) and requires replacement. If the steel rope in the non-activated brake ring is undamaged it can be re-used in the reinstated fence.</p>

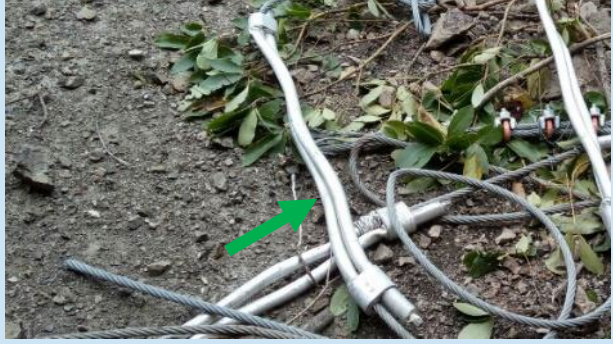
<p>Energy Dissipater Device (EDD)</p>	<p><i>Deformation of EDD observed, following activation due to impact of rockfall fence.</i></p> <p>The shortening of the EDD is less than 20% of the original length, therefore no replacement is required. The EDD should be monitored for any increased corrosion due to minor deformation.</p>

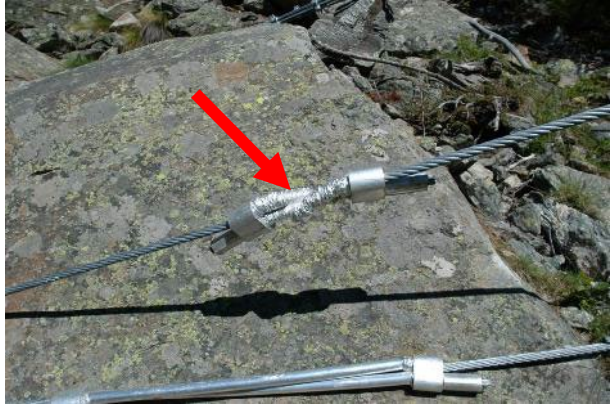
<p>Energy Dissipater Device (EDD)</p>	<p><i>Deformation of EDD observed, following activation due to impact of rockfall fence.</i></p> <p>The EDD has been completely activated with no remaining dissipater length. The EDD will need to be replaced with a new dissipater.</p>

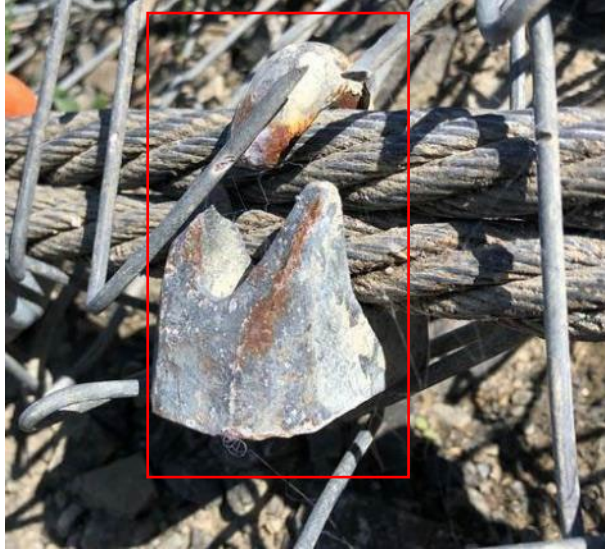
Component	Damage / Action	Reference Photo
Accessories		
Wire Rope Clip	<p><i>Obvious visible corrosion and failure of wire rope clip.</i></p> <p>The wire rope clip is broken and no longer holding the wire rope. The wire rope clip should be replaced.</p> <p>It is reasonable to assume that corrosion may have developed on other wire rope clips – spot check all other wire rope clips for visual signs of corrosion and/or damage. Consider checking the required torque is met on ~20% of the wire rope clips within the system.</p>

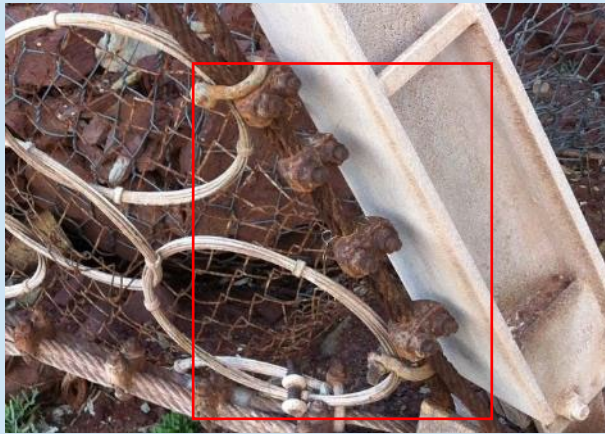
Wire Rope Clip	<p><i>Wire rope and wire rope clips are significantly corroded. Both require replacement.</i></p> <p>In some-cases minor corrosion may be tolerated, as long as the rust is only surficial, and the wire rope clip is checked to meet the required torque.</p> <p>It is reasonable to assume that corrosion may have developed on other wire rope clips – spot check all other wire rope clips for visual signs of corrosion and/or damage. Consider checking the required torque is met on ~20% of the wire rope clips within the system.</p>

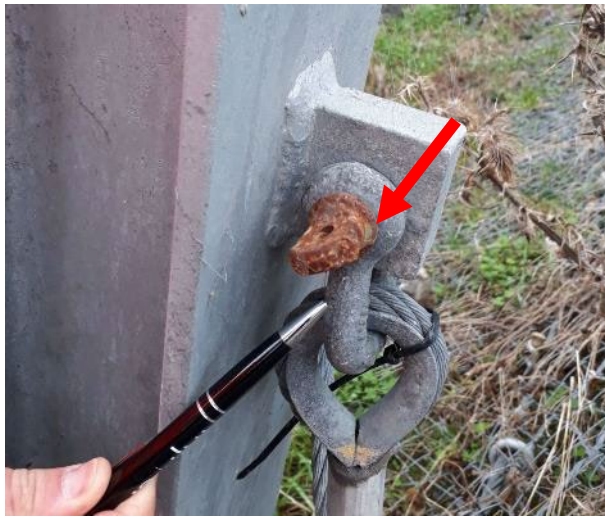
Shackles	<p><i>Visible corrosion observed on shackle.</i></p> <p>Rust appears to be surficial, check the shackle is able to open and close, if functional then no replacement is required, but monitor for changes. If the shackle is not functional, it will need to be replaced.</p> <p>It is reasonable to assume that corrosion may have developed on other shackles – spot check for visual signs of corrosion on all other shackles. Check functionality of any shackles visibly corroded.</p>

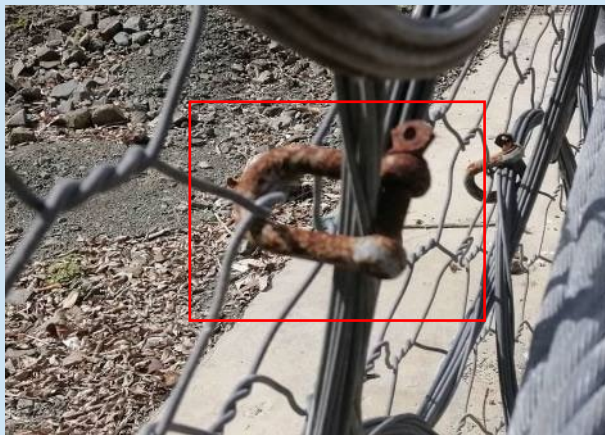
Component	Damage / Action	Reference Photo
Shackles	<p><i>Significant visible corrosion observed on shackle.</i></p> <p>The shackle is unable to open due to corrosion of the screw. The shackle should be replaced with the same size shackle in the same location connecting to the same elements.</p> <p>It is reasonable to assume that corrosion may have developed on other shackles – spot check for visual signs of corrosion on all other shackles. Check functionality of any shackles visibly corroded.</p>

<p>A close-up photograph of a metal shackle attached to a steel cable. The shackle is heavily rusted and appears to be stuck. A red rectangular box highlights the shackle.</p>
Spike Plate	<p><i>The mesh and spike plate have become loose – the spike plate is no longer tight against the mesh and is not horizontally aligned.</i></p> <p>The spike plate should be checked for damage and visible signs of corrosion. The spike plate can be re-used if corrosion covers less than 10% of the surface area (if greater than 10%, the spike plate should be replaced). Re-align the spike plate to horizontal and tighten the nut to the pre-tensioning torque as per design.</p>

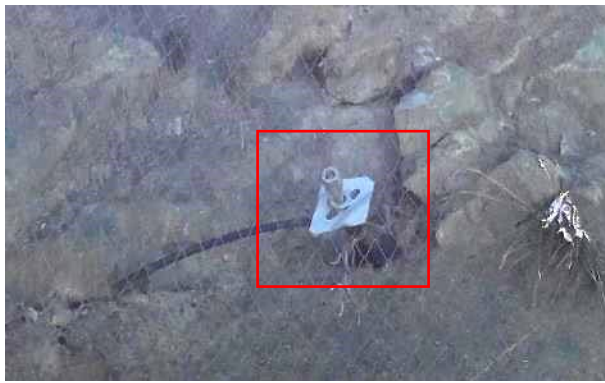
<p>A photograph showing a spike plate attached to a mesh structure. The spike plate is tilted and not horizontal. A red rectangular box highlights the spike plate.</p>

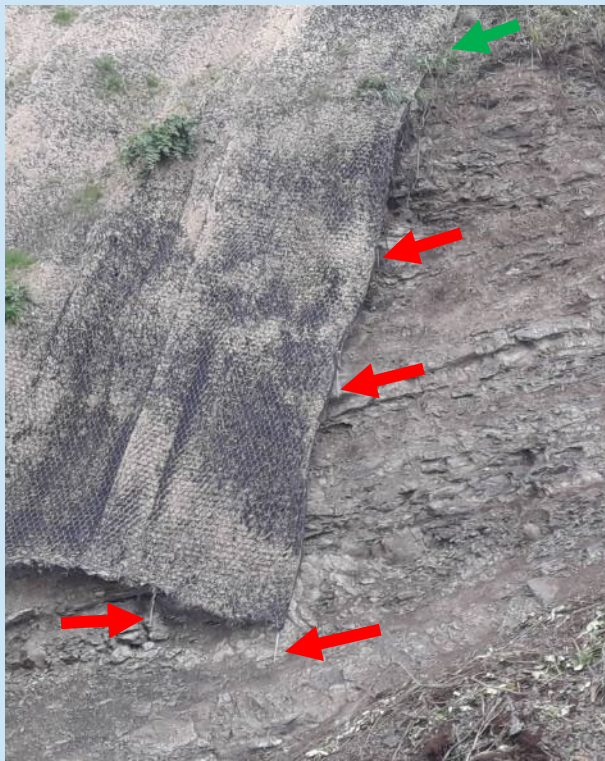
MacMatR pins	<p><i>Several of the steel pins securing the erosion protection matting to the slope are observed hanging from the mesh and no longer connected to the slope.</i></p> <p>As the pins have pulled out by greater than 30mm and more importantly are no longer connected to the slope they should be reinstalled. The pins should be checked for any bending or breaks. If bending is greater than 10° or obvious damaged is observed the pins will need to be replaced.</p>

<p>A photograph of a slope covered in erosion protection matting. Several steel pins are visible, some of which are hanging from the mesh and not connected to the slope. Red arrows point to the hanging pins, and a green arrow points to a pin that is still connected to the slope.</p>

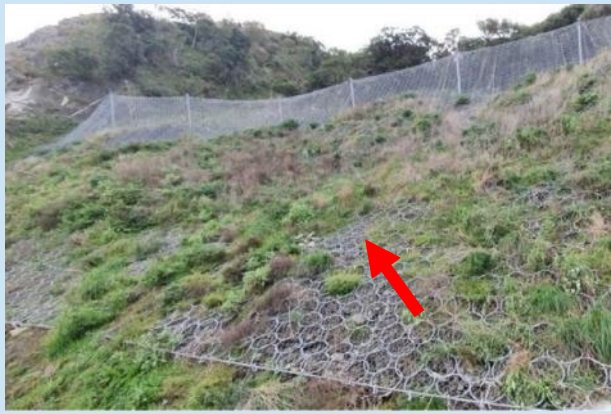
Component	Damage / Action	Reference Photo
Other		
Vegetation Growth	<p><i>Vegetation regrowth within active mesh may prove to be beneficial in improving the overall stabilisation.</i></p> <p>However, vegetation in rockfall fences, drapes, and hybrid fences (attenuators) that inhibits the movement of the mesh and has the potential to entrap material upslope should be cut-back.</p> <p>Consideration should be given to spraying any chemicals as it may adversely affect the corrosion protection coating of the system.</p>

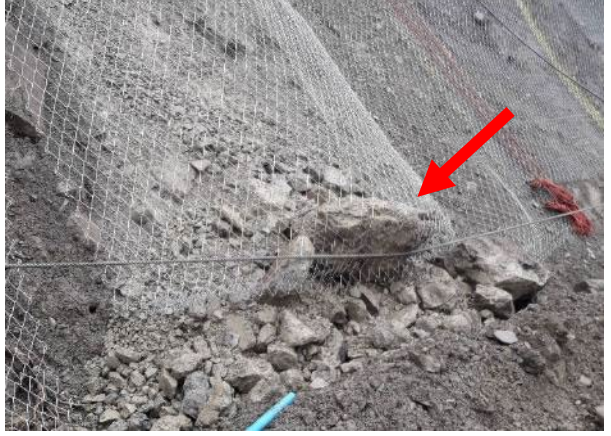
Debris Accumulation (Mesh)	<p><i>Material has accumulated beneath a mesh drape; the debris is bulging and has distorted both the mesh and bottom wire rope.</i></p> <p>As material is distorting the mesh, and the debris catch area is more than 1/3 filled, clearance will be required.</p> <p>An inspection by a geotechnical engineer will be required prior to clearance and reinstatement of the system.</p>

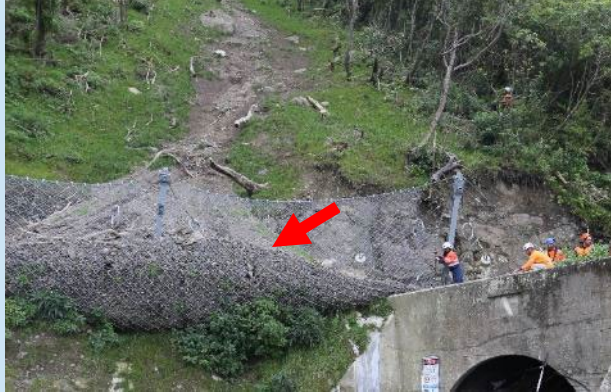
Debris Accumulation (Fence)	<p><i>Material has accumulated to approximately 1/2 to 2/3 the height of the barrier. Both the SPIDER and secondary mesh are visibly distorted.</i></p> <p>As material is greater than a 1/3 in height and the mesh is being distorted clearance is required.</p> <p>An inspection by a geotechnical engineer will be required prior to clearance and reinstatement of the system.</p>

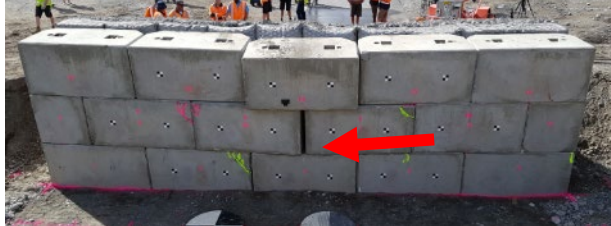
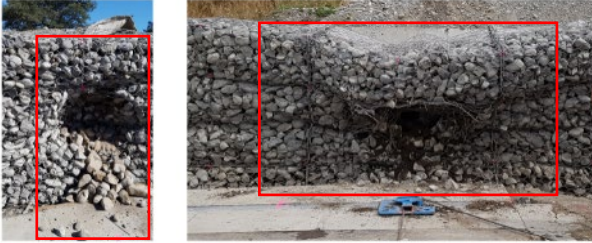
Debris Impact (Modular Rockfall Protection Wall)	<p>An impact into the Modular Rockfall Protection Wall has created the concrete blocks to move and the gabions to be visibly damaged.</p> <p>As the concrete blocks have greater than 50mm displacement, realignment of the blocks will be required – check supporting bars are not bent. There has been significant penetration >200mm with damage to the gabions and likely the sand filled</p>

Component	Damage / Action	Reference Photo
	<p>geotextile layer – both layers will need replacing.</p> <p>An inspection by a geotechnical engineer will be required prior to clearance and reinstatement of the system.</p>

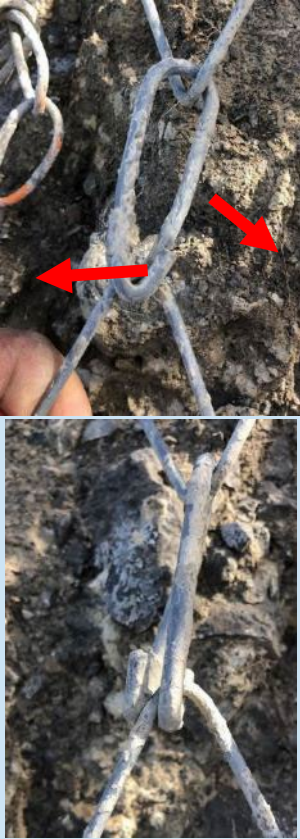
<p>Missing / Incorrect Components</p>	<p><i>A TECCO T3 clip is incorrectly attaching two sections of mesh.</i></p> <p>Missing and incorrect components should have been captured and resolved upon the completion of construction; however, some minor insufficiencies or incorrectly installed components may be found during maintenance. These should be resolved in accordance with the manufacturers' documentation.</p>

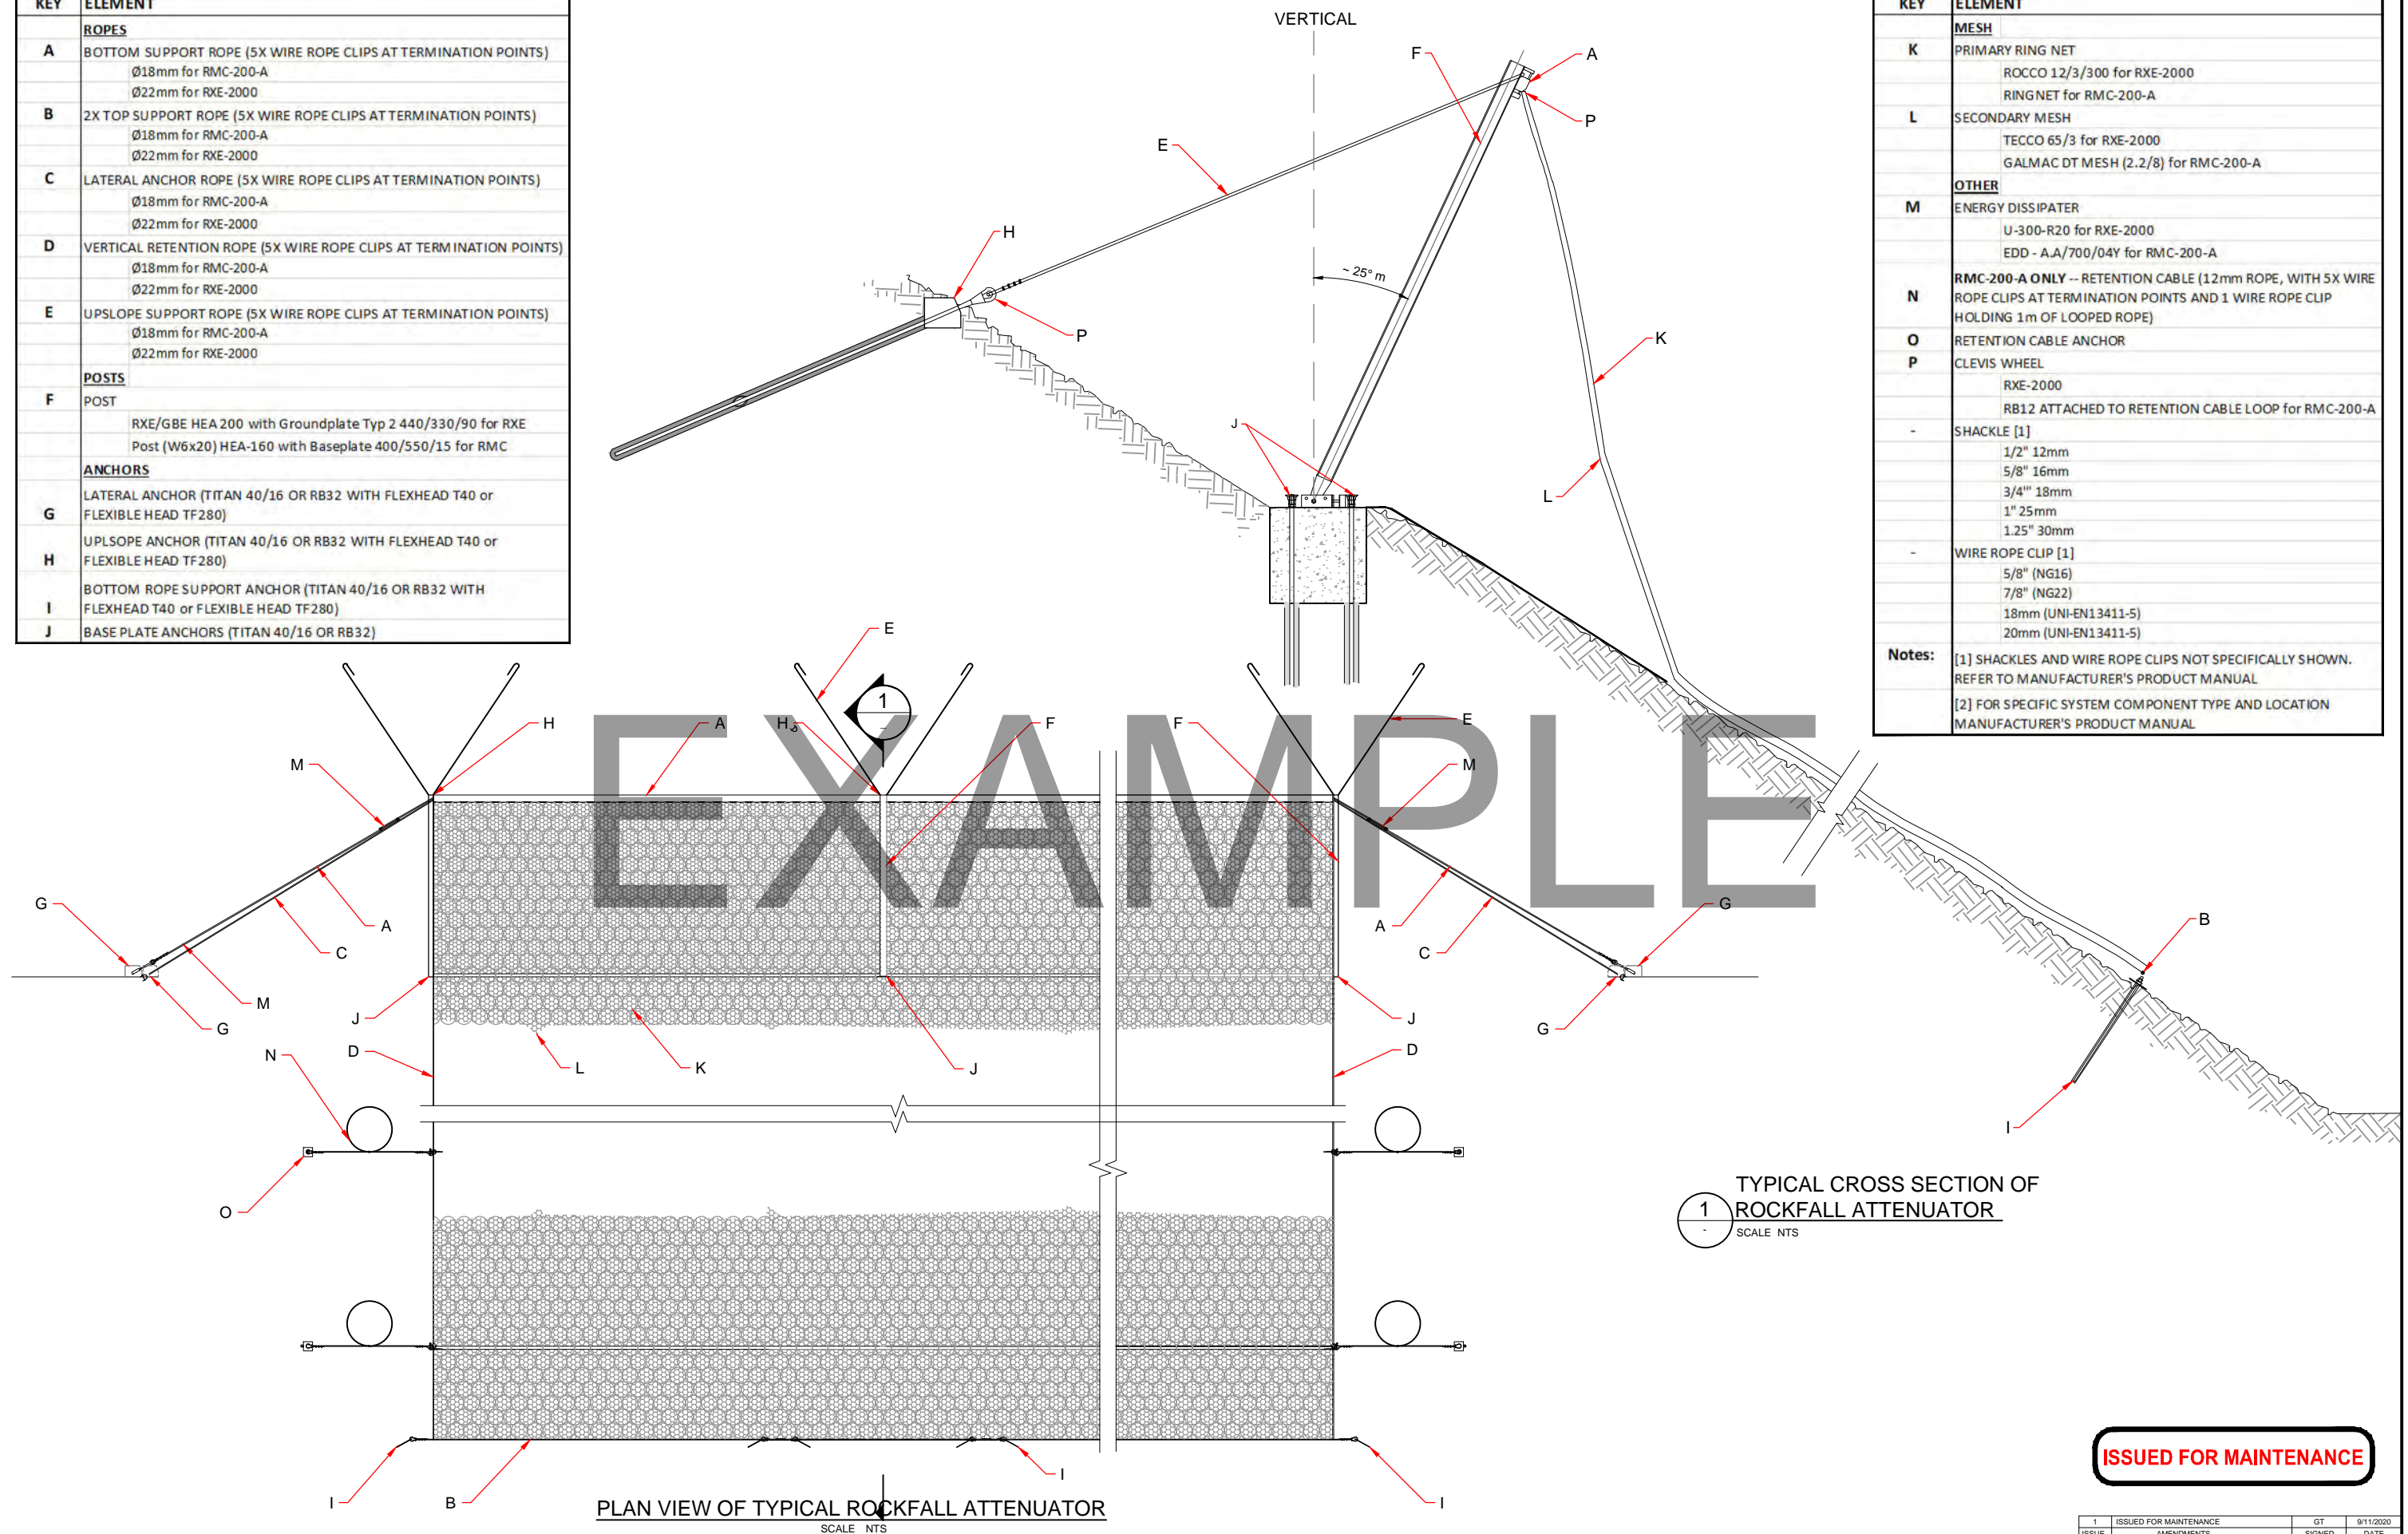
1 TYPICAL CROSS SECTION OF ROCKFALL ATTENUATOR
SCALE NTS

KEY	ELEMENT
MESH	
K	PRIMARY RING NET ROCCO 12/3/300 for RXE-2000 RINGNET for RMC-200-A
L	SECONDARY MESH TECCO 65/3 for RXE-2000 GALMAC DT MESH (2.2/8) for RMC-200-A
OTHER	
M	ENERGY DISSIPATER U-300-R20 for RXE-2000 EDD - A.A/700/04Y for RMC-200-A
N	RMC-200-A ONLY -- RETENTION CABLE (12mm ROPE, WITH 5X WIRE ROPE CLIPS AT TERMINATION POINTS AND 1 WIRE ROPE CLIP HOLDING 1m OF LOOPED ROPE)
O	RETENTION CABLE ANCHOR
P	CLEVIS WHEEL RXE-2000 RB12 ATTACHED TO RETENTION CABLE LOOP for RMC-200-A
-	SHACKLE [1] 1/2" 12mm 5/8" 16mm 3/4" 18mm 1" 25mm 1.25" 30mm
-	WIRE ROPE CLIP [1] 5/8" (NG16) 7/8" (NG22) 18mm (UNI-EN13411-5) 20mm (UNI-EN13411-5)
Notes:	[1] SHACKLES AND WIRE ROPE CLIPS NOT SPECIFICALLY SHOWN. REFER TO MANUFACTURER'S PRODUCT MANUAL [2] FOR SPECIFIC SYSTEM COMPONENT TYPE AND LOCATION MANUFACTURER'S PRODUCT MANUAL

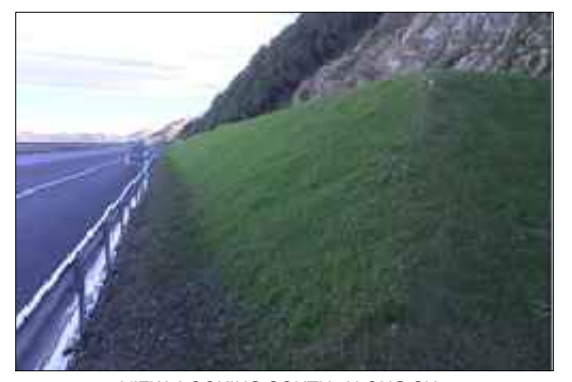
VIEW LOOKING SOUTH ALONG SH1 (1V:2H SECTION)
