Chipseal cracking

November 2015

DN Brown
R&D Consultants Ltd

Brown, DN, TFP Henning, P Herrington and JP Wu (2015) Chipseal cracking. *NZ Transport Agency research report 579*. 100pp.

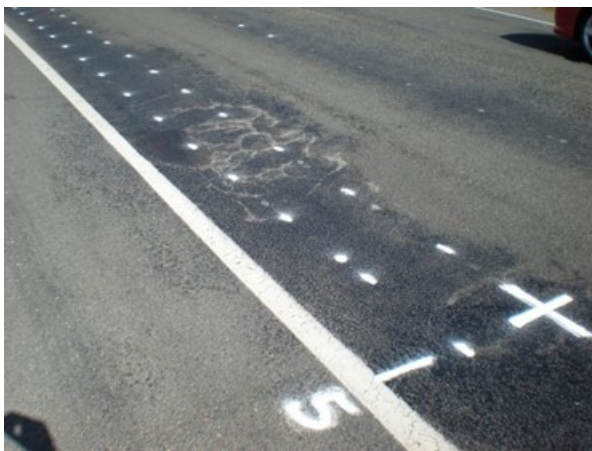
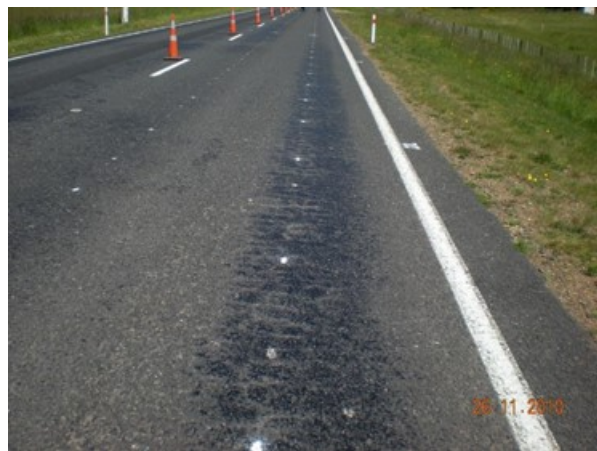
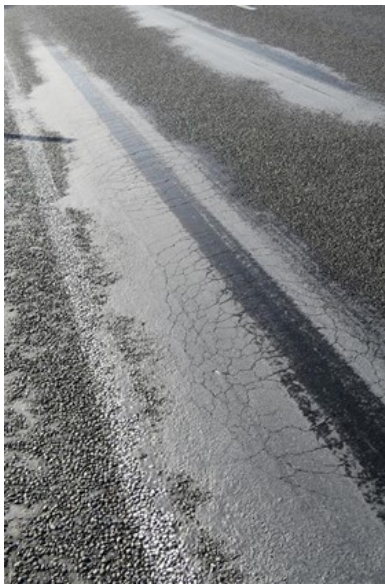
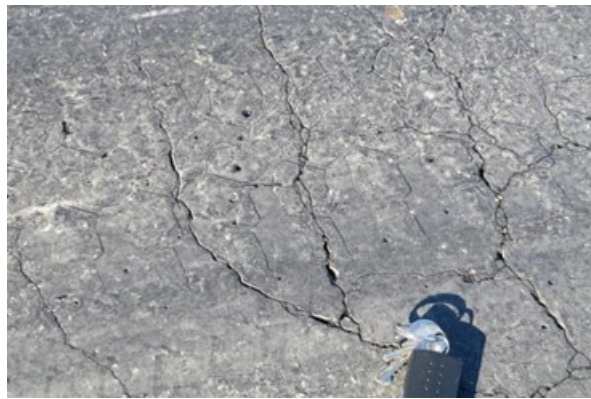
Figure 2.2 Chipseal alligator cracking in the wheel path

Cracking (eventually becoming alligator cracking), in or near the wheel paths is the most commonly observed form of cracking in chipseals, and is sometimes accompanied by evidence of basecourse fines pumping to the surface indicating that the crack is the full depth of the seal layer (see figures 2.2 and 2.3). Cracking is also very often associated with flushing and is usually localised as illustrated in figure 2.2 (a) and (b) where cracking has only occurred in one wheel path.

Flushing and cracking are often observed together (figure 2.2). Recent investigations into seal flushing have found that in multi-layer seals binder can be stripped from the bottom of the layer by water and forced to the top of the layer (Herrington et al 2015). This 'sub-surface stripping' leaves a weak layer of unbound chip that may gradually compact or 'collapse' under traffic to produce a rut and result in large deflections.

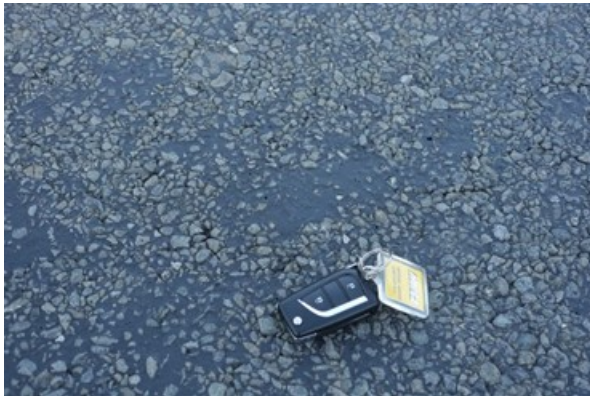
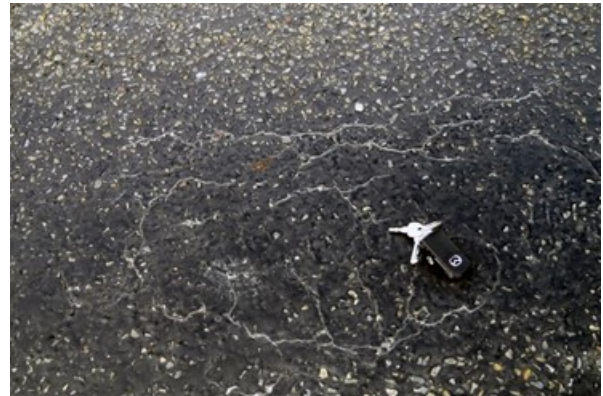
Figure 2.3 Cracking is very often associated with flushing

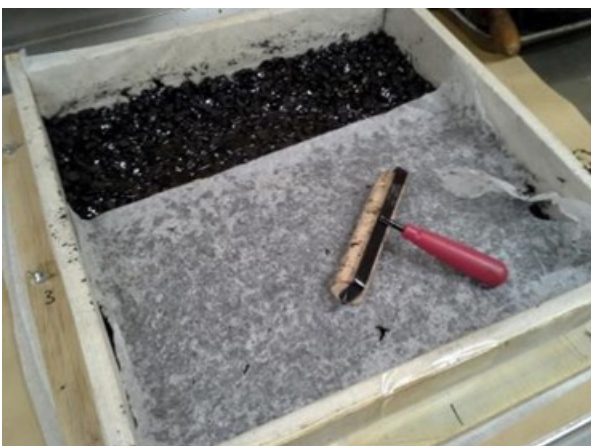
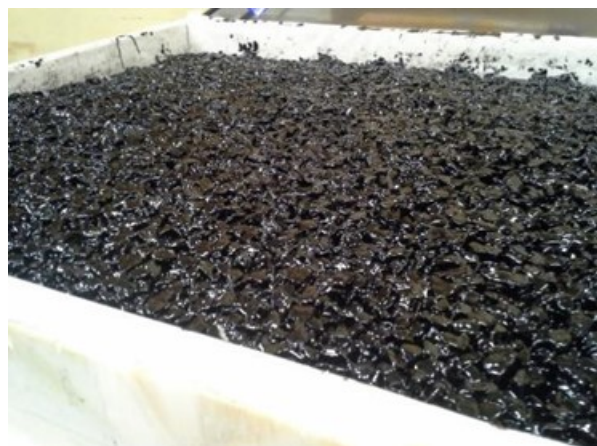
Figure 2.5 Roller compaction of the first layer (left); construction of the subsequent layer (right)

The correct amount of binder was weighed into and mixed with the aggregates in a mixer bowl until the surface of every chip was fully covered. The hot mix was poured and spread across the mould one aggregate deep and a rubber roller was used to distribute evenly the coated chips. Baking (silicone) paper was used to prevent bitumen sticking to the roller (figure 2.5). At least three layers of each grade were applied to make up a total thickness of 70mm. The final layer was a grade 3/5 'racked-in' seal (using hot uncoated chip) to try and produce a low texture surface to enable easy mounting in the beam fatigue apparatus (figure 2.6). The final sequence of seals was: 3/5/3/5/3/5/3&5. Sufficient time was spent using the rollers to ensure good packing of the chips into the voids of the underlying layer. A hot air gun was used to keep the assembly hot during compaction. This construction method was adopted after initial attempts to apply the bitumen onto each layer followed by hot clean chip proved unsuccessful as it was not possible to produce repeatable specimens with the chip properly coated with bitumen.

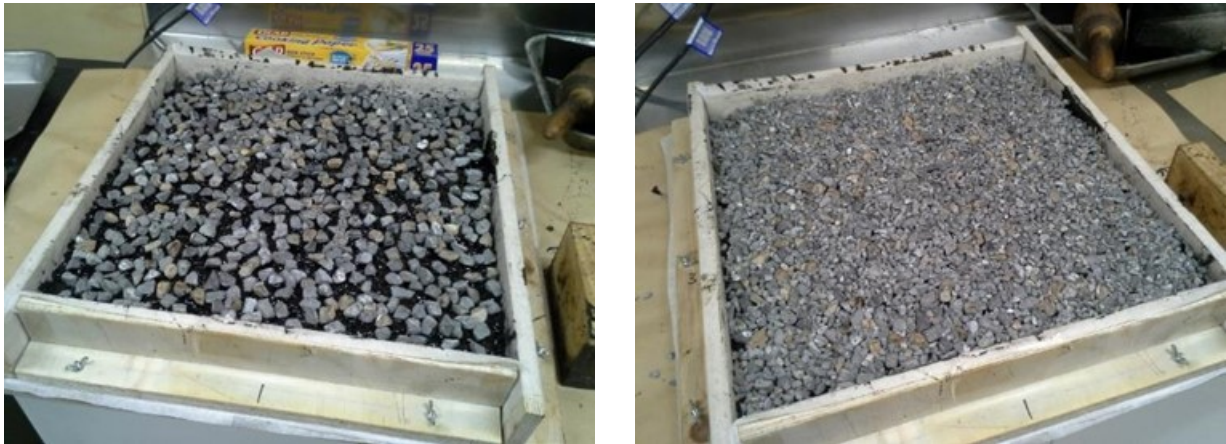
Figure 2.6 Application of grade 3 chip (left); application of grade 5 chip to complete the racked- in seal (right)

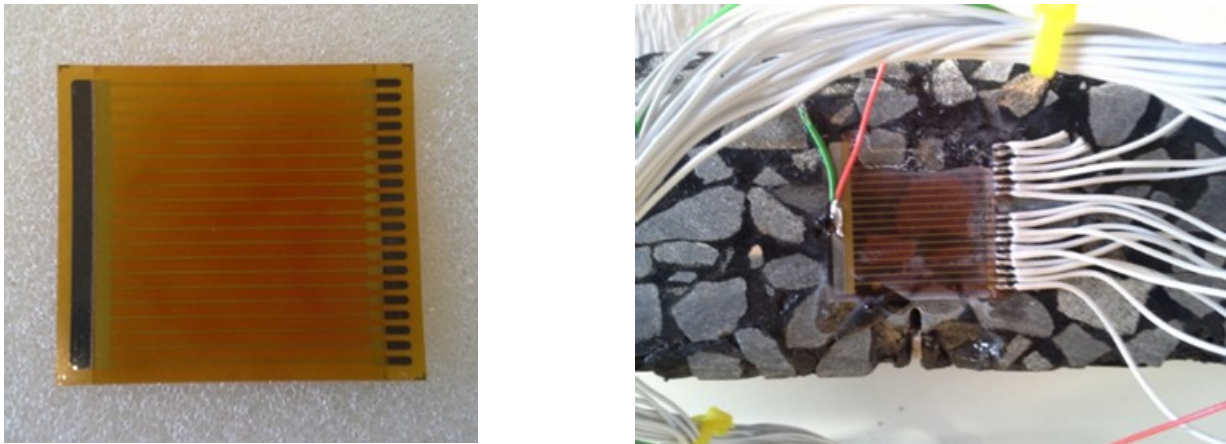
Figure 2.9 Crack propagation gauge (left); example of a gauge mounted on the side of a test beam (right)

Crack propagation in chipseal beams was measured using a specialist gauge (HBS model 1-RDS-20), which is mounted on the side of the beam with an epoxy-based adhesive. The gauge (figure 2.9) consists of 20 parallel wires, spaced at 1mm intervals), with individual contacts on one end and a joint one on the other. The gauge works by measuring the resistance across each wire. As a crack develops in the specimen the wires break creating an infinite resistance. The time of each break is recorded and used to calculate the rate of travel of the crack.

Each test beam had a 10mm deep notch applied on its bottom face to act as a stress concentrator to promote crack propagation (ie the crack travels from the bottom of the specimen upwards). Note that only the beams used for measurement of crack propagation rate were notched, not those used for the standard fatigue tests. The presence of the notch was particularly important for the four-point bending test geometry since the force is distributed across the inner 90mm of the specimen and in practice cracking tends to occur anywhere over this region.

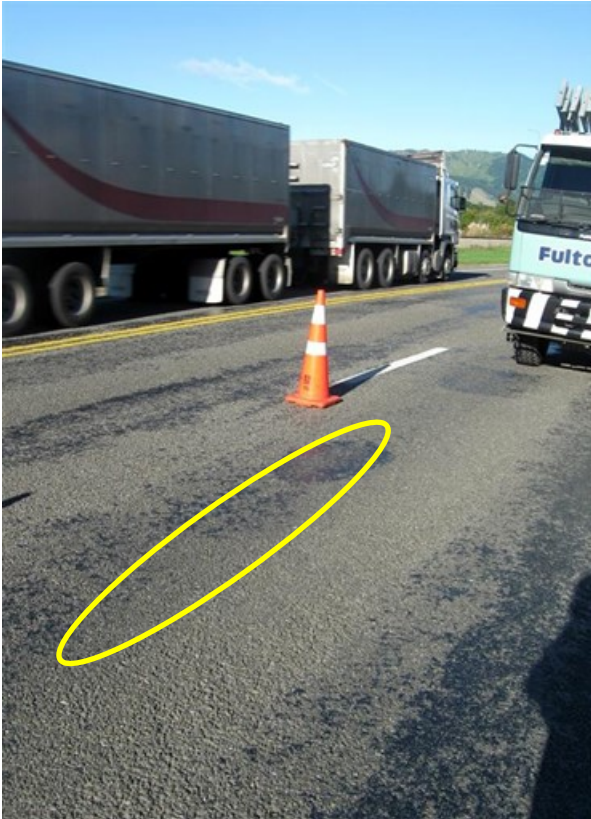
Figure 2.10 SH1 Otaki site showing position of slab 1 taken for preparation of fatigue test specimens

Seal samples were obtained from SH1 site near Otaki in the North Island (RP locations were 01N-0995/ 9.560 (between 9.530 and 9.583km), northbound outer lane). The site is shown in figure 2.10, flushing was evident in the wheel paths. The slabs for the preparation of fatigue test beams were taken from between the wheel paths at 5–10m intervals, where the seal condition was good.

Four slabs of approximately 500mm long, 300mm wide and 100mm thick were cut and removed from the site (figures 2.10 and 2.11). Five beams were cut from each slab as described in section 2.1.

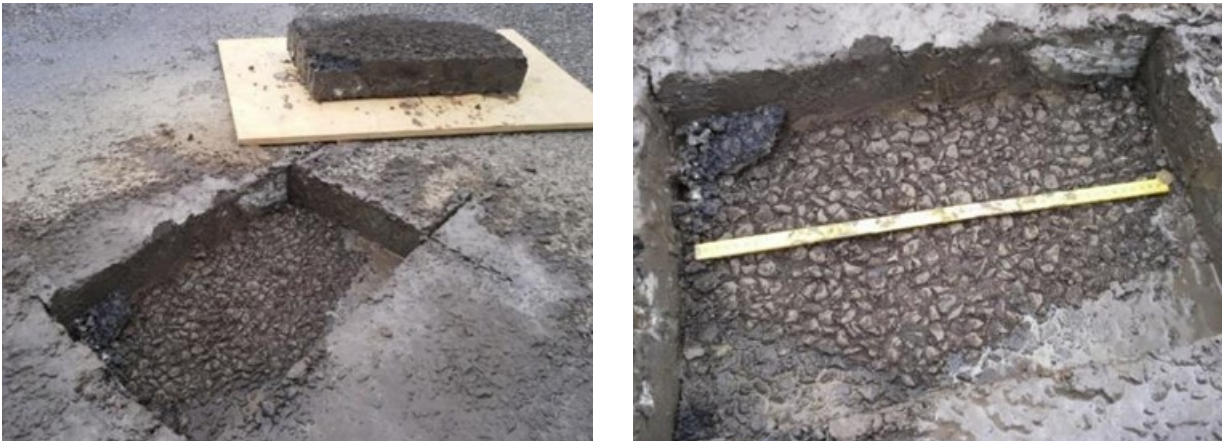
Figure 2.11 An example of a slab cut and removed from the SH1 site (left); in this case the slab partially delaminated leaving behind part of the first coat seal and was not used.

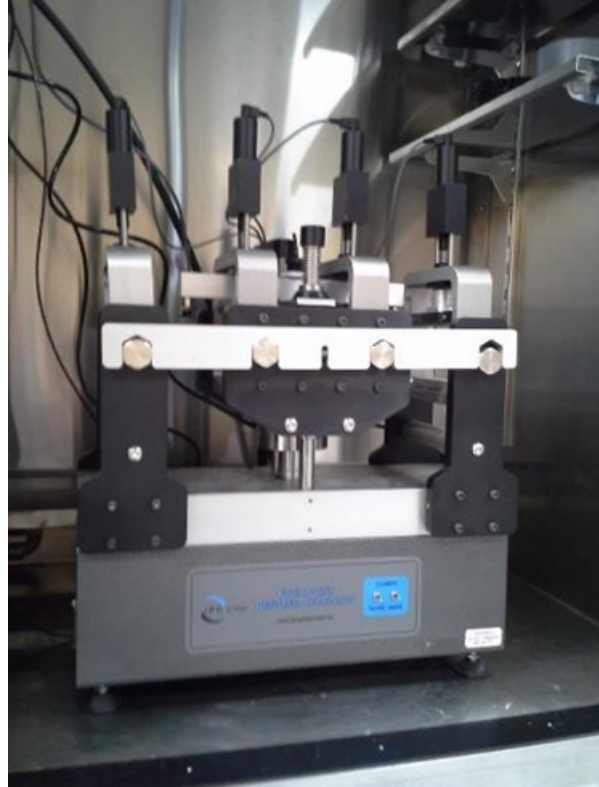
Figure 2.13 IPC Global's four- point bending apparatus with beam mounted (left). The load is applied downwards from the neutral position so the bottom surface is in tension

Fatigue testing of chipseal beams was conducted according to AG:PT/T233-2006, using a specialised four-point beam bending apparatus (see figure 2.13) to determine the fatigue lives at different strain levels in the seal layers. The initial modulus value was determined from the average of the first 50 haversine loading cycles at each strain level. The loading frequency was 10Hz with no rest periods. The final test conditions adopted were 5°C and strain levels of 200–800 $\mu\epsilon$. In most cases three to four

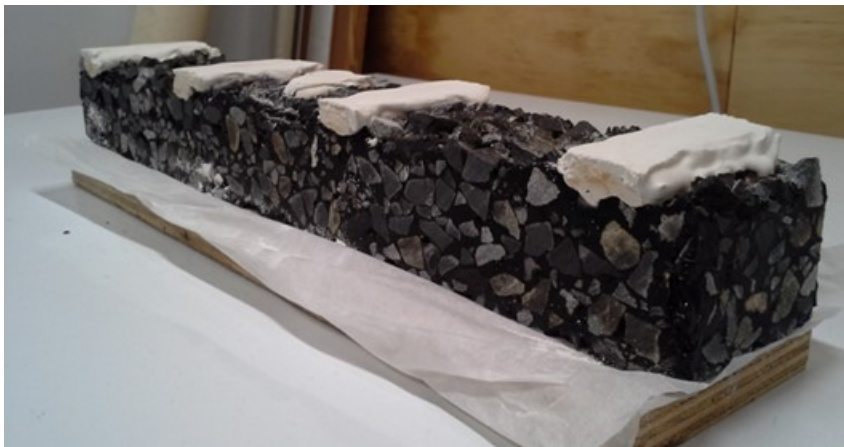
Figure 3.1 A test beam of multi-layered chipseal with clay seatings

Initially attempts were made to test the chipseal beams while retaining the textured surface (figure 3.1). Strips of modelling clay were applied to the surface and cured at room temperature to provide flat rigid seats for the loading clamps and the central linear variable displacement transducer. Beams tested using this system at $400\mu\epsilon$ demonstrated the same fatigue behaviour as that seen in asphalts. Cracks tended to propagate around the stone surfaces (figure 3.2). However, it was found that under high deflection settings, the clay seats were prone to delamination from the seal surface during repeated loading, which led to large variations in flexural stiffness readings and thus invalid fatigue results. As a result it was decided to test beams only with cut-stone faces to improve consistency. The top 10mm of the seal beam was cut resulting in beam dimensions of 55mm high, 60mm wide and 400mm.

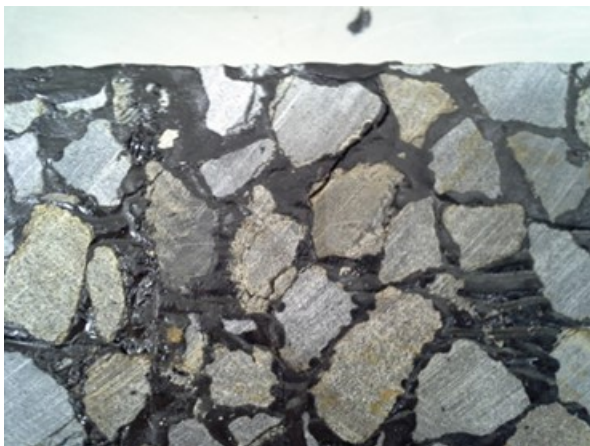
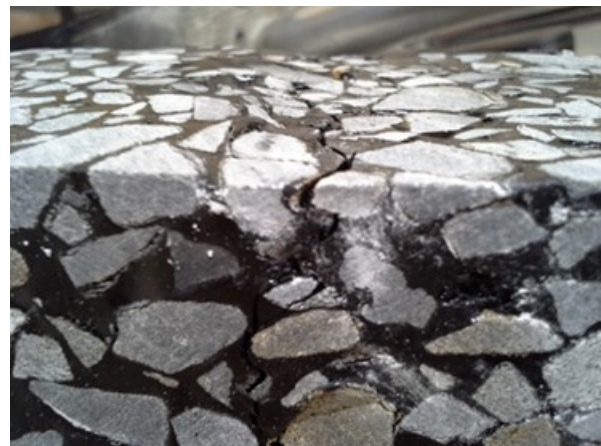
Figure 3.2 Photos illustrating cracks propagation as a result of repeated loading

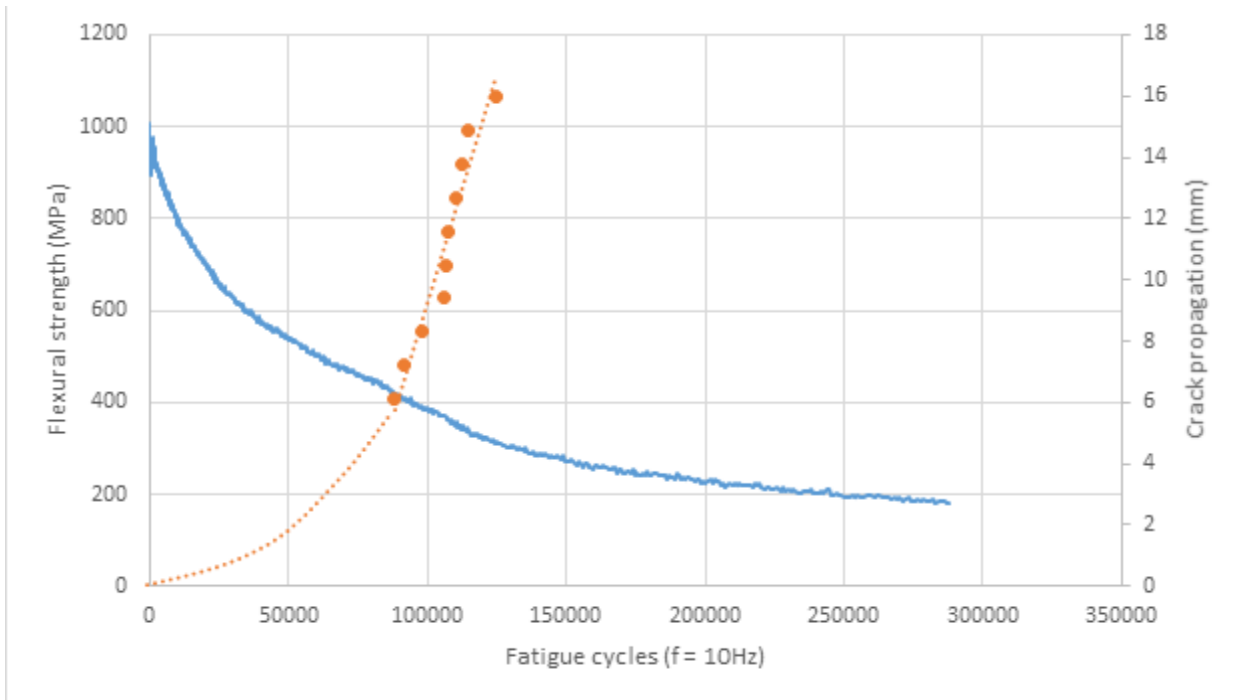
Figure 3.4 Measurement of crack growth during fatigue testing

For the one (partially) successful experiment, the beam sample was tested using a tensile $\mu\epsilon$ of 800 (equivalent to an average vertical deflection of 0.45mm) at 5°C, and a testing frequency of 10Hz. Figure 3.3 shows the beam after testing, the change in flexural modulus and progression of the crack with respect to time (number of cycles) is shown in figure 3.4.

The exponentially decreasing flexural modulus is the same behaviour as that typically observed when testing asphalt beams. Data for the first 5mm of crack growth could not be recorded due to problems with the gauge connections. Over the range recorded the crack growth rate was linear (2.7mm per 10,000 cycles). The early growth rate would probably have followed the exponentially increasing rate usually observed in the testing of metals and polymers (Roesler et al 2007), marked by the dotted line in figure 3.4

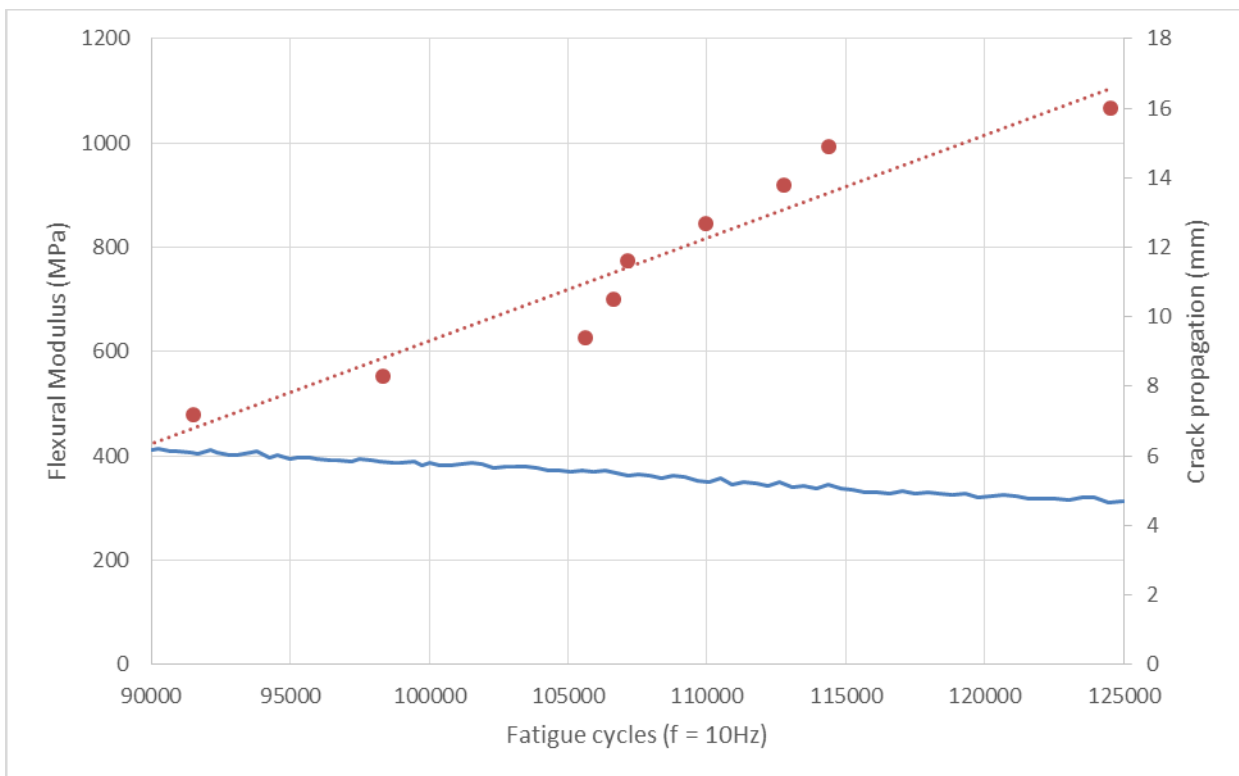
Figure 3.5 Crack growth rate data showing approximately linear change in flexural modulus

An important observation is that over the range of loading cycles spanning the measured crack growth rate data, the decrease in flexural modulus is also approximately linear, ie the rate of crack growth is directly proportional to the decrease in beam strength (figure 3.5). This indicates that under the test conditions used the decrease in modulus was due to the crack formation, not to some other effect related to flow or deformation of the bitumen and the test results could be interpreted directly in terms of fatigue cracking.

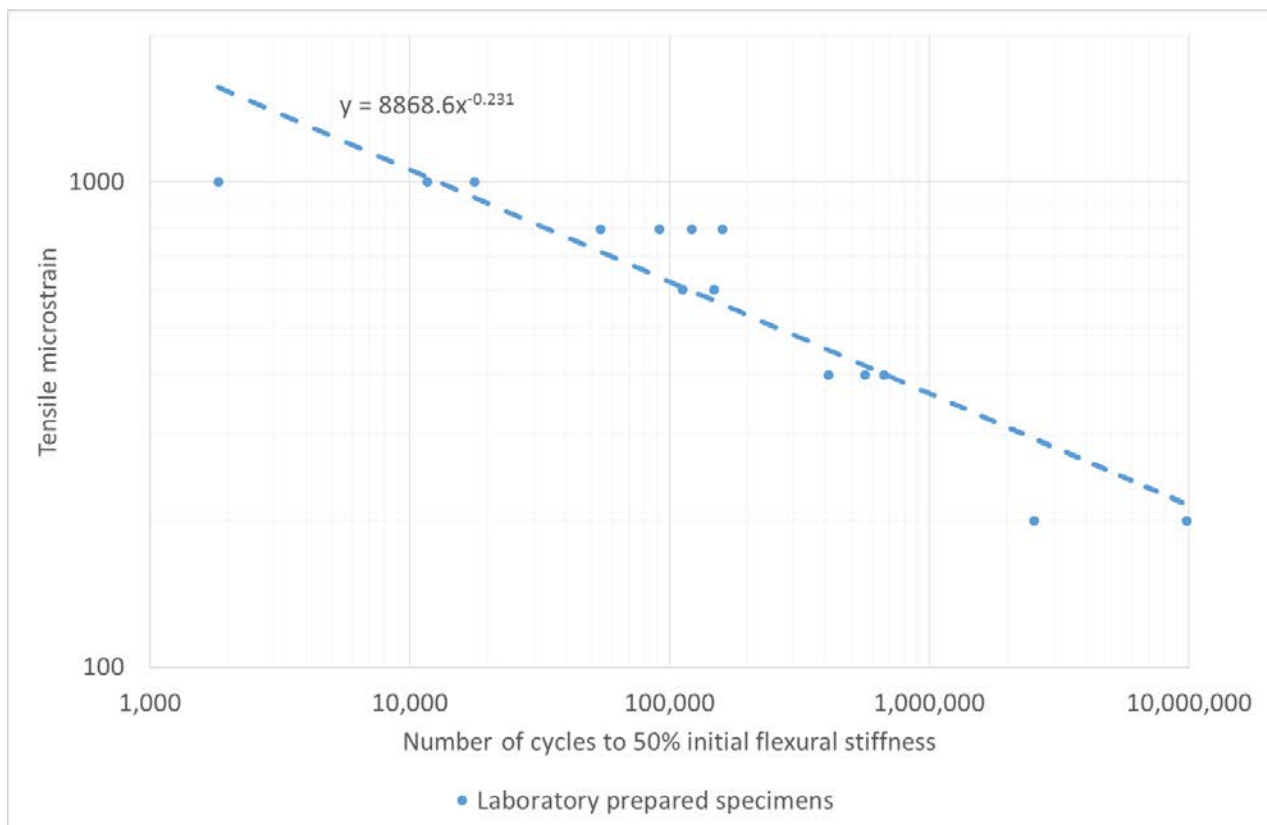
Figure 3.6 Fatigue test results for laboratory prepared chipseal beams

Results of fatigue tests carried out at 5°C on chipseal beams manufactured in the laboratory are shown in figure 3.6. As expected the fatigue life decreases with increasing strain level. The initial flexural moduli data shows considerable scatter (1200 ± 200 MPa (95% CI)) but no statistically significant trend (95% confidence level), with strain level, indicating that the beams were behaving elastically (at least at the 10Hz testing frequency used). Tests done at $100\mu\epsilon$ proved there was an endurance limit where the fatigue life of the chipseal became effectively infinite. The tests showed little reduction in the initial flexural modulus over 5,000,000 cycles (~6 days of continuous testing) and showed no sign of reaching 50% of the initial value. This phenomenon has previously been reported for fatigue lives of hot mix asphalt samples (eg Carpenter 2003; Prowell et al 2010). Carpenter claims that a continuous physical-chemical healing reaction occurs, even during continuous loading, at low strain levels. If damage due to loading falls below a certain level, then damage accumulation is virtually non-existent.

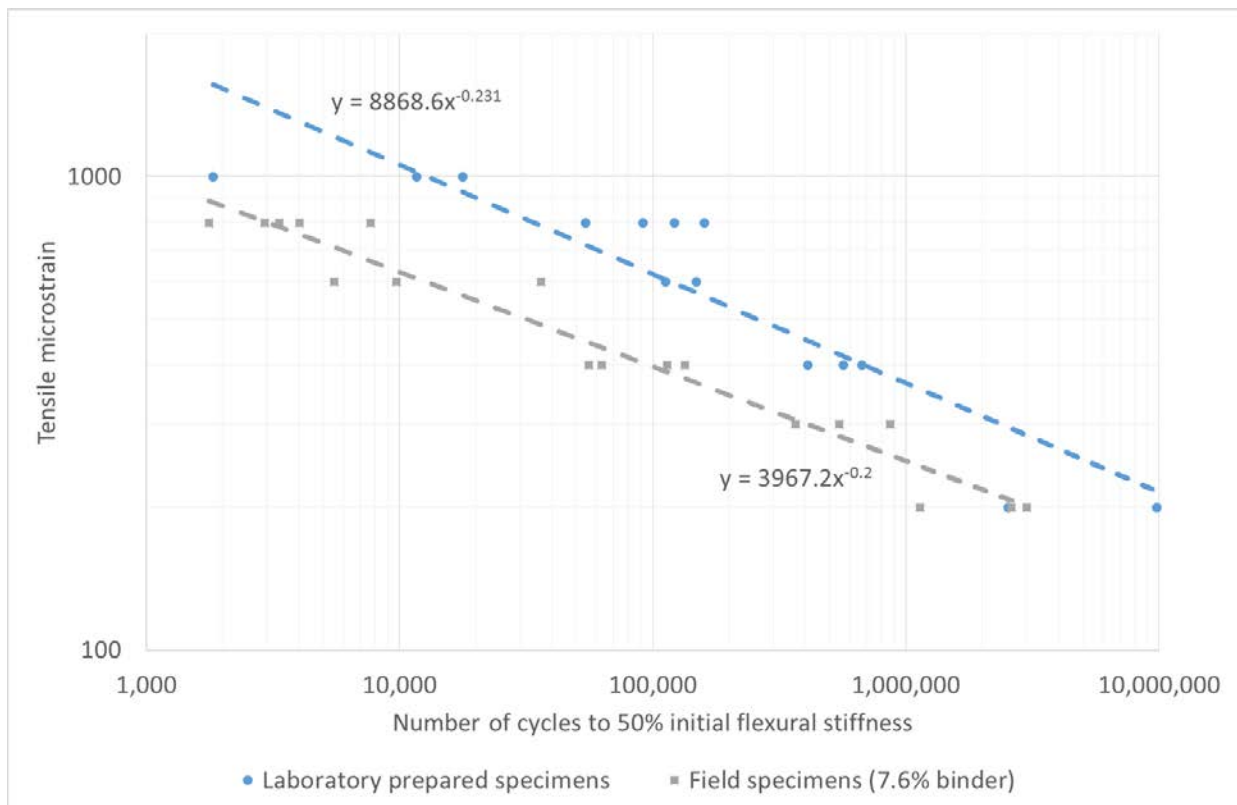
Figure 3.7 Fatigue test results for chipseal field samples compared to laboratory prepared seals

Fatigue test results for chipseal beams cut from field samples are shown in figure 3.7 superimposed on the laboratory sample results. The fatigue lives obtained are lower than those of the laboratory specimens. At $800\mu\epsilon$ the number of cycles to 50% of the initial modulus is approximately 3,000 compared with 33,000 for the laboratory specimens. This observation is consistent (by analogy with asphalt mix), with the lower bitumen content (7.6% compared with 10%), and the significantly higher initial flexural modulus of the field specimens ($4,100 \pm 1,000$ MPa compared with $1,200 \pm 200$). The fatigue life is known to increase exponentially with the volume of bitumen present and decrease exponentially with the specimen

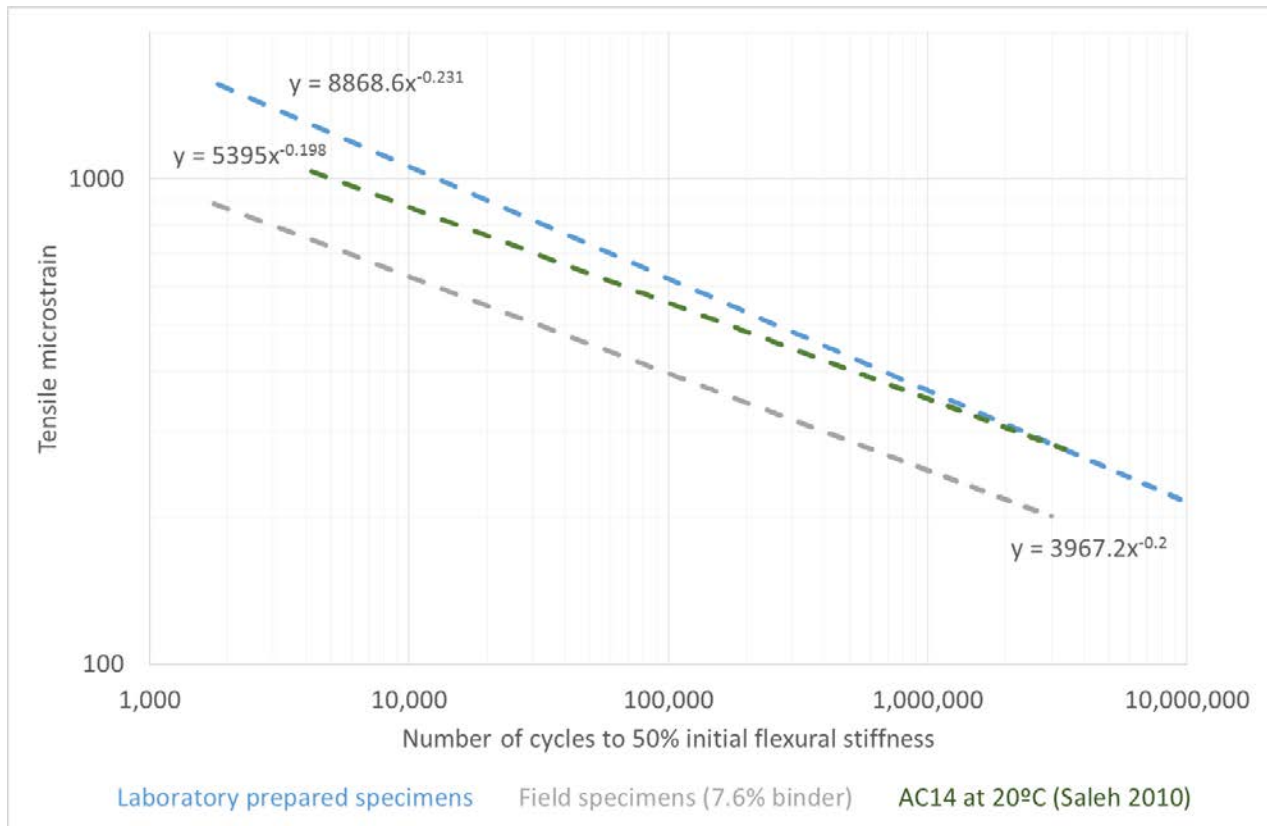
Figure 3.8 Comparison of fatigue test results for chipseal and asphalt specimens tested at 5°C and 20°C respectively (points omitted for clarity)

The chipseal beam fatigue data is compared with that for asphalt mix in figure 3.8 (data points have been removed for clarity). The data is for a New Zealand asphalt concrete (AC) 14 mix (60/70 bitumen), tested by Saleh (2010) at 20°C using exactly the same test conditions at that used here (except for temperature). At 400 µε the asphalt mix has a fatigue life of 500,000 cycles.

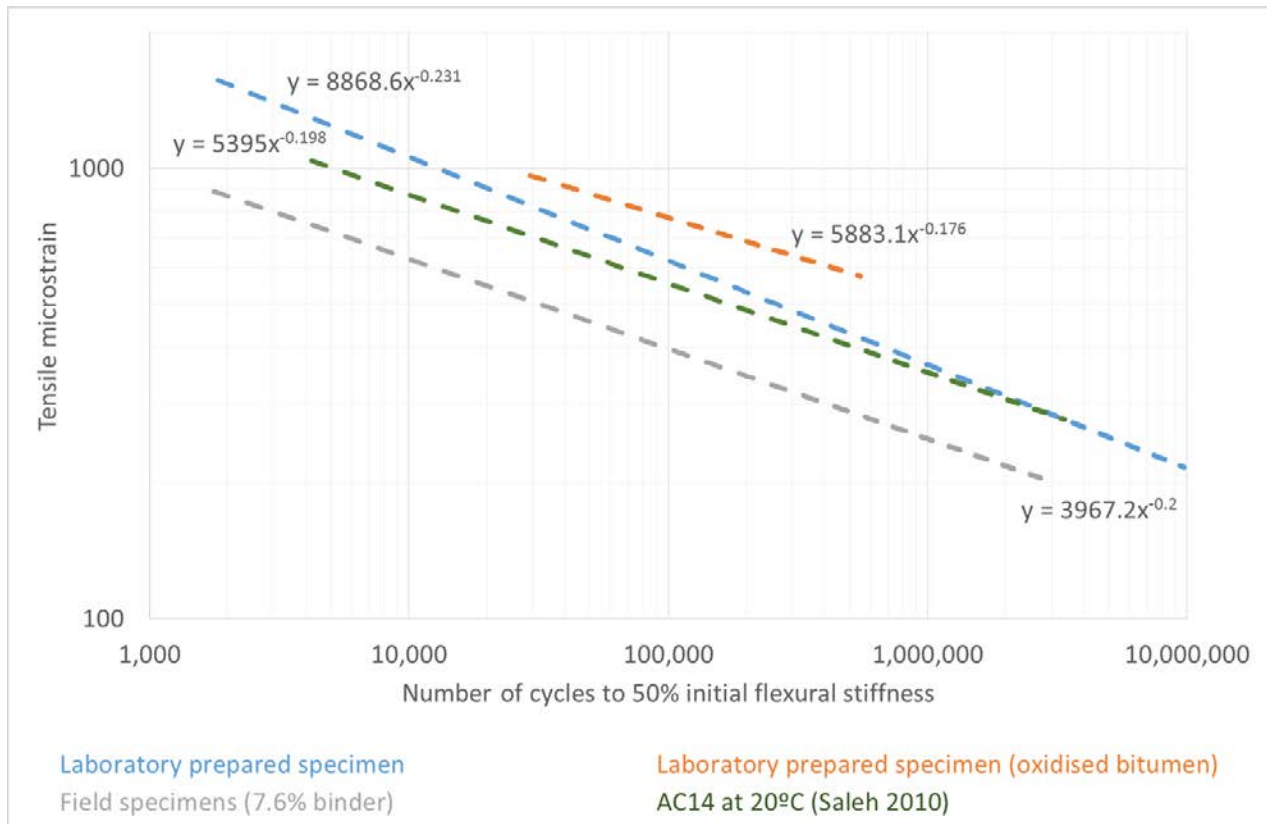
Figure 3.10 Fatigue test results for laboratory prepared beams using oxidised bitumen

Fatigue test results for chipseal beams made with the oxidised bitumen are compared to those of the original bitumen, the field samples and asphalt in figure 3.10. Oxidation of the bitumen had no significant effect on the seal beam moduli (at 5°C). Interestingly, however, the results suggest that oxidation had a small (with respect to the precision of the measurement), but positive effect on fatigue life. At 800µε the mean initial flexural moduli and cycles to failure were 1,200 ± 200MPa and 33,000, and 1,300 ± 400MPa and 84,000 respectively. An increase in fatigue life for oxidised bitumens (ie not mixed with aggregate) has previously been reported by (Hintz et al 2011).

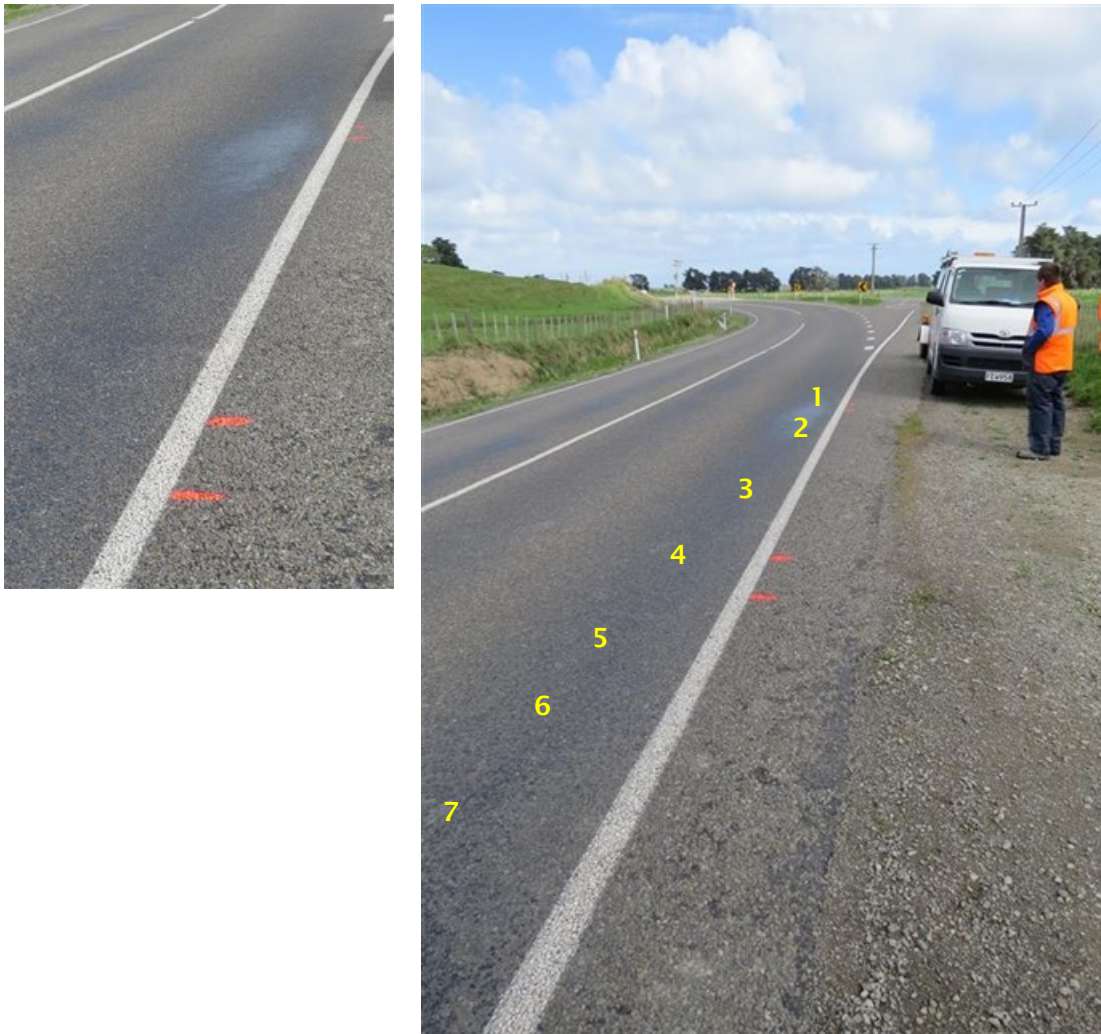
Figure 3.11 Cracked and flushed seal site (SH57 Shannon) showing core sample positions

Whether water first gains entry in these cases through a crack developing from deflections caused by localised poorly compacted basecourse, or some other defect such as chip loss or roll-over cannot be determined without further investigation. On the whole given the prevalence of water-induced flushing damage observed on the network and recent work on the permeability of newly constructed seals (Alabaster et al 2015), the latter seems more likely.

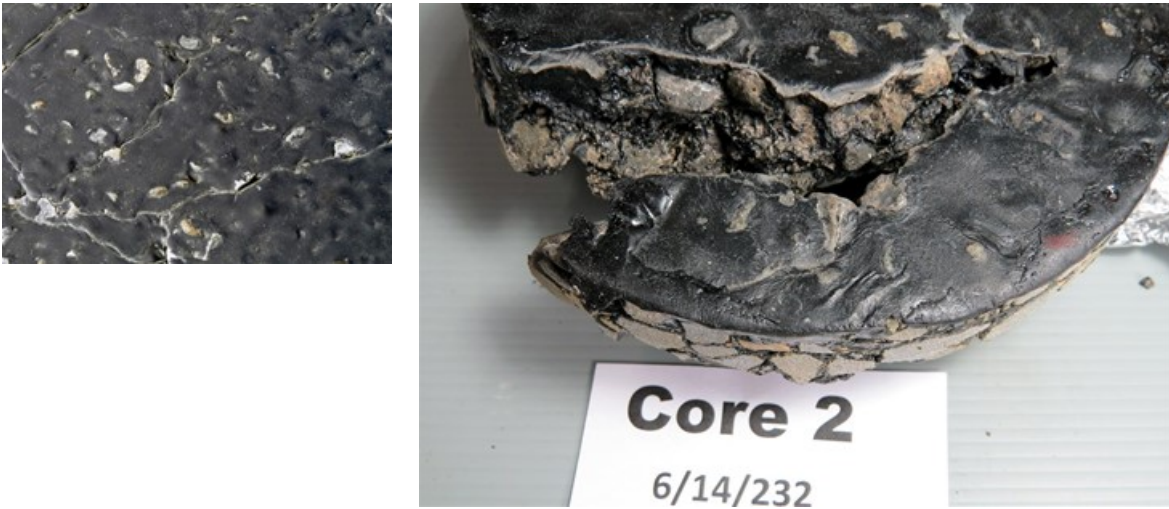
Figure 3.12 Cracked seal surface (left) and interior view of a crack showing the stripped seal (right)

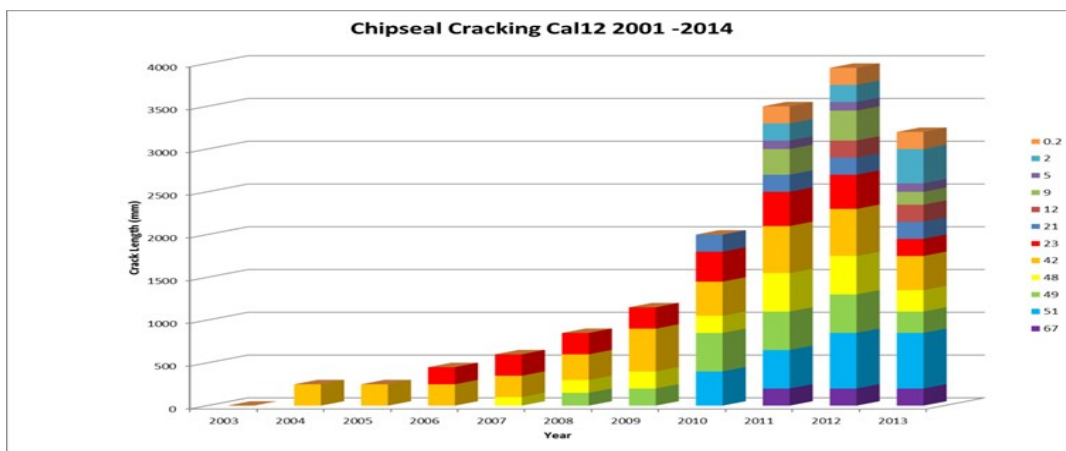
Figure 5.4 Cal12d transverse crack growth

There is a gradual increase in both the number of cracks and the length of the individual cracks. A plot of the data is presented in figure 5.4. Note that in these figures a crack identified at the same location each year is represented by a particular colour. For example the light brown crack present from 2004 to 2013 is 0.2m from the site start. The red colour represents a crack located 23m from the site start and is present from 2006 to 2013. The height of each coloured box represents the crack length and so as a crack grows the height of the coloured box is increased.

This same notation is replicated in figures 5.6 and 5.8.

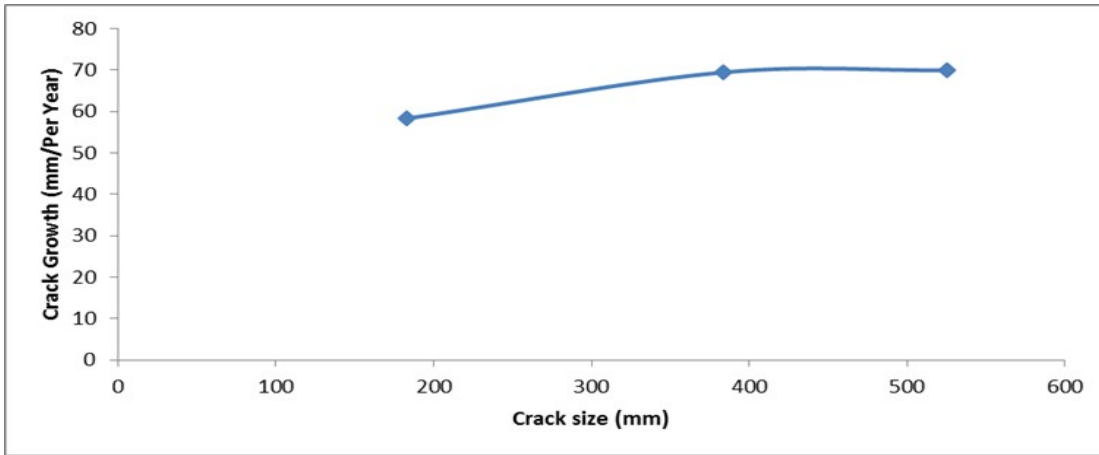
The rate of crack growth was determined for three different crack sizes and is presented in figure 5.5. This reveals crack growth of 70mm/year, which is relatively independent of the crack size for this site.

Figure 5.5 Cal12d transverse crack growth rate

The following sites Cal12 SH5, Cal43 SH1, Cal49 SH1, and Ak13 Nielson St were selected to represent the three crack types and show individual crack length growth. These sites have had little or no maintenance and are relatively unaffected by other external factors that might unduly affect the crack growth. For this analysis, cracks were split into five groups, determined by their length. The groups were adjusted so that as near as possible there was an even number of cracks in each group. Then the average crack length for each group was calculated, followed by a calculation of the average crack growth rate of the cracks for each group. This data was then plotted with crack length (mm) for the x axis and crack growth (mm/year) for the y axis. The graphs, figures 5.5 to 5.9 define the growth rate for individual cracks.

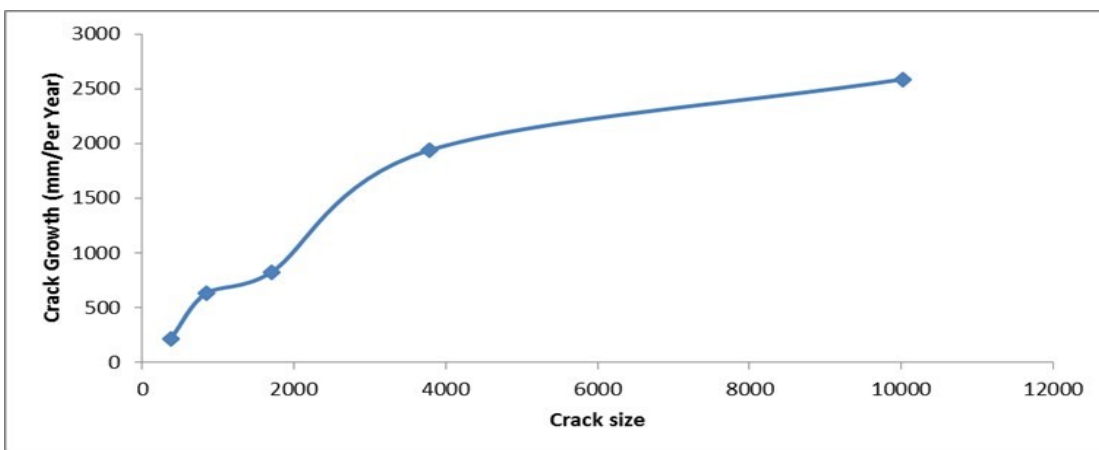
Figure 5.7 Cal43 longitudinal crack growth rate

Clearly there is a significant difference in both crack size and crack growth when compared with the transverse cracking example, with crack growth of up to 3,500mm per year. The true picture of the crack progression is somewhat distorted by the patch repairs undertaken in 2006 and 2008.

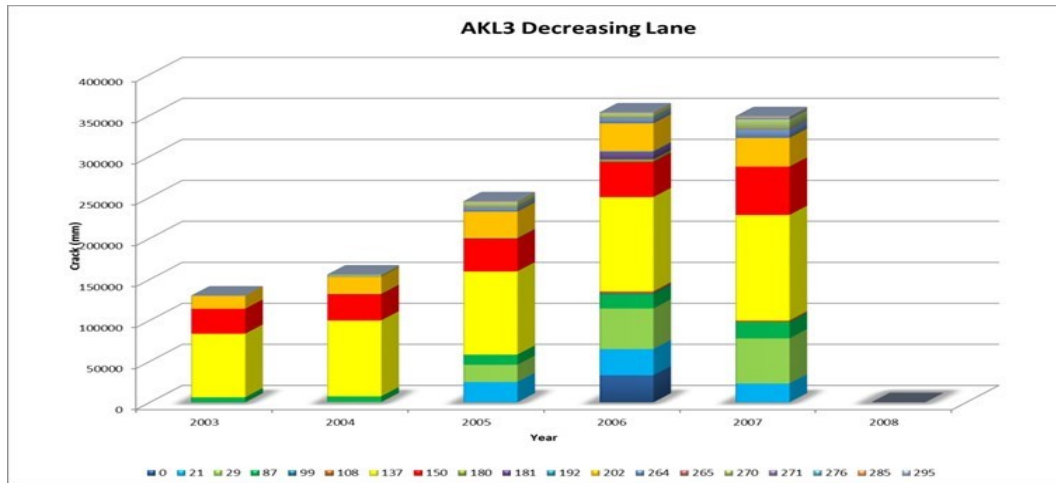
Figure 5.8 AKL3 alligator crack growth

Table B.4 in appendix B details the cracking data presented below from AKL3 Nielson St Auckland, a site primarily affected by alligator cracking. This site has a large volume of heavy trucks and underwent a full rehabilitation in 2008. The data is presented here in figures 5.8 and 5.9.

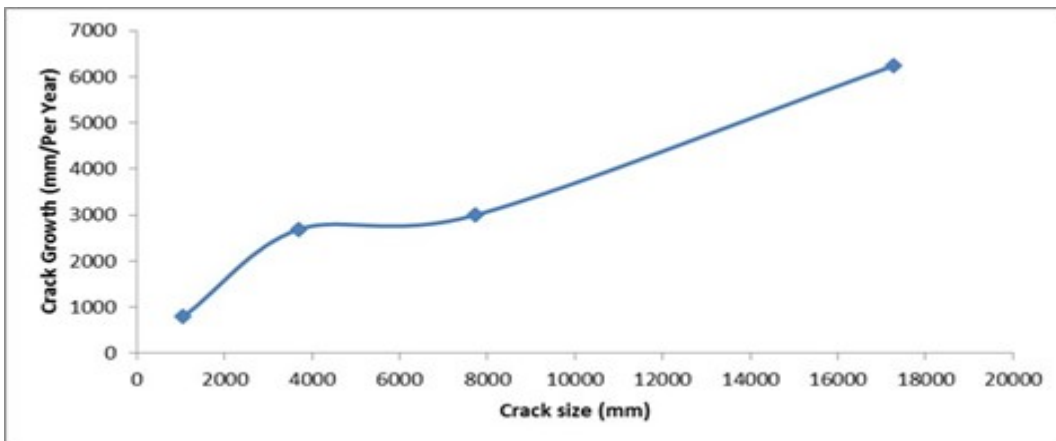
Figure 5.9 AkI3 alligator crack growth rate

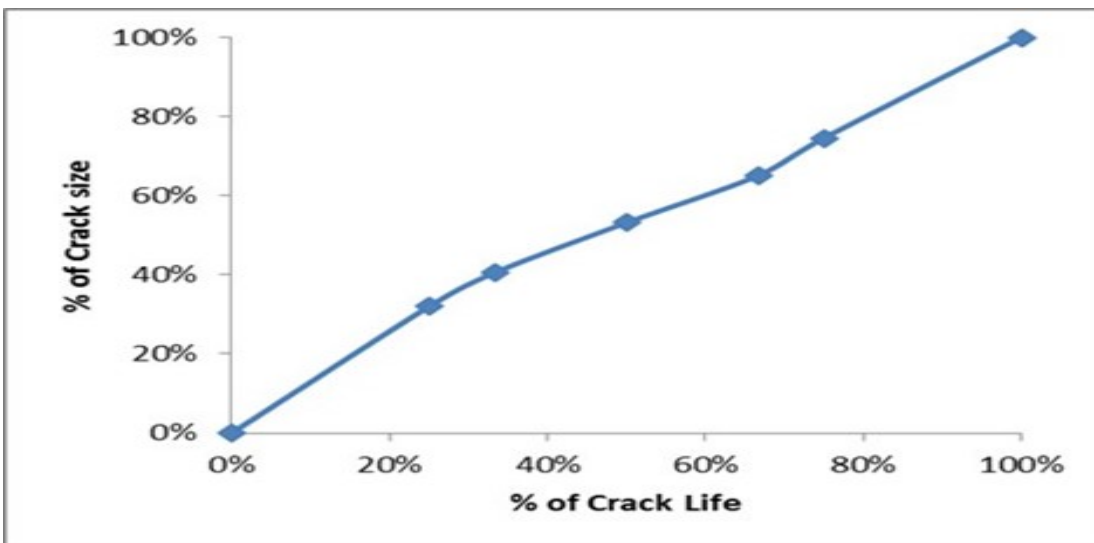
Figure 5.11 Cal12 crack growth as percentage of crack life

For this site (transverse cracking example) the cracked area growth increases exponentially after several years of low growth, whereas the crack size versus crack life is relatively linear.

The growth pattern, in terms of crack size versus crack life, shows how growth rate changes as the crack develops. This is presented in figures 5.11, 5.13 and 5.15 where the percentage of crack life is determined once the crack has reached its maximum length. The time in years taken from the point when the crack is first observed until the maximum length is observed is noted and then the percentage of the total length of the crack is plotted against the percentage of the time it took to reach maximum length.

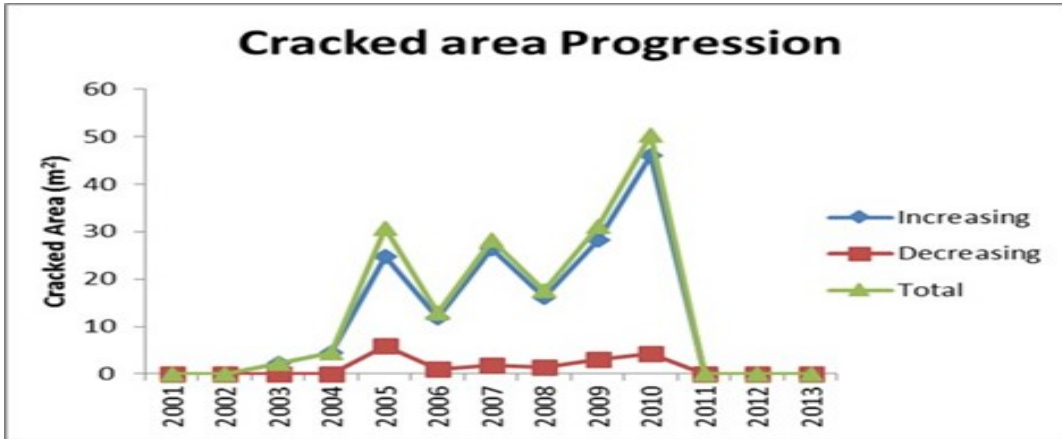
Figure 5.12 Cal43 cracked area growth

For this site, Cal43, the cracked area growth has been affected by regular patching and repair work, reducing the peaks of 2005 and 2007 until the site underwent a full rehabilitation in 2010. The crack size versus crack growth for this site (predominantly longitudinal cracking) is also relatively linear, but has an increase midway through the cycle.

The total cracked area for the increasing and decreasing lanes and both lanes combined for each of the three representative sites is presented here in figures 5.10, 5.12 and 5.14.

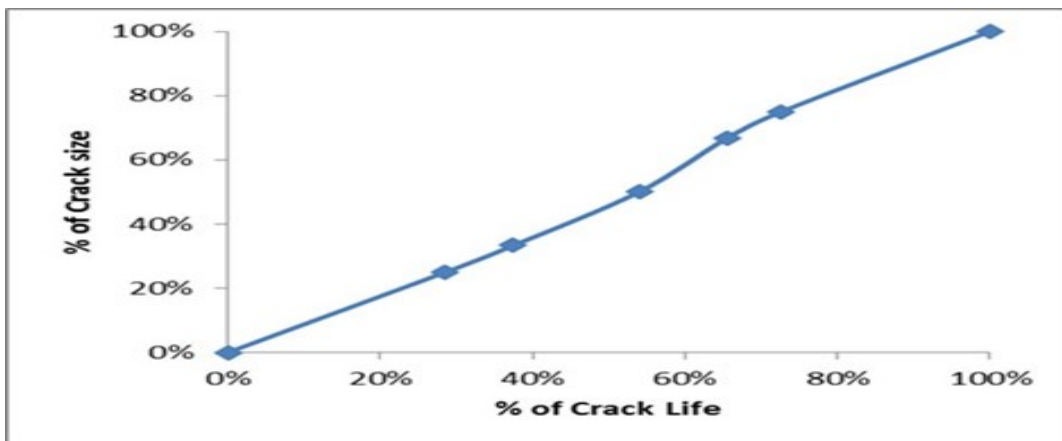
Figure 5.13 Crack growth as a percentage of crack life

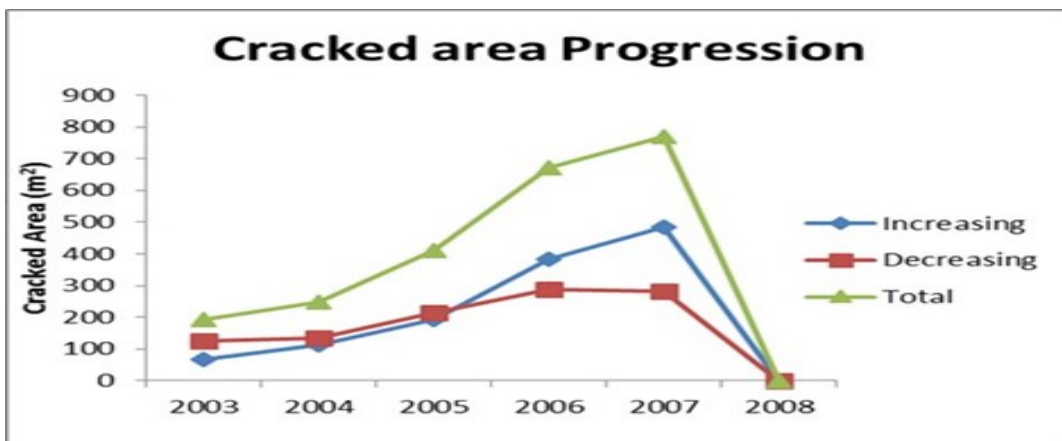
Figure 5.14 AKI3 cracked area growth

This site, AKL3, is predominantly alligator cracking and shows there is a levelling off of the total cracked area in the decreasing lane (figure 5.14) which suggests that a saturation point may have been reached where the severity of the cracking may increase but not the total cracked area. The crack size versus crack life plot is very similar in shape to that for the transverse crack example, and this may be due to the fact that at both of these sites the failure mechanism is predominantly structural with associated rutting in the wheel path.
