Chipseal cracking

November 2015

DN Brown
R&D Consultants Ltd

Brown, DN, TFP Henning, P Herrington and JP Wu (2015) Chipseal cracking. *NZ Transport Agency research report 579*. 100pp.

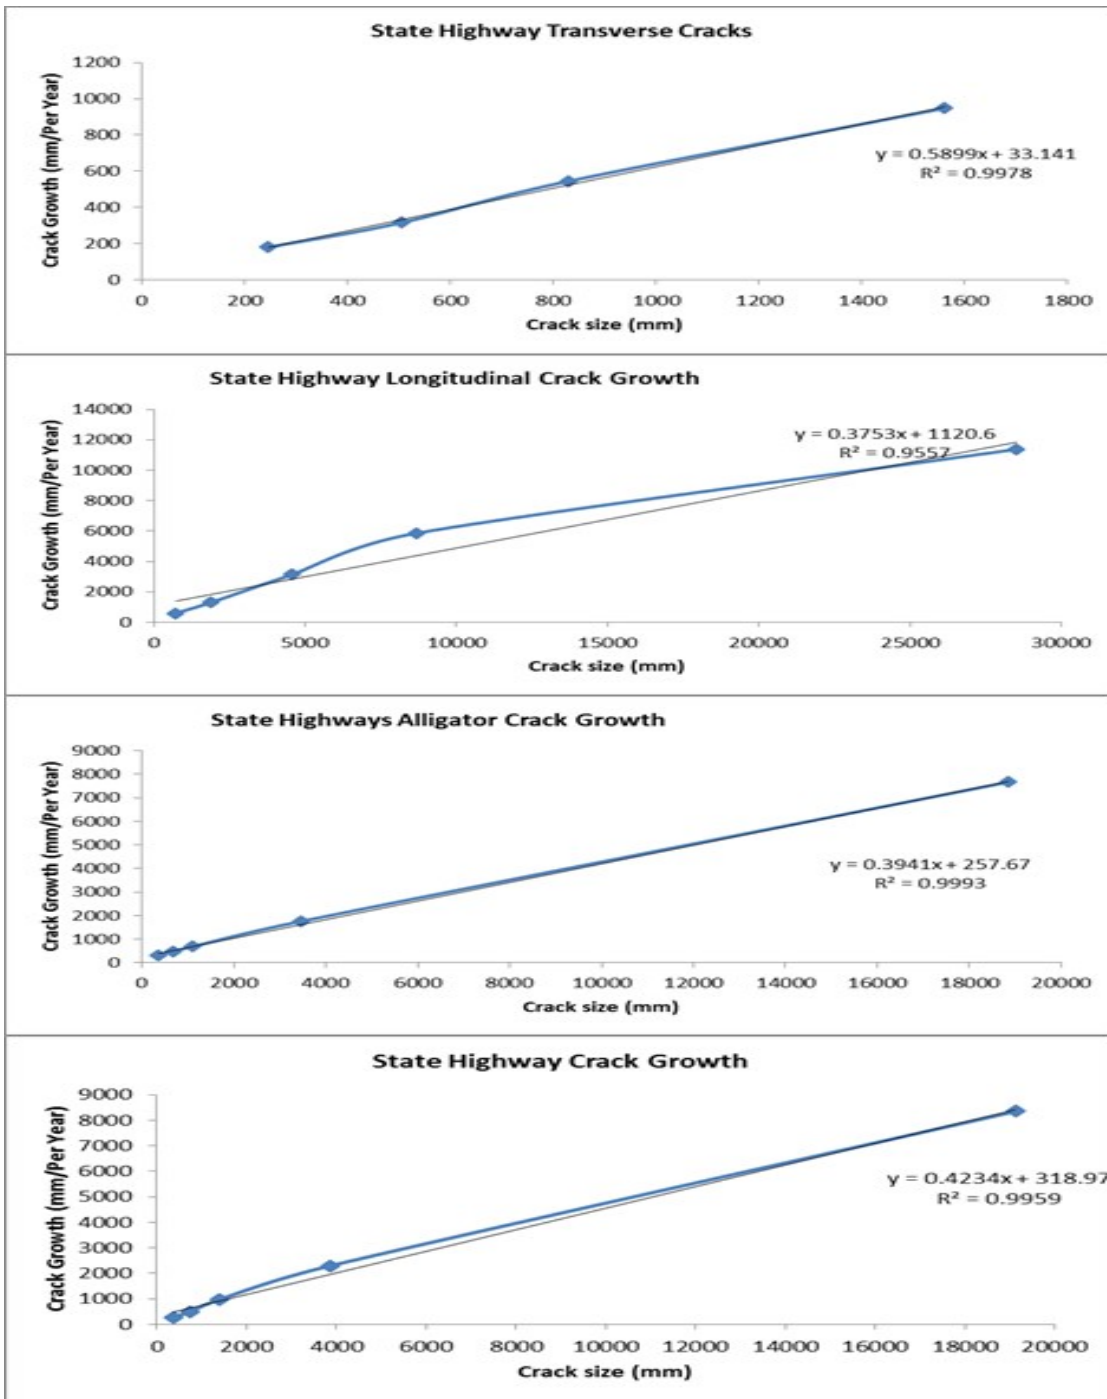
Figure 5.17 State highway crack growth rate

Figures 5.17 and 5.19 show the crack growth rate in mm/year for different crack lengths for state highway and local authority sites respectively.

All three crack types have similar growth rates, although it appears that initially the longitudinal crack growth rate is higher, reducing once the crack length exceeds 8m.

State highways: $\text{crack growth (mm/year)} = 0.4234 * \text{crack length (mm)} + 318\text{mm}$

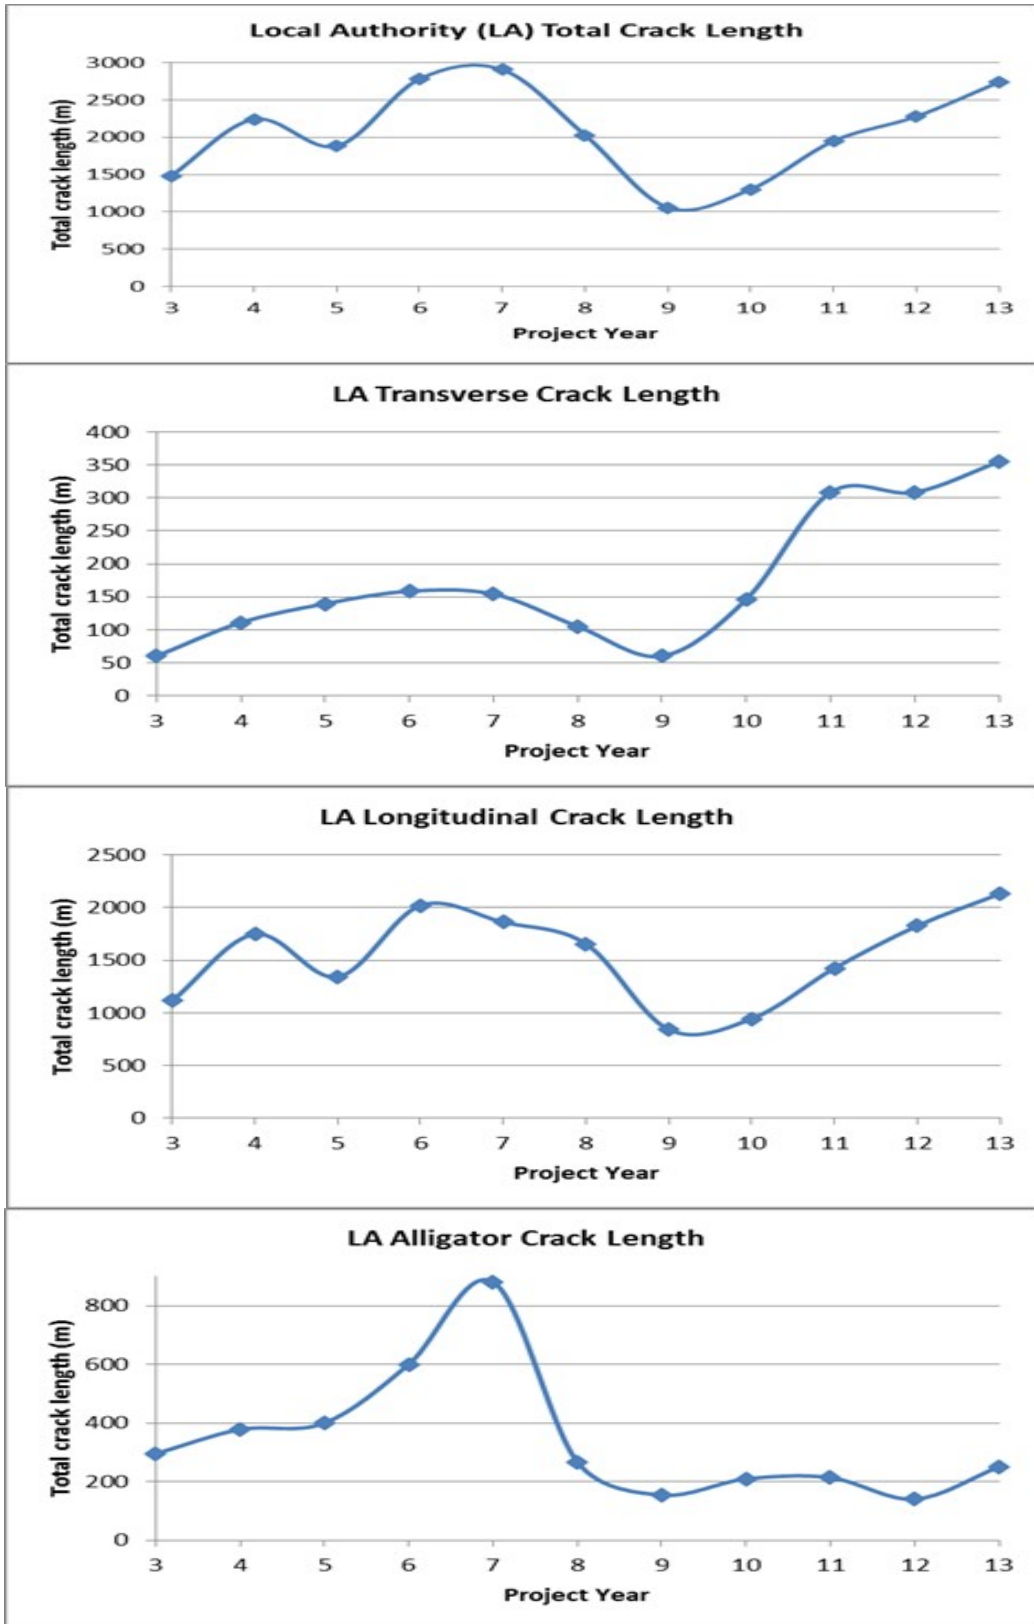
Figure 5.18 Total crack length local authority sites 2003-2014

Initially there is no obvious pattern on the local authority sites with the total crack length remaining fairly constant, a pattern that might be expected on sites with lower volume traffic. However if the maintenance undertaken on these site is taken into account it becomes clear how this has affected the results.

Figure 5.18 presents the total crack length observed each year for all local authority sites.

Site AKL3, which contained the bulk of the alligator cracking for the local authority sites, underwent a full rehabilitation following the year seven survey. Three of the Dunedin sites had a significant portion of the longitudinal and transverse cracking and were resealed after the year eight survey. The effect of the reseal in Dunedin was short lived as most of the cracking returned after two years. If we take these factors into account then both the transverse and longitudinal cracks show a steady increase with time while the alligator cracking remains fairly constant. Figure 5.19 shows the crack growth rate on the local authority sites.

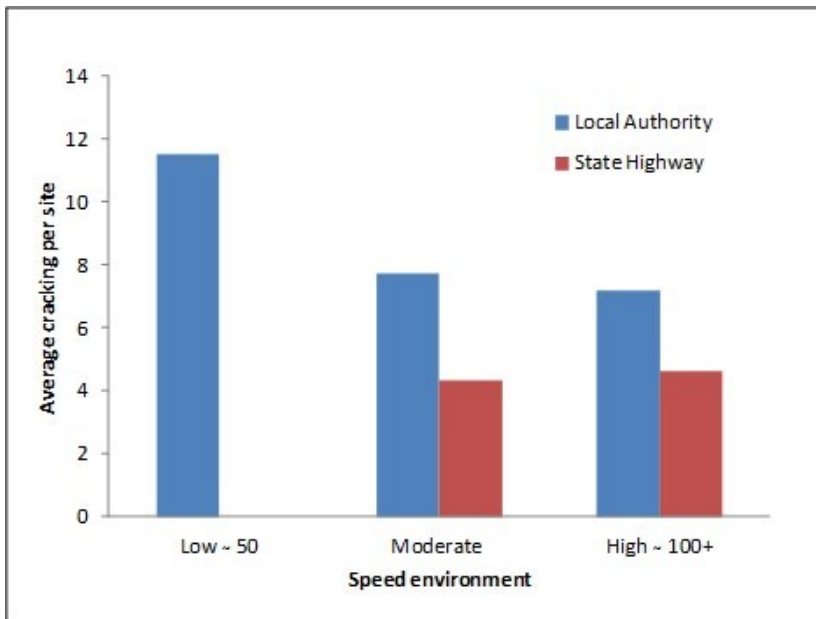
Figure 5.22 Average cracking vs speed environment

There is insufficient data to make conclusive comparisons on how the speed environment influences the state highway sites, but it would appear that it does not significantly influence cracking. On the local authority sites the low speed sites have more cracking than the moderate and high speed sites (shown in figure 5.22). Underground services where there are a lot of seal joint cracks are the most likely cause for this increase as they are more predominant on the 50km/h sites. Analysis of cracking at high speed environment showed there was a significant difference in average number of cracks per site between local authority sites and state highway sites (p -value = 0.090).

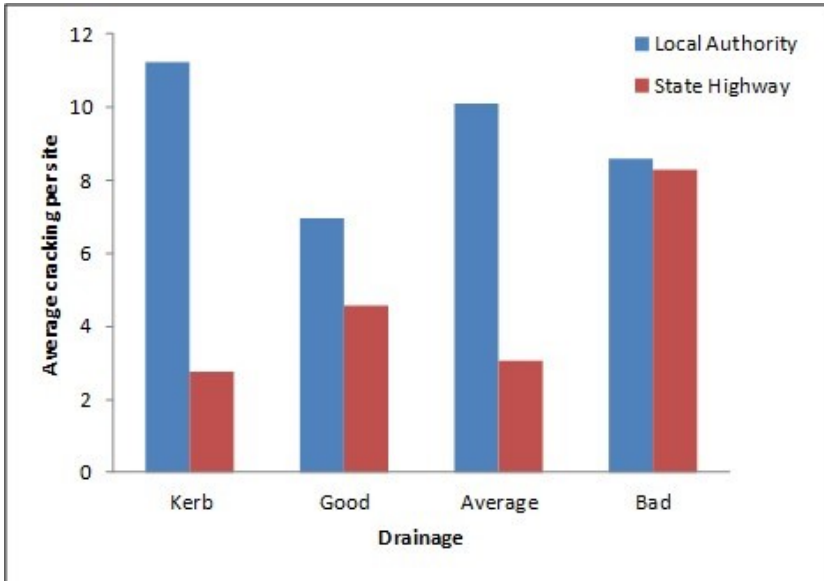
Figure 5.23 Average cracking per site vs drainage

Interestingly the local authority kerb and channel sites are the poorest performers with the most cracking, as shown in figure 5.23. On the state highway sites there is an increase in cracking for bad drainage only.

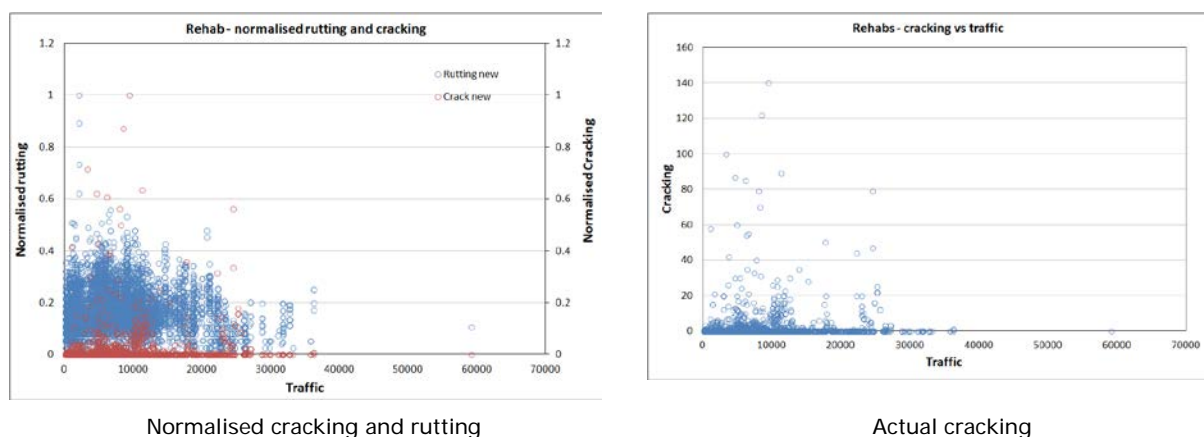
In order to compare rutting and cracking levels for rehabilitation sites, both values were normalised for their extreme values. Therefore both could be assessed on a scale from 0 to 1 (refer to figure 6.12). The figure on the left hand compares the rutting and cracking levels for rehabilitation sites. The figure on the right contains all the cracking information for the sites that were rehabilitated.

Figure 6.12 Levels of cracking and rutting for rehabilitation sites

- It is obvious that rutting is more of a driver for rehabilitation than cracking. This is evident from the trend that the bulk of the normalised rutting is higher than that of cracking.
- Cracking levels are much lower during rehabilitation than crack levels during resurfacing (compare both right-hand plots from figure 6.12 and figure 6.13).
- There were some isolated sections where the cracking was considered as outliers (more than 20% cracking). It is assumed that these sites displayed a significant level of decay.

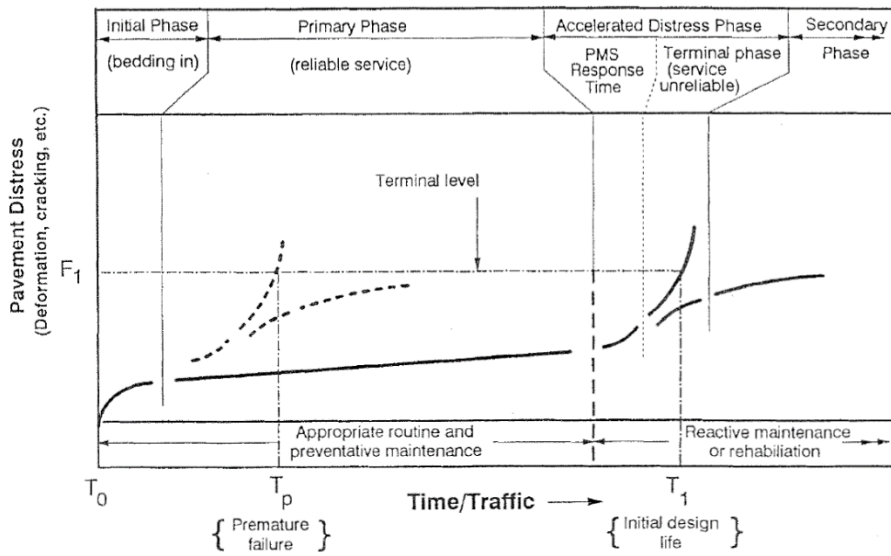
This research has also shown that the type of treatment is as important a decision as the timing of the treatment. For example, a section that displays rutting in combination with cracking should receive immediate intervention. The window where a resurfacing can still make a difference to the life of a pavement is relatively short (refer to figure 6.16).

Figure 6.16 Optimal intervention timing for pavements

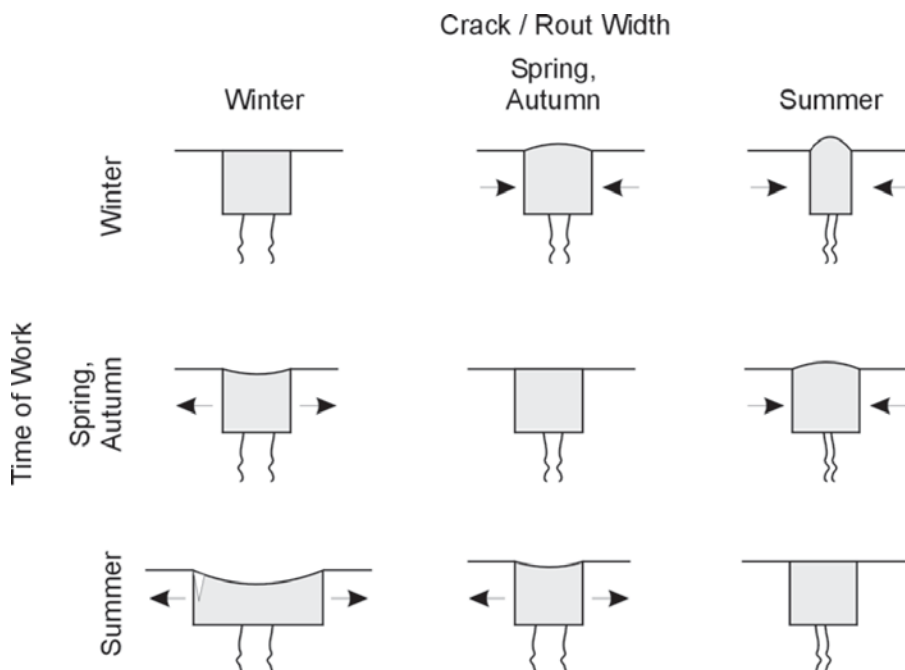
- edge break (spalling) – the edges of the crack break away as a result of poor routing or sawing
- pick-up – the sealant is pulled out of the crack by tyre action
- tracking of the sealant – the sealant has been picked by vehicle tyres or has bled in hot weather.

Figure A.2 Effects of crack sealing at temperature extremes
