RIPRAP PROTECTION OF BRIDGE ABUTMENTS

Transfund New Zealand Research Report No. 181

Auckland Uniservices Ltd, University of Auckland

Eve N.J., and Melville B. W. 2000. Riprap Protection of Bridge Abutments. *Transfund New Zealand Research Report No 181*. 31 pp.

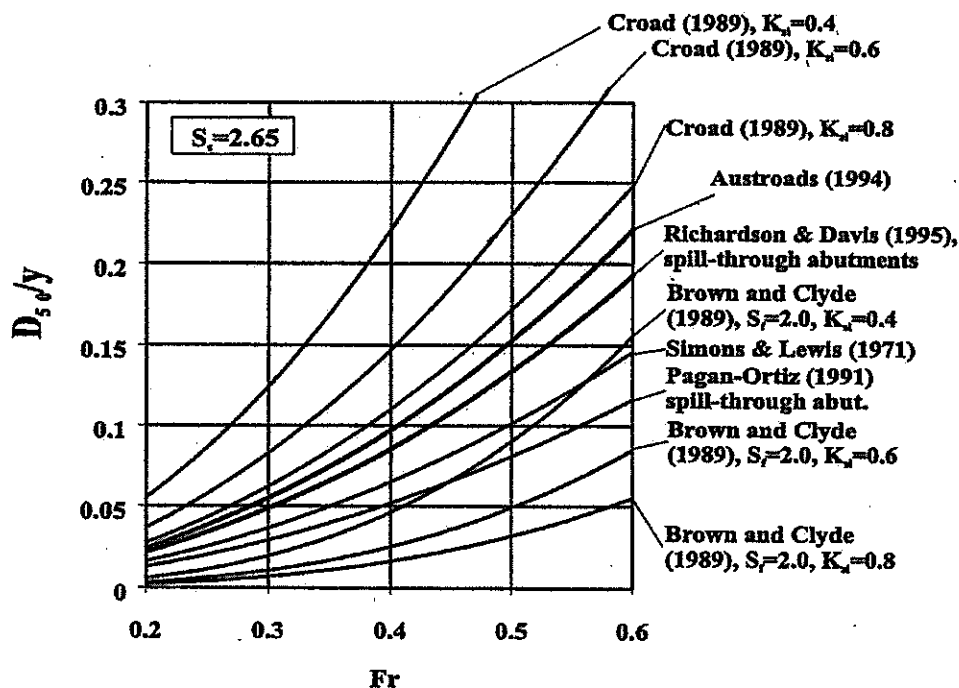
Figure 1.1 Comparison of equations for riprap sizing at bridge abutments (Melville and Coleman, 1999).

Melville and Coleman (1999) carried out an extensive review of available literature. Equations for estimating riprap sizes are summarised in this work. Melville and Coleman compared the equations graphically, for a specific gravity (S_s) value of 2.65. This is shown below in Figure 1.1. It can be seen that the various equations give a wide range of recommended riprap sizes. The equation given by Croad (1989) is conservative in comparison with the other equations and is likely to lead to conservative riprap size. The modified equation by Croad is:

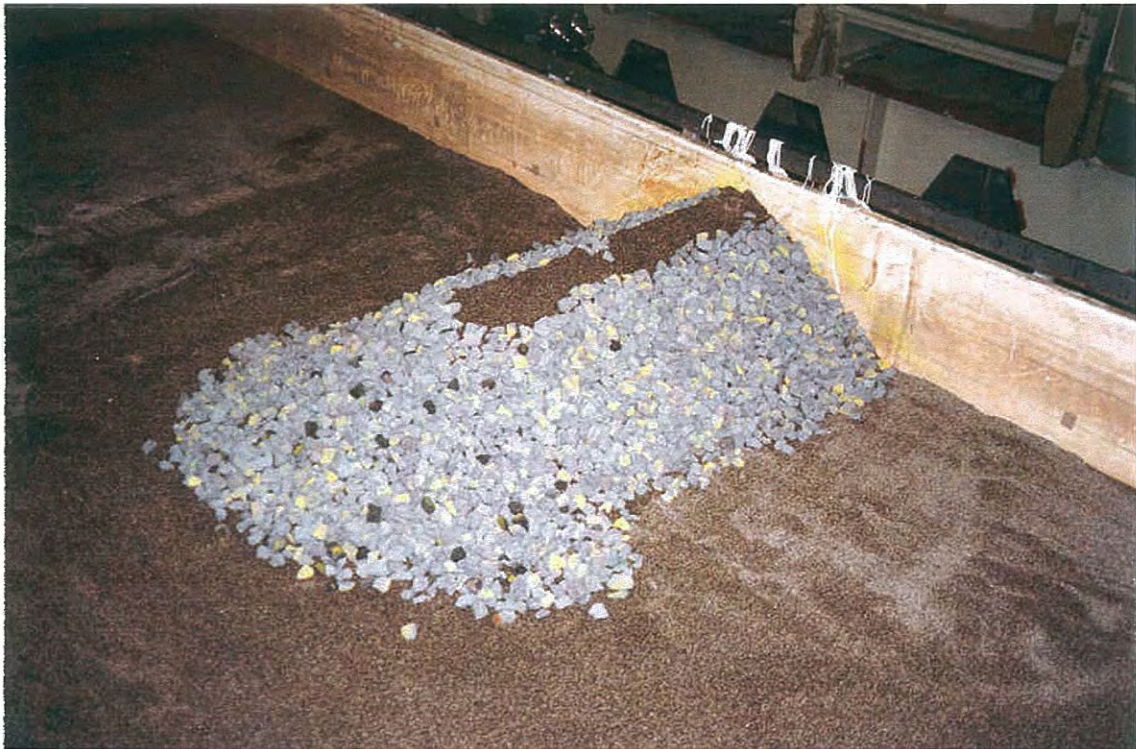
Figure 2.1 An abutment model ready for testing.

An abutment was constructed in the sediment recess section, by levelling the bed and then filling the mould with bed sediment. The mould was removed and riprap placed in the desired configuration. An abutment ready for testing is shown in Figure 2.1.

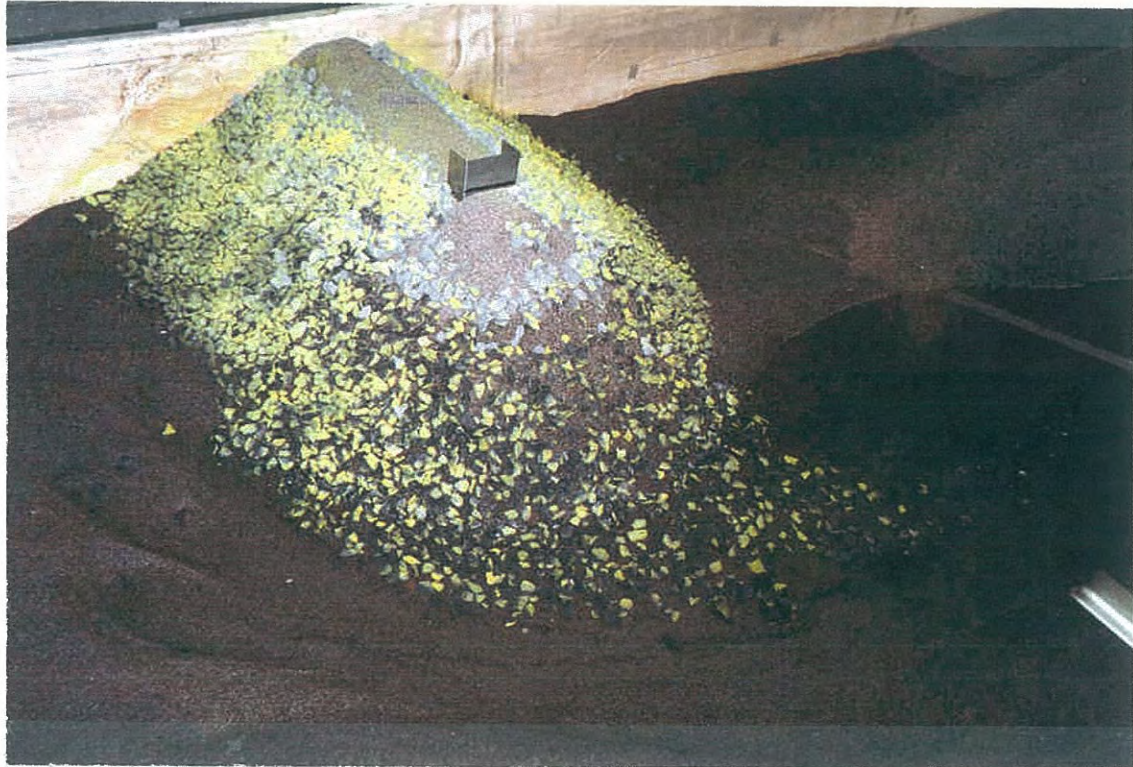
(a) Total failure.

Figure 2.2 Types of observed results under clear water conditions.

- **Total failure**, where large-scale movement of abutment material and riprap had occurred on the abutment slopes. The slope of the abutment embankment had slumped to a gentler slope, and large areas of sediment were exposed with no riprap protection.
- **Partial failure**, where riprap and sediment movement had initiated in one part of the embankment, but not resulted in a change of the embankment slope as a whole. Typically, partial failure was observed at the water level, with a small number of riprap stones displaced a small distance down the embankment slope, and at the base of the embankment, if undermining of the toe had occurred.
- **No failure**, where no change could be seen in the embankment slope, and the sediment and riprap on the embankment slope had maintained their original positions.

The three types of result, total, partial or no failure, are illustrated in the following figures, Figure 2.2 (a) to (c). If there was any doubt as to what type of failure had occurred, the more conservative option was taken.

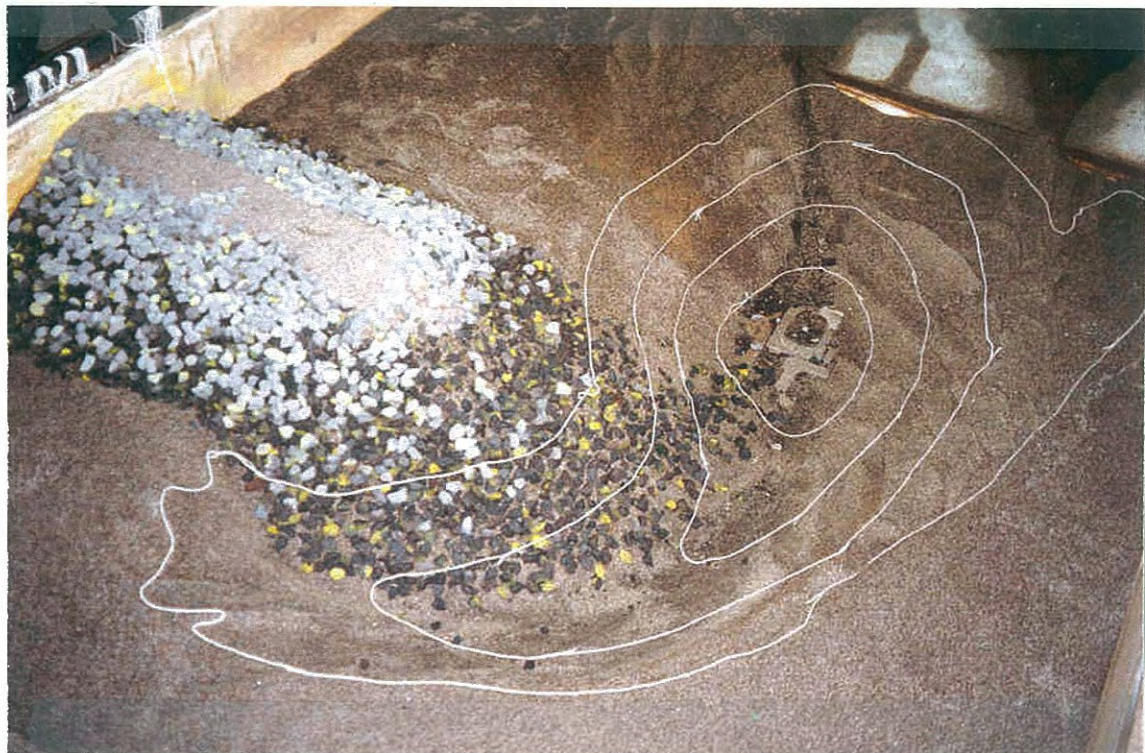
(b) Partial failure.

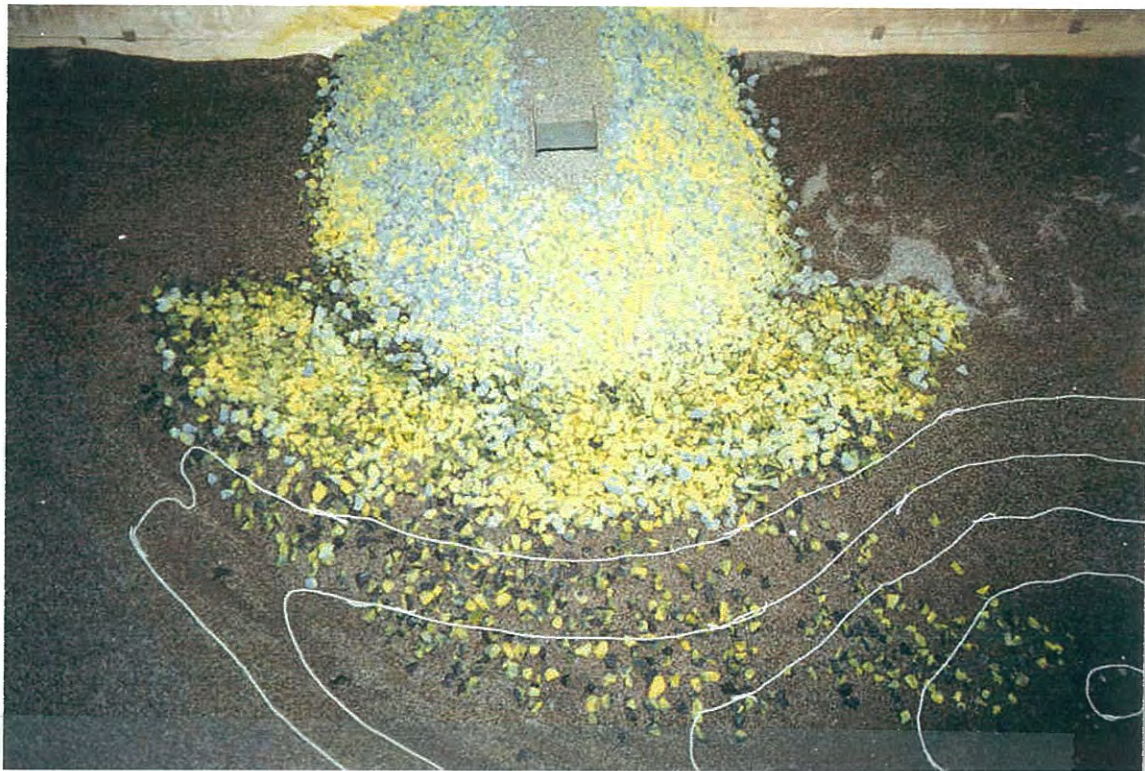
(c) No failure.

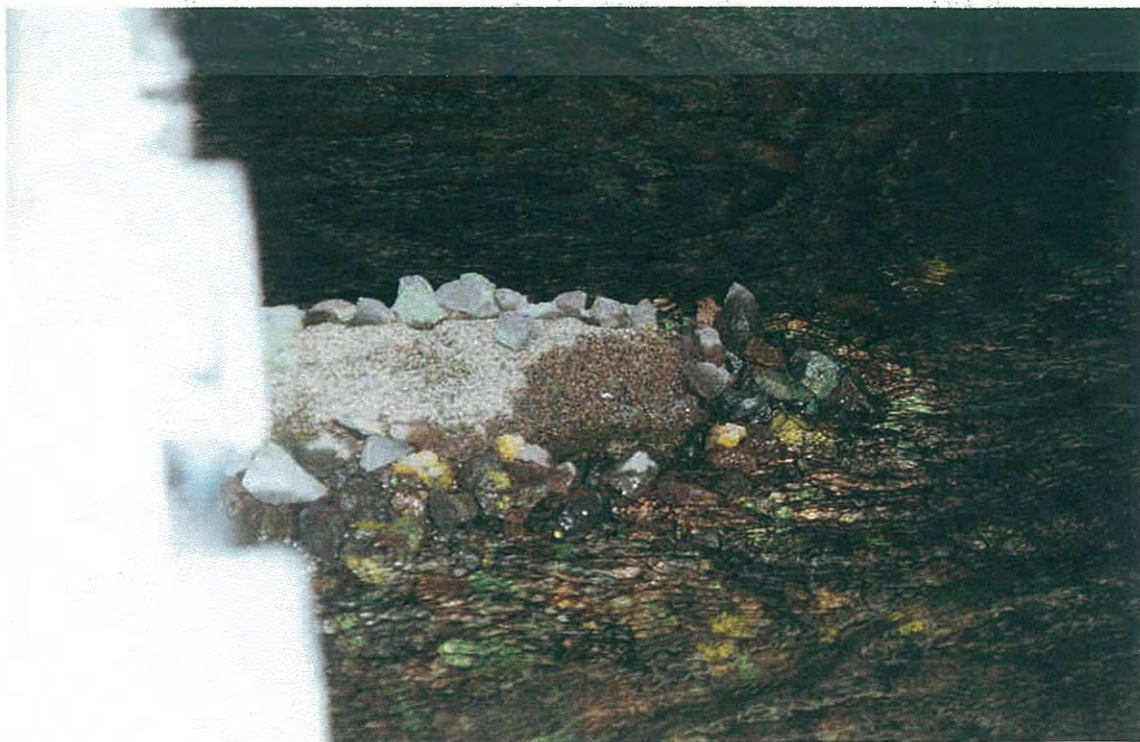
(a) Catastrophic rapid failure (no filter fabric).

Figure 2.3 Types of failure for an abutment under mobile bed conditions.

- **Catastrophic rapid failure** (no filter fabric), where the abutment sediment was rapidly winnowed from between the riprap stones. The abutment was rapidly flattened, with no structural integrity remaining.

The three types of failure are illustrated in Figure 2.3 (a) to (c). The failure illustrated in Figure 2.3 (b) is considered less catastrophic than the failure illustrated in Figure 2.3 (a), due to the differing time scales. Failure of the abutment with no filter fabric occurred very quickly, whereas failure of the abutment due to exposure of the filter fabric footing was more gradual, and, in a real situation, would give more time for warning the public.

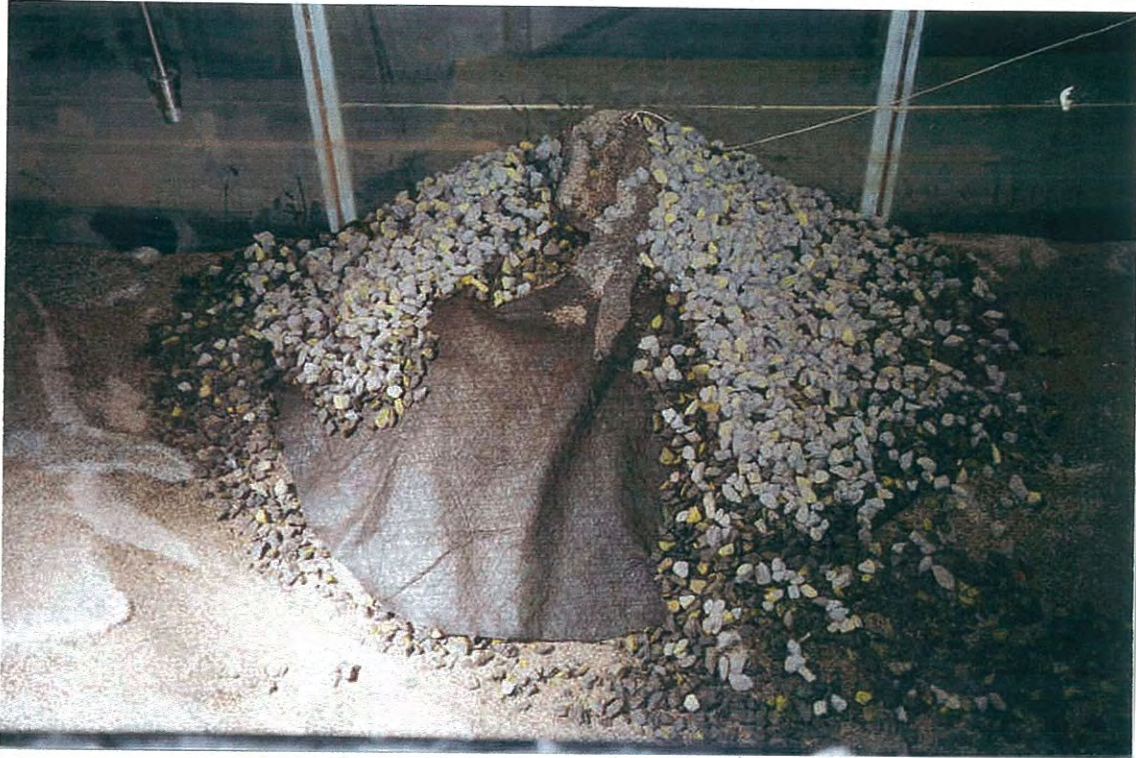
(b) Failure due to exposure of the filter fabric at the abutment toe, allowing slumping of the sand embankment.

- **Slumping failure**, where the abutment failed due to the exposure of filter fabric at the toe of the abutment, allowing slumping of the sediment beneath the fabric. If exposure of the filter fabric at the toe occurred before a stable slope had been achieved on the side slopes of the scour hole, the sediment beneath the fabric would be rapidly eroded by the flow. This led to slumping of the sediment, reducing the height of the abutment. In a severe case, this led to overtopping of the abutment.

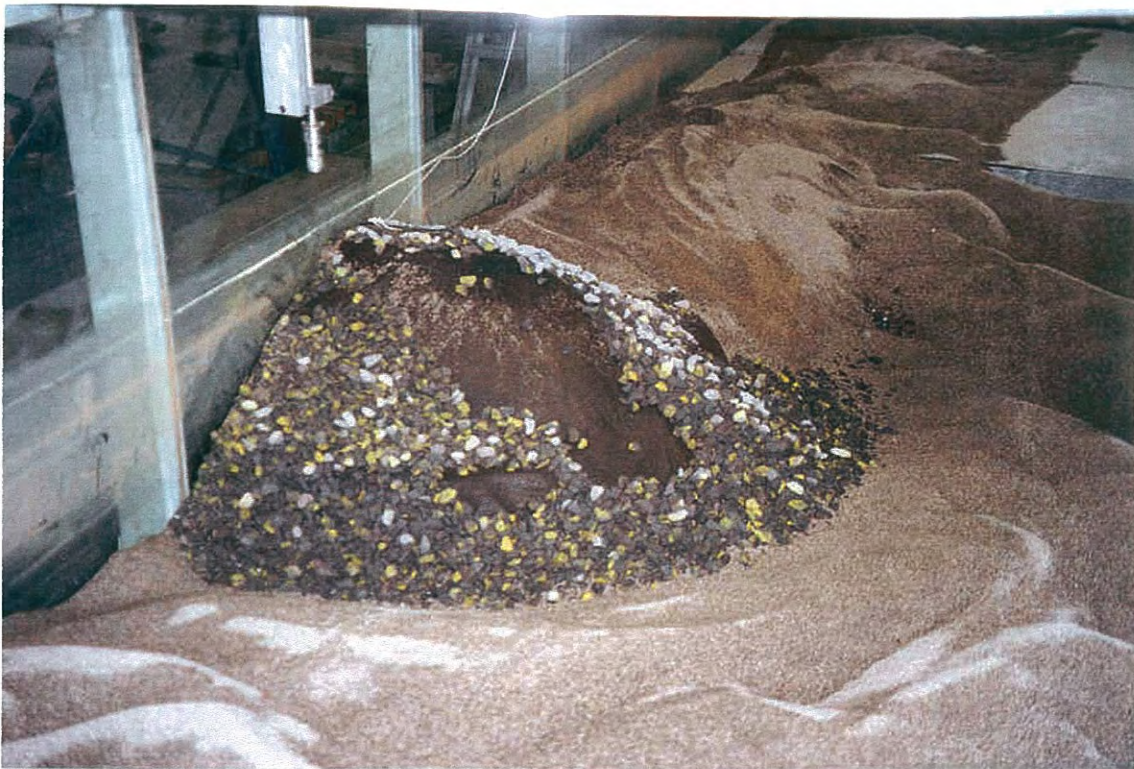
(c) Riprap failure

- **Riprap failure**, where the sediment foundation was still intact at the end of the test but the riprap blanket on the embankment slopes had failed. This failure type can vary in severity, depending on the amount of filter fabric exposed.
