**Watercutting – investigating
the lifecycle of watercutter
rejuvenation of aggregates
February 2008**

Land Transport New Zealand
Research Report 336

J. C. Waters, Surfacing Development Engineer
B. D. Pidwerbesky, General Manager Technical
Fulton Hogan

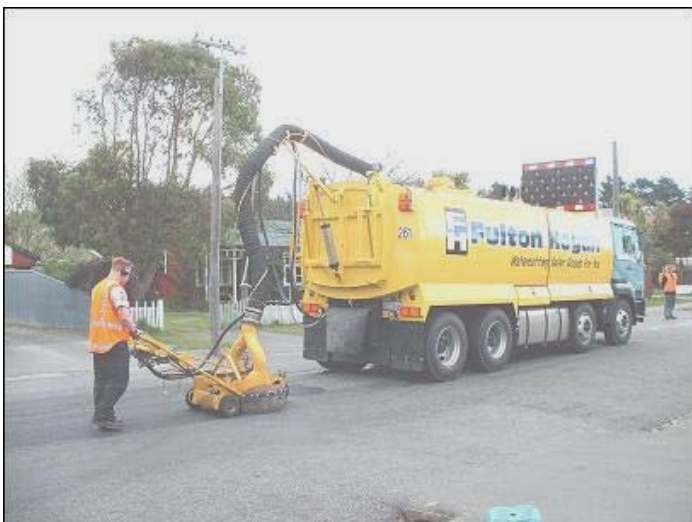
Figure 2.2 Water supply and vacuum recovery system.

The UHP watercutter equipment comprises the truck-mounted UHP pump, water supply, vacuum recovery system and an independently operated umbilical deckblaster (see Figure 2.2) that directs the very high-velocity water jets at the road surface. The watercutter's cutting head has an effective cut width of 560 mm and can restore macrotexture on the road surface (Figure 3.1). As no heat is used in the process, binder is easily collected within the unit's recovered material tank for recycling.

The recovered product tank on the truck has been designed to cope with the difficult material removed from the road surface. The recovered product contains approximately 20%–30% bitumen-based binder and 20%–30% fine aggregate, which settles in the tank. The tank has been designed as a tipping body with a steep tipping angle and a large

Having an operator on the ground with the deckblaster, see Figure 2.2, means that only those areas of the road surface that require treatment can be easily identified and treated. This maximises the useful work achieved, minimises the fuel used and minimises wasted energy. A system mounted entirely on a vehicle cannot deliver this flexibility and efficiency.

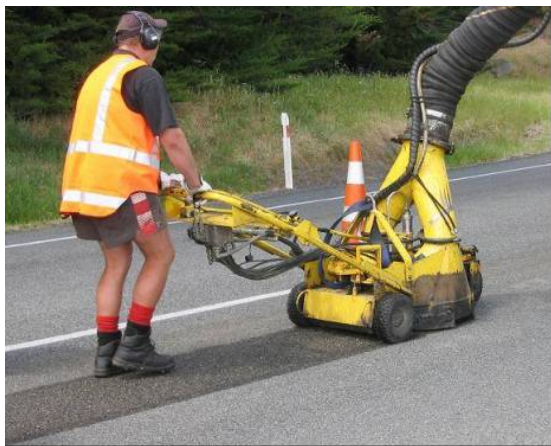
Figure 3.1 Watercutting during the Tai Tapu trials.

Watercutting was carried out at various operating speeds of the watercutting device on a polished site on State Highway 75 past Tai Tapu, see Figure 3.1. The microtexture of the surface was measured before and after treatment with the British pendulum to identify the appropriate target speed to deliver both optimum retexturing and minimised damage to the chipseal integrity.

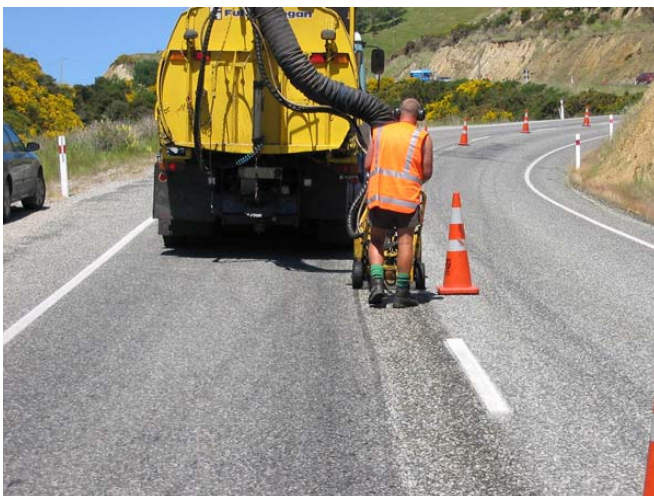
Figure 4.3 Watercutting at Tunnel Hill.

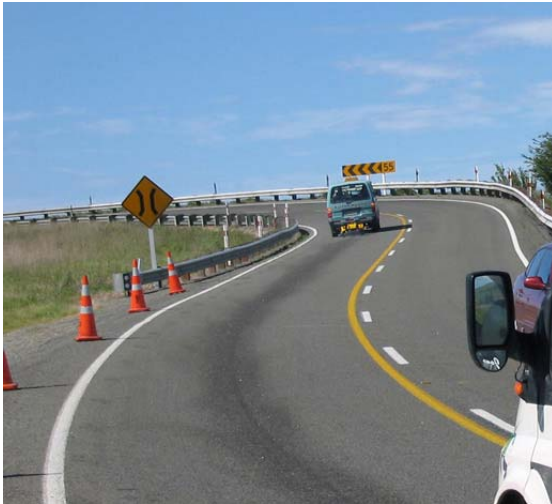
Figure 4.5 Griptesting between the wheelpaths at Tumai Overbridge site.

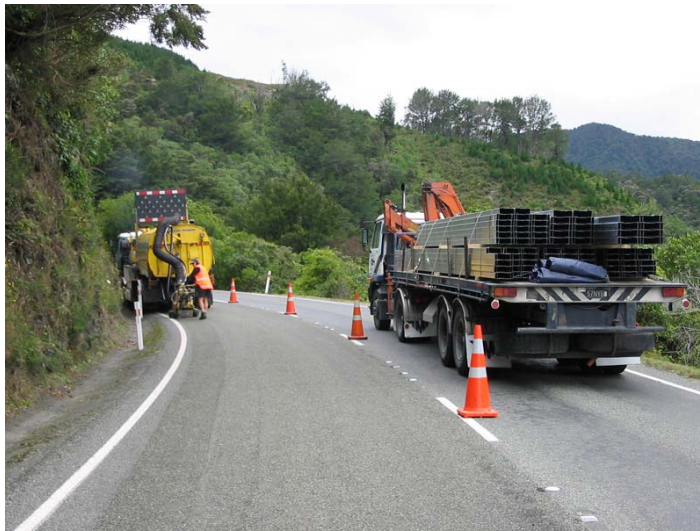
Figure 4.7 Watercutting at Whangamoia Saddle site.

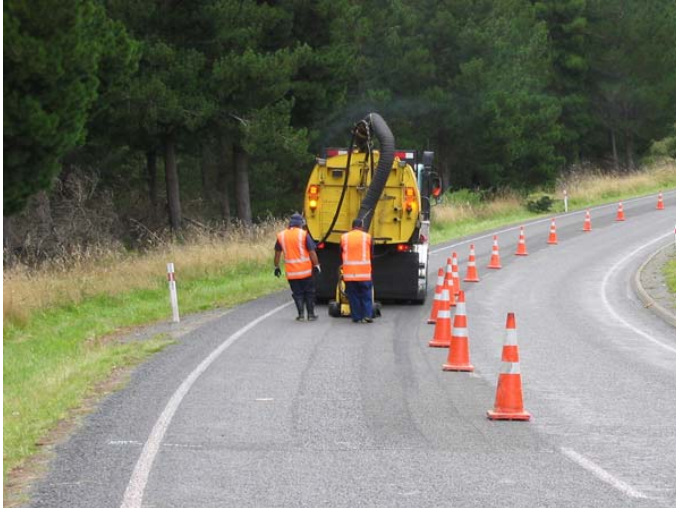
Figure 4.13 Watercutting on Wishing Well site facing southwest.

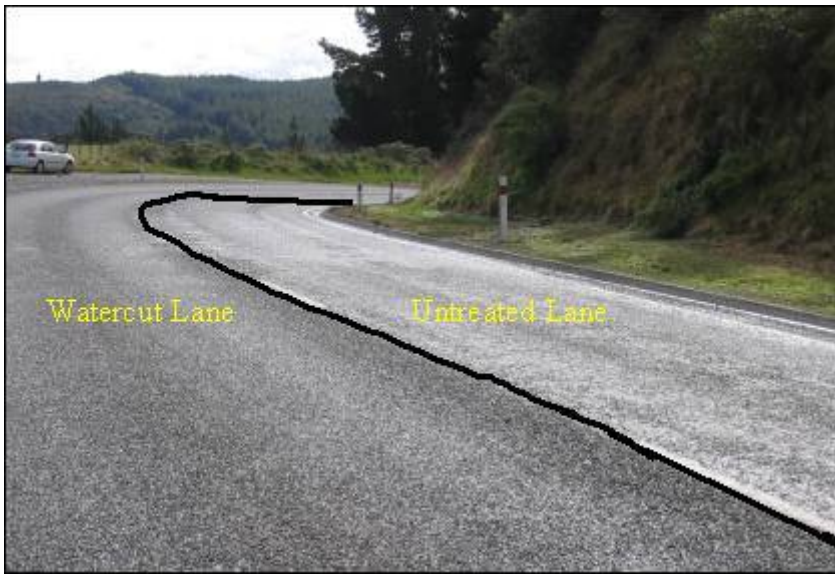
Figure 4.14 Poppewells Road site 17 months after treatment.

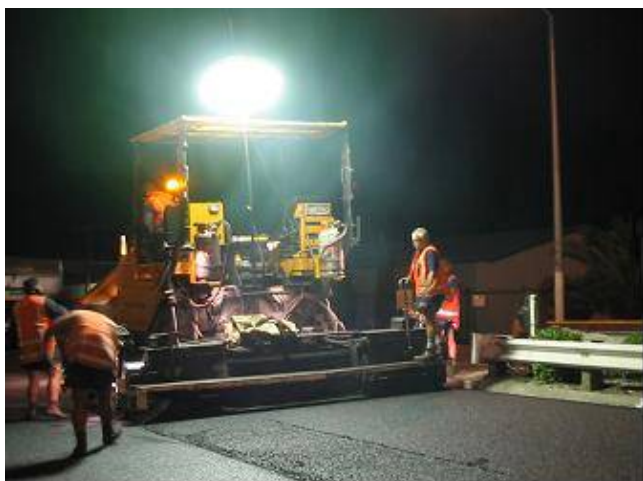
Figure 4.16 Laying SMA on Rosebank site.

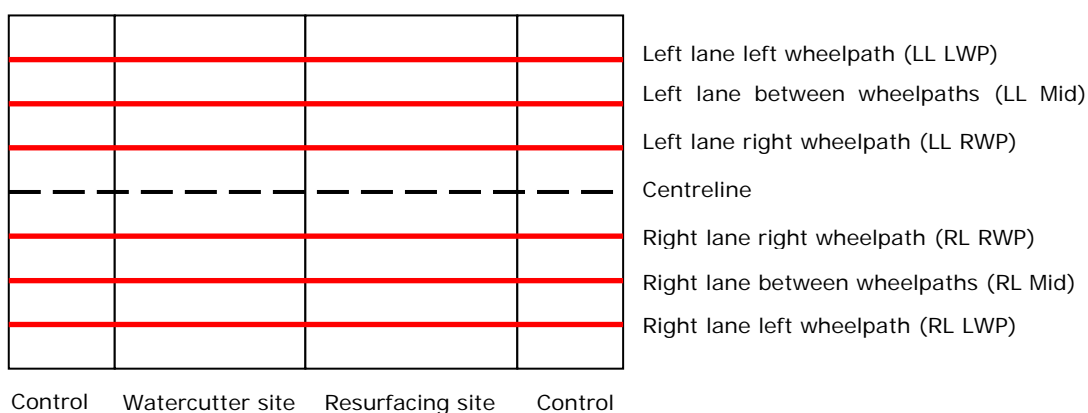
Figure 5.1 Preferred trial site layout.

Griptesting was carried out on the site immediately before and immediately after watercutting of the polished surface, then at intervals of approximately six months for two years from the time of watercutting. A minimum of two runs per test line (see Figure 5.1) was carried out to check consistency and repeatability, and these were averaged if considered acceptable. If there were significant variations caused by line deviation, further test runs were carried out until the variation in the surveys was considered acceptable. There was no consistent increase or decrease between surveys that could have been explained by surface washing or rubber contamination from previous runs. The general absence of these phenomena in the testing could be easily explained as the test runs were not a perfect overlap.

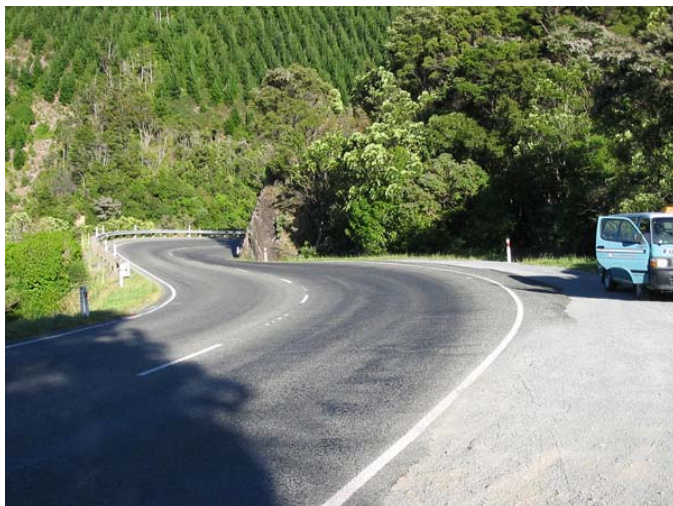
Figure 6.1 Bitumen tracking from below Whangamoia Hill site.

The new grade 3 chipseal lost chip and was fragile during the first summer. The new grades 3 and 5 chipseal had problems with rollover and Figure 6.1 shows the excess bitumen from the surface being tracked towards the watercut section.

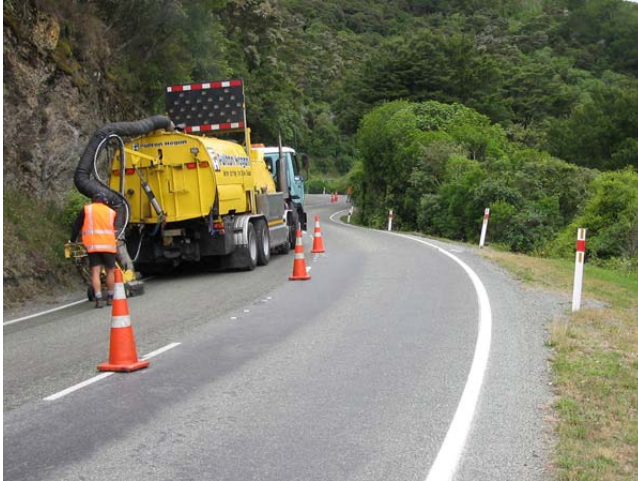
Figure 6.2 Flushed, rutted wheelpath on Whangamoia Hill site.

The first 60 m of the left lane of the watercut section had a pavement repair and was surfaced with a two-coat grades 2 and 4 chipseal. The right wheelpath in the area of the repair was identified as flushed and rutting (see Figure 6.2) during the course of the 'before' testing so it had not been watercut as it was likely to fail.

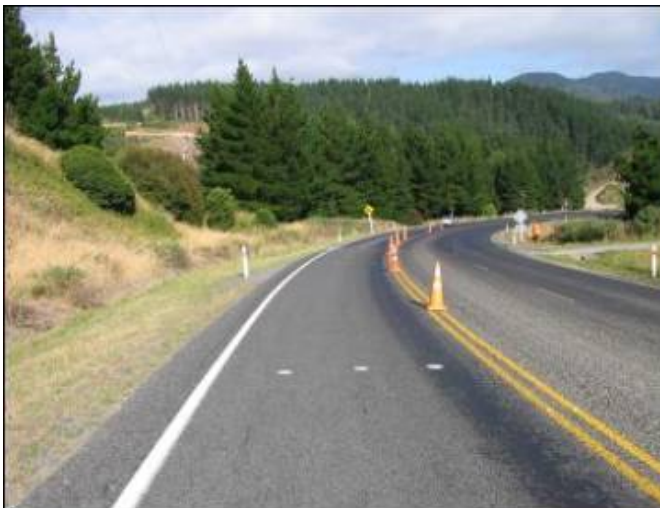
Figure 6.3 Turangakumu Hill site looking south.

The right wheelpath of the watercut lane (right lane) was affected by the construction and failure of the chip seal on the left lane. See Figure 6.3.

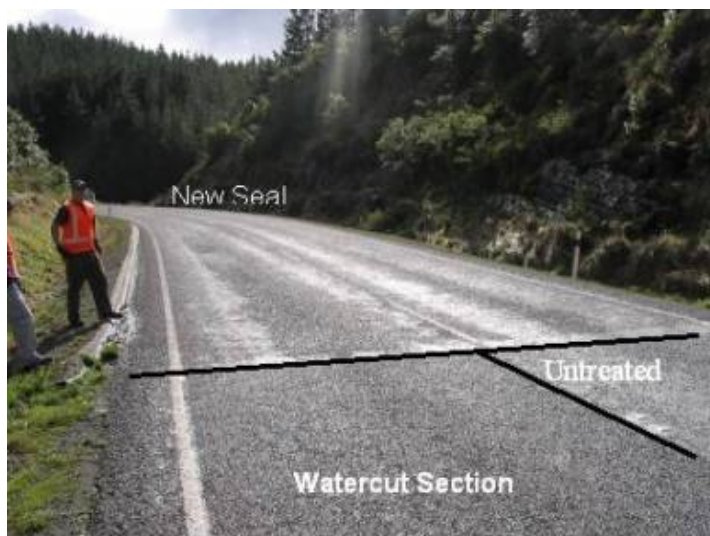
Figure 6.4 New chipseal on Wishing Well site six months after construction.

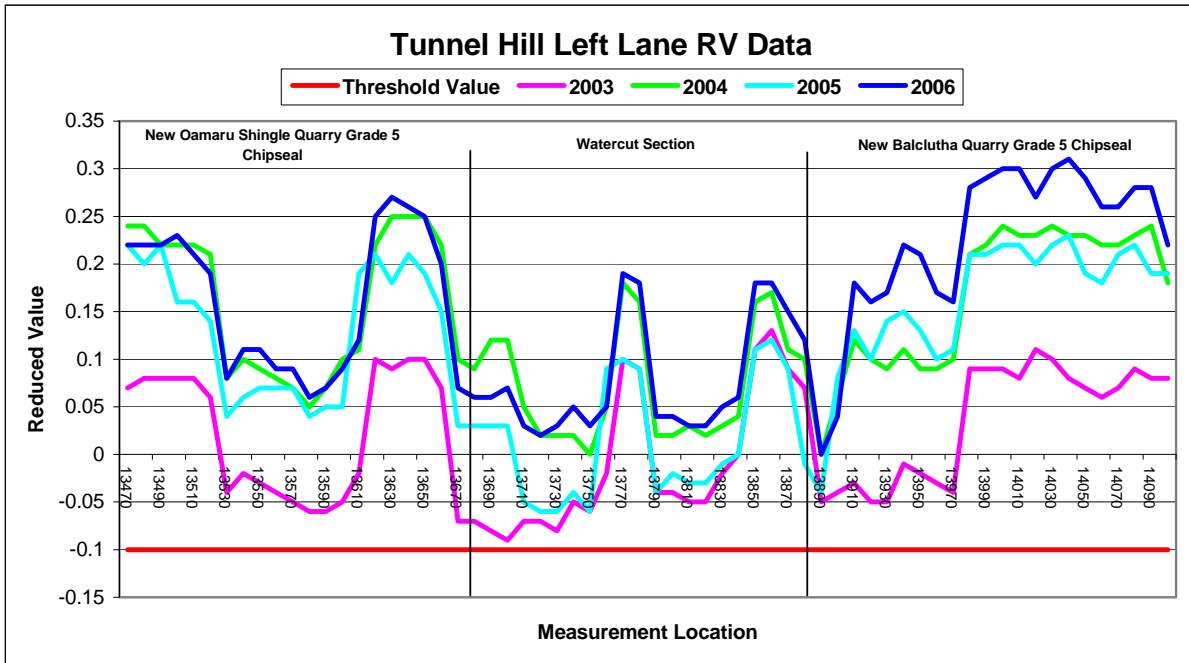
Appendix 6: Tunnel Hill monitoring data

SCRIM+ reduced value data analysis

The reduced value data represents a calculation comparing the combined measurement of the microtexture in both wheelpaths of the lane with the investigatory level (IL) for each 10 m length of the lane. The threshold level (TL) is set at 0.1 lower than the IL.

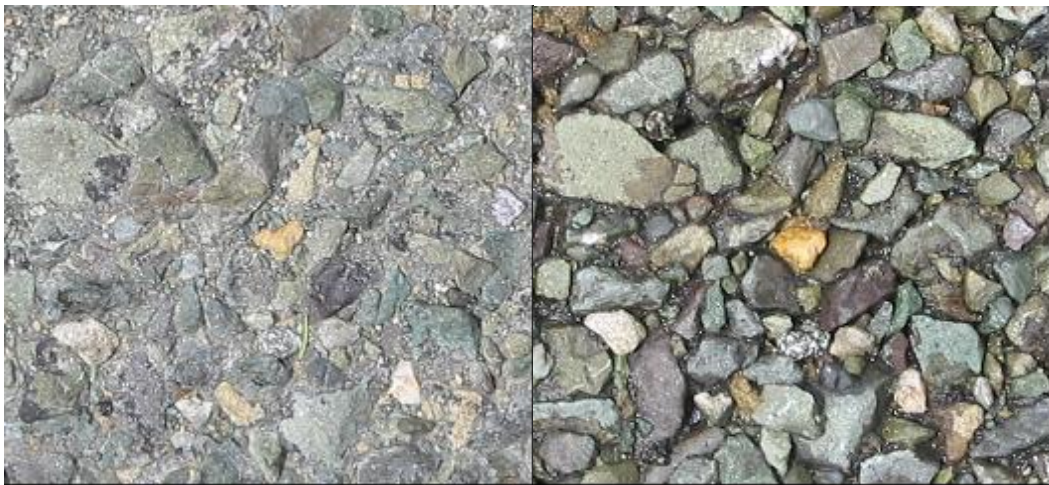
Figure A1. Whangamoia Saddle – surface before and after watercutting.

The surface (above left) before watercutting was dull and full of detritus compared with the freshly watercut surface (above right).

The site had steep banks above and below it, with frequent slips during heavy rainfall all year round. The detritus was tracked up and down the site filling the texture and contributing to the polishing of the aggregate.

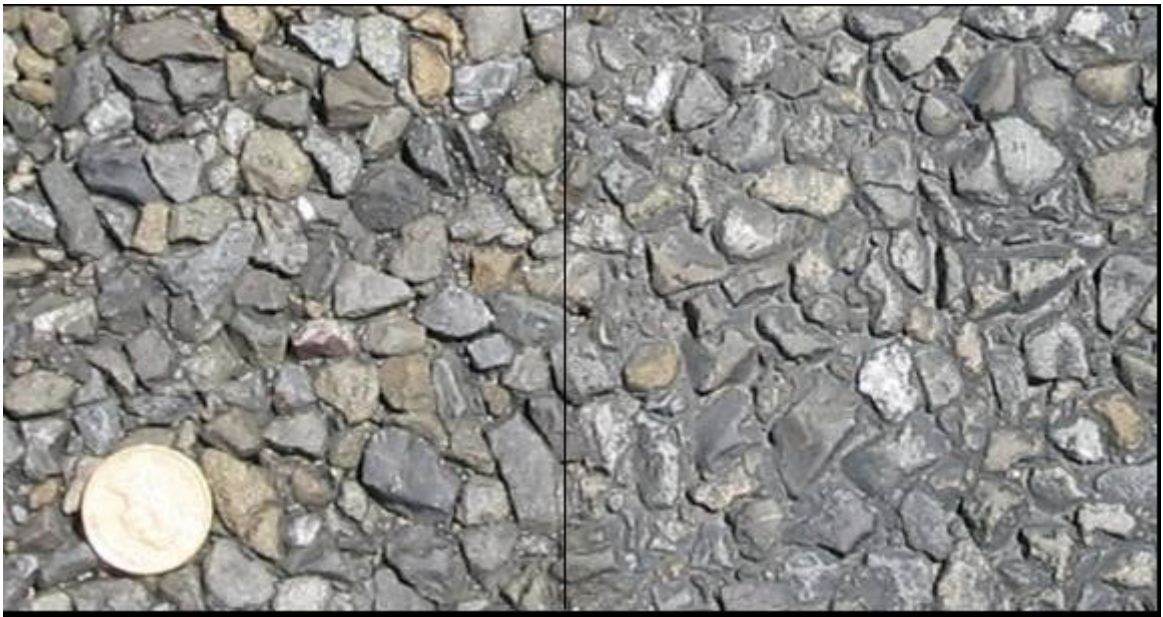
Figure A2 Watercut surface left of line and untreated 16-year-old chipseal right.

The chipseal was 16 years old when watercut and the grade 3 chip was well worn with a build up of road grime in the voids (see Figure A2). The watercutting removed the grime and sharpened the surface increasing the microtexture. The site was on a short radius curve with high traffic counts that had been steadily increasing over the 16 years of the seal's life.

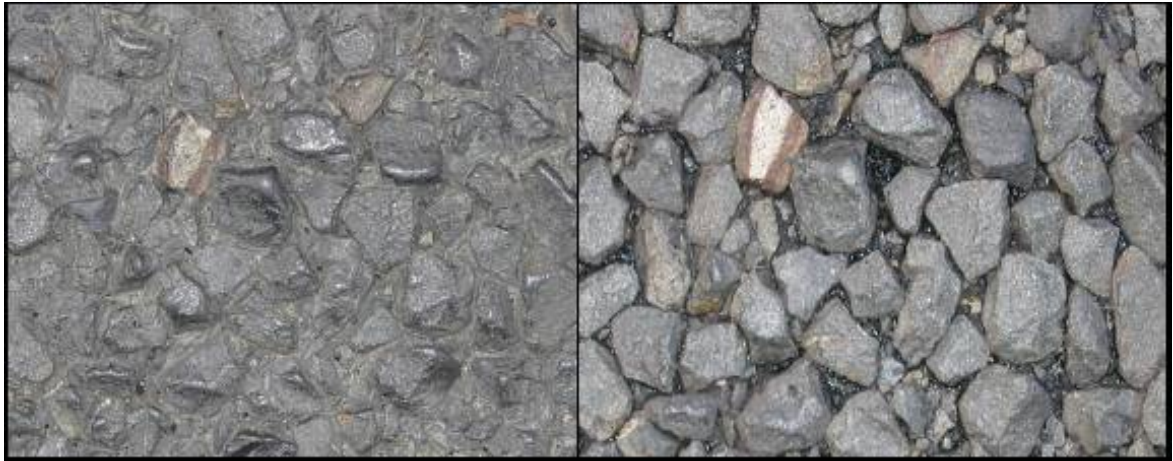
Figure A3 Wishing Well before (left) and after (right) watercutting.

Investigation of the polished surface showed that the points and edges of the exposed surfaces of the large chip were rounded and blackened by possibly tyre rubber and bituminous contamination (see Figure A.3 below).

The small contact surface footprint of the test tyre on the road surface caused by the coarse surface of large chip seal had contributed to the accelerated polishing resulting in the low microtexture measured on this site. Figure A.3 shows the rounding and contamination on the tips of the chips, which would only serve to reduce the measured microtexture further.

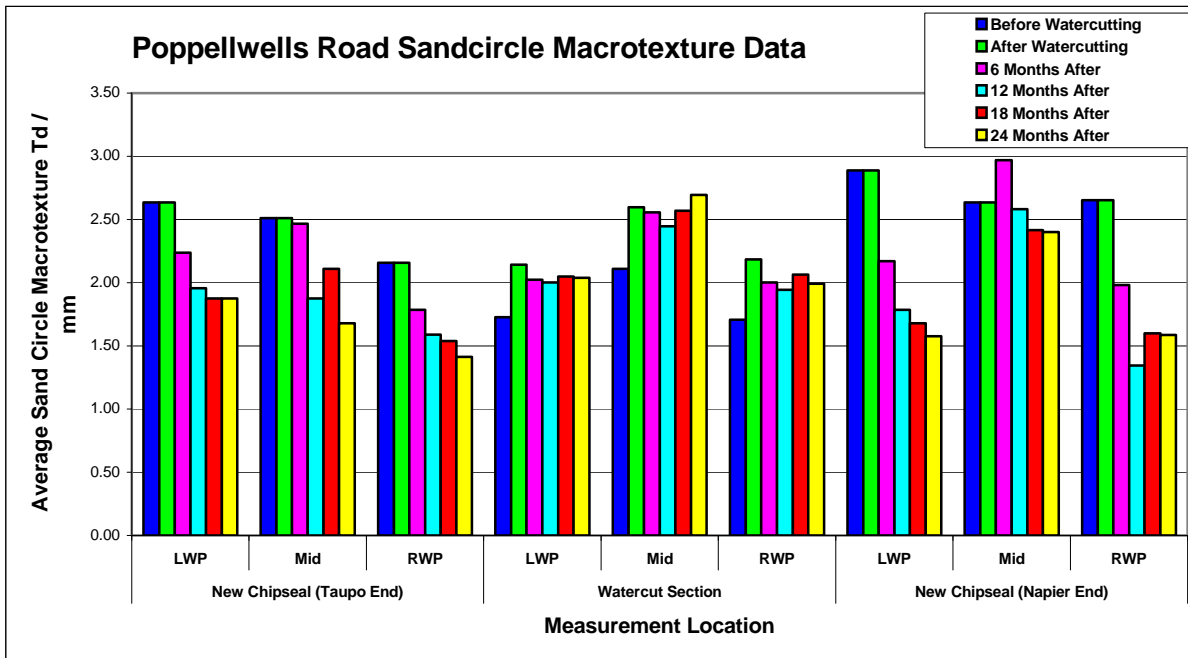
Sand circle macrotexture data analysis

- Average sand circle macrotexture measurements showed an increase of 0.46 mm Td after watercutting the surface.

- Sand circle measurements showed that 24 months after watercutting the average macrotexture of the watercut section was still 0.39 mm Td higher than that measured before the surface was watercut.

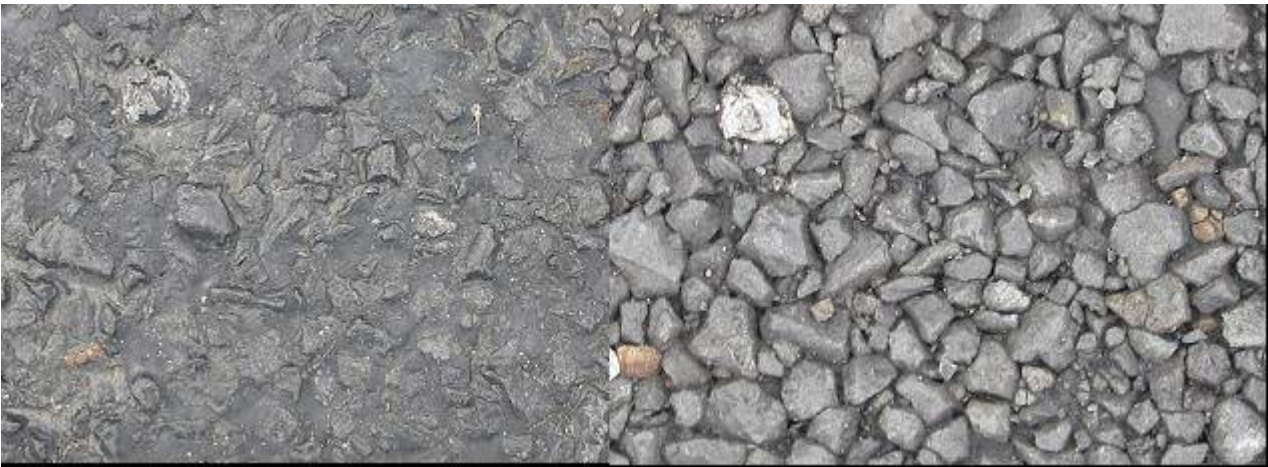
Figure A4 Poppellwells Surface before (left) and after (right) watercutting.

The surface was constructed using a two-coat chipseal with sealing chips with a PSV of 54. As can be seen from calculations for the Turangakumu and Wishing Well sites, which had similar input data, this was probably not the correct aggregate for the site as it had a

combination of events radius $\leq 250\text{m}$ and down gradient $>5\%$ and $<10\%$ that would have contributed to the polishing of the stone.

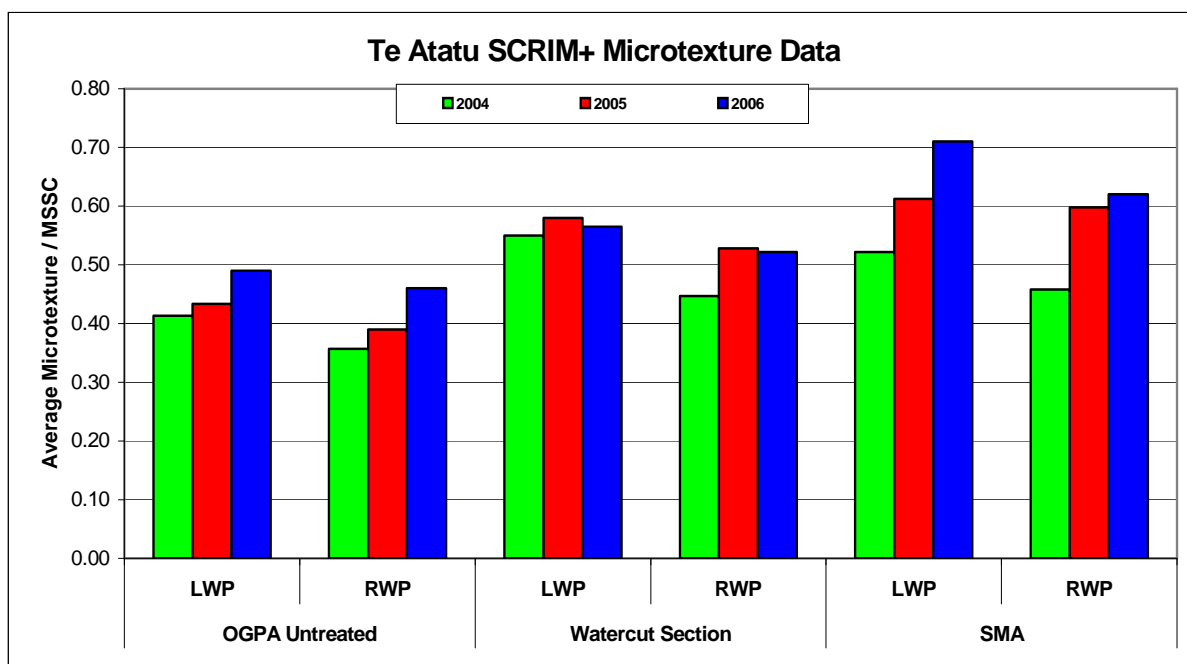
SCRIM+ microtexture data analysis

The average microtexture in the left wheelpath of the watercut section measured in the 2005 SCRIM+ survey, 13 months after the SMA was laid, showed an increase from 0.52 to 0.61 MSSC. The 2006 survey, 23 months after resurfacing, measured 0.71 MSSC showing a further increase as the higher PSV aggregate was exposed by the traffic wearing away the mastic.

The average microtexture in the right wheelpath of the SMA section measured in the 2005 SCRIM+ survey, 13 months after the SMA was laid, showed an increase from 0.46 to 0.60 MSSC. The 2006 survey, 23 months after the resurfacing, measured 0.62 MSSC showing the improvement had remained.

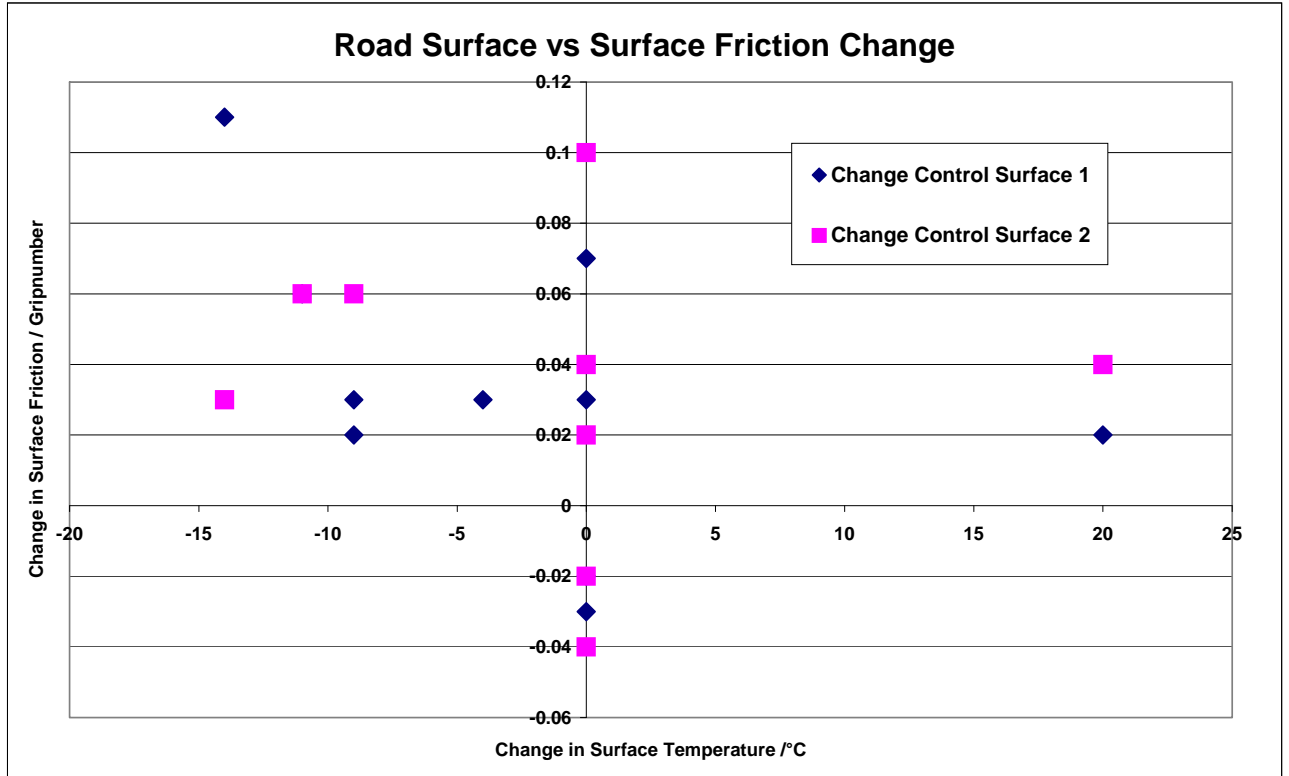
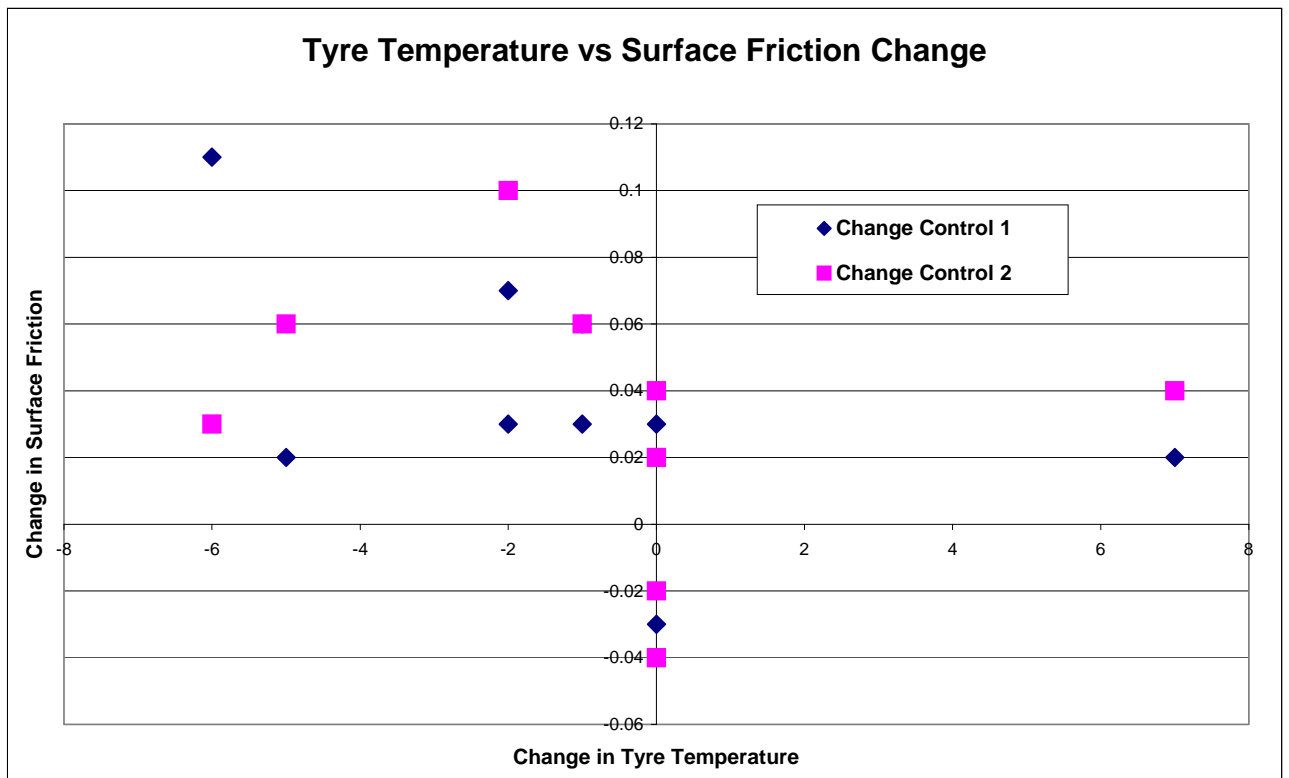
Appendix 16: Surface friction change compared with tyre and surface temperature change
