The Waterproofness of First-Coat Chipseals

October 2009

John Patrick

Patrick, J. 2009. The waterproofness of first-coat chipseals. *NZ Transport Agency research report 390*. 24pp.

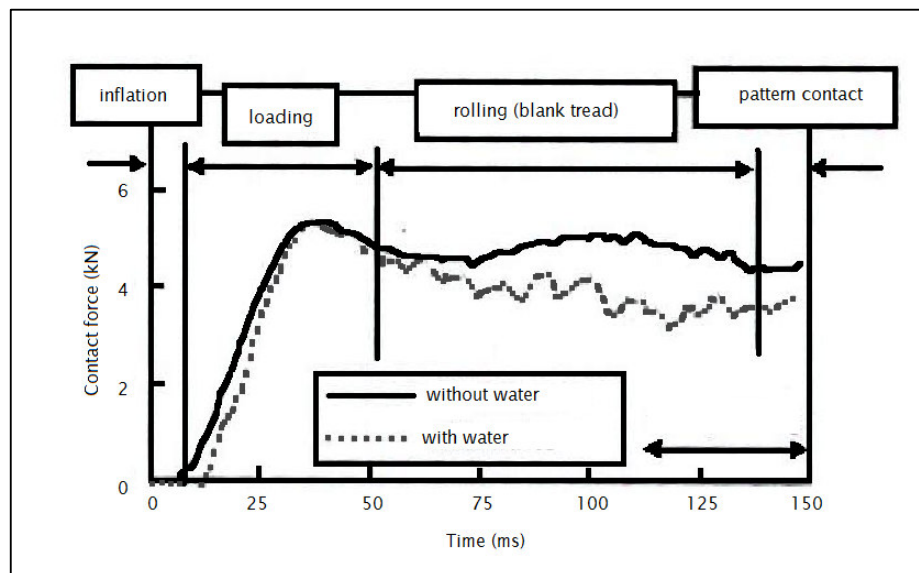
A brief review of the literature associated with aquaplaning (Seta et al 2000) has shown that the pressure generated under a tyre may not approach that of the tyre until aquaplaning occurs. Seta et al modelled the water flow under a tyre as it went through a 10mm deep water film. The illustration (figure 5.2) shows that the pressure on the pavement with and without water is different in the area noted as “rolling”. This difference in pressure is the hydrodynamic uplift force caused by the water not being removed from under the tyre.

Figure 5.2 Pressure on a pavement under a rolling tyre (from Seta et al 2000)

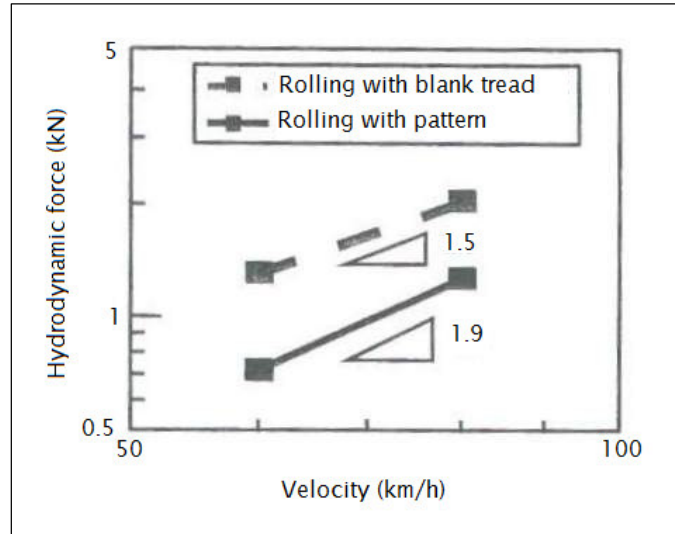
Seta et al (2000) also modelled the effect of vehicle speed and tyre tread, which is illustrated in figure 5.3. This figure shows the effect of tyre tread on the hydrodynamic force and also that this force can double from approx 0.7kN at 60 km/h to approx 1.4kN at 80km/h.

Figure 5.3 Hydrodynamic force as a function of vehicle speed (from Seta et al 2000)

An estimate of the pressure in terms of kilopascals has been made from the details given by Seta et al (2000) and 1 kN of force approximates a pressure of 100kPa.

This analysis shows that water pressures in the order of 100kPa can easily be generated under vehicle tyres. This pressure is of the same order as found in the previous research that generated significant water flow through a chipseal. It is contended that this pressure exerted on a film of water can result in significant water pressure under traffic that is enough to force water through the seal. If the traffic volume is high then the water pressures will not have time to dissipate and the build-up of pore pressure will lead to shear and potholing in the basecourse.

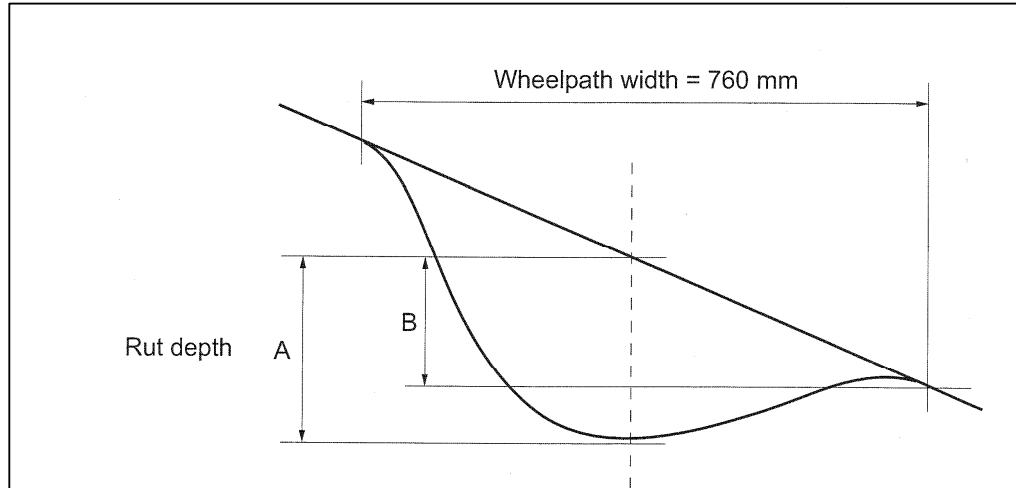
The Queensland Department of Transport (2002) has also looked at water ponding and developed a simple equation relating pavement geometry to water ponding. The relationship is illustrated in figure 5.4. This figure also includes the equation (equation 5.1) required to calculate the depth of water (puddle) that can be formed.

Figure 5.4 Relationship between rut depth and water puddle depth

$$D = A - (3.8 \times C)$$

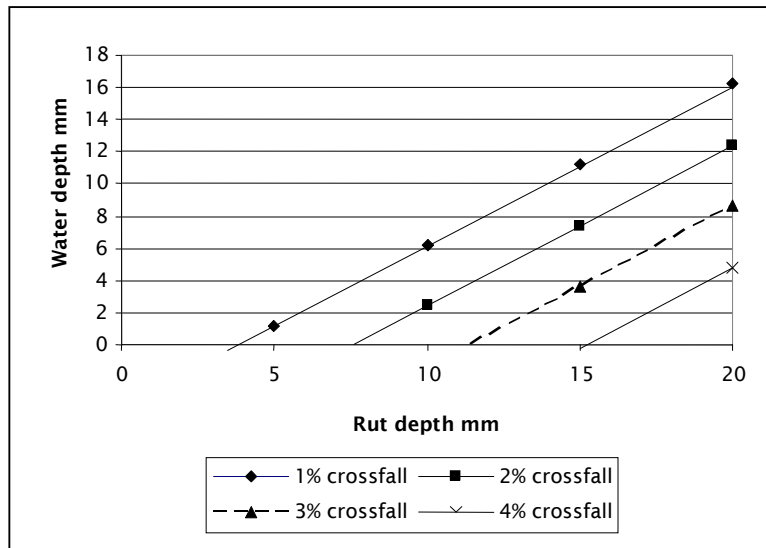
The results of an analysis using equation 5.1 are shown in figure 5.5. It can be seen that a 4mm water depth will form on a 1% crossfall with a rut depth of 7–8mm but a rut depth of 19mm is required to result in the same water depth when the crossfall is 4%. Using this relationship, the water depth that will form on a pavement is illustrated in figures 5.6 and 5.7 for two crossfalls.

Figure 5.5 Relationship between rut depth and water film depth as a function of crossfall

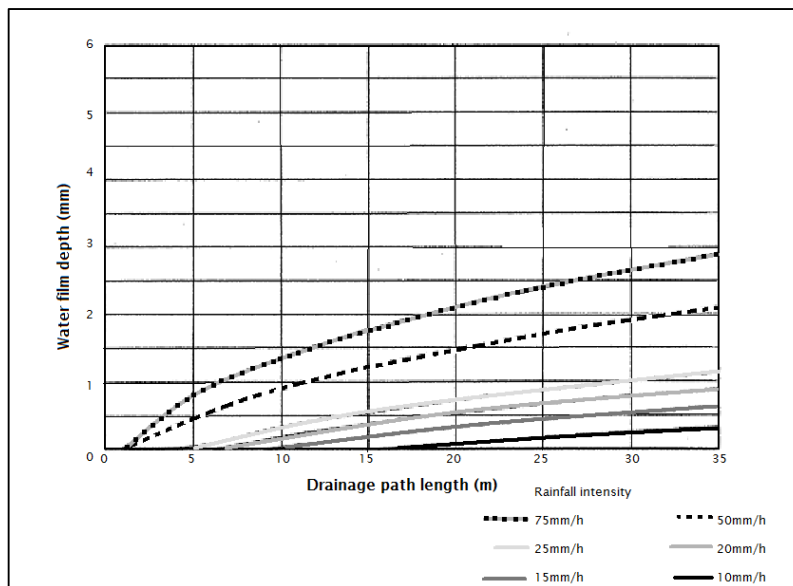
Water can also run along the road and the depth of water can accumulate without any rutting. The effects of drainage length and rainfall intensity on a pavement with a 0.8mm texture depth are shown in figures 5.6 and 5.7 for a 3% crossfall and a 1% crossfall, respectively (also taken from Queensland Department of Transport 2002).

Figure 5.6 Relationship between rainfall intensity, drainage path and water film depth for a 3% crossfall and 0.8mm texture depth

For a 50mm/hr rainfall and a 20m drainage path, the water film thickness increases from 1.5mm for the 3% crossfall to 2.8mm for the 1% crossfall.

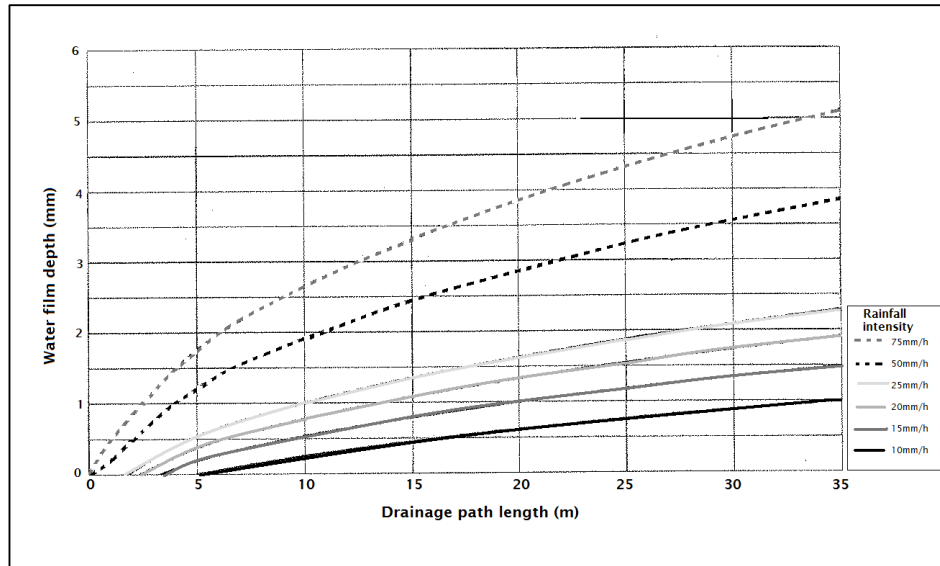
Figure 5.7 Relationship between rainfall intensity, drainage path and water film depth for a 1% crossfall and 0.8mm texture depth
