road safety issues

Auckland state highways

Land Transport New Zealand has prepared this road safety issues report. It is based on reported crash data and trends for the 2000–2004 period. The intent of the report is to highlight the key road safety issues and be a resource to identify possible ways to reduce the number of road deaths and injuries on Auckland state highways.

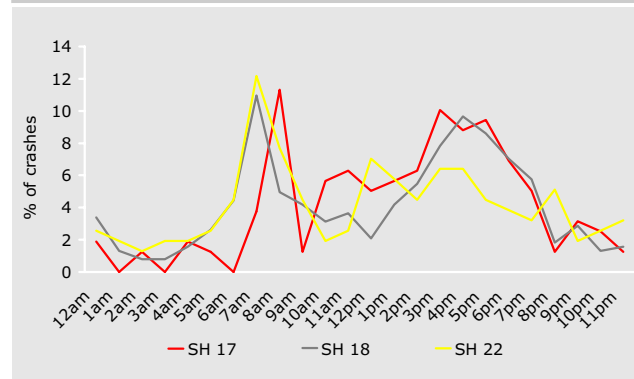
Crash times on SH 17, SH 18 and SH 22 2000–2004

State Highways 17, 18 and 22 (above) show a crash pattern which reflects their usage as commuter routes, while State Highways 1N and 16 (below) show a more even distribution, with a bias toward the afternoon and early evening.

The crash distribution by time of day is similar for State Highways 17, 18 and 22, while 16 and 1N are similar. (SH 1A has too few crashes to make this comparison).

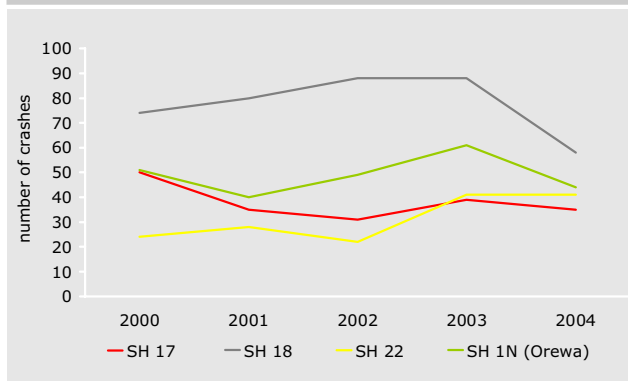
Reported crashes 2000–2004

When comparing these highways and looking at the total number of crashes reported between 2000 and 2004, only SH 22 showed a rising trend.

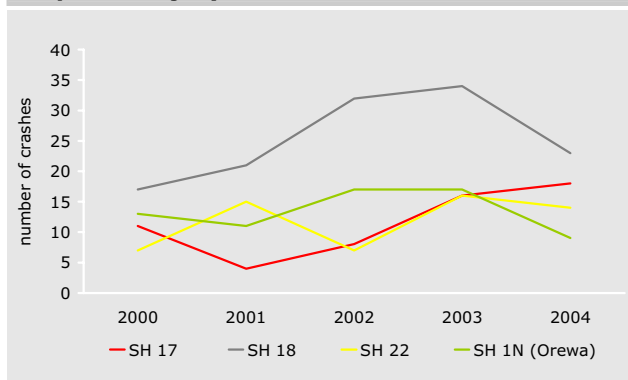
Reported injury crashes 2000–2004

However, as the chart below indicates, all highways except SH 1N at Orewa showed a gradual rise in the number of injury crashes reported, with SH 17 showing the steepest rise (although the differences are not great).

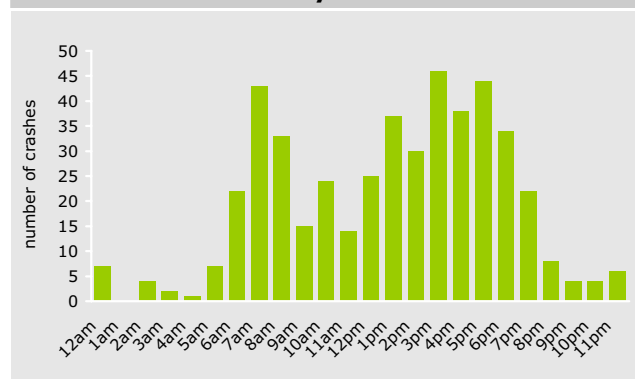
Intersection crashes by hour 2000–2004

Most crashes (78 percent) occurred during the hours of daylight, with a strong bias towards afternoon and early evening.

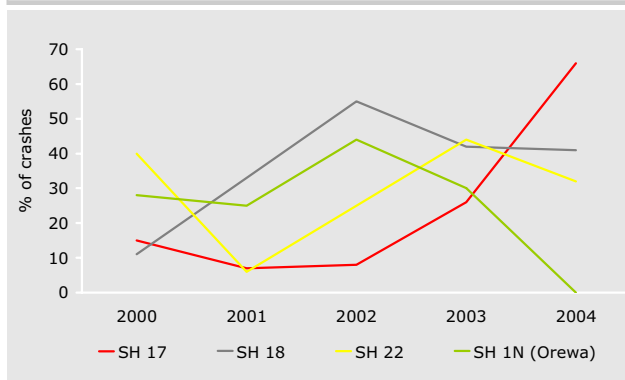
Injury crashes on bends 2000–2004

During this period the number of injury crashes at bends remained relatively constant, however, the number of reported non-injury crashes generally decreased.

The trend on SH 17 should be of concern as the crash distribution is significantly different from the other highways in this group for this type of crash.

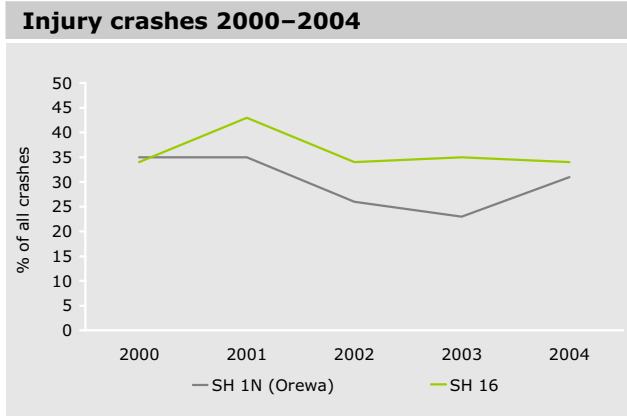
The chart above shows the proportion of injury crashes on each highway. The proportion of injury crashes to all crashes reported can be taken as a proxy for the reporting rate when comparing similar roads. The higher the percentage of injury crashes, the lower the overall reporting rate generally is.

As the relative proportion of injury crashes on SH 16 is higher than that of SH 1N, it could be concluded that the overall reporting rate is lower on this highway. Therefore, it is important that in costing remedial measures for SH 16, this potentially lower reporting rate is taken into account.

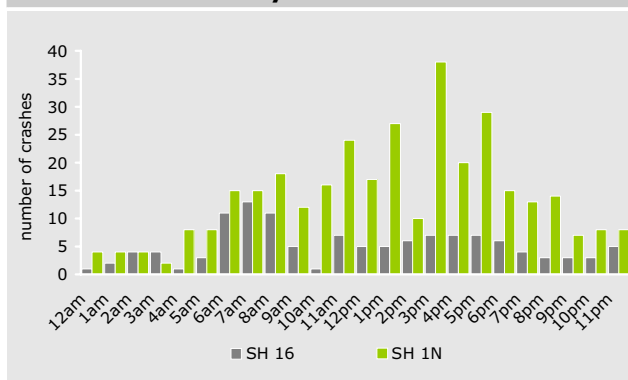
Wet road crashes by hour 2000–2004

Crashes on SH 16 reached a peak in the morning while those on SH 1N climbed steadily toward the mid-afternoon, reducing in the evening.

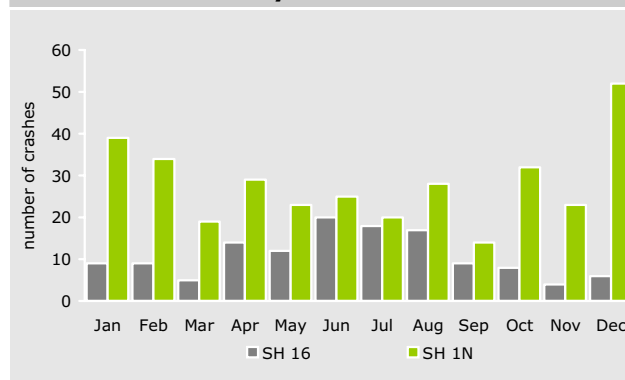
Wet road crashes by month 2000–2004

The seasonal pattern of crashes on these highways is almost a mirror image of each other, with crashes on SH 1N reaching a peak in the summer months while those on SH 16 peaked during winter. It is not clear why this is so, however, it could give an indication as to the most effective time to reseal each highway.
