Speed Management Consultancy Services Panel Technical Assessment Report - SH5 Taupo to Bay View

Rev 1 - October 2020

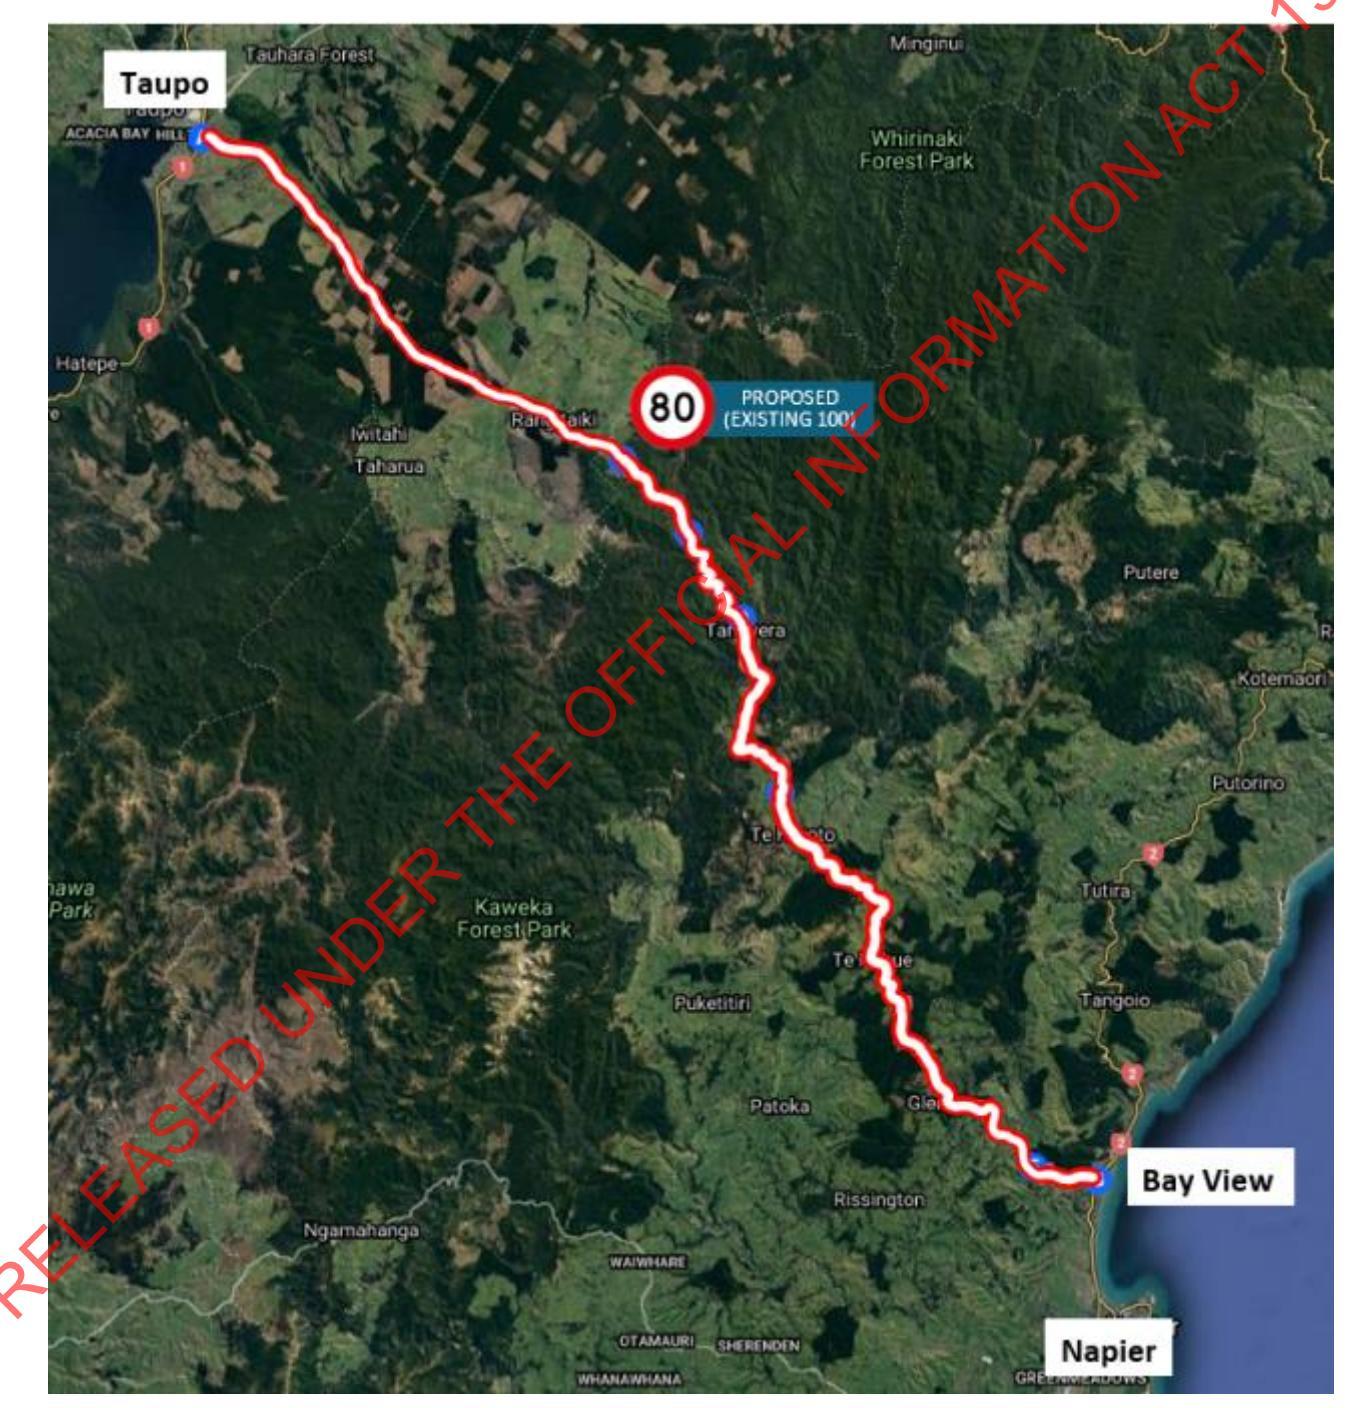
Figure 1 - Proposed Safe and Appropriate Speed Limits for SH5 Taupo to Bay View

This technical assessment has been undertaken via desktop analysis only. It is recommended a site visit be undertaken at a later stage to verify and confirm the results of the desktop technical assessment. A map of the proposed SaAS recommendations for the corridor is shown below in Figure 1.

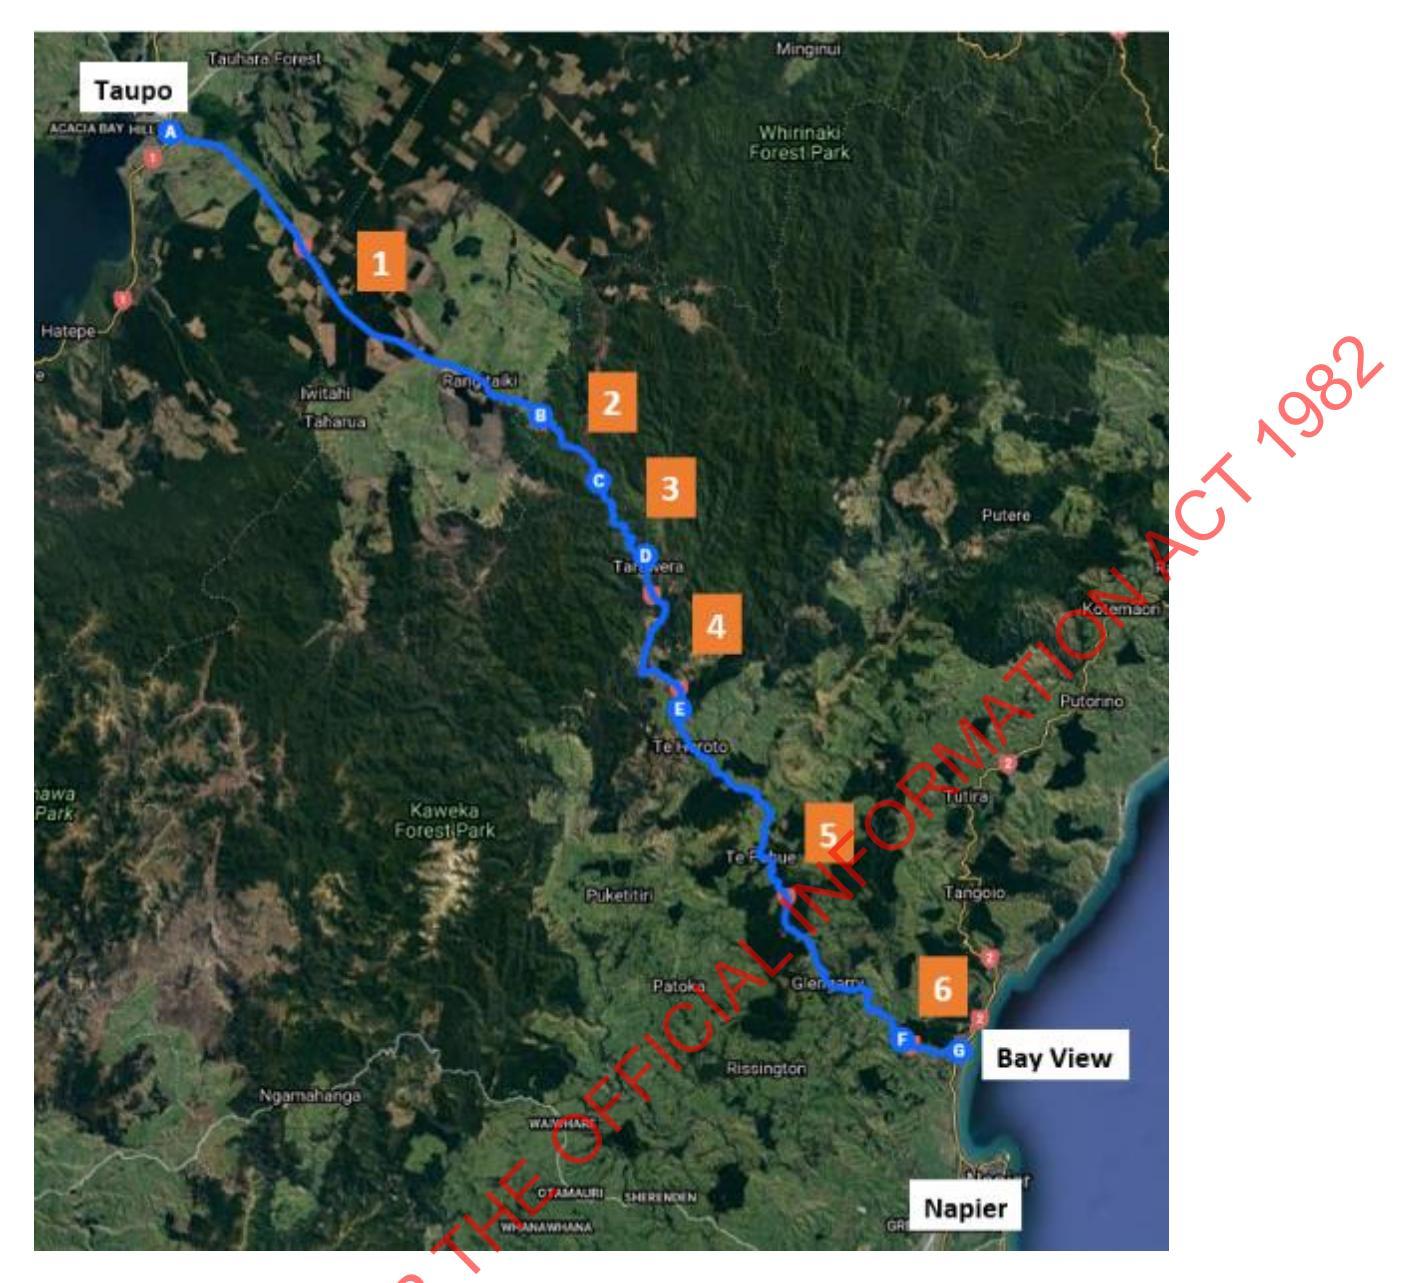
Figure 2 – Aerial Image of the consider homogeneous sections for SH5 Taupo to Bay View

Following site information provided by the NZ Transport Agency, the corridor has been broken down into six homogenous sections for the technical assessment, reflecting the key changes in environment along the corridor. The homogenous sections are outlined below in Table 1. An aerial image showing the six homogeneous sections is also shown below, in Figure 2.

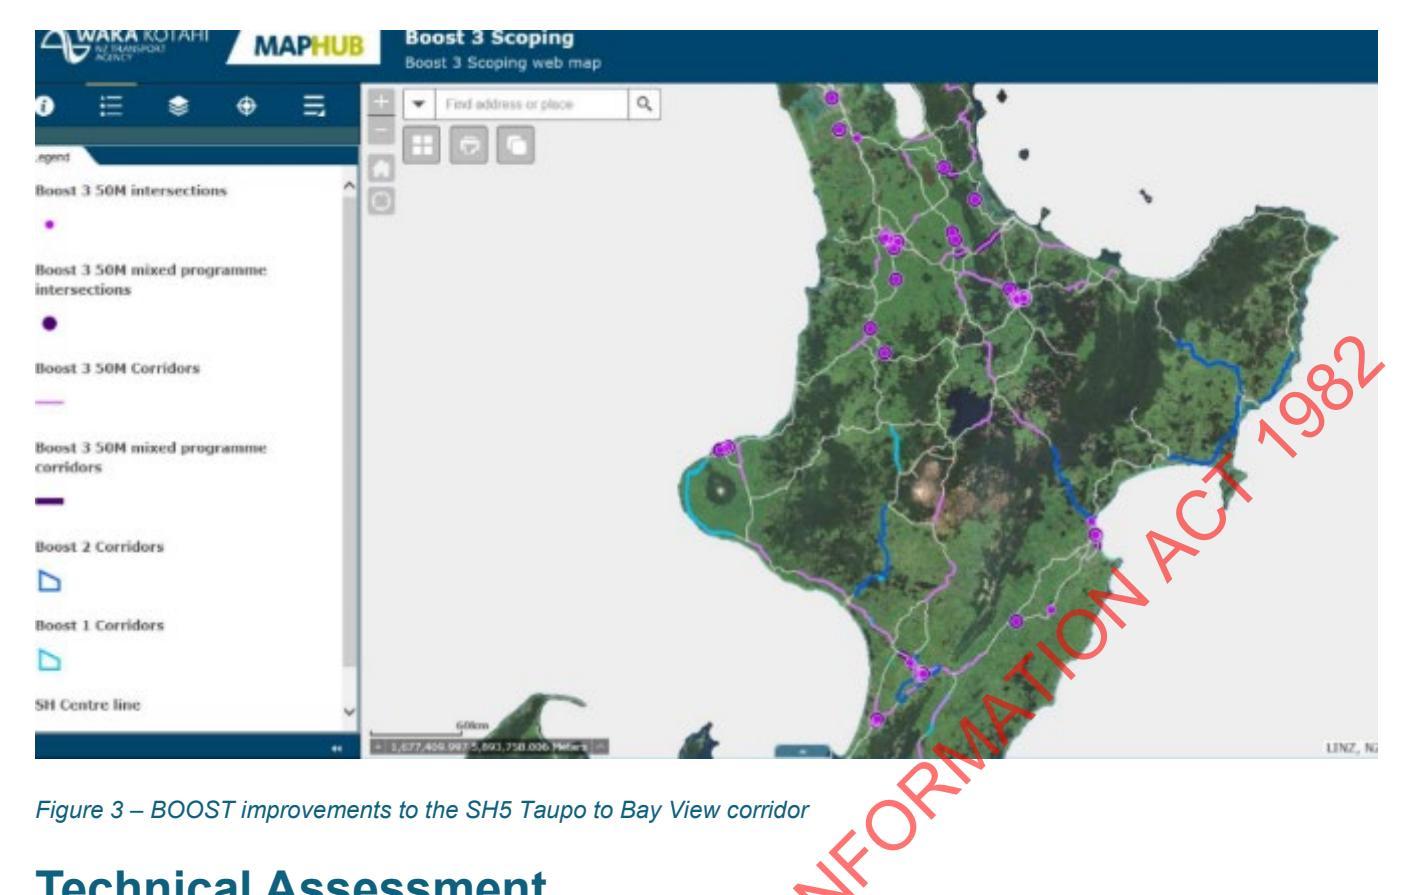
Figure 3 – BOOST improvements to the SH5 Taupo to Bay View corridor

The consultant is aware of Boost 2 works which have recently been completed on SH5. Boost 3 works are also planned for this corridor, as shown below in Figure 3. Works have included installation of ATP, curve signage upgrade, and some additional roadside barrier improvements. It is expected that general maintenance activities will continue to be undertaken as part of the NOC Maintenance Contract. Early identification and discussion with the relevant parties should continue to be undertaken to reduce the risk of conflicts and impact and investigate opportunities for any potential cost sharing.

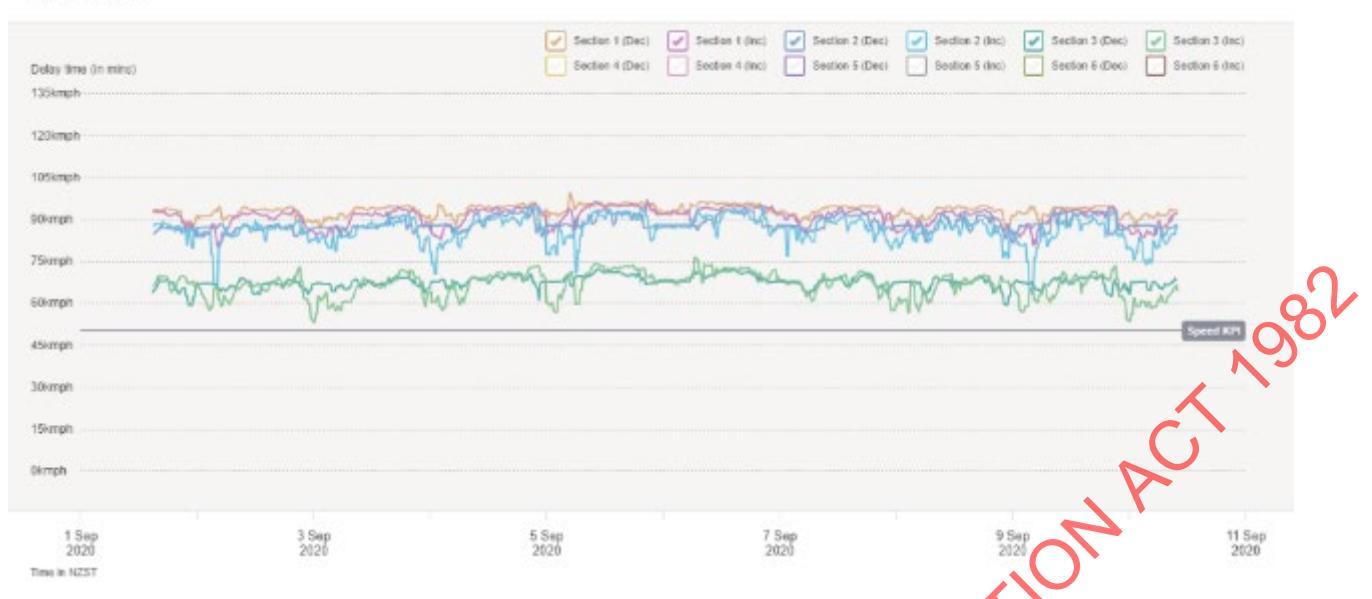
Figure 4 – Average speed for sections 1 – 3 (both increasing and decreasing directions) by time of day (Source: Mooven)

Figure 3 shows that for section 1 the mean operating speeds are generally greater than 90 km/h. This is consistent with both the existing speed limit and suggested SaAS limit of 100 km/h. The mean operating speeds for section 2 are approximately 85 km/h. This contrasts with section 3, where the highway becomes more winding, which has an average speed of approximately 70 km/h. This shows that for sections 2 and 3, the mean operating speeds are currently lower than the existing posted speed limit of 100 km/h and more in line with the suggested SaAS limits of 80 km/h.

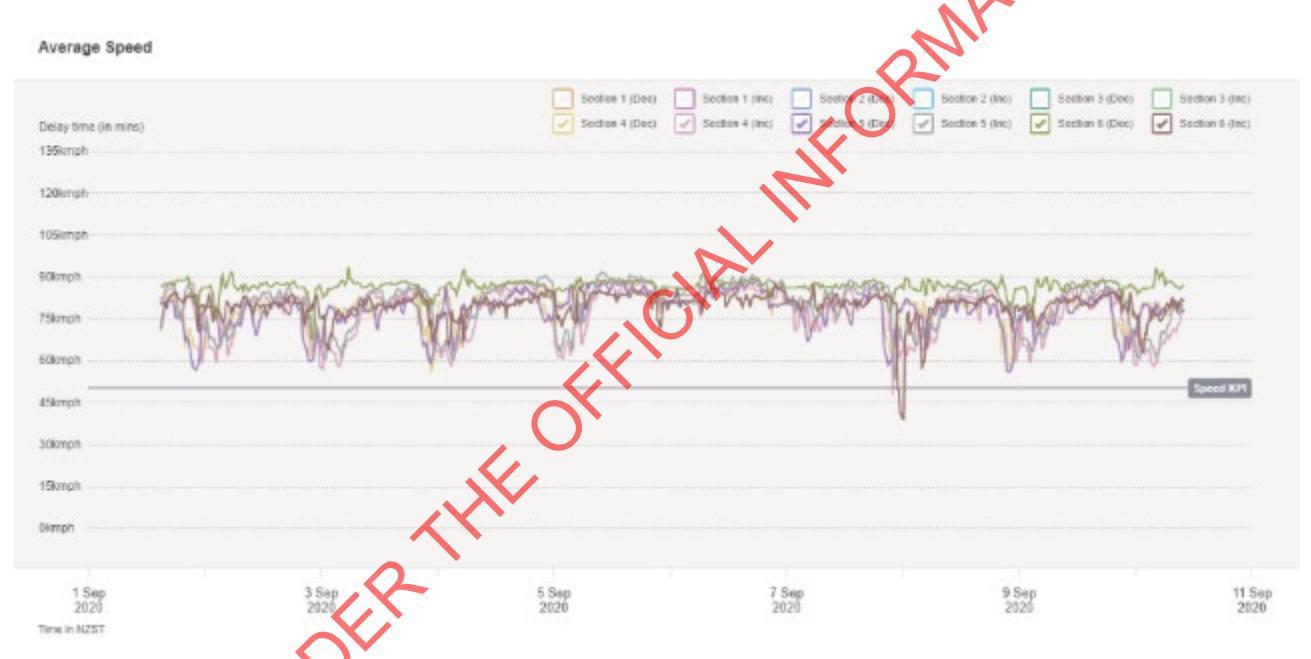
Figure 5 - Average speed for section 4 - 6 (both increasing and decreasing directions) by time of day (Source: Mooven)

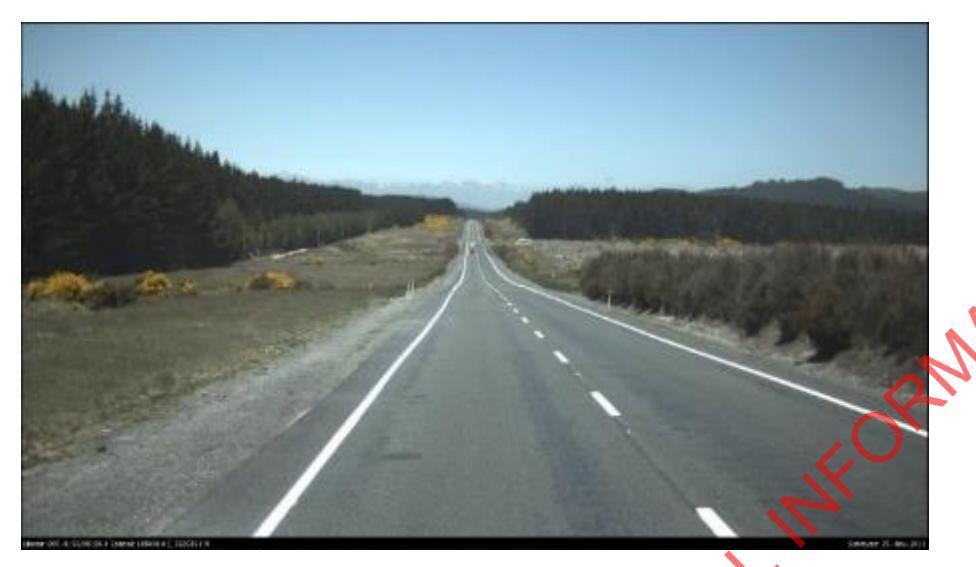
Figure 6 – Example of section 1 (source: NZTA Network Video)

The results of the SMG assessment show the recommended SaAS for section 1, east of Taupo, is to be retained at 100 km/h. This is a result of low personal and collective risk and a low-medium IRR score, primarily due to only moderate roadside hazards and wider shoulders along this straight section of the SH5 corridor, as shown in Figure 6. Although a 100 km/h posted speed would match the existing speed and the classification in the SMG, the carriageway is not median divided and would require other infrastructure 10MACT 1982 improvements to justify retaining the 100 km/h posted speed limit. It is recommended an 80 km/h posted speed is installed for section 1, until such time that further infrastructure improvements are implemented.

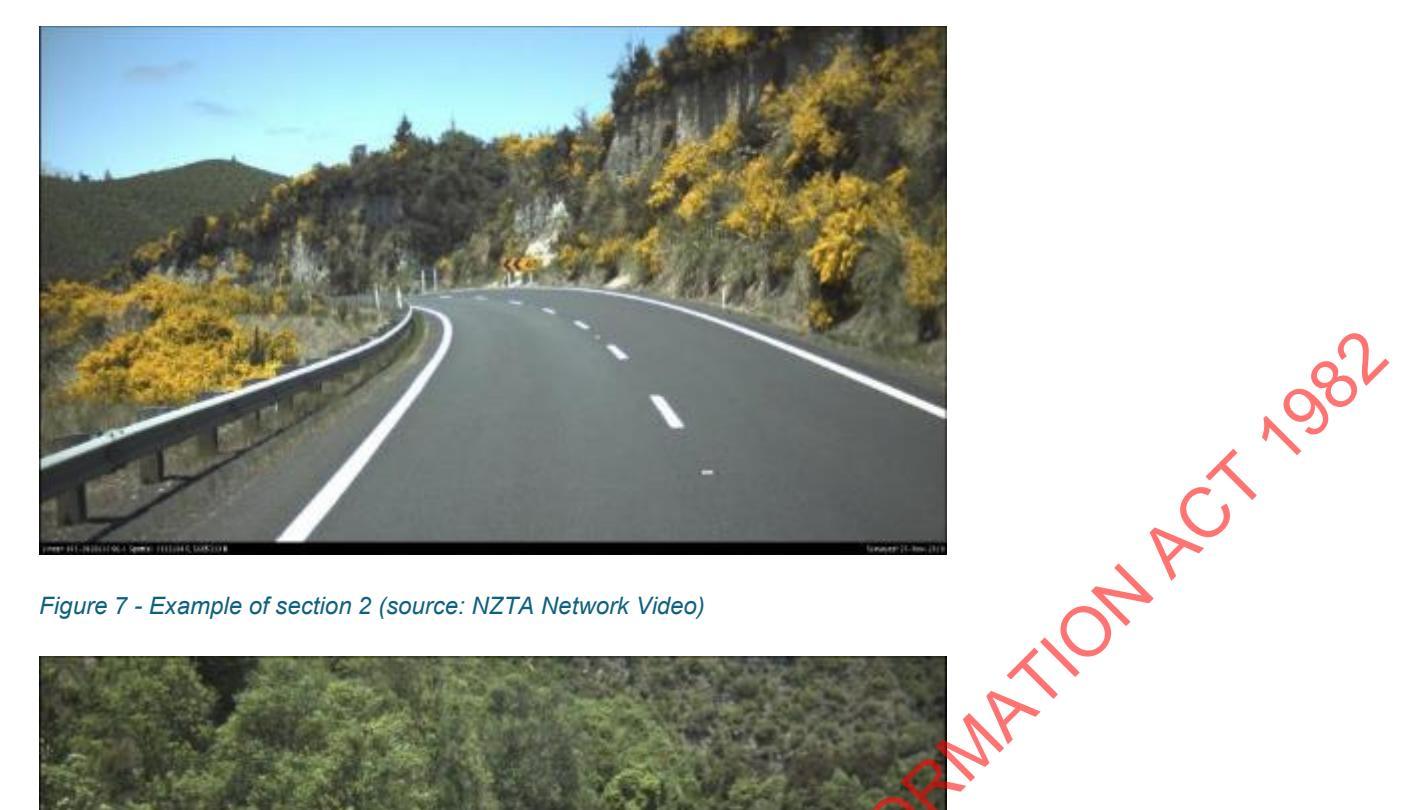
Figure 7 - Example of section 2 (source: NZTA Network Video)

The recommended SaAS for sections 2, 4 and 5 is 80 km/h. The road environment is more curved and typical of a rural highway with few accessways and some roadside hazards, such as trees, embankments, and drainage channels Examples of this are shown in Figure 7, Figure 9, and Figure 10. The highway has an existing posted speed limit of 100 km/h and a medium IRR band for these three sections. A lower speed limit is supported by the crash history and current mean operating speeds, which range from 75 km/h to 90 km/h.

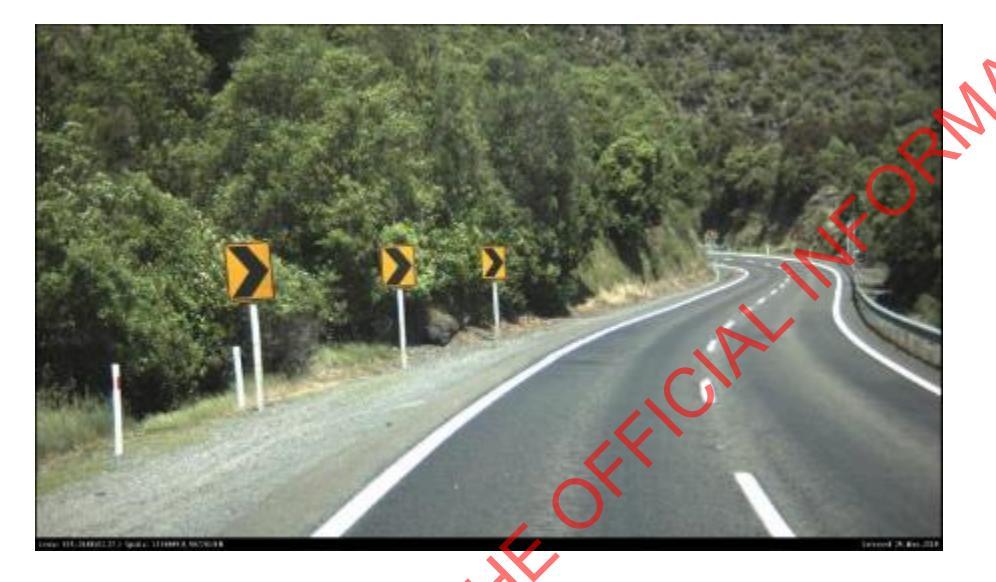
Figure 8 - Example of section 3 (source NZTA Network Video)

The results of the SMG assessment show the recommended SaAS for section 3 is less than 80 km/h. The current posted speed limit of 100 km/h. This section was considered separate to the adjacent sections for the purpose of the assessment as it is more winding than the surrounding sections, as shown in Figure 8. Although the SMG suggests a SaAS of less than 80 km/h based on IRR band, it is sensitive to the roadside hazards as there are still some unprotected embankments along this section. Additionally, the mean operating speed data suggests vehicles may be naturally slowed by the alignment and vertical grade of the highway. It is recommended an 80 km/h posted speed limit is installed, with some infrastructure improvements, to retain consistency throughout the network.

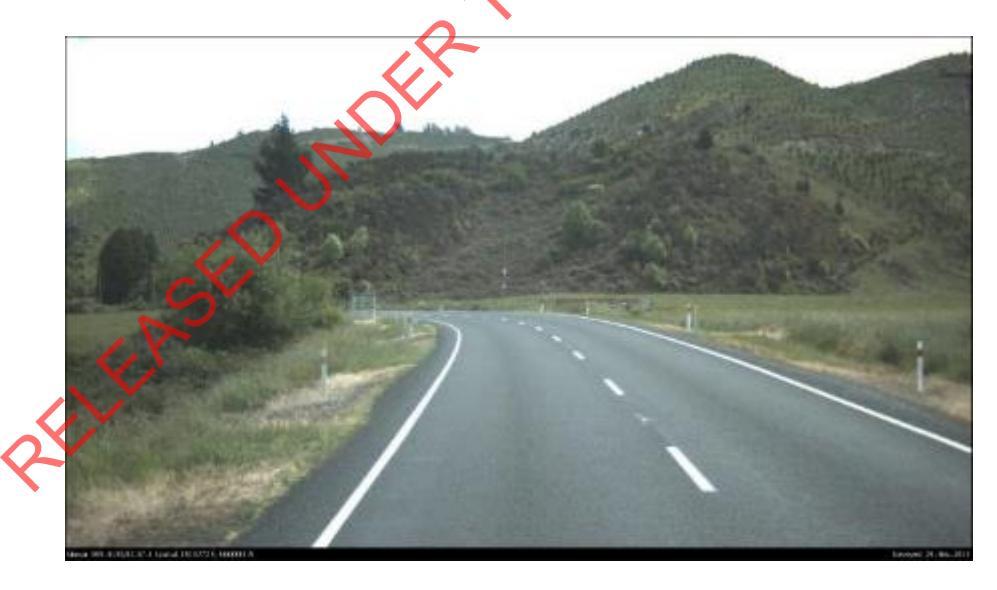
Figure 9 - Example of section 4 (source: NZTA Network Video)

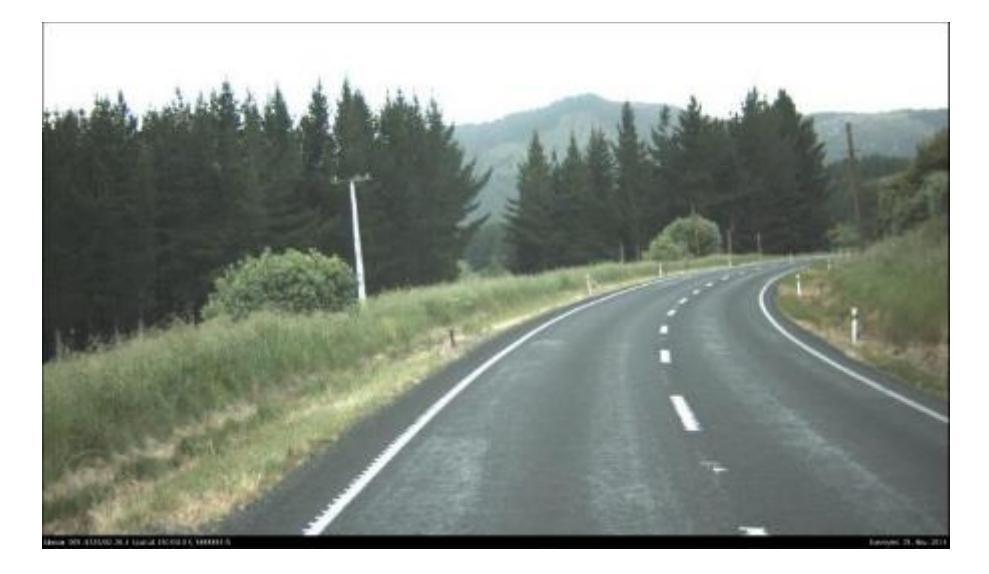
Figure 10 - Example of section 5 (source: NZTA Network Video)

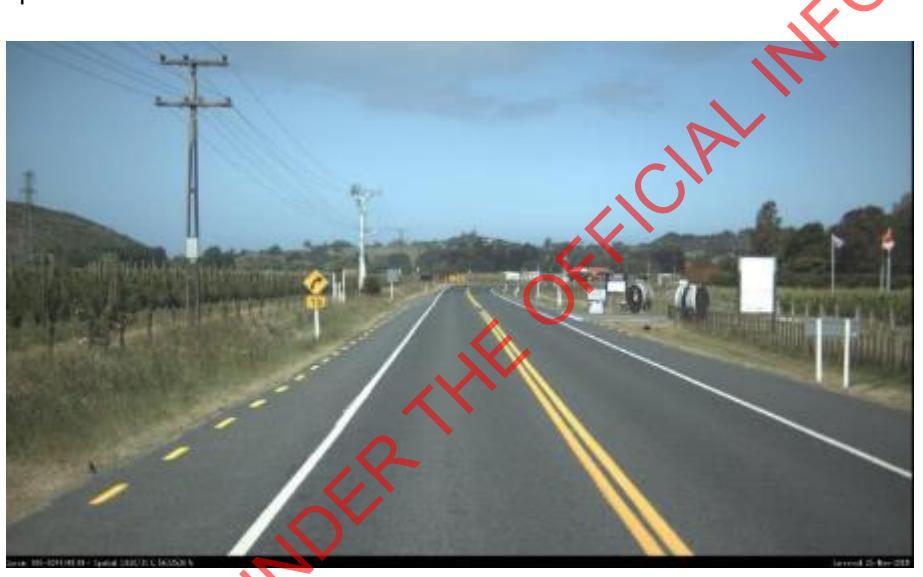
Figure 11 - Example of section 6 (source: NZTA Network Video)

The results of the SMG assessment show the recommended SaAS for section 6, through the rural residential area of Eskdale, is 80 km/h. This is primarily due to the medium IRR band, with a mix of vegetation, power poles and other structures present as roadside hazards, as shown in Figure 11. A speed of 80 km/h would be consistent with the surrounding network and the mean operating speeds, which are between 80 km/h and 90 km/h. Additional infrastructure investment is recommended to improve safety and encourage lower speeds.

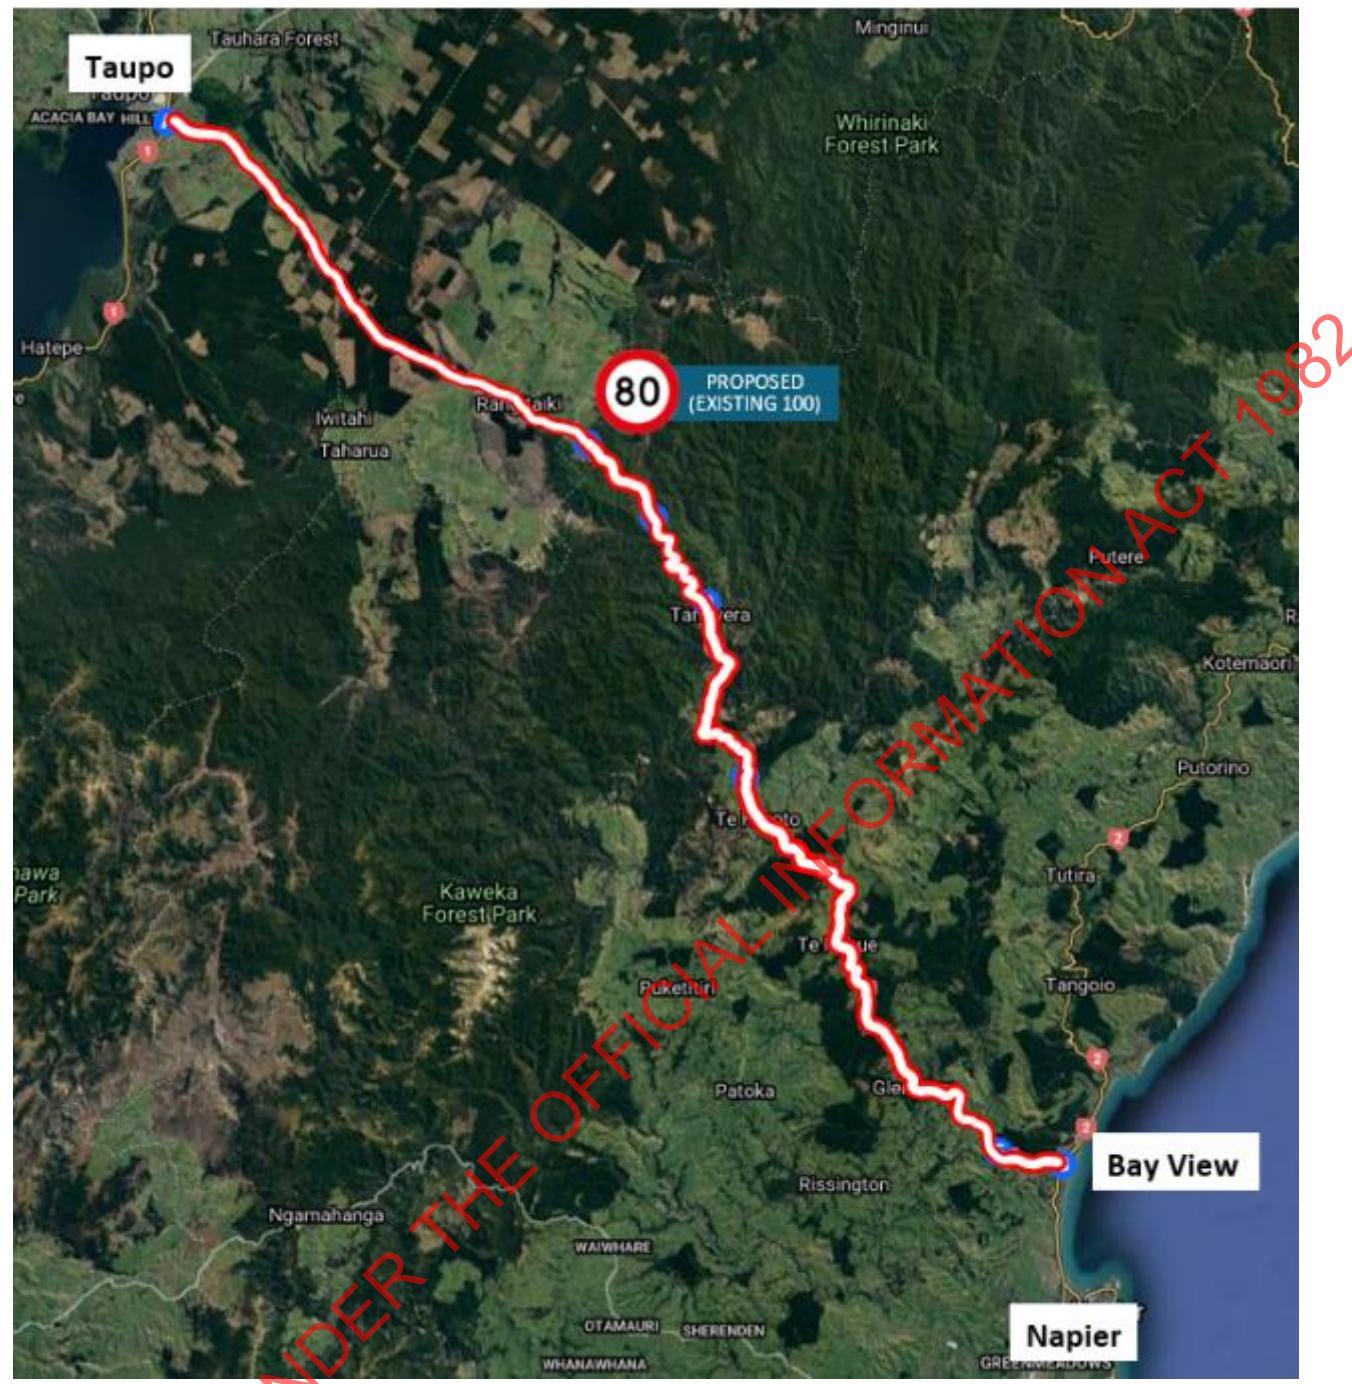
Figure 12 - Proposed Sale and Appropriate Speed Limits for SH5 Taupo to Bay View

A map of the proposed SaAS recommendations for the corridor is shown below in Figure 12.

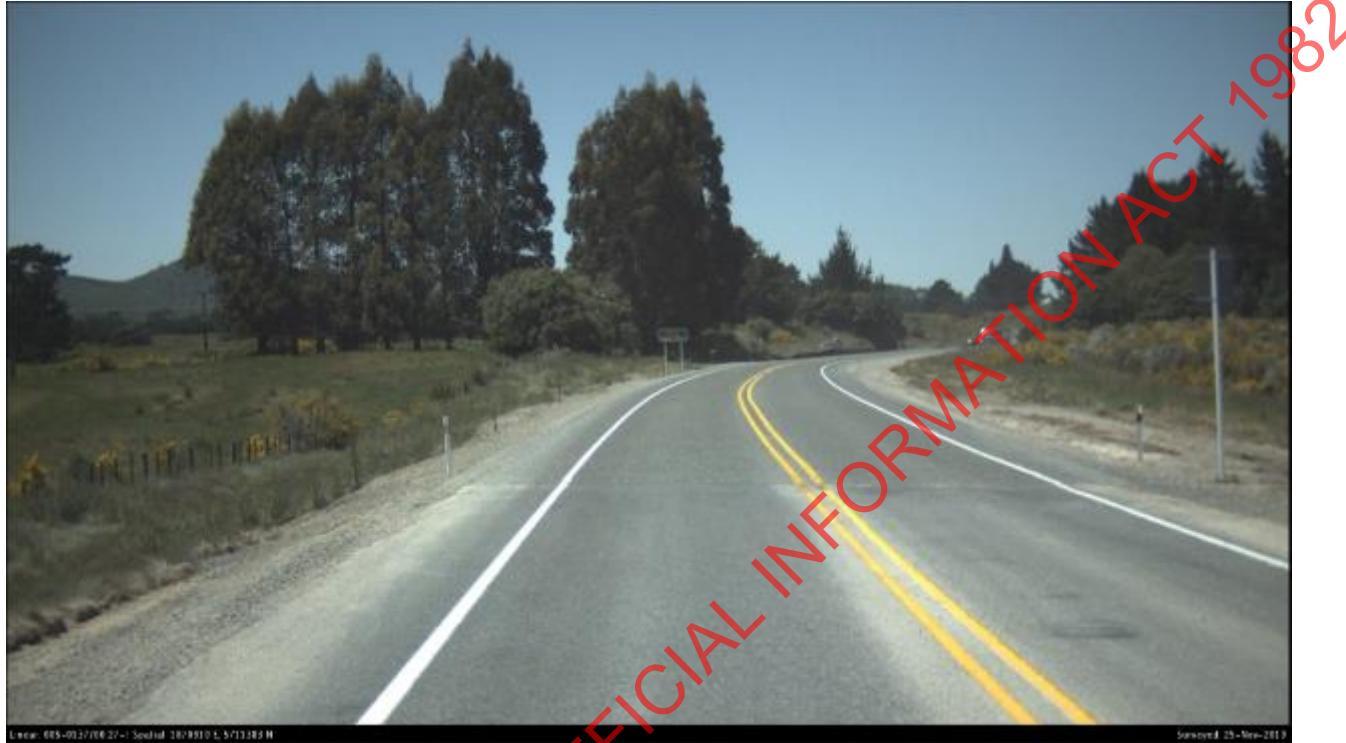
RP 005 – 0130 / 0.300 Increasing direction (vieweast) – Proposed 80/100 threshold location

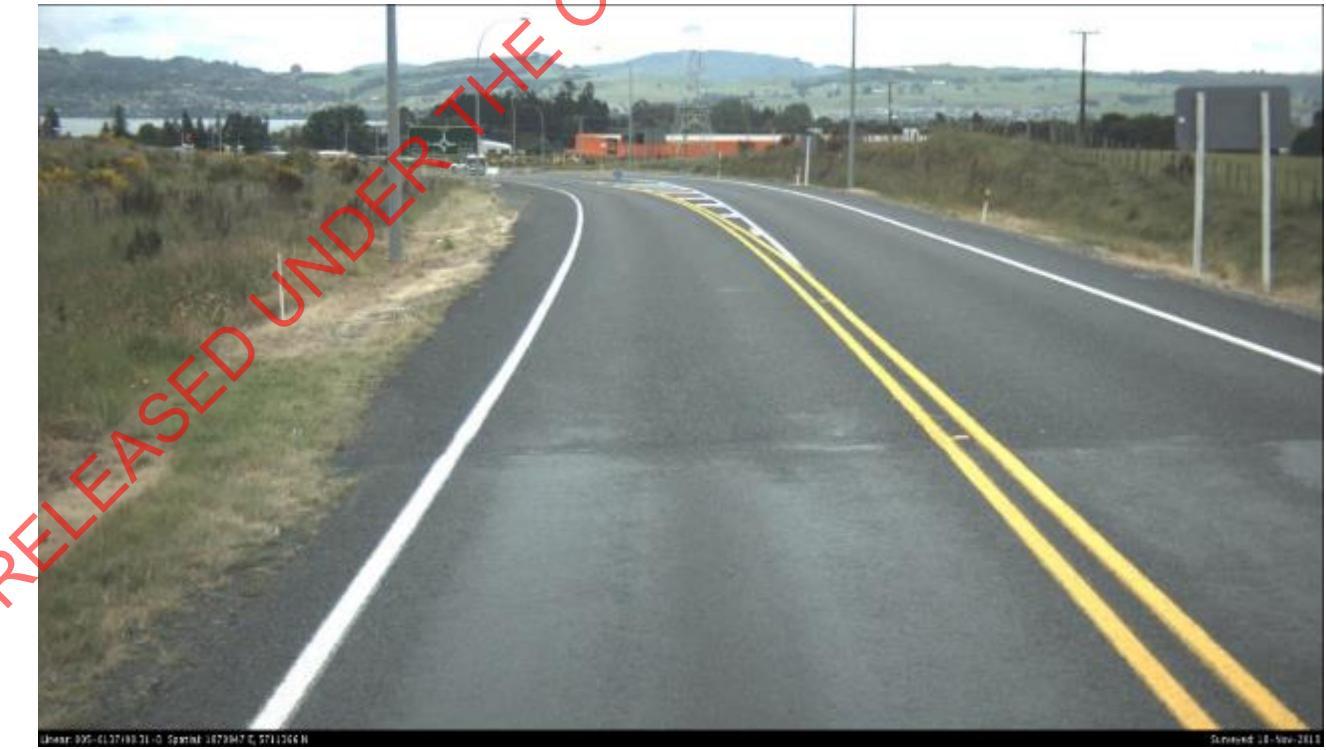
RP 005 - 0130 / 0.300 Decreasing direction (view west) - Proposed 80/100 threshold location

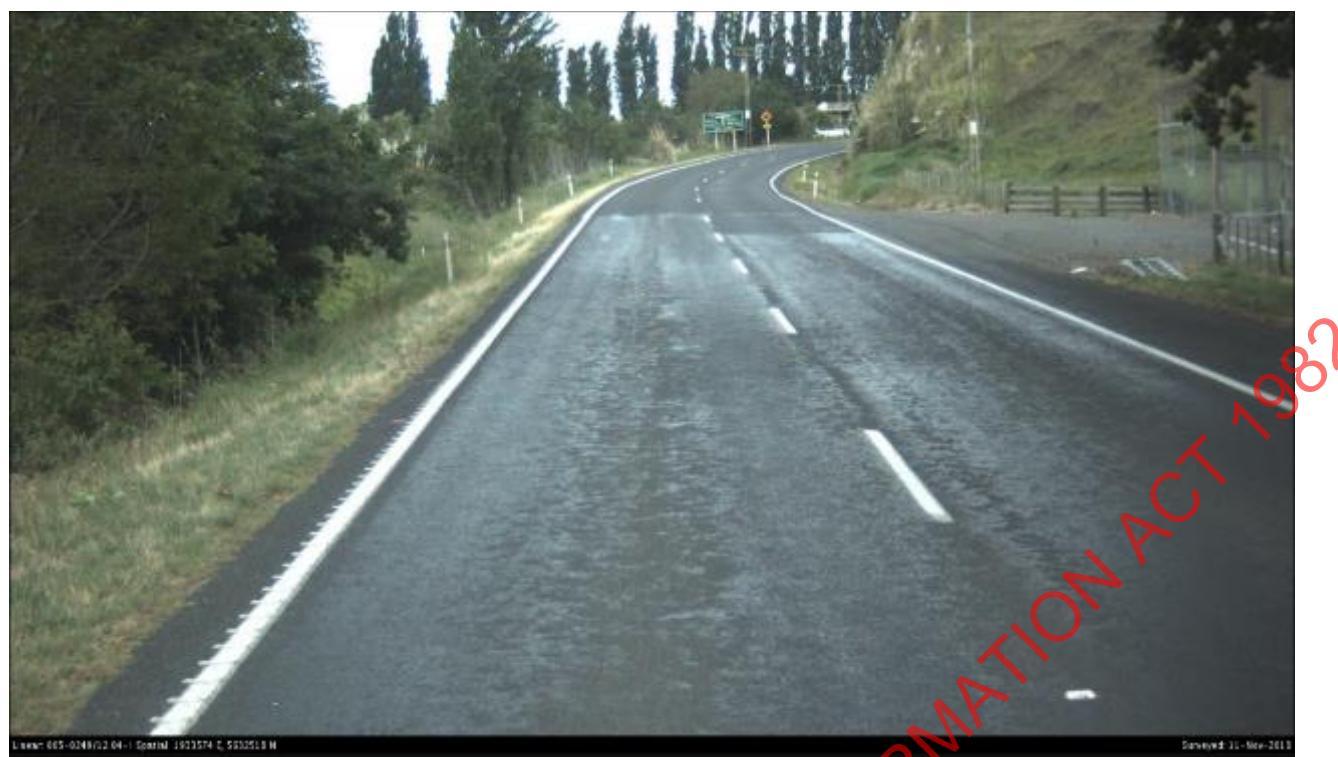
RP 005 – 0249 / 12.060 Increasing direction (view east) – Proposed 100/80 threshold location
