**Re: SH1: Mackays to Peka Peka, Kapiti Coast Expressway – Road Safety Review:
SH1/Otaihanga Road intersection**

The safety audit team (SAT) for this project has been asked to carry out an initial road safety review of the proposal to construct a roundabout at the existing SH1/Otaihanga Road intersection.

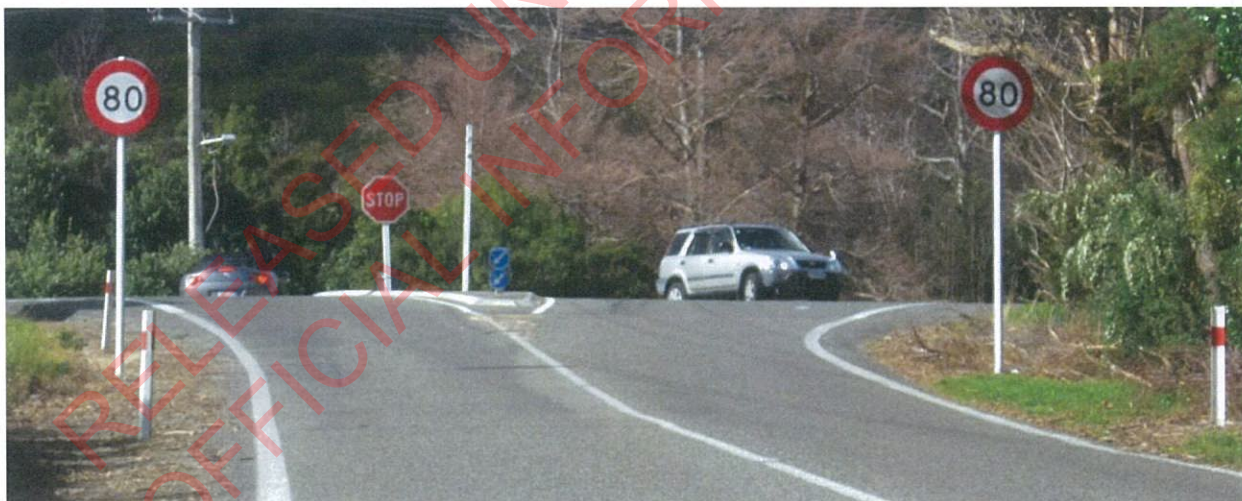
Photo 1

4. Conspicuousness: As the roundabout is elevated, the central island will need to be made clearly visible on all approaches. This is a critical safety issue. The island will need to be made conspicuous by way of mounding, planting and lighting, with appropriate levels of delineation provided.

5. Roundabout level: Following on from 4 above, consideration should be given to lowering the level of the roundabout to reduce the gradients on the approaches (see **Photos 1 and 2**) and so improve the conspicuousness of the roundabout.
