Causeway Alliance as we focus on getting State Highway 16 between Te Atatu and Great North Road raised and widened. We'll provide a round-up of some of our progress in this issue.

CAUSEWAY ALLIANCE
working for our **thriving** city

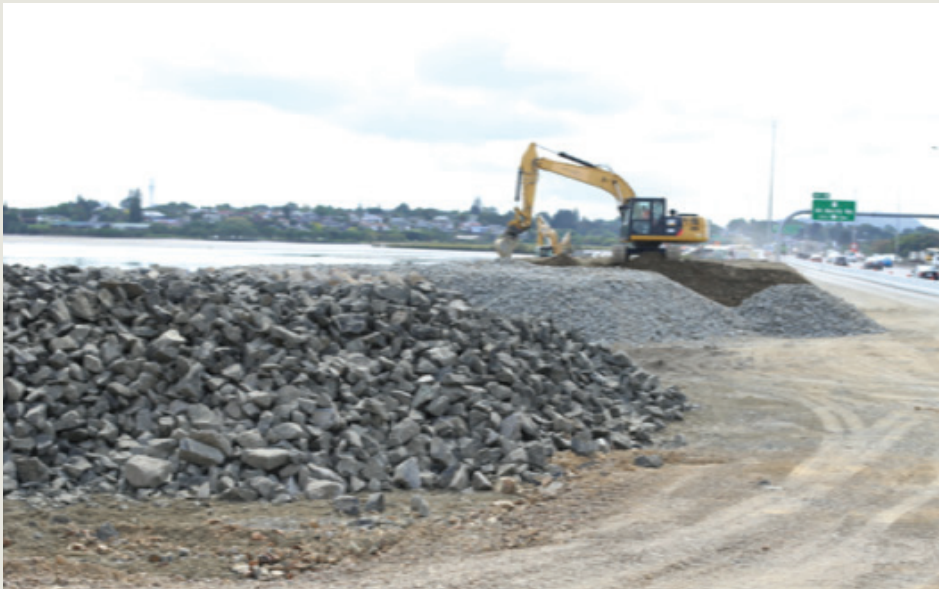
Traherne Island reclamation

Along the project eastbound towards the city, intensive ground reclamation is taking place. More than 10,000 wick drains have been planted to help remove sea water from thick mud. The drains – made from plastic and fabric – are planted 10–15 metres deep in marine mud on both sides of the Traherne Island area. They work like elaborate drinking straws and are placed 1.3m apart, draining water from deep underground to help with the consolidation of the layers of marine materials.

A two to three metre layer of fill or drainage-blanket using more than 26,000 truckloads of marble-sized quarry stones, has now been spread on top of the wick drains to help squeeze water out of the mud below – a process that will take up to 12 months. When the results indicate that the ground is stable, construction of new motorway lanes will start on top of it. The drainage blanket is a combination of recycled asphalt and greywacke from Auckland quarries.

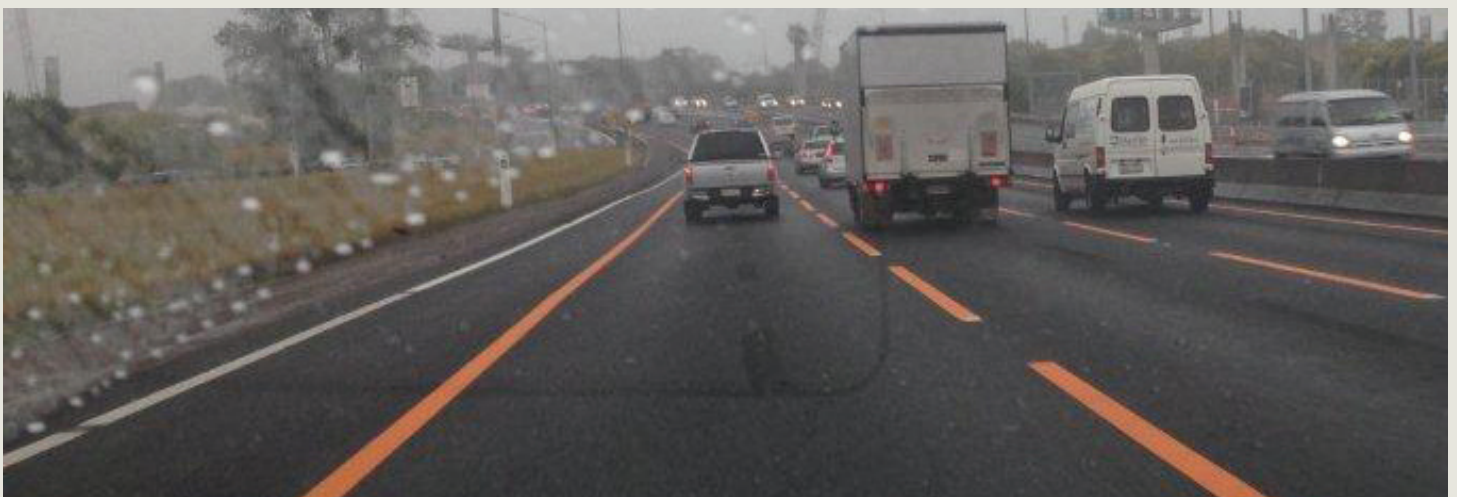
Drivers now have a bright new guide to help direct them safely on State Highway 16 over Great North Road heading towards the city – specialised orange coloured tape to clearly define the temporary lanes.

The specialised tape has been installed by our team on the eastbound approach to the Great North Road Interchange where there are extensive changes to lanes and it's important to keep road users and our workers safe.

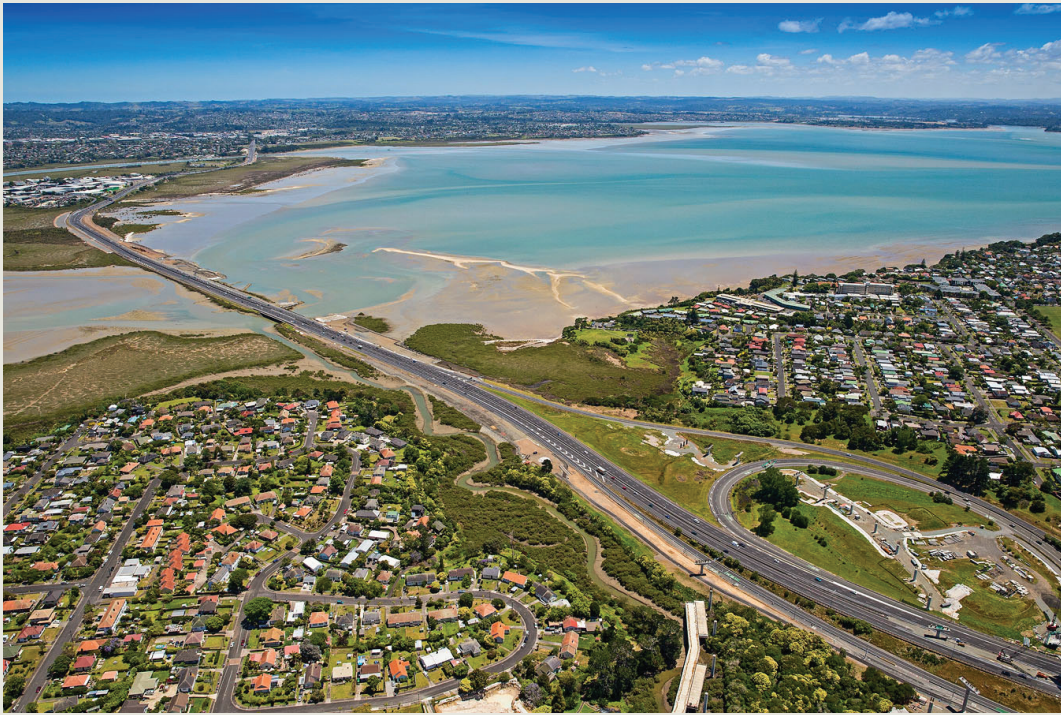
Photo: Greg Kempthorne, January 2014.
Looking west from the Great North Road Interchange
