Haywards Hill curve realignment

A dangerous black spot needs to be fixed on State Highway 58.

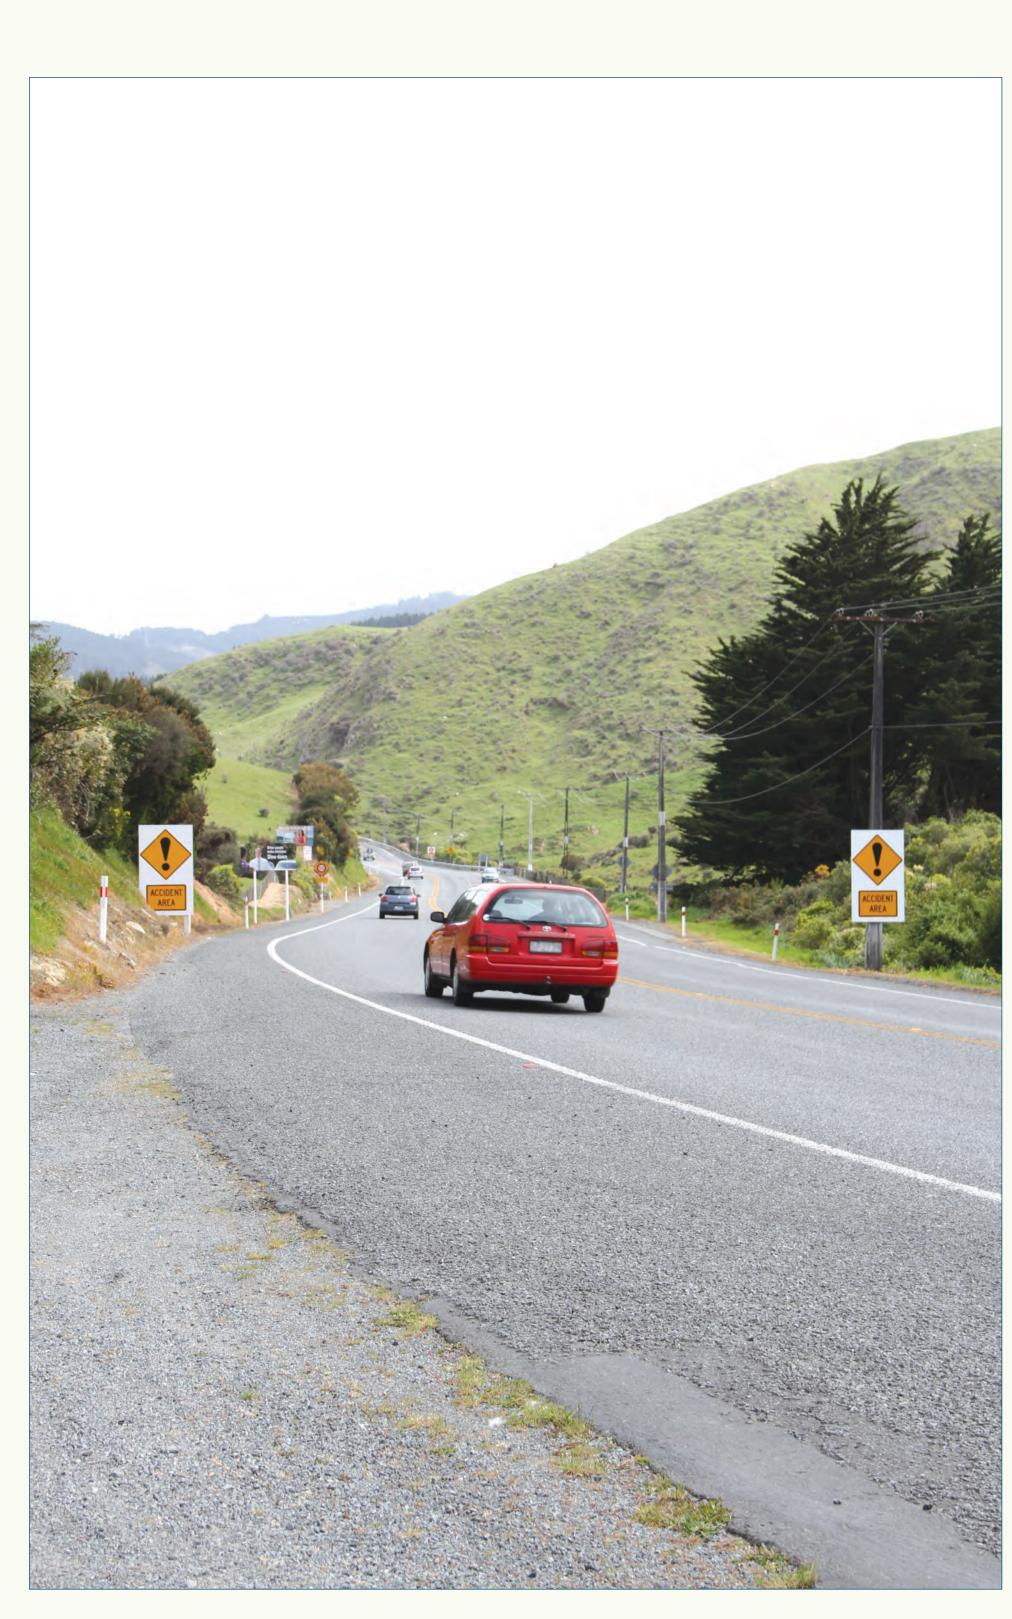
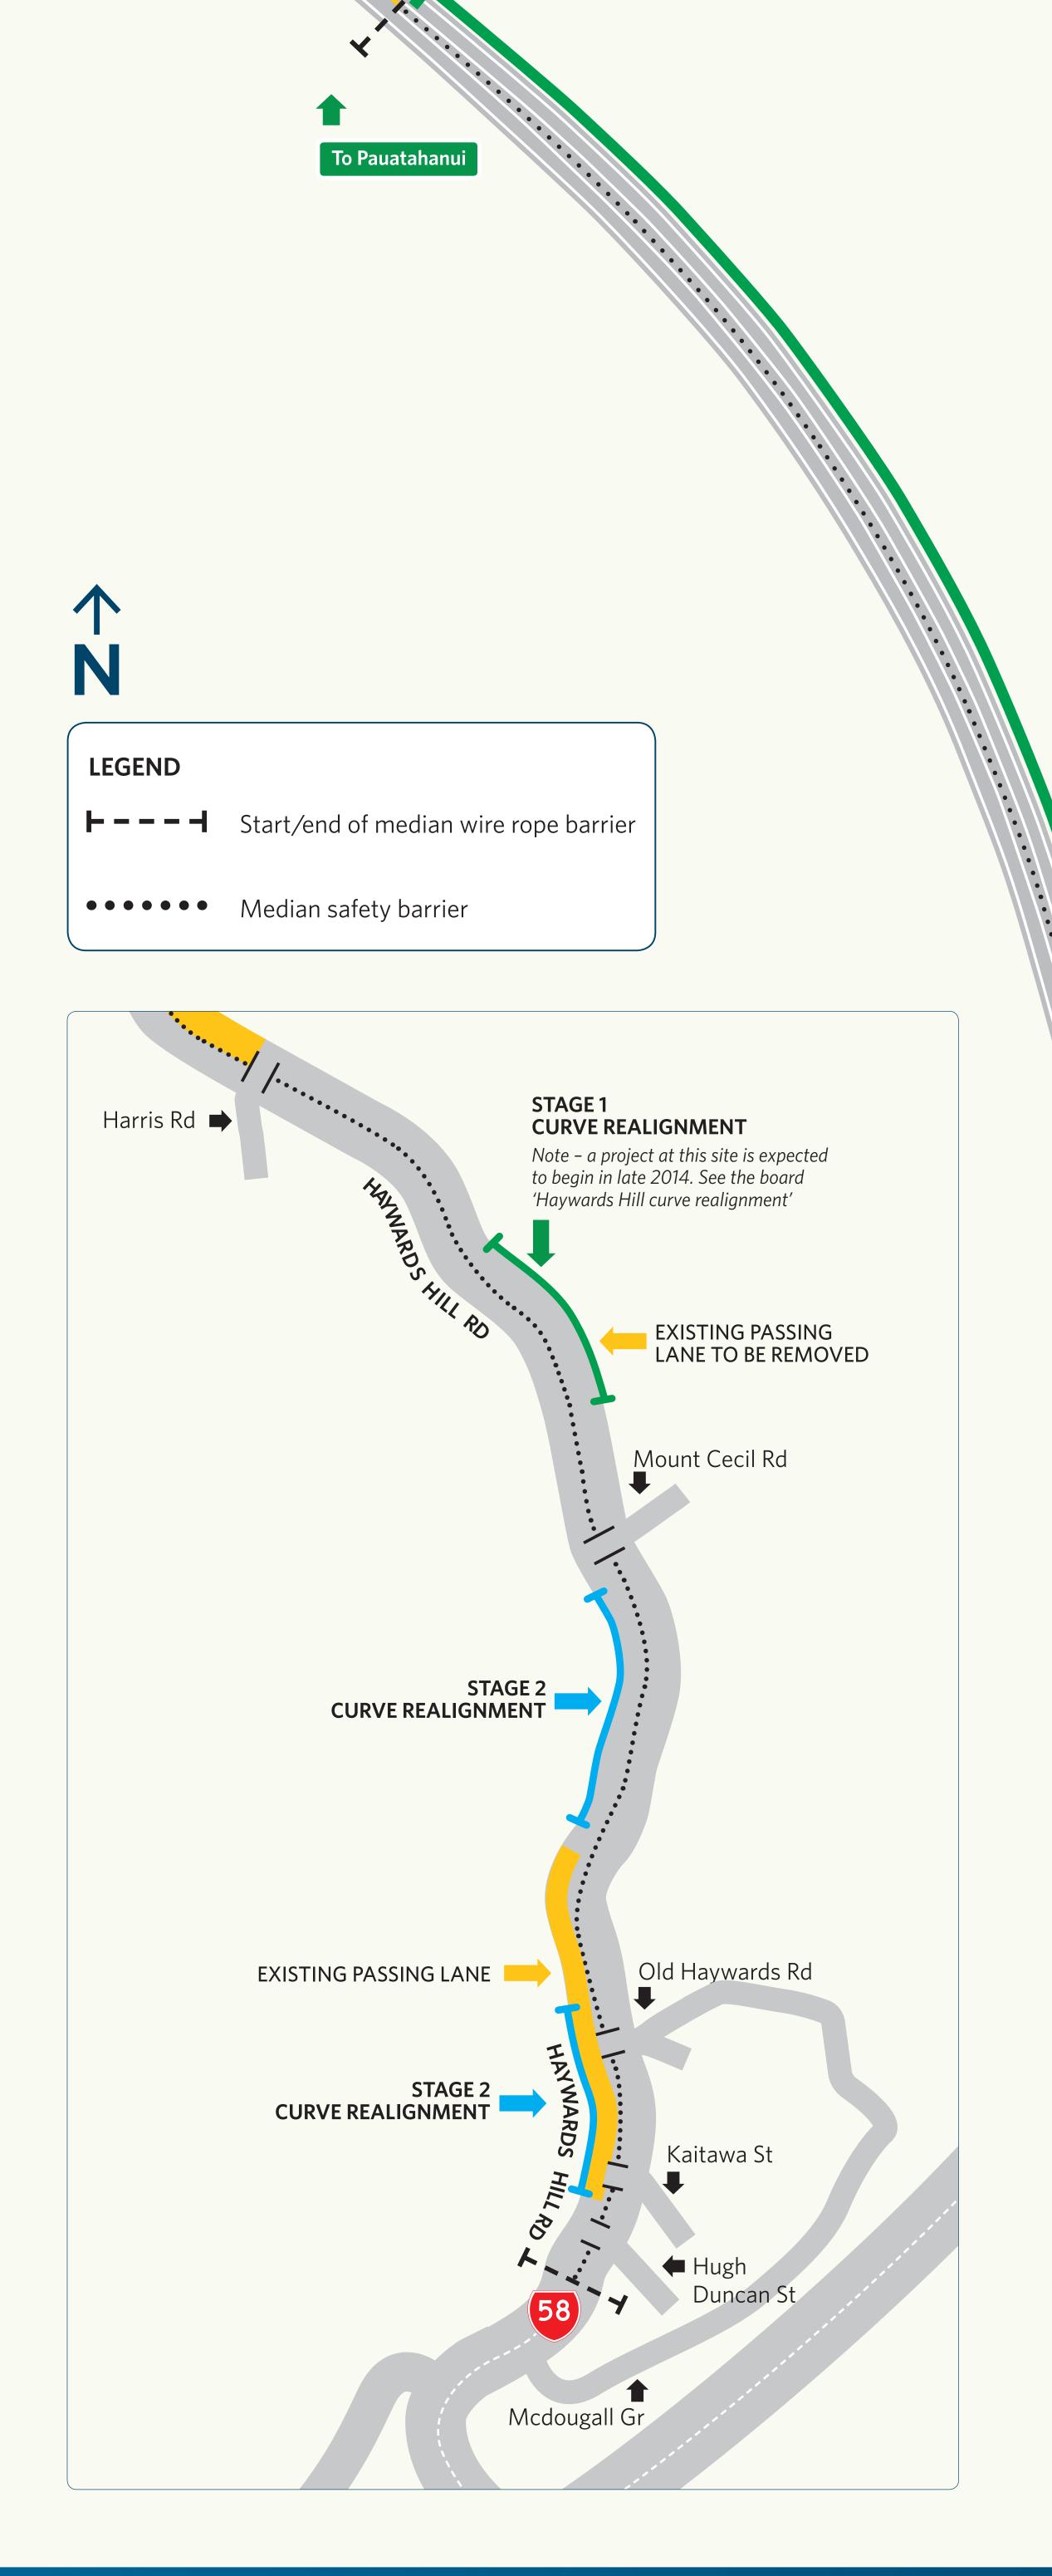
To address this issue, we're cutting 8m into the south-side hill, rebuilding a straighter road and installing a wire rope safety barrier between the two lanes of traffic.

Our proposal to install a wire rope safety barrier beyond this section (as seen on the larger diagrams of the whole route from State Highway 2), will be constructed separately.
