# New Beaumont Bridge

Hydraulic Assessment & Design Information

Date: 10 June 2019 Reference: 6-CT012.00 Status: Second Issue

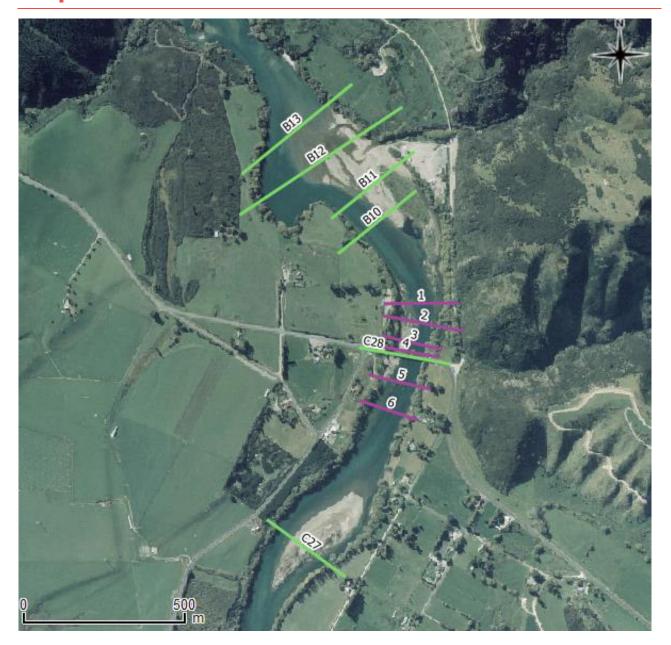
Figure 3-1 Cross-sections surveyed by Eliot Sinclair (shown in pink) and by ORC (shown in green)

Cross-sectional survey data supplied by Otago Regional Council (ORC) was used in addition to the Eliot Sinclair survey data to inform the hydraulic assessment. The locations of these cross-sections are shown below in Figure 3-1.

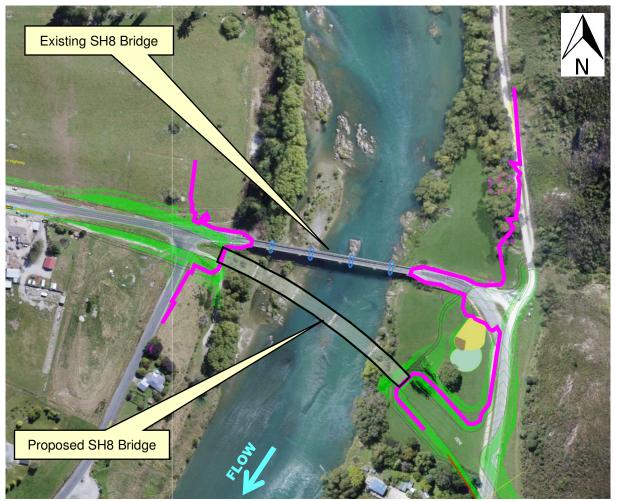
Figure 4-1 Detail of Clutha River and the existing and proposed SH8 bridges showing channel alignment and SLS event flood extent near the bridges (pink).

As discussed in Section 1.1, the proposed bridge structure is to be located across a straight section of an incised channel immediately downstream of a bend (Figure 4-1). Consequently, the flow velocity is likely to be slightly higher on the true left (i.e. east or Dunedin) side of the river. The channel is characterised by rock outcrops that protrude from the low flow water level.

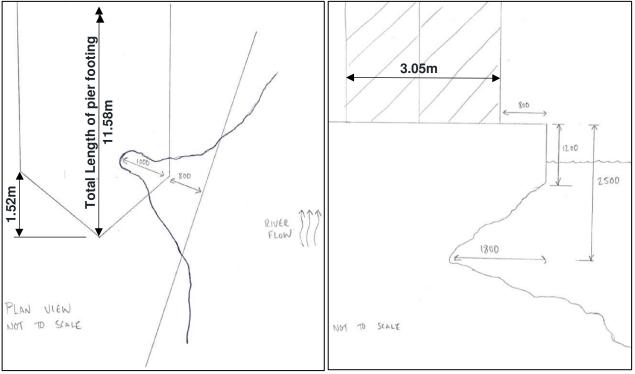
Figure 4-4 Plan (left) and section (right) of scour undercutting of Pier D of the existing SH8 bridge (Source: Underwater Solutions Ltd, 2014 and PWD, 1885)

The existing SH8 bridge structure (Figure 4-3) was well founded with concrete footings on rock outcrops that have protected its piers during flood events. The only scour known to have occurred to the existing SH8 bridge structure is underneath Pier D where the rock, on which the concrete footing sits, has been locally undercut by up to 1.8m (Figure 4-4). Only 1.0m of that undercutting is directly under the pier footing with the opening width being a very small proportion of the entire footing perimeter. The deepest point of this scour is located approximately 2.5m beneath the top of the concrete footing. No repairs have been made to date and consequently it must be assumed that this scour is being monitored and is not currently of concern.

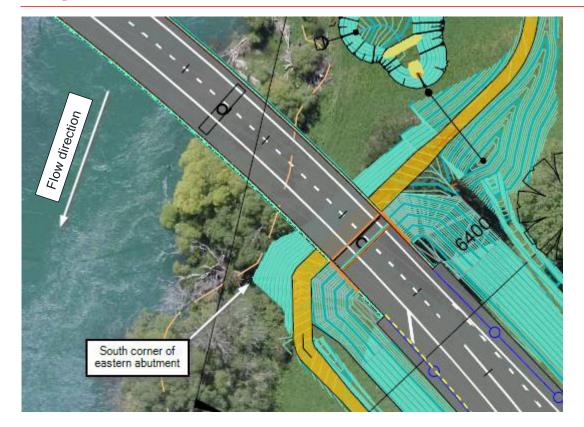
Figure 4-5 Location of eastern abutment in relation to the river channel

The proposed abutments are located outside of the main channel on the true left and right floodplains. The proposed bridge will be constructed downstream of the existing bridge with the abutments set back slightly further from the main channel than the existing bridge. The average flow velocity in the main river channel in the SLS flood event is approximately 3.4m/s. The flow velocities on the floodplain are expected to be significantly lower. However, the south corner of the eastern abutment does protrude close to the main river channel where the flow velocities will be much closer to the average flow velocity. Figure 4-5 shows a plan image of this abutment.

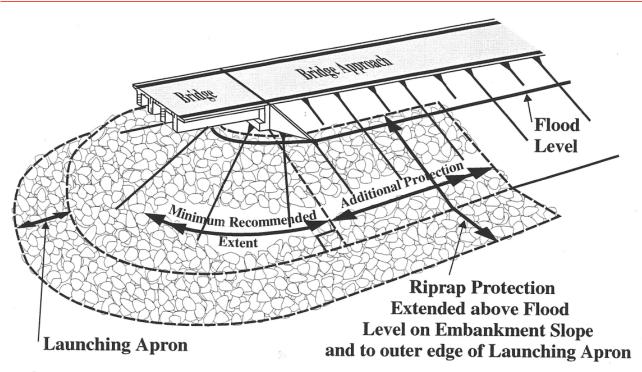
Figure 5-1 Recommended practice for the placement of riprap protection at bridge abutments (Source: Fig 9.29 in Melville and Coleman (2000)).

The rock revetment will wrap around the full abutment in line with the abutment face to minimise risk of undermining as per the minimum recommended extent in Figure 5-1. The bridge embankments will have batter slopes of 2H:1V, however the south corner of the eastern abutment may require a steeper batter slope of 1.5H:1V due to the limited space available and has been considered when selecting the size of the riprap rocks.

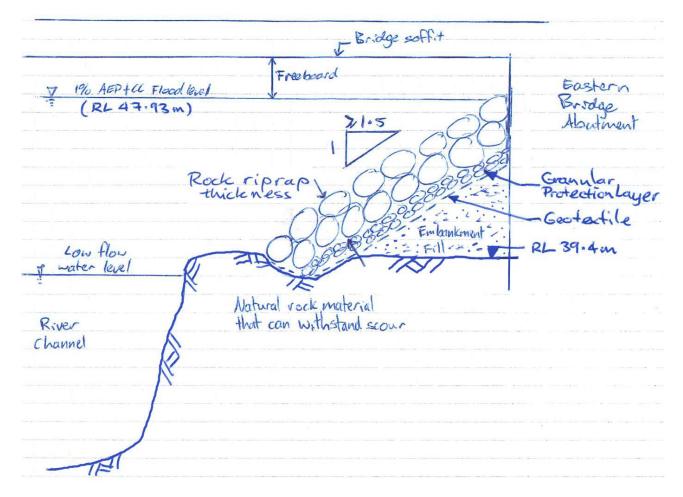
Figure 5-2 Sketch of rock revetment design at south corner of eastern abutment

The toe of the rock revetment must be positioned such that it is not at significant risk of undermining by scour. This would typically be achieved by locating the toe of the rock revetment beneath the scour depth, or by including a launching pad in the rock revetment so that natural scour processes shift the rock material down to the scour depth (as shown in Figure 5-1). However, these approaches are not suitable for this location due to the nature of the deep incised channel at the toe of the rock revetment and the shallow depth of the natural rock. It is therefore recommended that the toe of the rock revetment is keyed into existing natural rock outcrop capable of withstanding the scour. This can be achieved through thickening the toe, use of larger rocks in the toe, trenching into the natural rock material or a combination of these and other methods. Figure 5-2 shows an indicative sketch of the proposed rock revetment at the south corner of the eastern abutment.
