Waterview Operational Air Quality Monitoring Report December 2017

The Waterview Tunnel opened on 02 July 2017. This report includes analysis of validated air quality monitoring data for Waterview Tunnel Joint Operations (WTJO) for the period December 2017. This air quality monitoring report has been prepared in accordance with Waterview Connection BOI Operational Air Quality Condition OA.4.

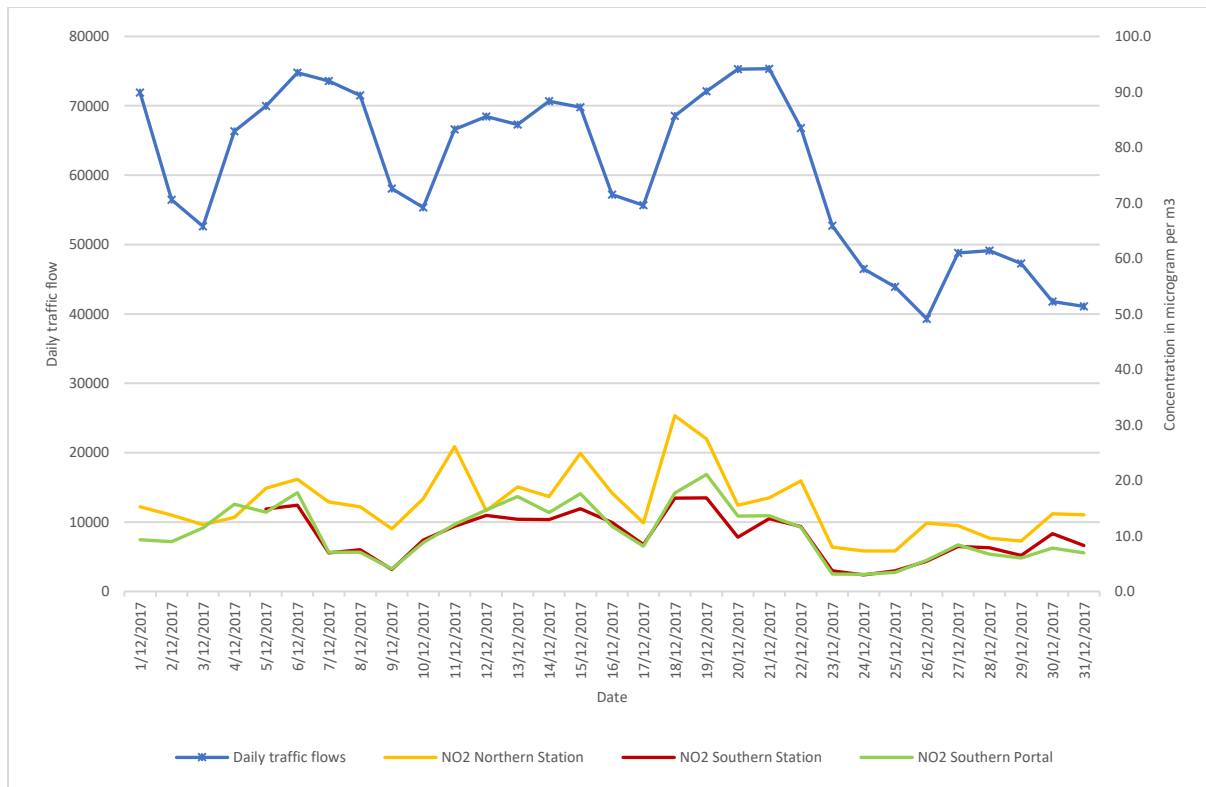
The daily traffic flow through the Waterview tunnel during December 2017 is shown in Figure 1 below with daily nitrogen dioxide concentrations. The traffic flow shows a distinct weekly pattern, with traffic flows generally increasing from Monday to Friday and dropping off at the weekend, with the lowest traffic flow on Sundays. The traffic flow shows a decreasing trend after December 22nd which coincides with the beginning of the Christmas holiday period. This weekly pattern is similarly reflected in the NO₂ data, indicating the contribution of traffic emissions to measured NO₂ concentrations. The northern air quality station shows the highest measured levels of NO₂. The northern station is located closer to major traffic sources than the other two stations and has no obstruction between the adjacent traffic sources and air quality station. The portal and southern stations show similar NO₂ trends.

Figure 1: Waterview tunnel traffic flows and NO₂ December 2017

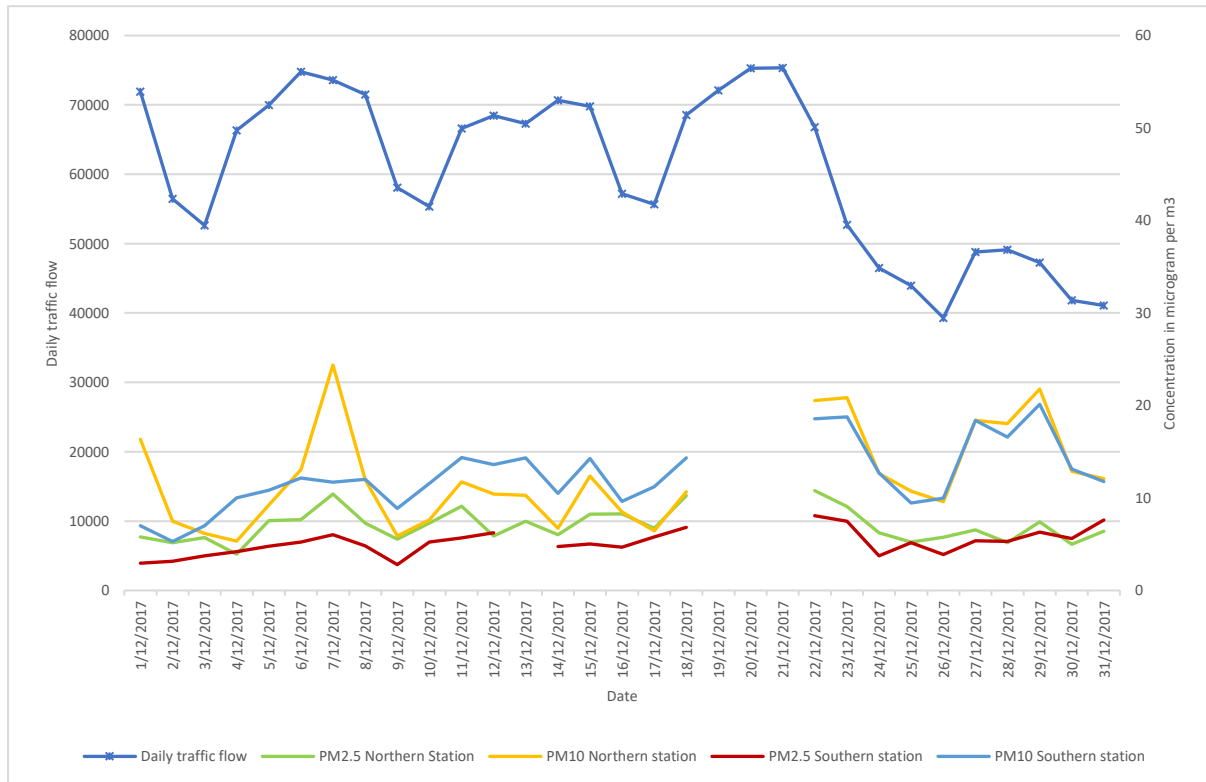
The weekly pattern of PM_{2.5} and PM₁₀ concentrations shows some similarity in peaks and troughs to the daily traffic flow, as shown in Figure 2, although the pattern is not as evident as with NO₂, indicating the influence of other background sources. The PM₁₀ and PM_{2.5} concentrations show similar trends at the northern and southern stations, although the PM₁₀ at the northern station showed a peak on 07/12/17 which was due to paving works in the vicinity of the station.

Figure 2: Waterview tunnel traffic flows and PM_{2.5}/PM₁₀ December 2017

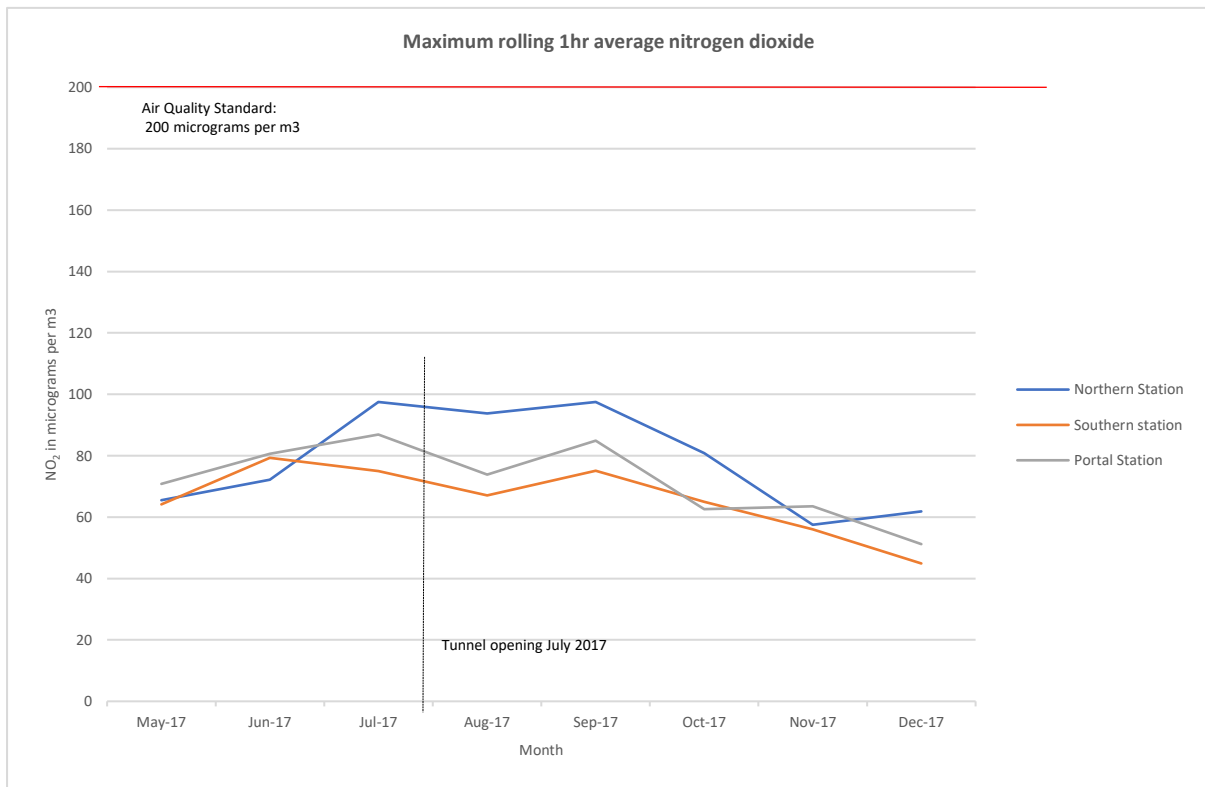
The maximum hourly pollutant trends for nitrogen dioxide are shown in Figure 3. These show the pollutant level changes after tunnel opening in July 2017 and the monthly variation (seasonality) in pollutant concentrations. Measured pollutant levels in winter are generally higher than in summer months due to meteorological influences.

Figure 3: Waterview stations trends in hourly nitrogen dioxide concentrations

NO₂ measurements in December were similar to October and November, and were lower than in the three (winter) months after opening. Highest measured concentrations of NO₂ were recorded at the northern station. This station is located closer to major traffic sources than the other two stations and has no obstruction between the adjacent sources and air quality station. The concentration of PM₁₀ (and PM_{2.5}) at the northern and southern stations were similar to each other, with the exception of 7 December 2017 when the northern station was affected by construction (paving) works.

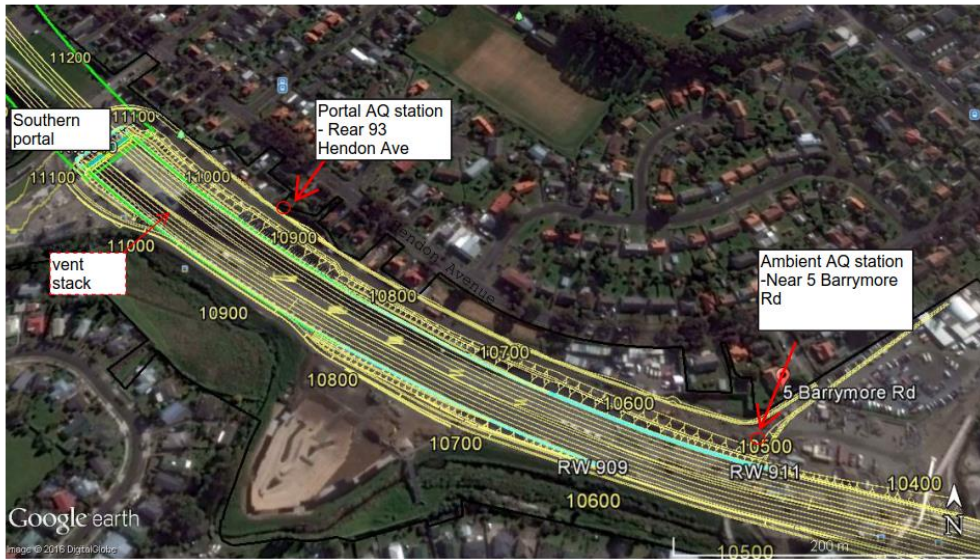
A portal monitoring station with Cavity Attenuated Phase Shift Spectroscopy (CAPS) NO₂ analyser has been installed at the rear of 93 Hendon Avenue near the Southern portal, to monitor NO₂ in accordance with the requirements of consent condition OA.2 and to demonstrate compliance with consent condition OA.8. The portal station is located approximately 80 m from the southern tunnel portal on the residential boundary (40 m from SH20). SH20 is screened from the nearest receptors within the southern approach trench.

The southern ambient air quality station is located in the approximate location of the original pre-construction baseline monitoring for the WTJO, near to 5 Barrymore Road. The southern station is also located near to the residential boundary approximately 470 m from the southern tunnel portal (25 m from SH20) where SH20 achieves grade.

Figure B 1: Southern area stations

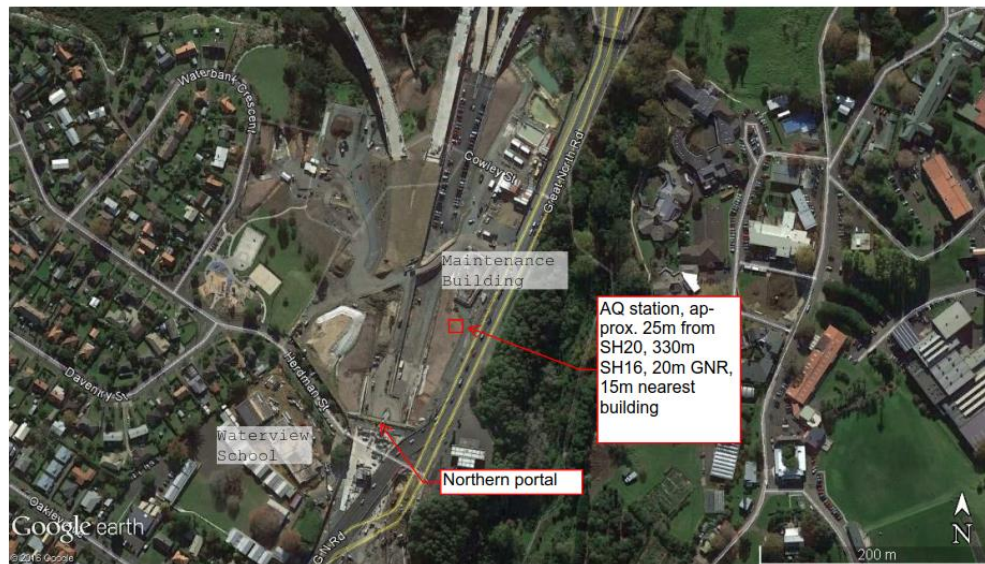
Under condition OA.2, the northern ambient air quality station should be located at Waterview School subject to agreement by the School; this agreement was not secured. The northern station is therefore located in the approximate location of the original pre-construction baseline monitoring for the WTJO, near to the operation maintenance building. This station is located approximately 100 m from the northern tunnel portal in the prevailing wind direction (25 m from SH20, 330 m SH16 and 20 m from Great North Road), with no obstruction between the adjacent traffic sources and air quality station. This location will experience higher levels than the proposed location at the School and is therefore considered conservative.

Figure B 2: Northern area station

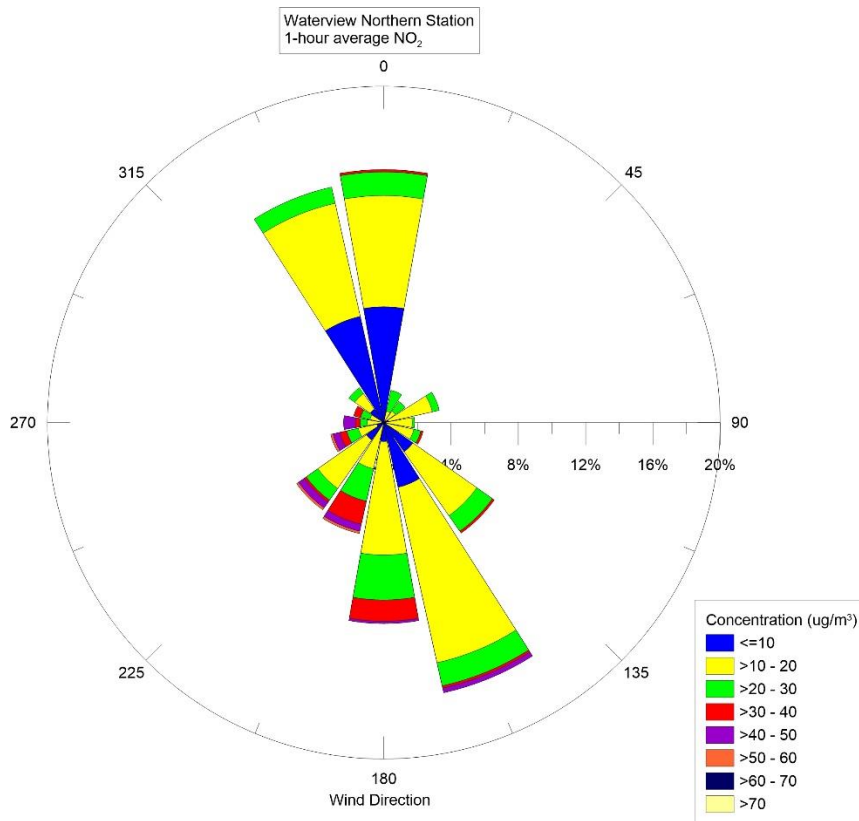
- The main sources of NO₂ influencing the northern station are located in the direction of the adjacent SH20 alignment to the south, south-west and west, SH16 to the north-west and Great North Road in the easterly and south-easterly wind directions.

Figure D 1: Northern station 1-hour average NO₂

- The NO₂ pollution roses indicate that the main source of NO₂ is traffic emissions. The PM₁₀ and PM_{2.5} pollution roses for December similarly indicate that traffic emissions are the dominant source, although the asphaltting works on Great North Road also influenced particulate levels at the northern station.

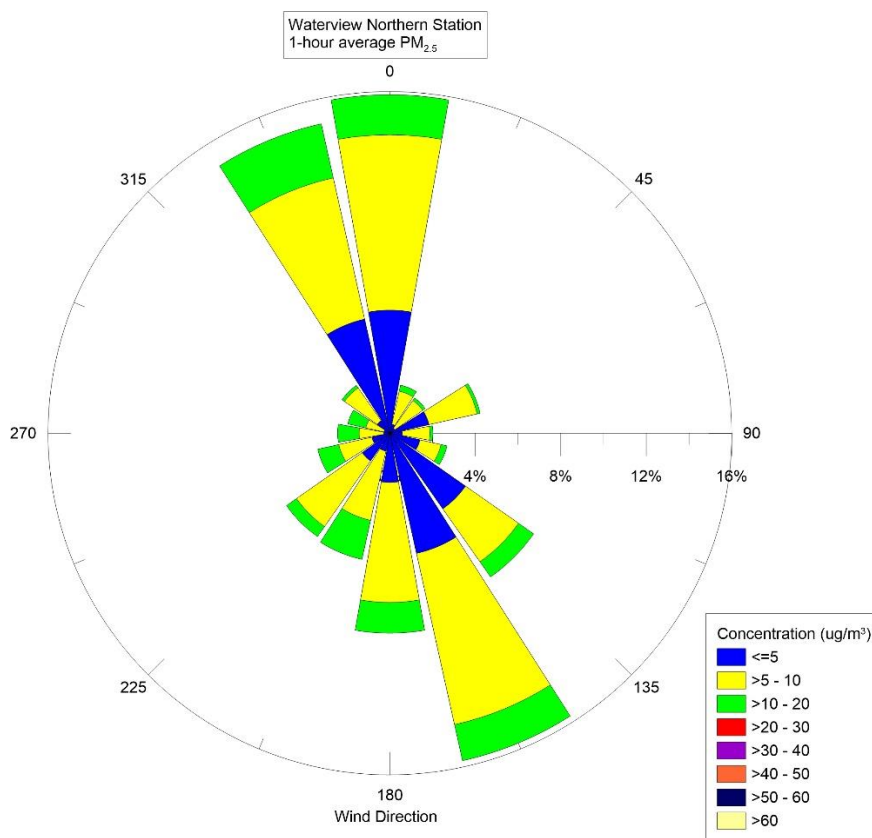
Figure D 2: Northern station 1-hour average PM_{2.5}

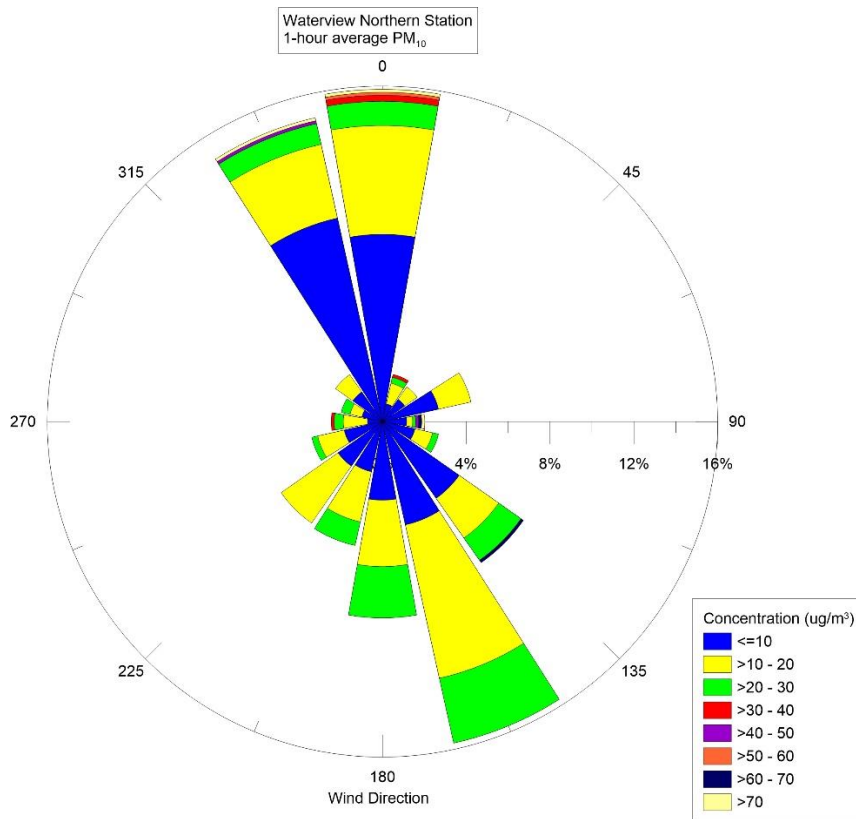
- The main sources of PM₁₀ influencing the northern station in December are located in the north to north-west and east to south-east wind directions. The source of elevated PM₁₀ from the east to south-east can be attributed in part to asphaltting work on nearby Great North Road.

Figure D 3: Northern station 1-hour average PM₁₀

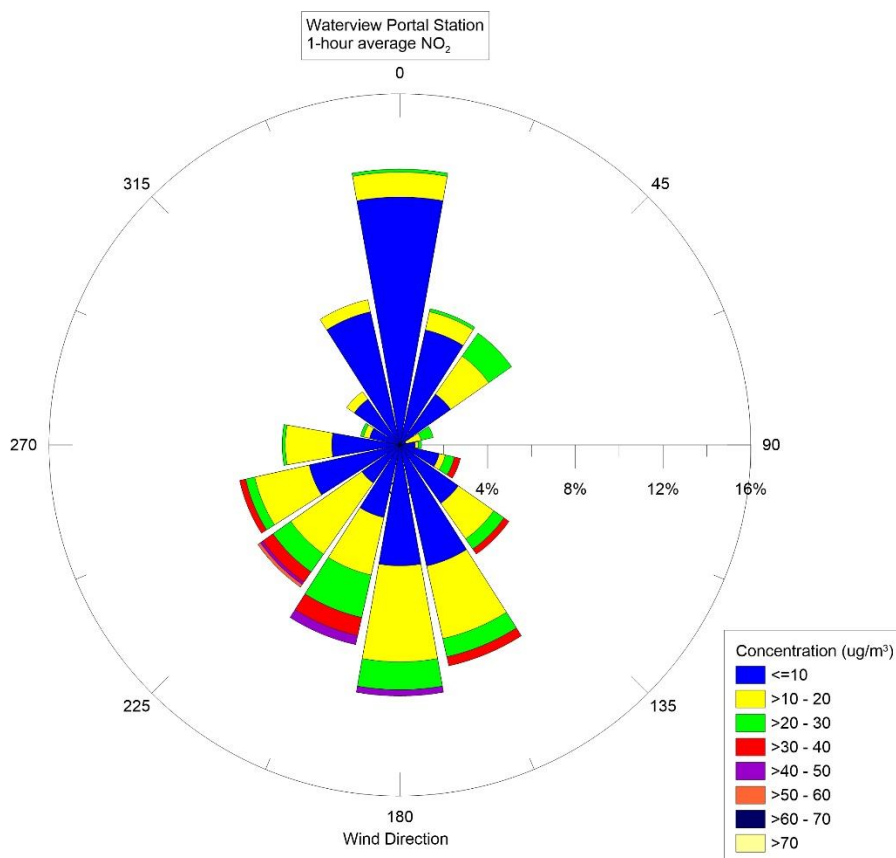
- The main source of NO₂ influencing the portal and southern stations is located in the direction of the adjacent SH20 alignment to the south and south-west. The second largest source was to the east-northeast, toward Hendon Ave. PM_{2.5} and PM₁₀ showed similar pollution roses with the dominant sources in similar directions to NO₂.

Figure D 4: Portal station 1-hour average NO₂

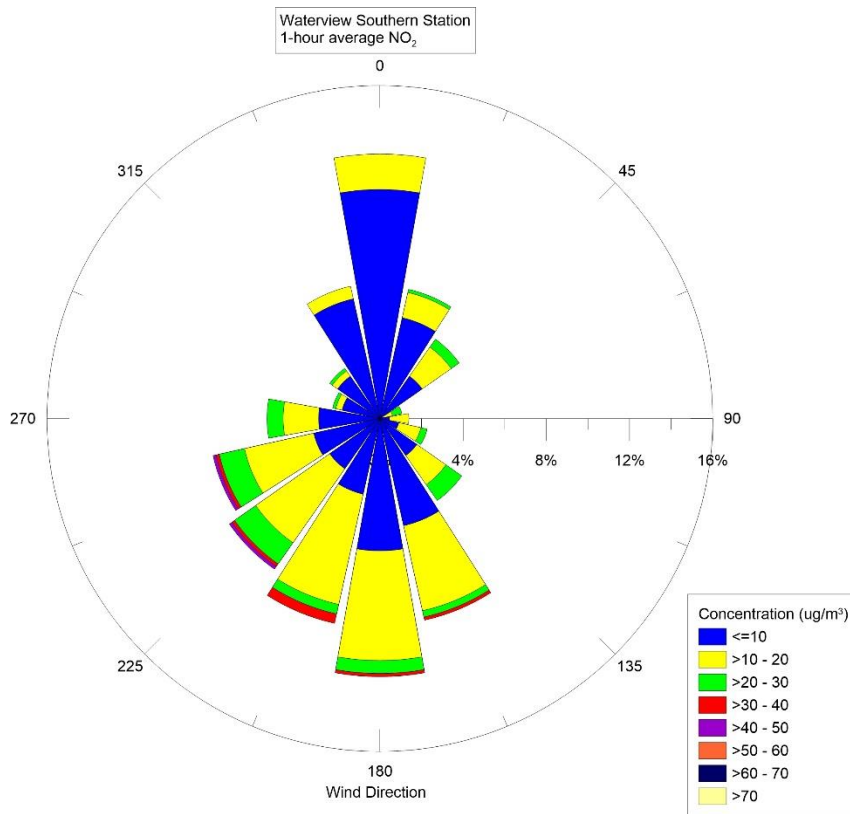
Figure D 5: Southern station 1-hour average NO₂

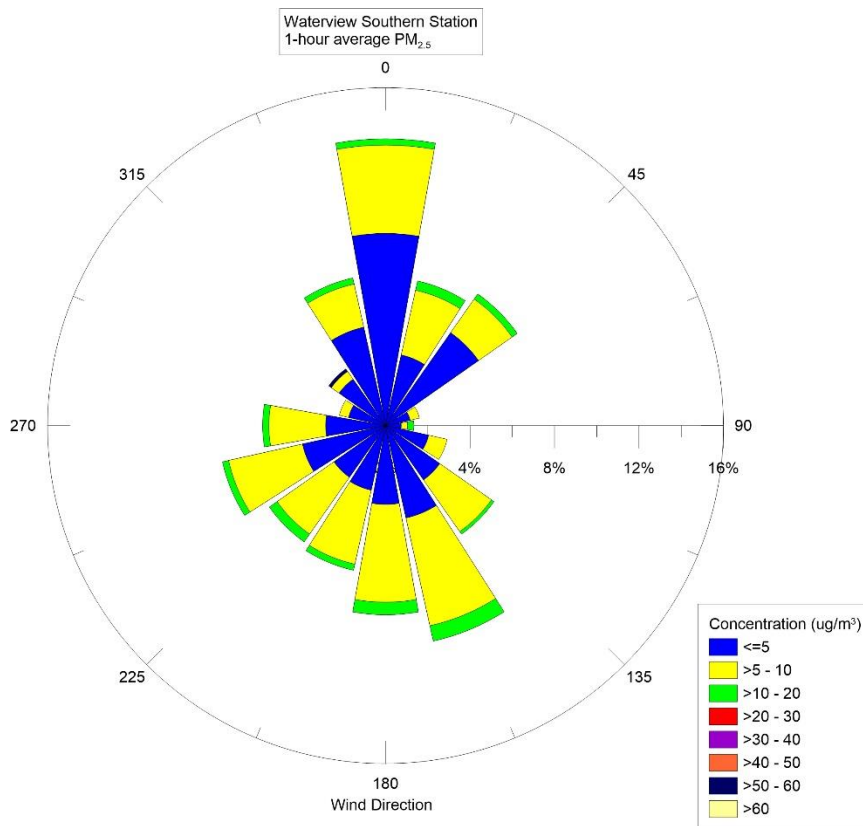
Figure D 6: Southern station 1-hour average PM_{2.5}

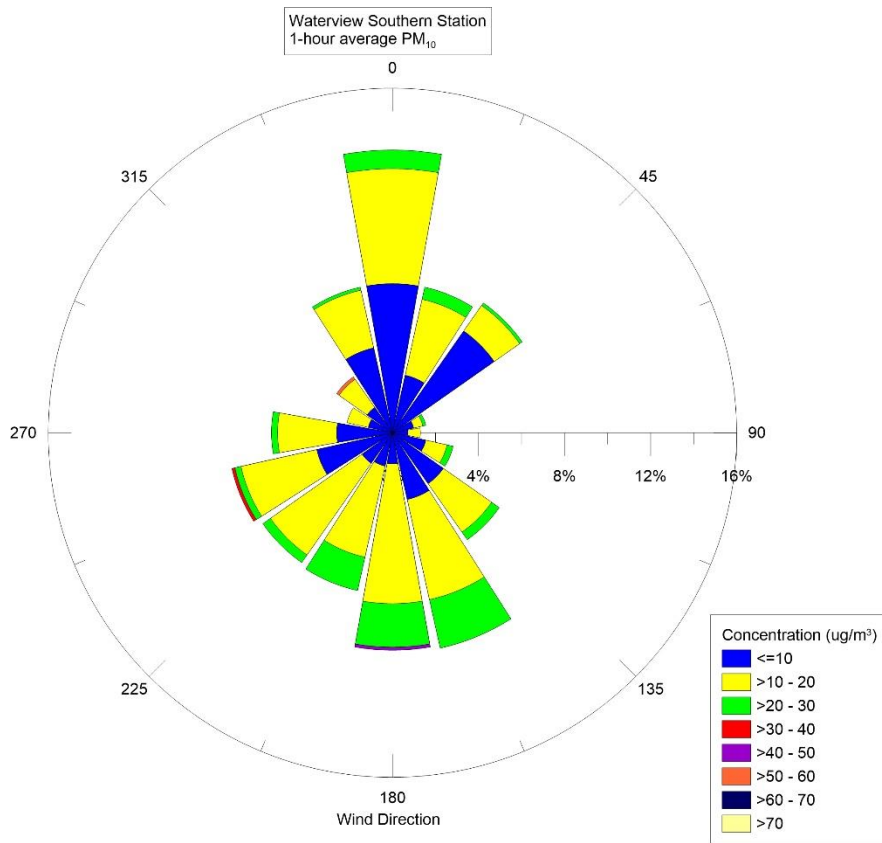
Figure D 7: Southern station 1-hour average PM₁₀
