9 FOUNDATIONS

9.1 GENERAL

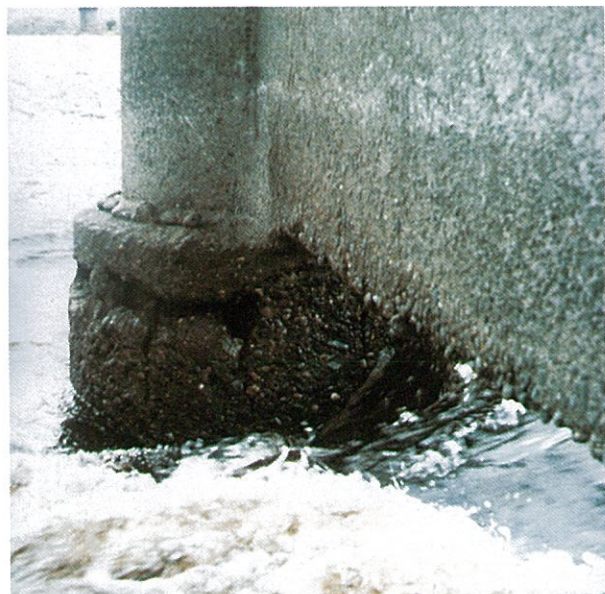
Figure 9.1: Abrasion of concrete pile cap.

Foundations in gravel-bedded rivers with high-velocity flow may be subject to abrasion at bed level and below. Detection may require divers or remote TV, but should be carried out during a Detailed Inspection. If abrasion is significant, the effective cover remaining should be verified by measurement or by use of a covermeter.

A remedy for abrasion is to jacket the piles with reinforced concrete. There are proprietary sleeves available to use as formwork, and the recommended method of placing the concrete is to use pre-placed aggregate and then grout it.
