# Mobile phone and seatbelt detection trial

## Report

24 July 2023

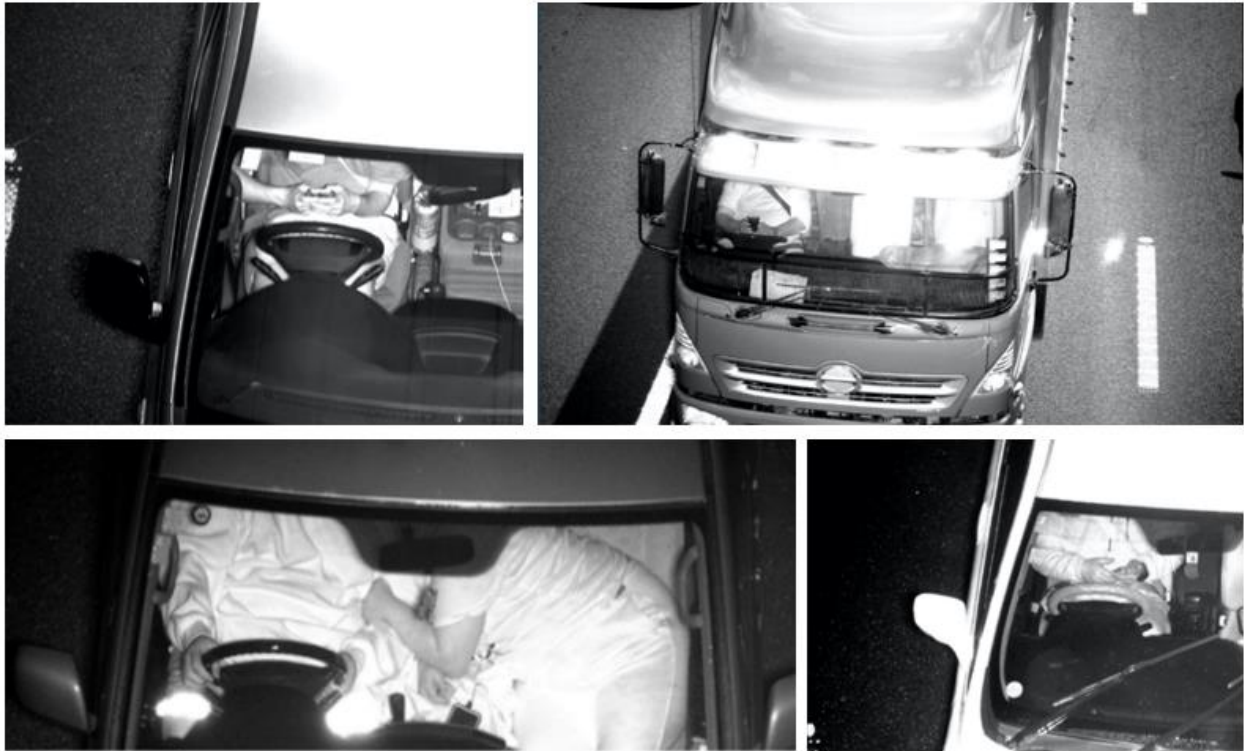
The images evaluated were very clear and would allow offence processing in line with the current practices followed in Aotearoa New Zealand for speed and red-light offences. For image-based offence detection, the current legal requirements are that the image shows a motor vehicle on a road and captures the offence (the offence description may be supported by data included in the header on an evidential image). The images evaluated met these criteria.

### Anonymised sample of offence images:

The safety cameras take a photo of the cockpit of an approaching vehicle and focus the image on the driver's hands. The automated detection system uses Artificial Intelligence (AI) to determine whether the driver is holding a mobile phone or wearing a seatbelt. This happens at the roadside. Should the AI return a positive result, the encrypted image is sent through to the vendor back office for human verification. Images that don't appear to show distracted driving or a driver not wearing a seatbelt are deleted instantly by the camera. All data is fully encrypted throughout the capture, AI scan, transfer and subsequent back-office activity.
