## Welcome to the Construction Update for the Baypark to Bayfair Link (Bay Link) project.

CPB Contractors is carrying out the design and construction for Bay Link. The Construction Update provides an overview of what's happened and what's coming up for the project.

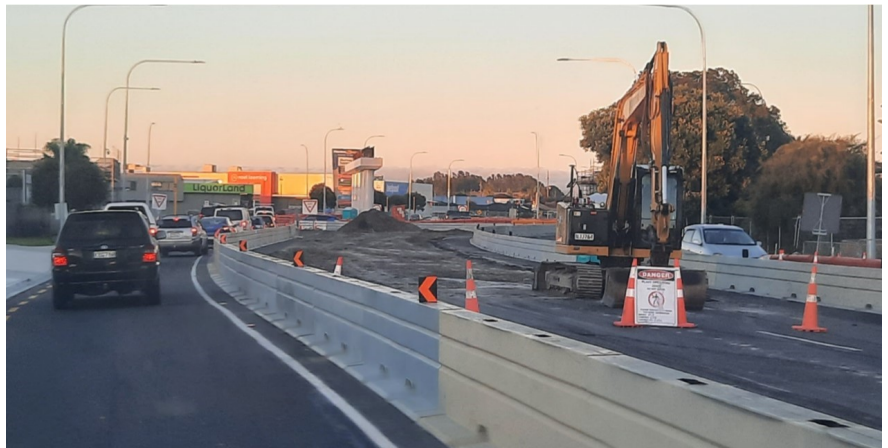
The inside lanes on this section of Girven Road are temporarily closed to enable the road in this area to be replaced (pictured). In the central work zone, created as a result of the lane reduction, you'll continue to see crews excavate into the ground before the road is rebuilt.

- Once the existing asphalt is removed, the road is dug out down to the top of the subgrade level (approximately 500mm below the finished road level).
- A rigorous testing regime will be carried out on the exposed subgrade to ensure the new road is constructed on a solid foundation. Tests will be undertaken to a depth of 1500mm (approximately two metres below the finished road level) to check the subgrade's quality, including its density and composition. If organic material (such as topsoil, tree roots or shells) is discovered, it will be removed and replaced by a more stable material. Subgrade preparation is sensitive to wet weather, and rain during this stage may cause delays.

- Once the subgrade meets the required standard, a 150mm thick layer of sub-base will be constructed on top using roading metal.
- To form the basecourse, structural asphalt will be laid on top of the sub-base, up to 240mm thick, prior to these lanes reopening to traffic. The sections of permanent road that have already been constructed elsewhere on Bay Link, such as the left-hand lanes of Girven Road near the Bayfair roundabout, are all at this stage.

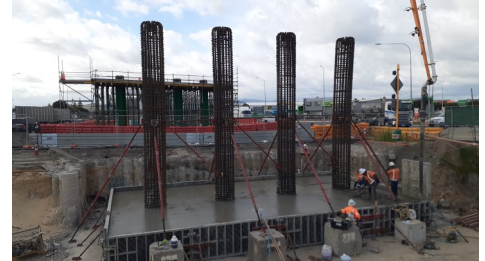
- A second bridge pier is under construction inside the Bayfair roundabout. Steel reinforcement cages have been stood vertically and concrete columns poured. Steel reinforcement is being assembled for the pier head (the component on which bridge beams are placed), before this is poured in the first week of March .
- A third bridge pier is also under construction between the Bayfair roundabout and the underpass (pictured). Steel reinforcement cages have been stood and the pier base poured.
- The manufacturing of bridge beams, which will be installed on the Bayfair flyover in stages later this year, has begun offsite. The four-span flyover will comprise 24 beams (six beams per span).
- Base slabs have been poured in the central, open-air trench section of the underpass.

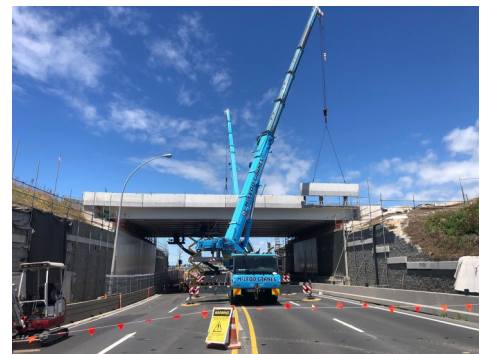
- Barriers and service ducting were installed on the bridge over State Highway 2 near the Te Maunga intersection during a weekend closure of SH2 in January. Crews worked around the clock with two cranes installing barriers simultaneously (pictured), enabling the closure to be completed ahead of schedule.
- Road construction is in full swing in this area, ahead of the partial opening of the Te Maunga interchange mid this year. The final stage of the ramp between the new southern roundabout and the rail bridge was recently asphalted. Subgrade testing and preparation is underway on the ramp between SH2 and Eversham Road, and the area between the two new Te Maunga bridges.
- Service ducting for traffic and street lights is also being installed.
